EVALUATION OF 22A GRADATION  
OPEN HEARTH SLAG AS A BASE AND  
SUBBASE CONSTRUCTION MATERIAL

Final Report

**J. H. DeFoe**

**Research Laboratory Section  
Testing and Research Division  
Research Project 68 E-43  
Research Report No. R-1147**

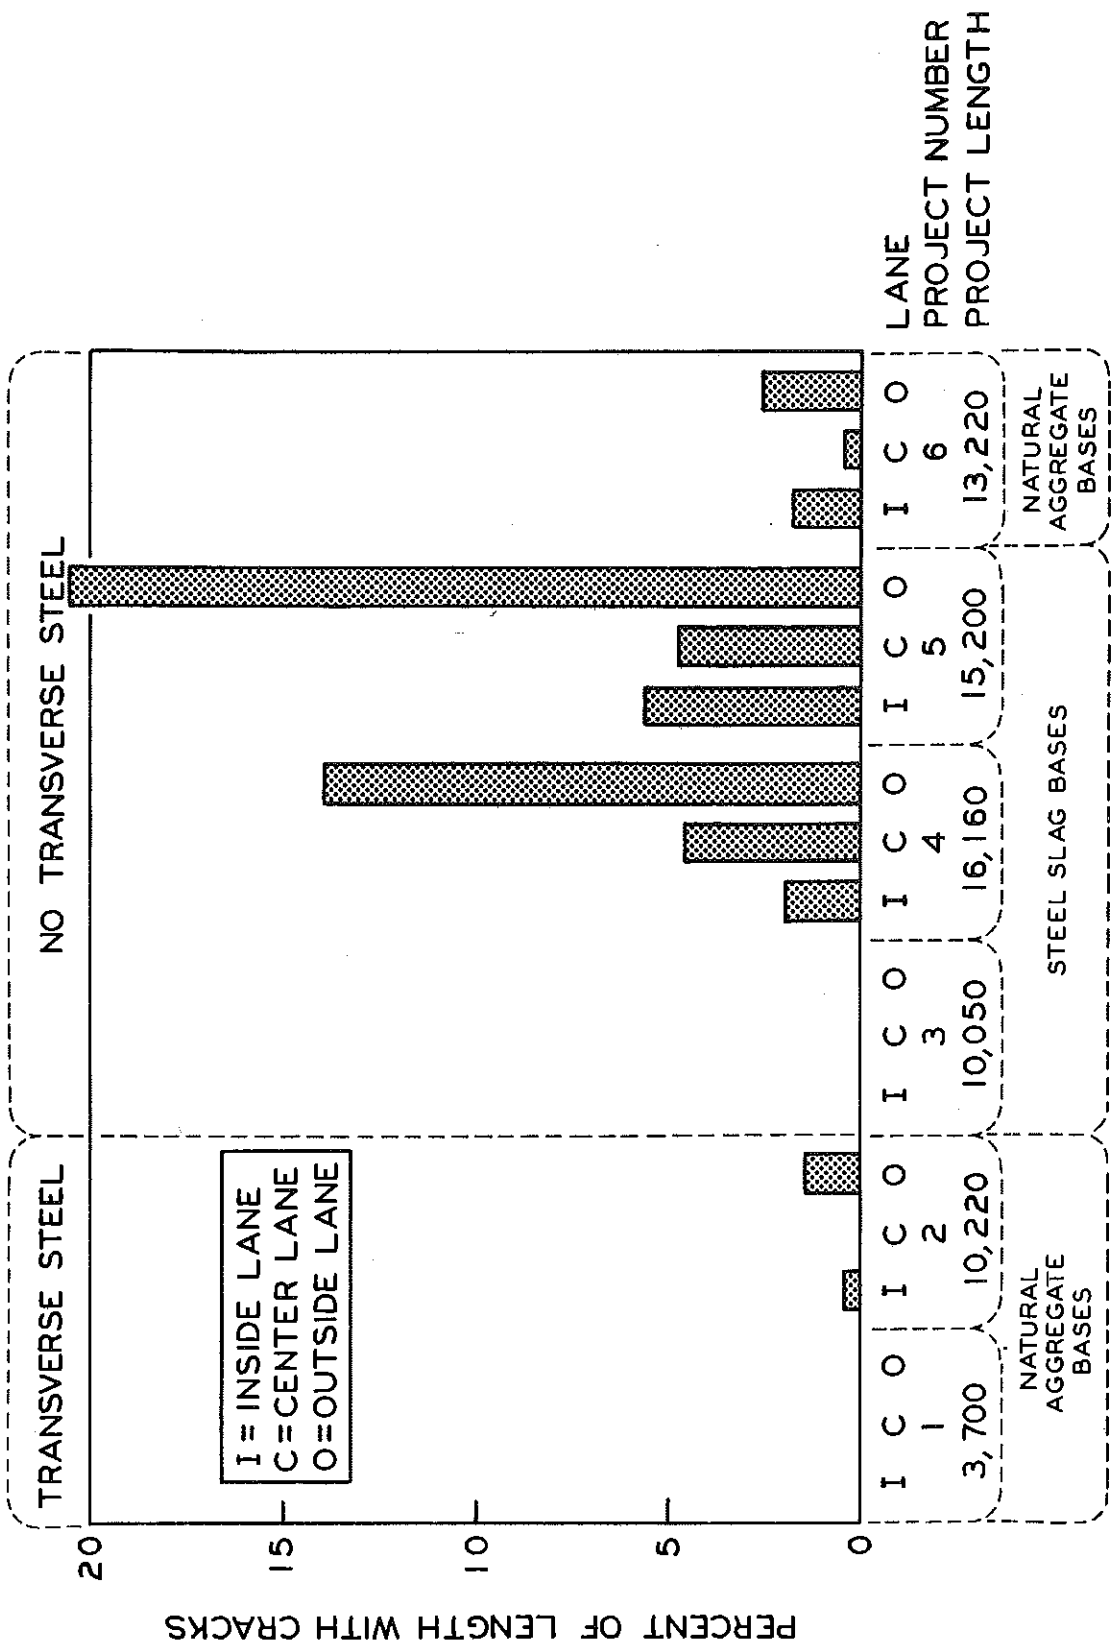
Figure 1. Percent of lane with longitudinal cracks on Projects 1 through 6 as of March 1979 (from Ref. (18)).

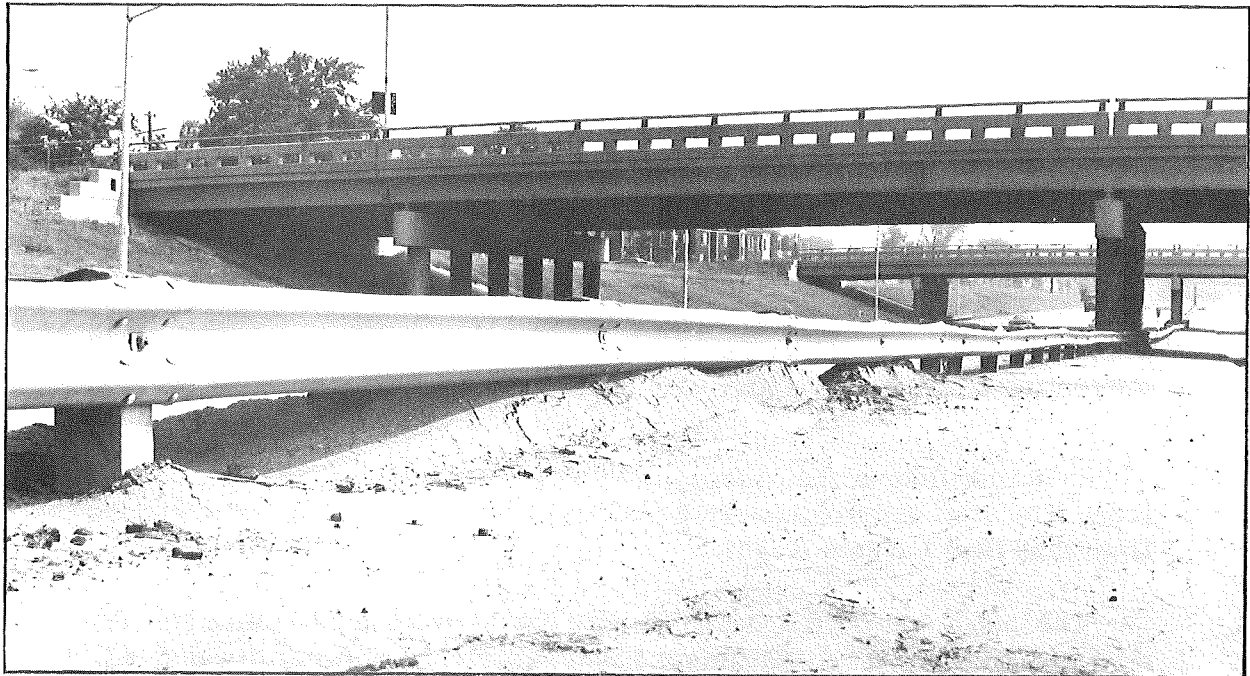
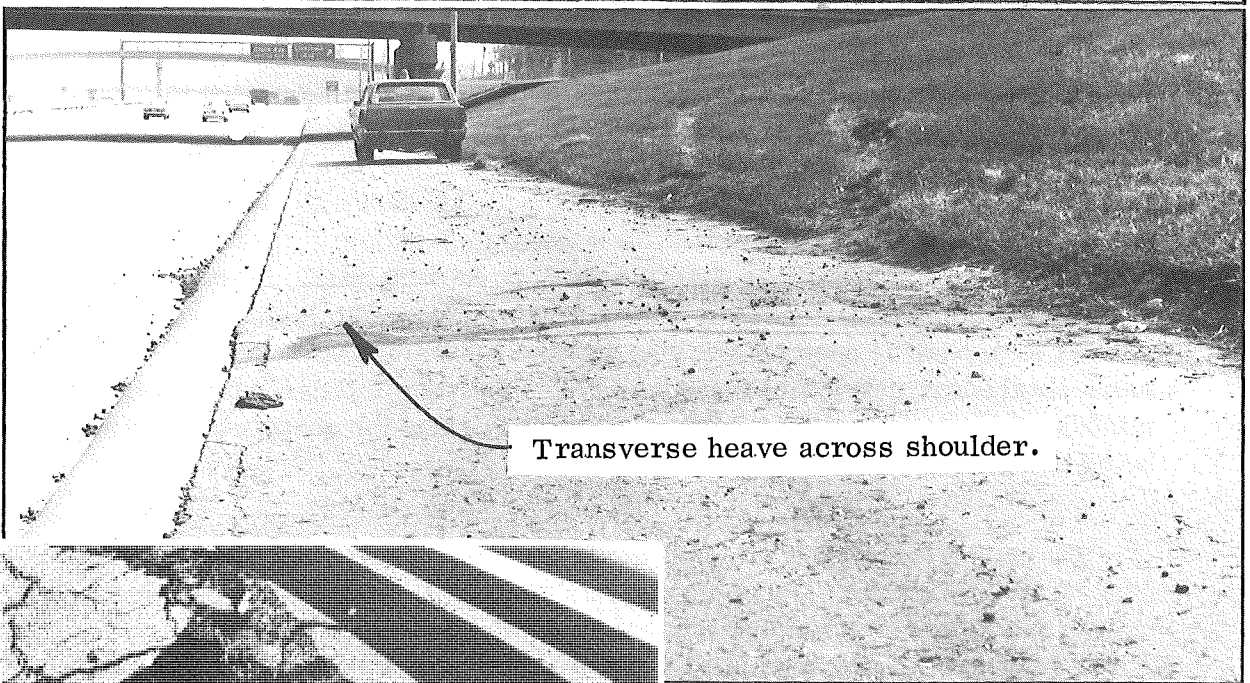
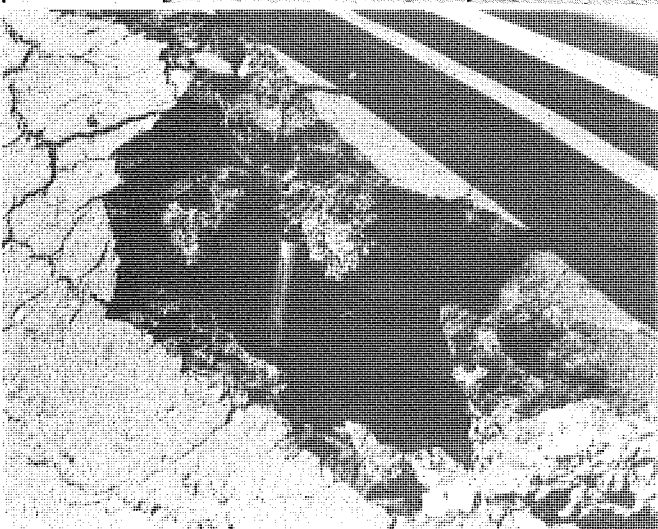
Fisher Freeway Median - This severe heaving problem, which resulted in the initiation of this research project (68 E-43), is documented by photographs.

Figure 2. Heaving of bituminous surfacing placed over base of steel furnace slag, Fisher Freeway, I 75, Wayne County.

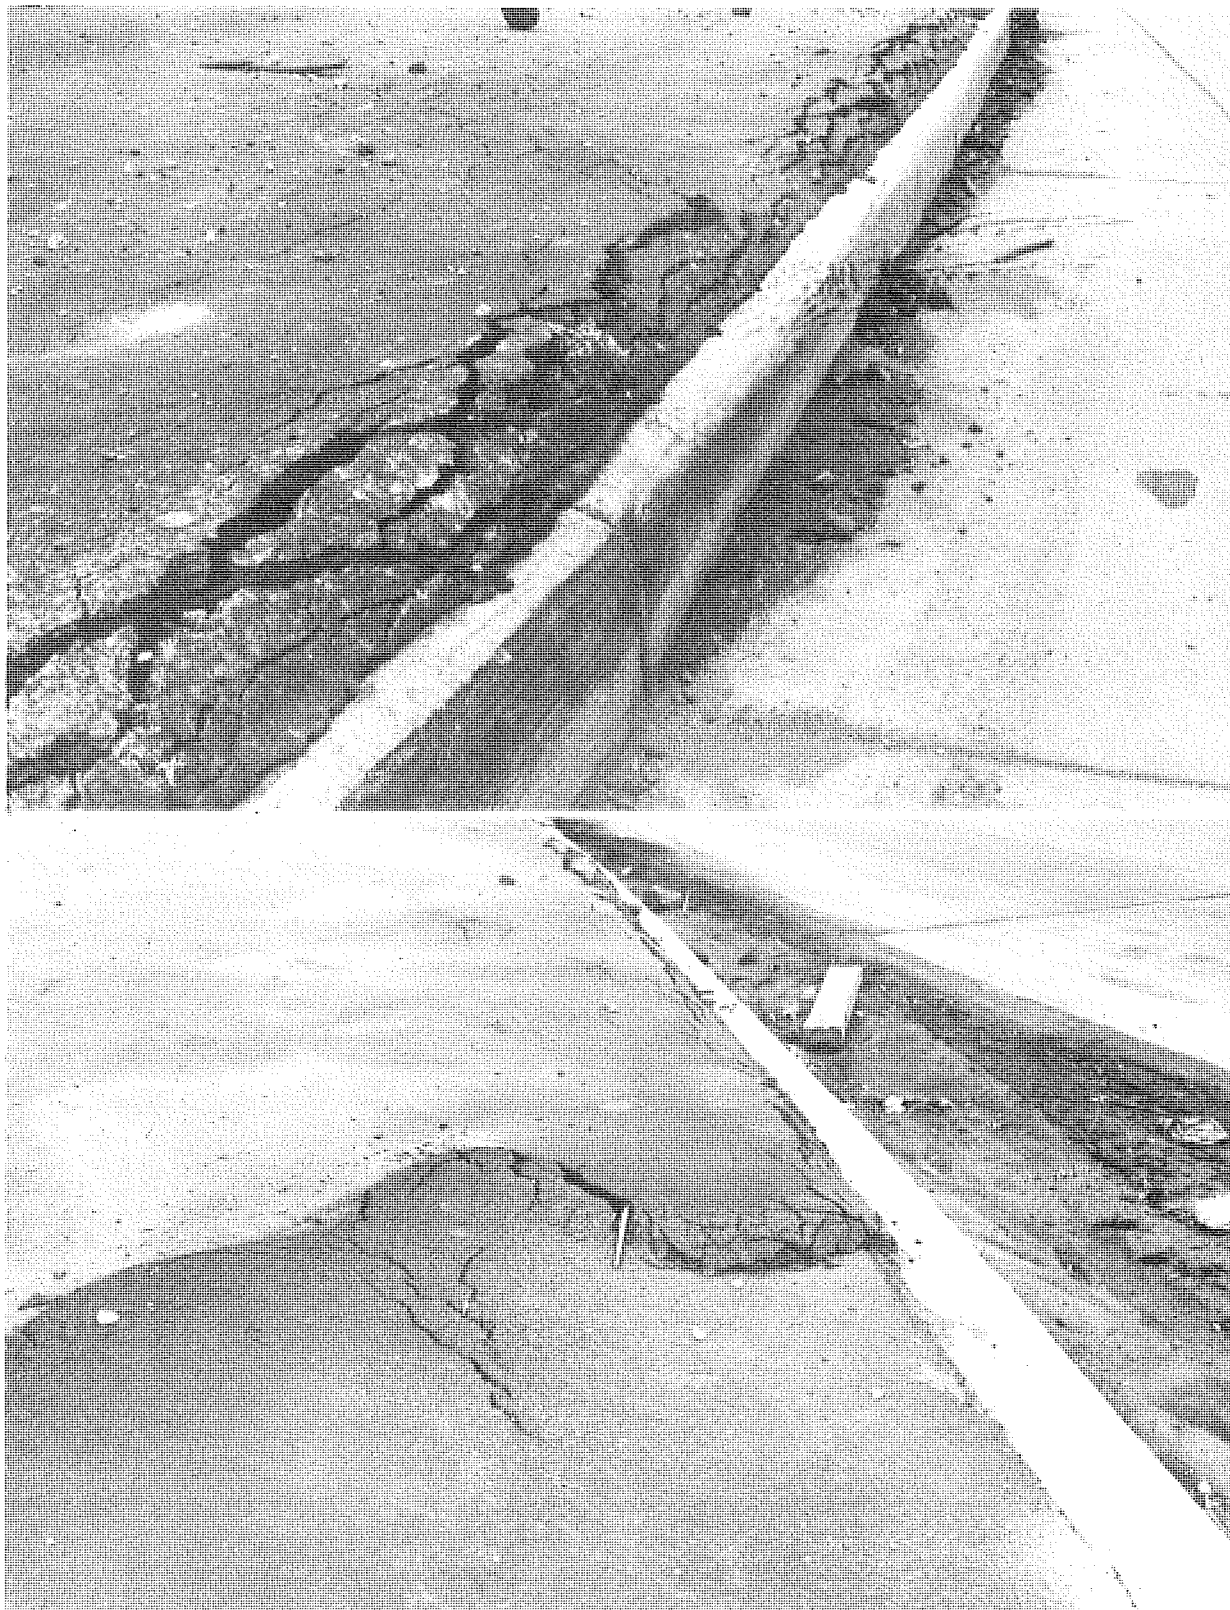
Figure 3. Bituminous surface, Dearborn St traffic island, constructed over base of steel furnace slag (1968).

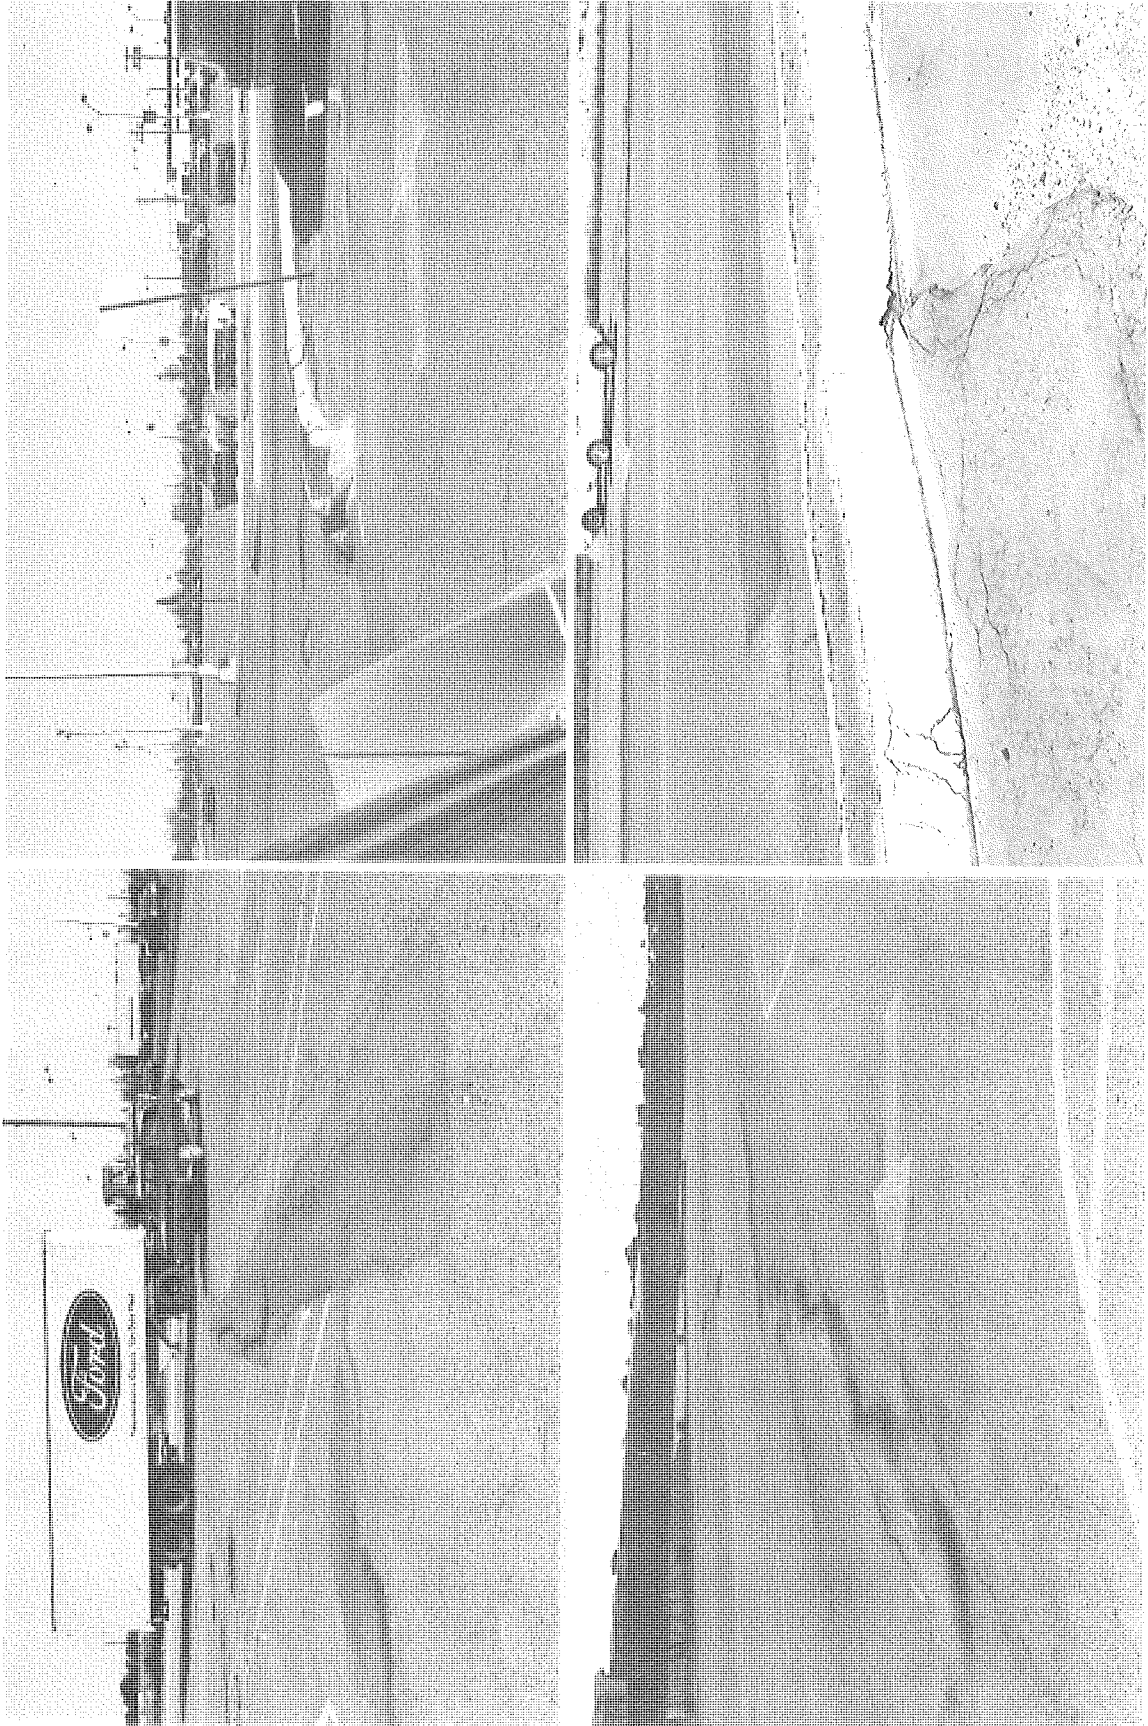
Figure 4. Shopping mall parking lot, 14 Mile and I 75, with open hearth slag base (constructed 1967 and 1968).

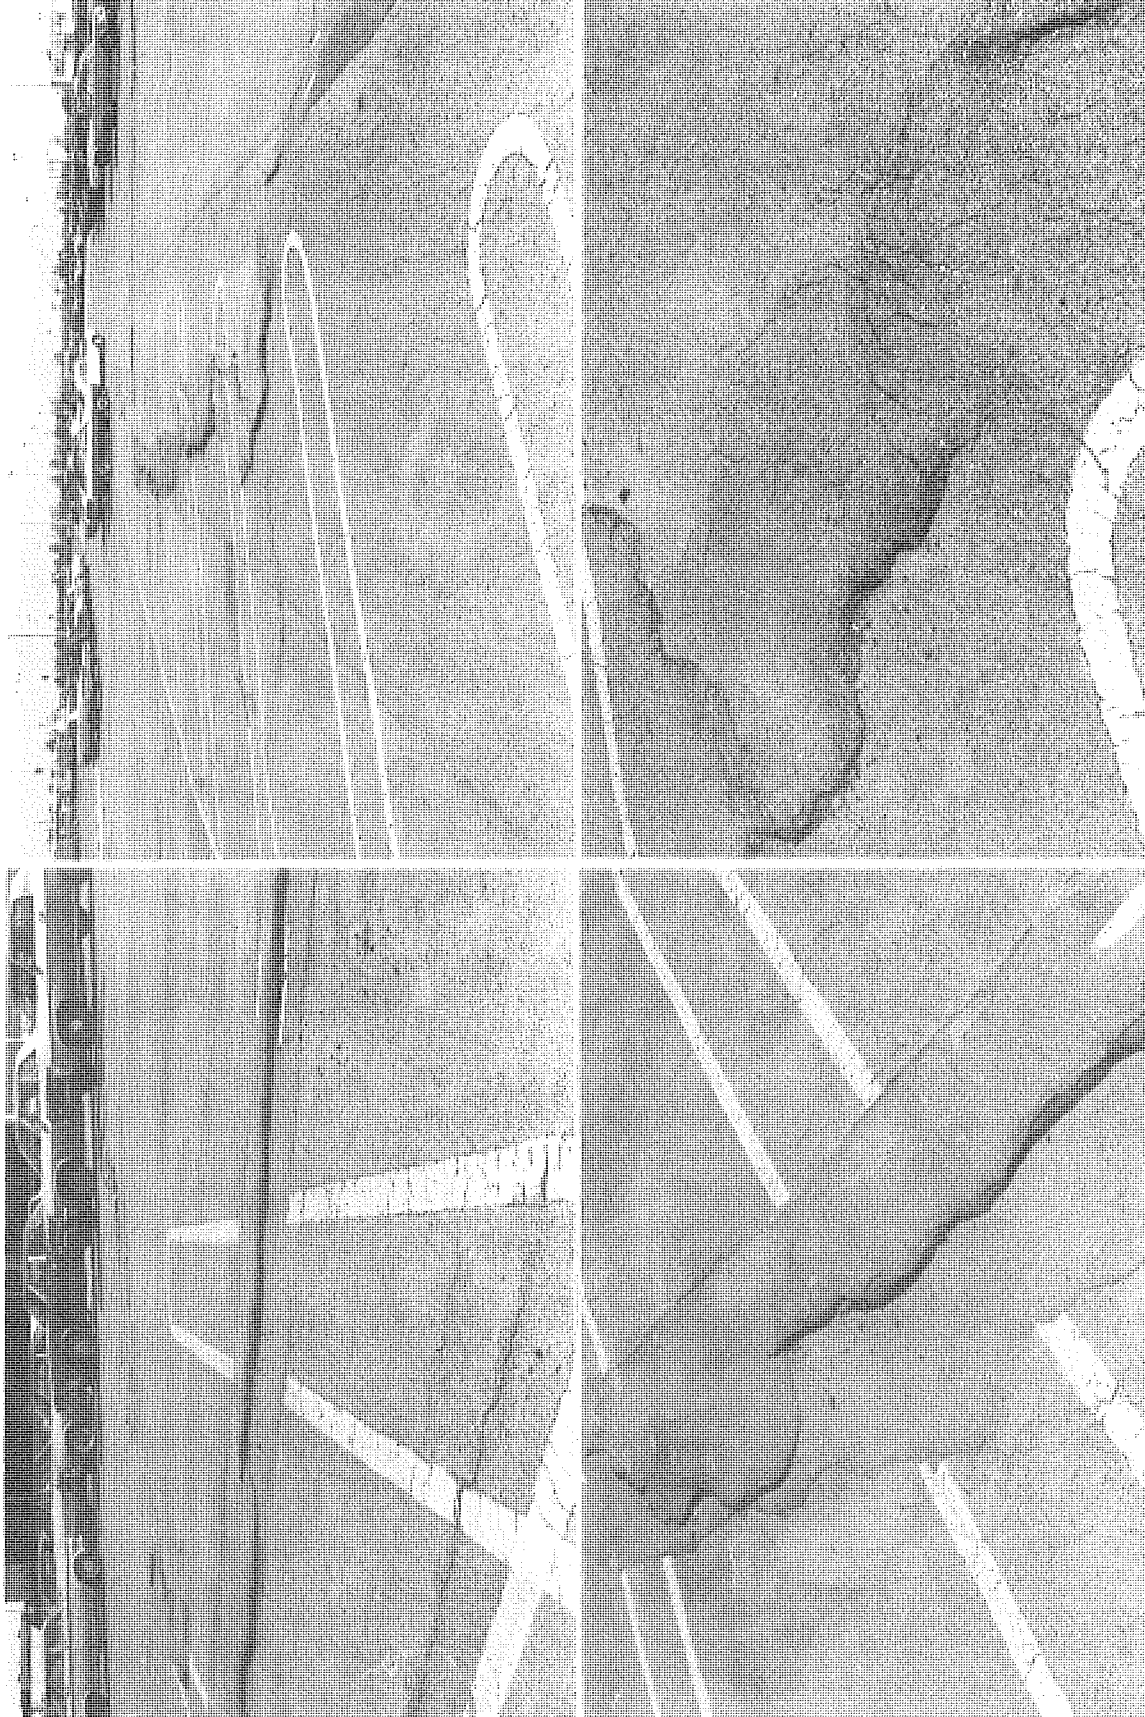
Figure 5. Shopping mall parking lot, 14 Mile and I 75, with open hearth slag base (constructed 1967 and 1968).

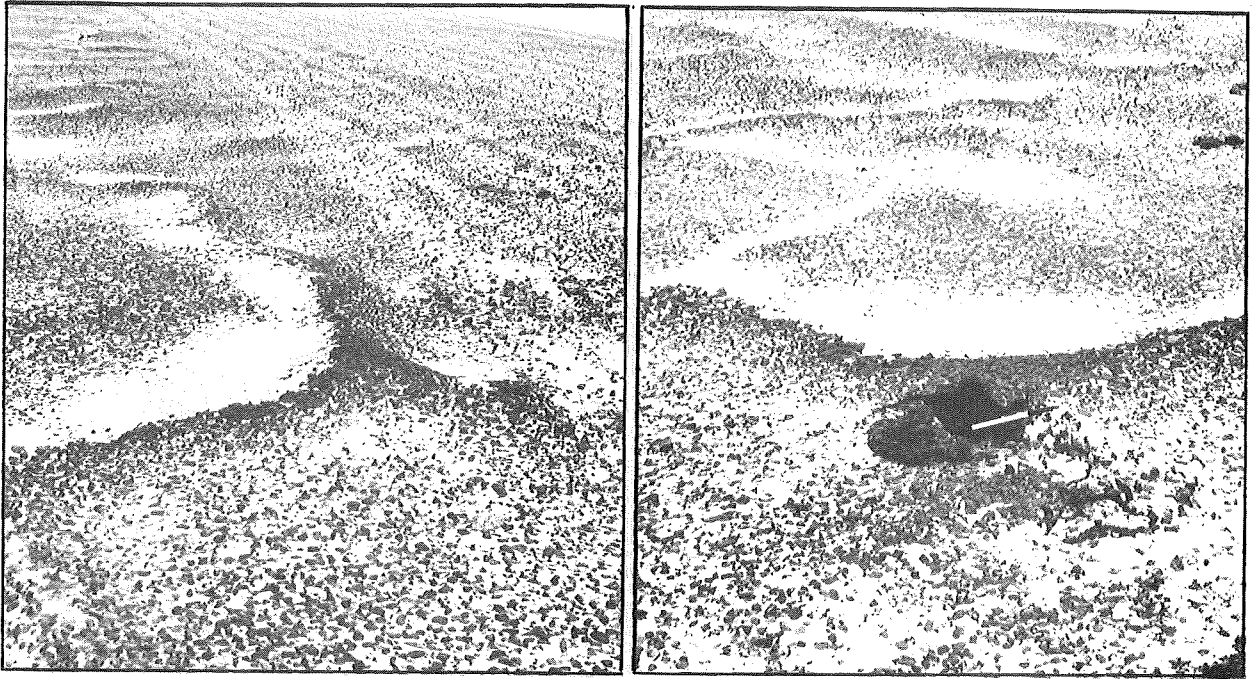
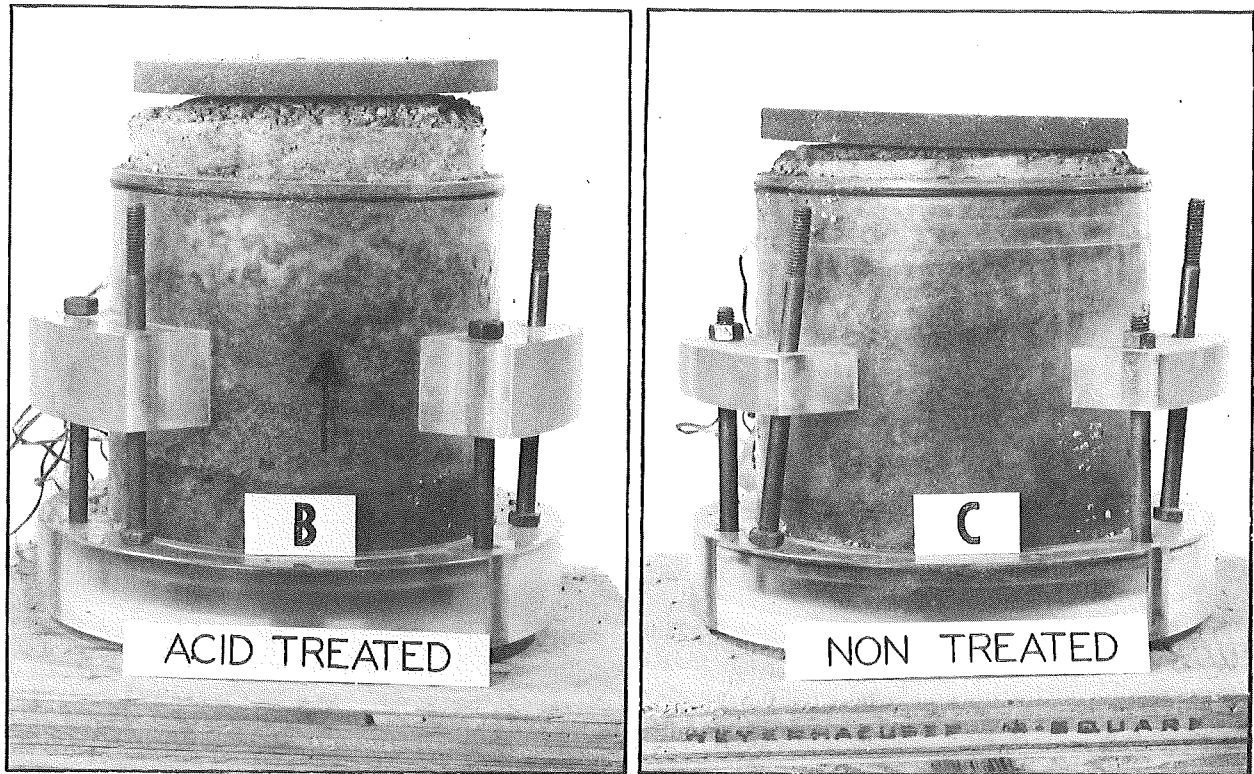
Figure 7. Laboratory frost susceptibility tests showing relative heaving of acid treated and non-treated steel furnace slag.

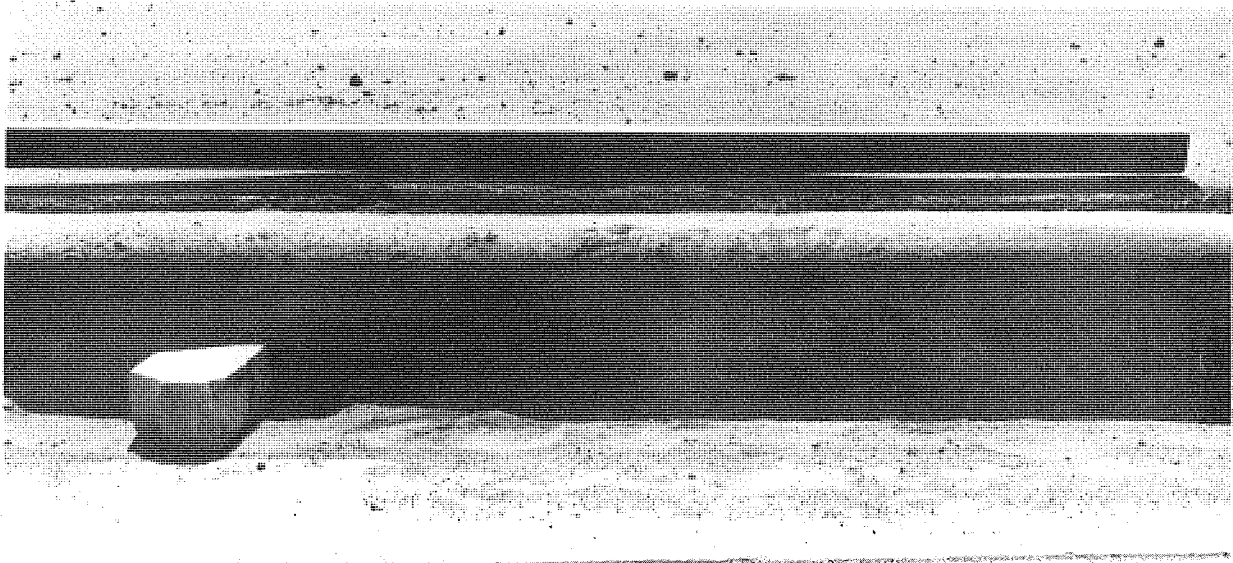
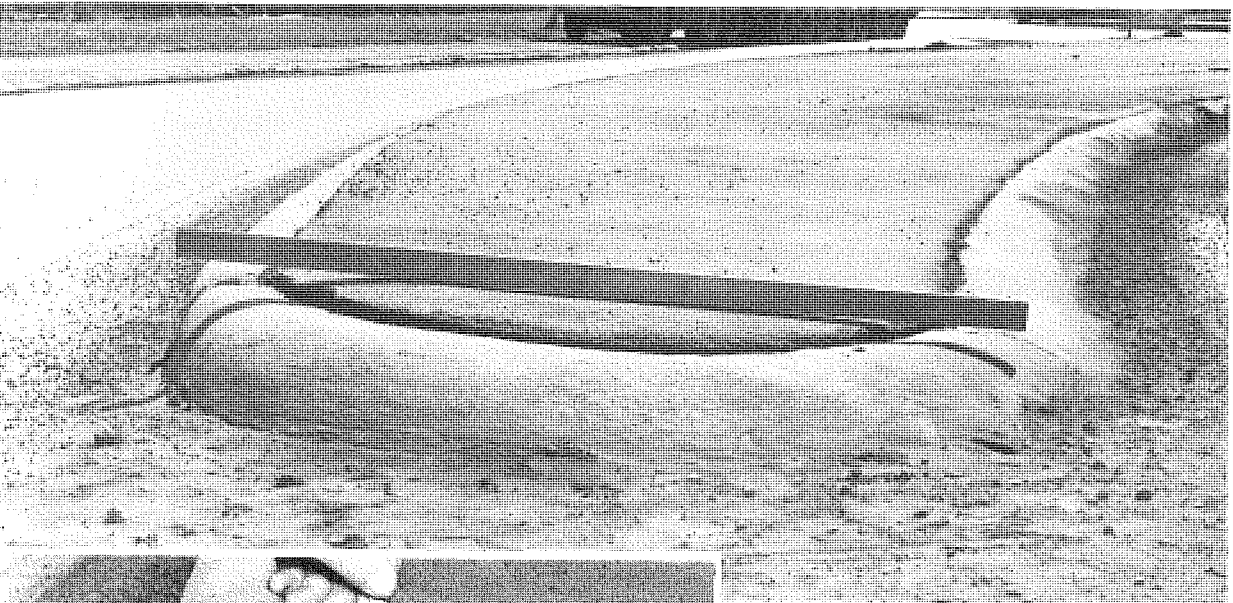
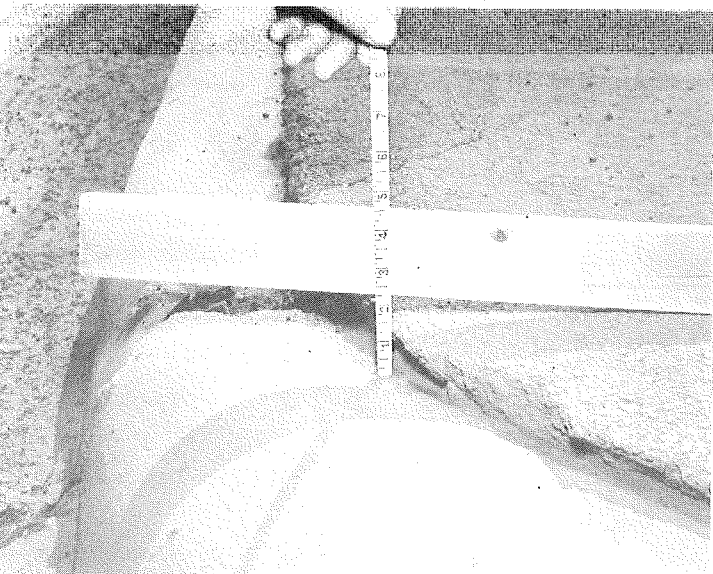
Figure 8. Condition of Dearborn St traffic island after reconstruction of base and surfacing showing heaving of slag base area.

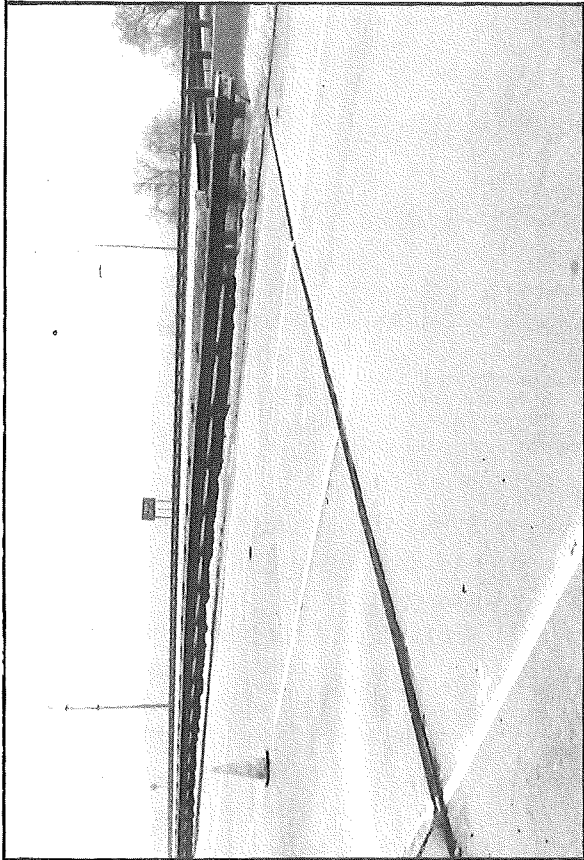
Vertical slab displacement of approximately 2 in.

Figure 9. Heaving of concrete pavement slab constructed on a base of steel furnace slag, I 275 in Wayne County.

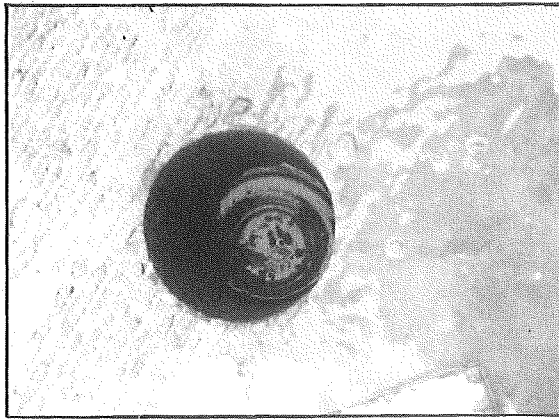
Core hole through pavement showing water retained in the slag base.

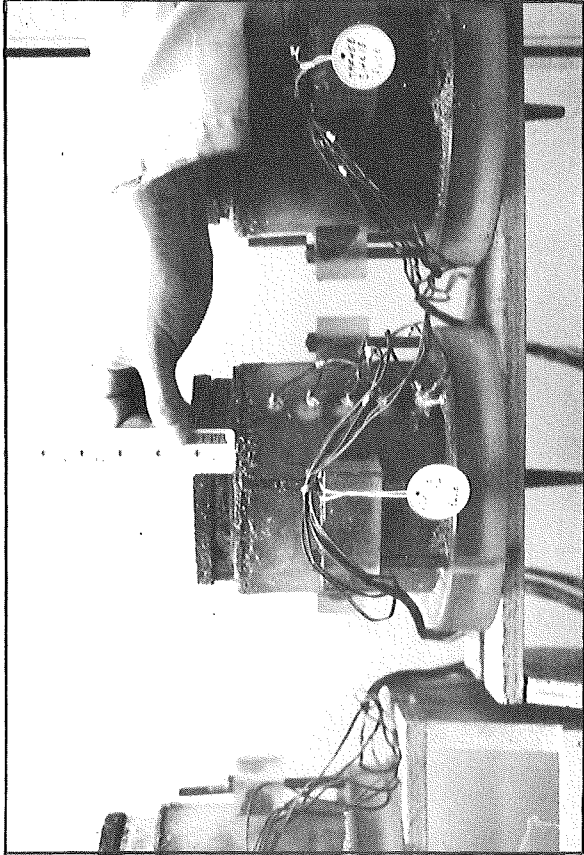
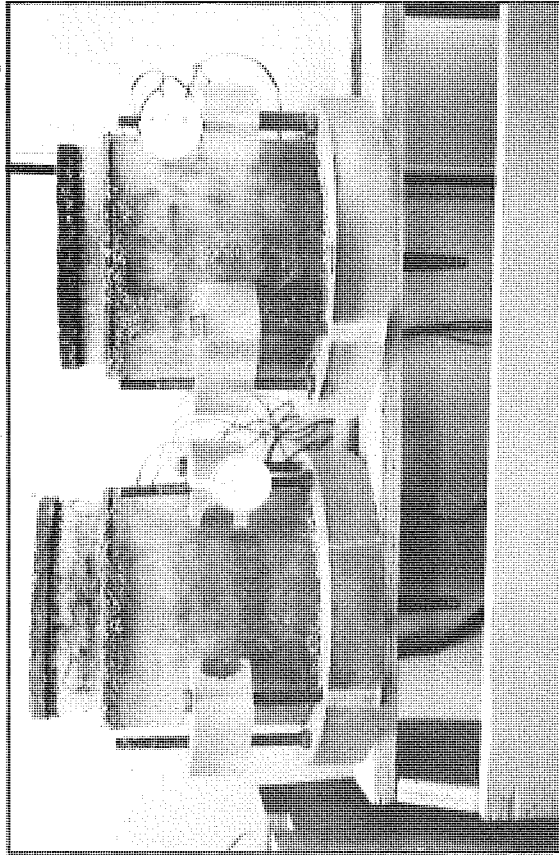
The most recent Departmental study which involved steel furnace slag concerned problems on I 275 in Wayne County (18). The steel slag base course exhibited frost heave values ranging from 1.06 to 4.07 mm per day. Frost heave values of from 1 to 2 mm per day are classified as low and values from 2 to 4 mm per day are considered moderate. In addition, the slag base material was shown to be impervious rather than to be free draining as a base should be. Of the six construction projects in this study, three with steel slag bases showed a significant amount of longitudinal cracking; whereas, the projects with natural aggregate bases had much less longitudinal cracking (Fig. 1). A photographic history of problems encountered in Michigan with steel furnace slag is presented in Figures 2 through 10.

Figure 10. Laboratory frost susceptibility tests showing heaving of steel furnace slag taken from the base course of I 275, Wayne County (1979).
