STATE HIGHWAY DEPARTMENT

September 14, 1966

Subject: "Fiberglass" Reinforced Plastic Rods. Research Project 66 NM-155.
 Research Report No. R-606.

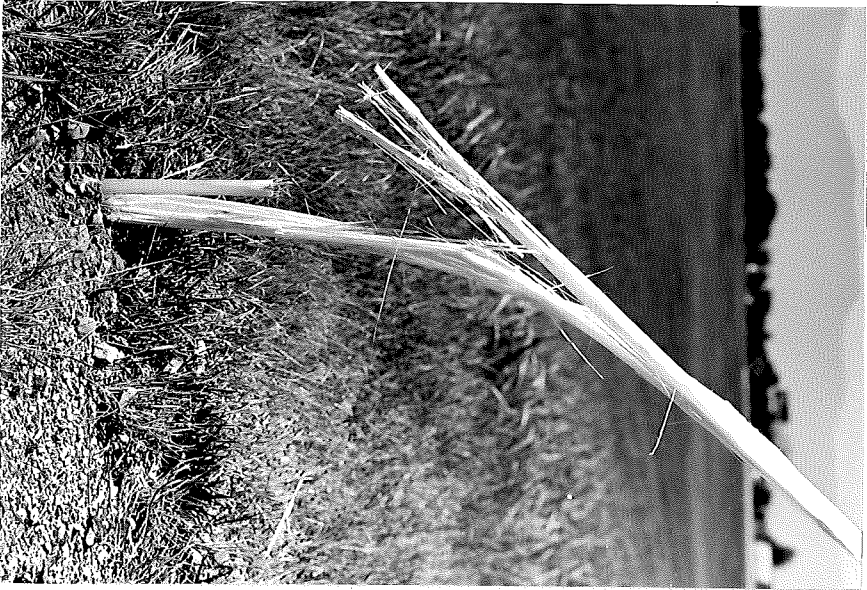
Figure 1 shows the damage caused by hitting a rod 6 in. above ground and 12 in. above ground. Although the rods hit at the 12-in. height returned to their original position after impact, their rigidity was greatly reduced, because of fractures in the outside fiber layers. As illustrated, major damage to the rod hit 18 in. on the side from which the rod was hit were fractured near the top of the rod, as well as at the point of initial impact. Based on the results of these tests none of the rods could be re-used after impact.

Impact 6 in. above ground.

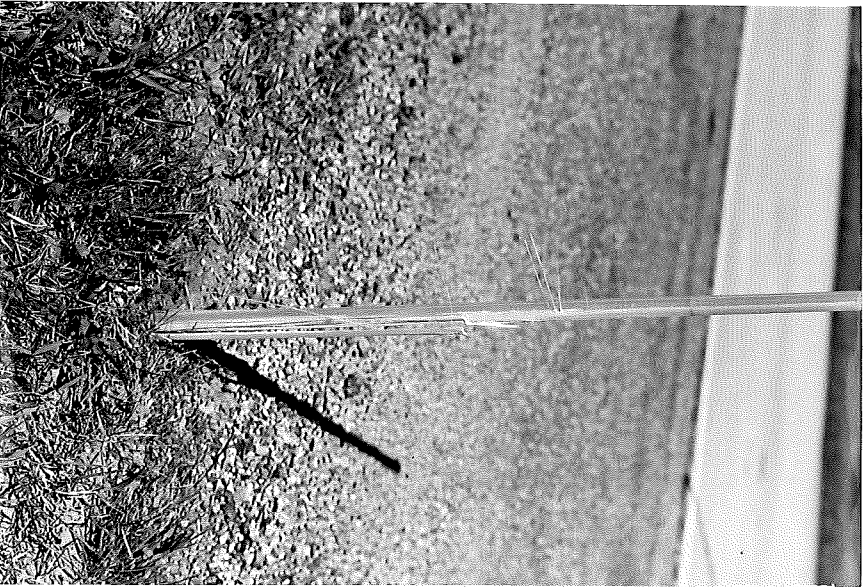
Impact 12 in. above ground.

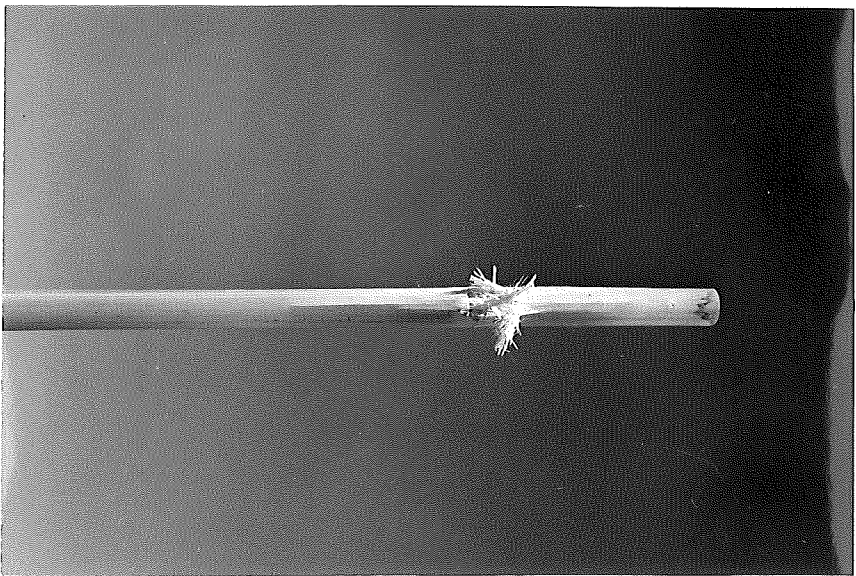
Impact 18 in. above ground.
