September 14, 1966

Subject: "Fiberglas" Reinforced Plastic Rods. Research Project 66 NM-155.
Research Report No. R-606.

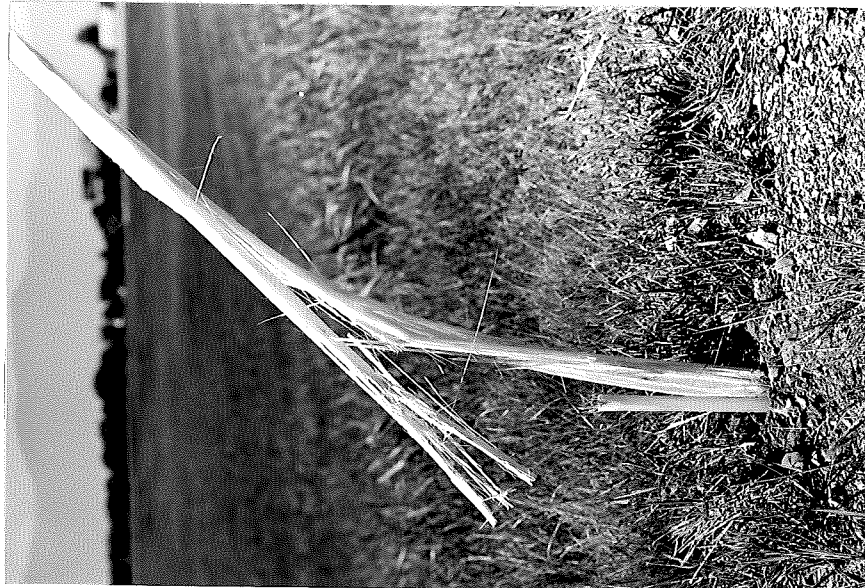
Impact 6 in. above ground.

Figure 1 shows the damage caused by hitting a rod 6 in. above ground and 12 in. above ground. Although the rods hit at the 12-in. height returned to their original position after impact, their rigidity was greatly reduced, because of fractures in the outside fiber layers. As illustrated, major damage to the rod hit 18 in. above ground was confined to its top. The rod split longitudinally, and the fibers on the side from which the rod was hit were fractured near the top of the rod, as well as at the point of initial impact. Based on the results of these tests none of the rods could be re-used after impact.
