PERFORMANCE OF A 20-YEAR-OLD SECTION OF US 27
Marshall to the Eaton County Line (13072)

Research Laboratory Division
Office of Testing and Research
Report No. 306
Research Project 54 F-37

Michigan State Highway Department
John C. Mackie, Commissioner
Lansing, March 1959

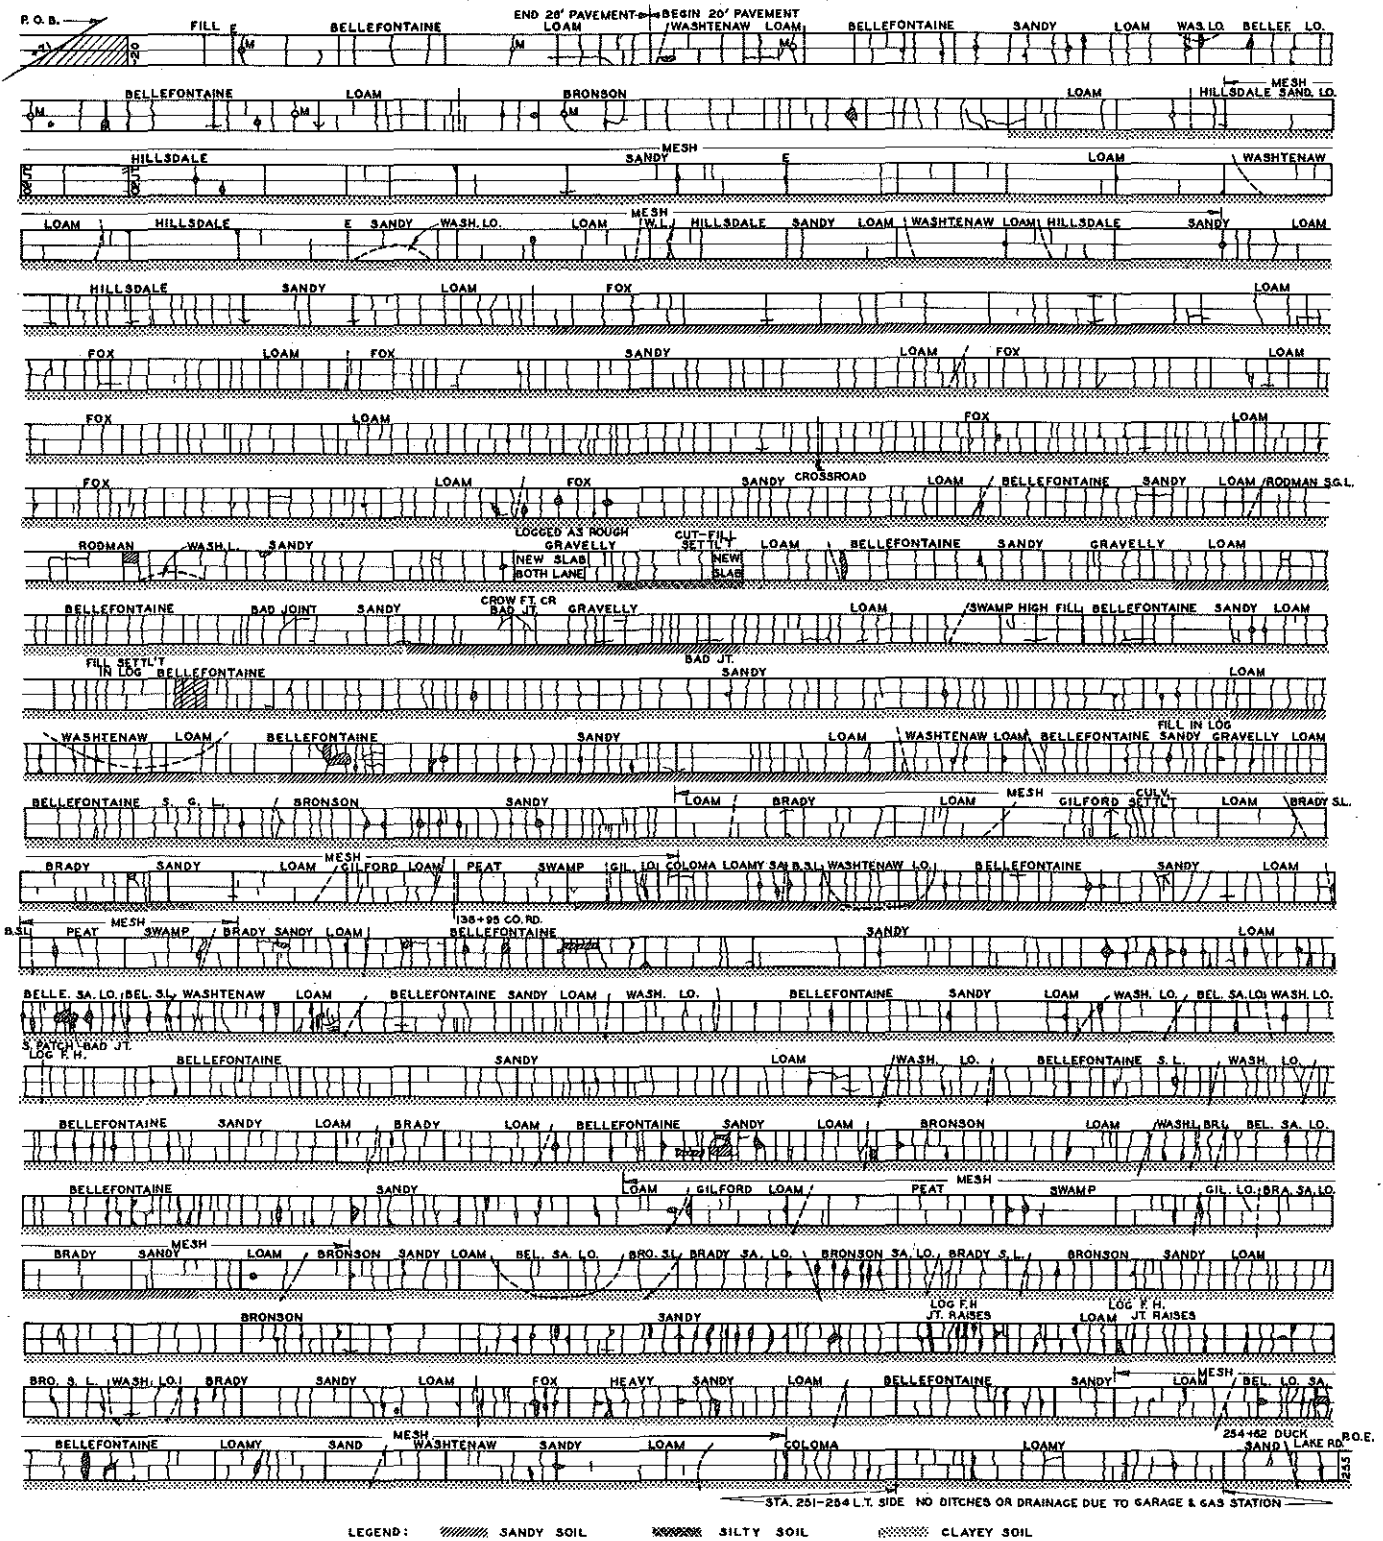
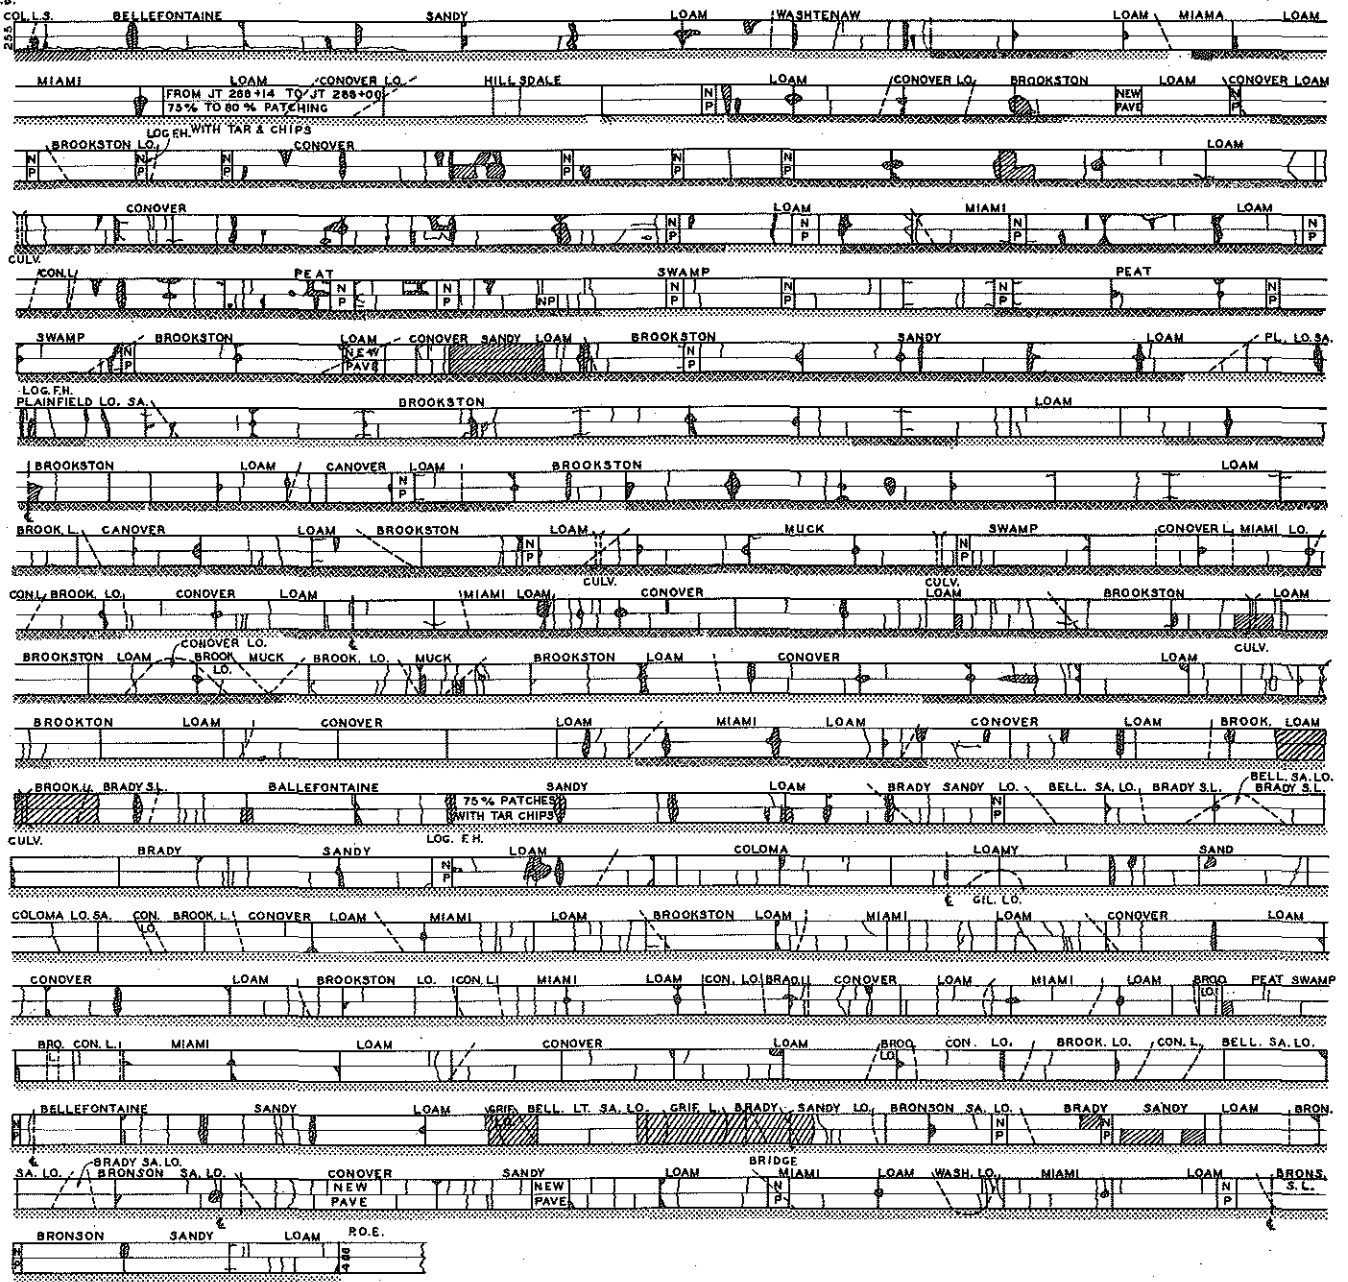
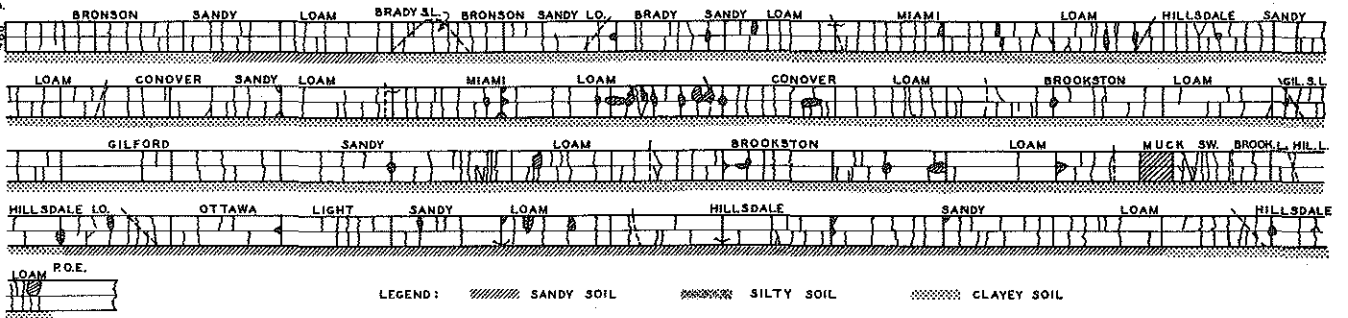
Figure 3. Pavement Condition and Soil Survey Information

Pavement surface condition was determined by field parties and plotted to scale on a base map, as shown in Figure 3, according to standard procedures of the Research Laboratory Division. In addition, a photographic record was made of the most important pavement features and others considered typical of these contracts (Figs. 4-6). In analyzing data from a pavement condition survey, any crack whose length exceeds half a lane-width, forming an angle less than 45 deg with a perpendicular to the slab centerline, is considered one crack. A crack extending across two lanes is considered two cracks. Repairs included surface patching, deep patching, and slab replacement.

The soil types determined by shoulder borings are shown in Figure 3, plotted by stations on the same base map used for the surface survey. From this notation a general picture may be developed, relating pavement condition and soil type.

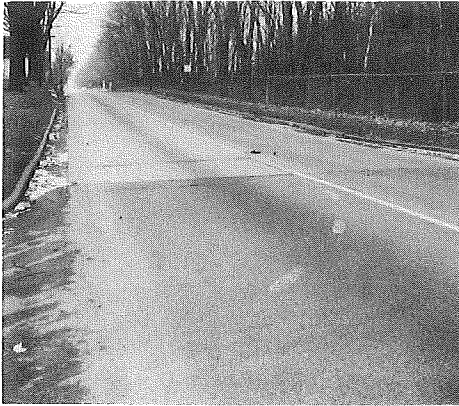
▲ Station -20+17 looking north. The widened urban section of US 27, built by part-width construction, has a generally smooth-riding surface. Slight faulting occurred at the transverse joint in foreground.

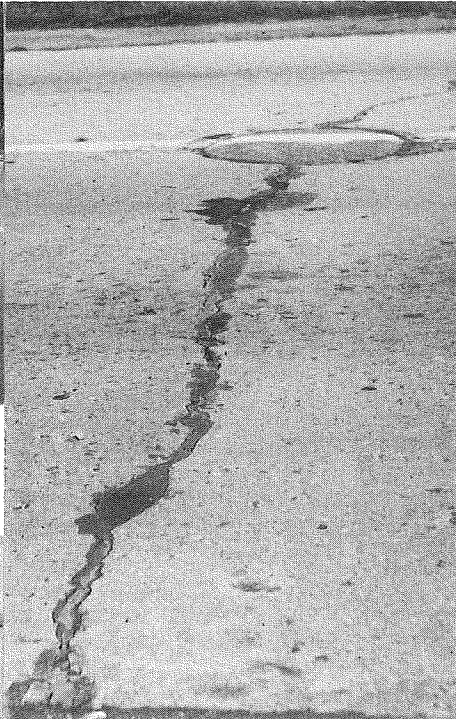
▲ Station 13+98. Transverse cracks developed over sanitary sewer pipes.

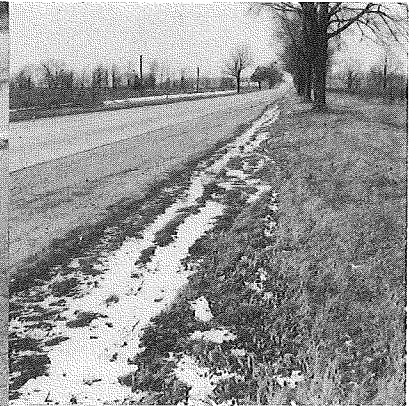
▲ Station 48, looking north. Drainage was blocked along much of the route, with tire ruts crossing shoulders and ditches.

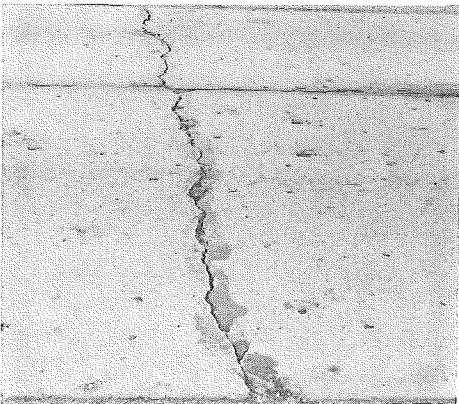
▲ Station 49+78. Typical of cracks in non-reinforced concrete sections.

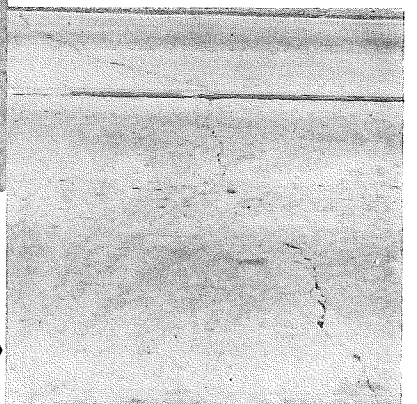
Station 113+50 looking south. On this Contract, deterioration was often found over inadequately compacted soil and where heaving occurred at a point of transition from cut to fill.

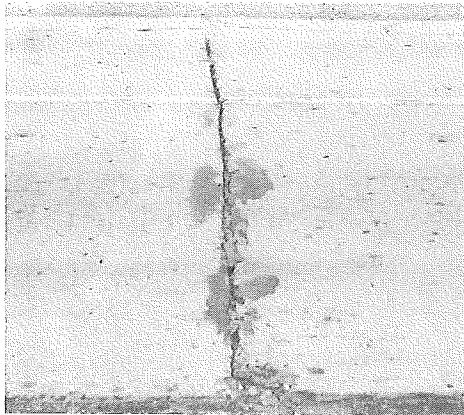
Station 89+49. The condition of this expansion joint was typical of those in Contract 3; note longitudinal cracking (top). occasionally found in this project.

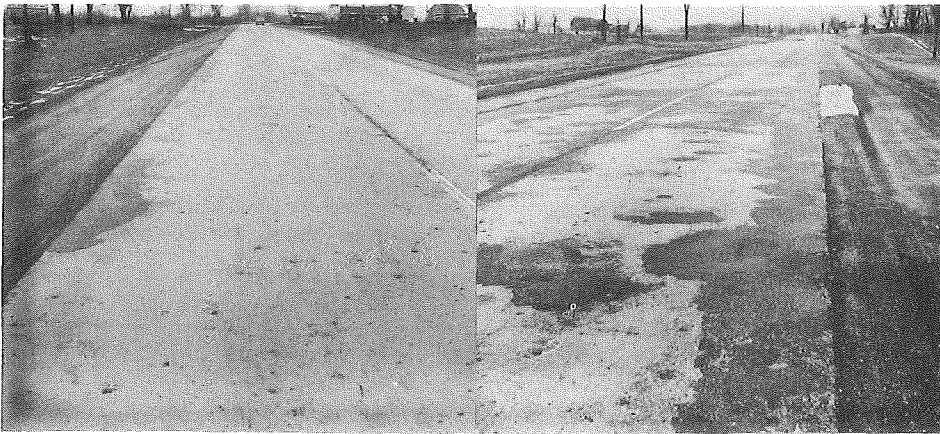
▲ Station 249 looking South. Edge disintegration without presence of serious cracking was frequently found in Contract 4. Built in 1934, this section's wire mesh reinforcement seemed to have effectively controlled cracking for more than 20 years (POB at top of Figure).

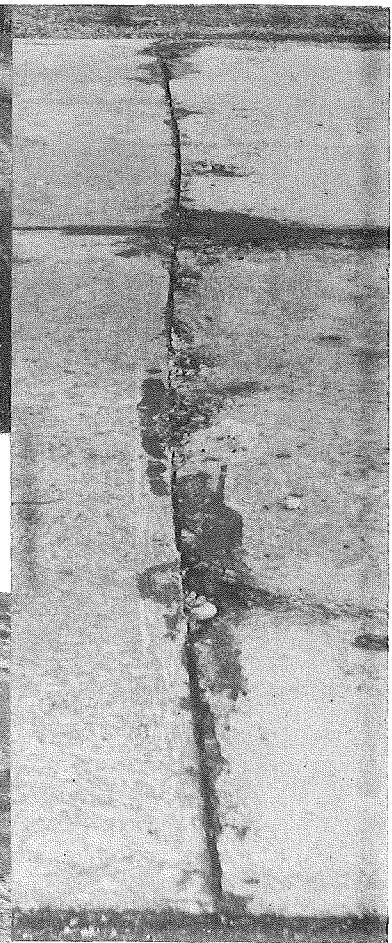
▲ Station 278+20. This patch, placed in 1954 by part-width construction, was subject to pumping along its transverse, center, and shoulder edges; note differential slab elevation at centerline.

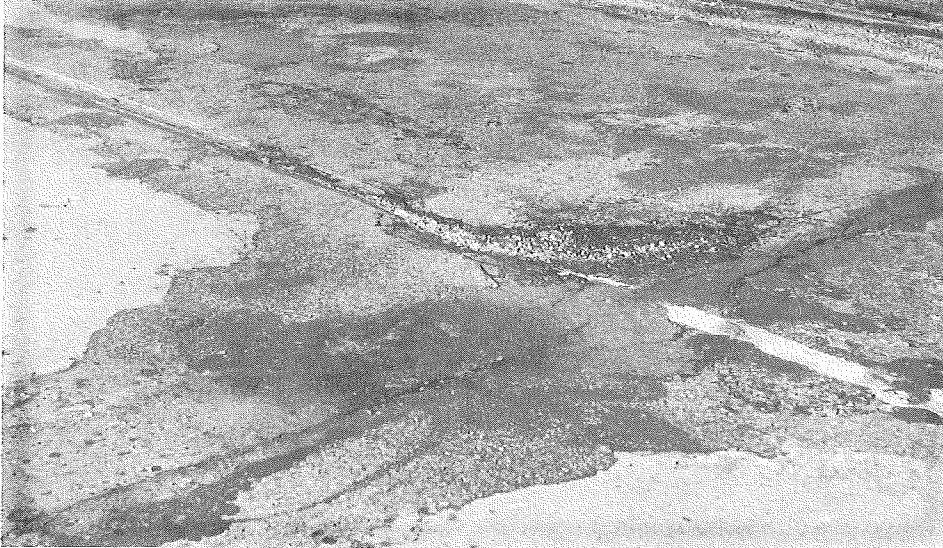
▲ Station 288. In 1955, a blowup developed at a tar-patched joint on this badly disintegrated and multipatched slab.

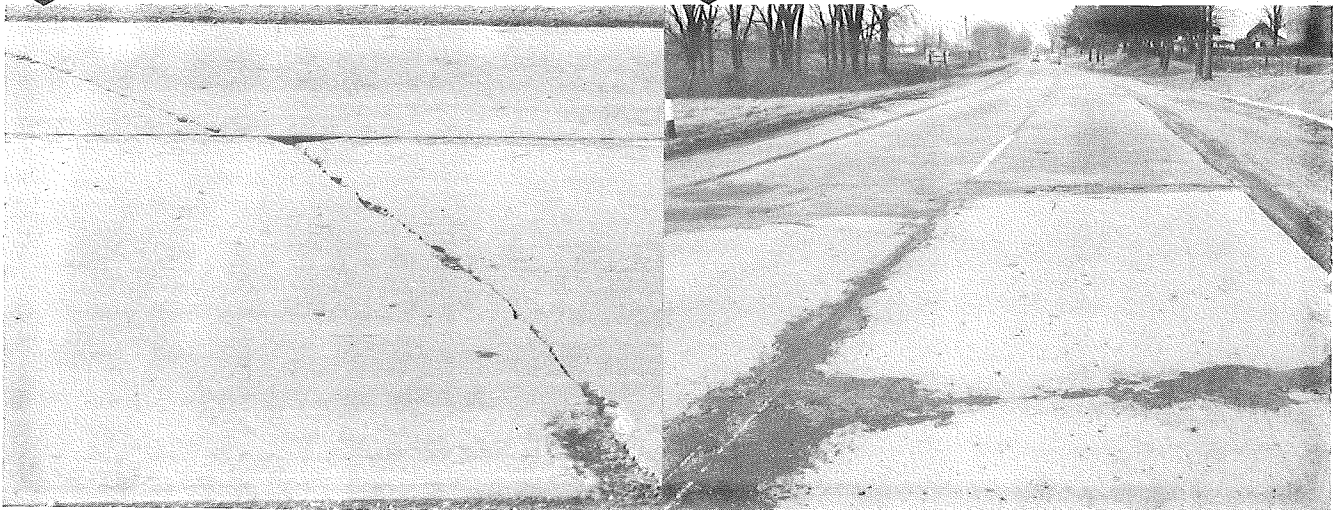
Station 318+50. This crack developed in a patch which replaced a failed expansion joint in the original pavement. Advanced disintegration is visible at the centerline and at the shoulder edges.

Station 319 looking North. The pavement settled and the surface disintegrated over this skewed transitional section, presumably because of poor soil conditions uncorrected during original construction.

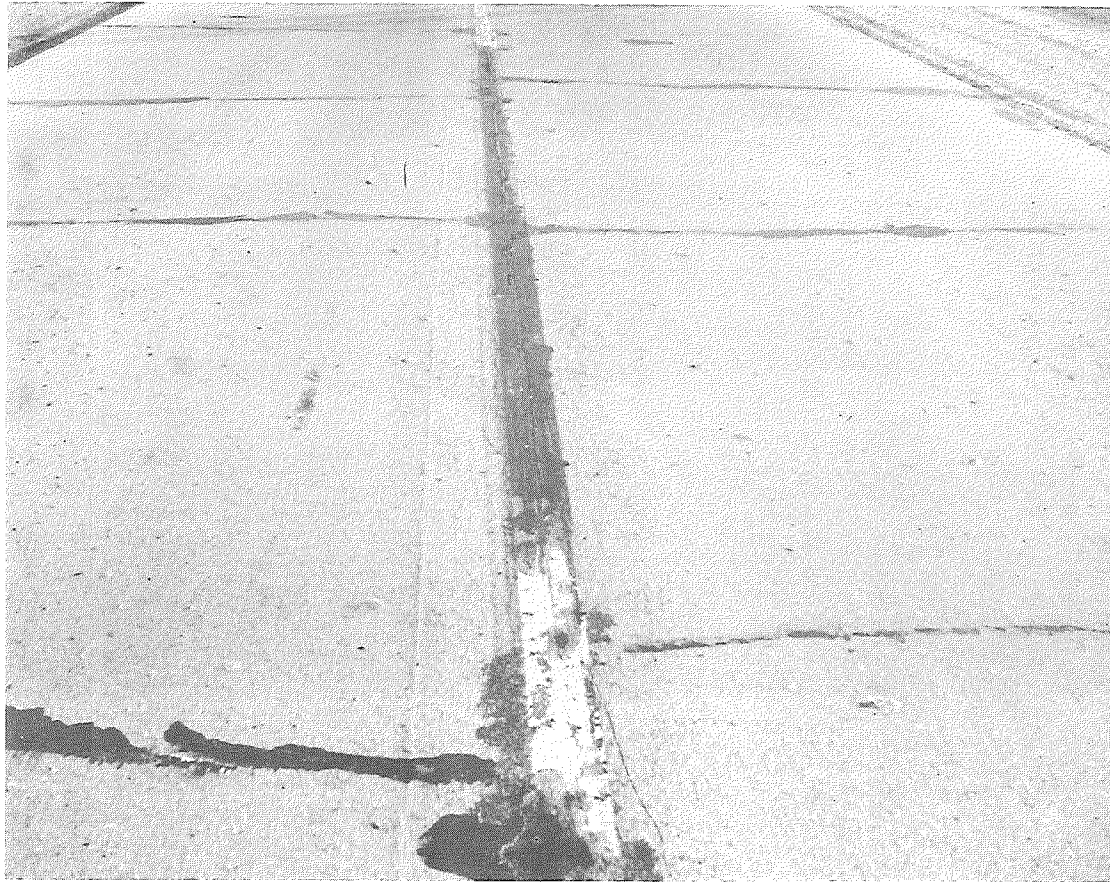
▲ Station 487 looking north. Popouts and frequent transverse cracks were encountered on even the best sections of Contract 5.

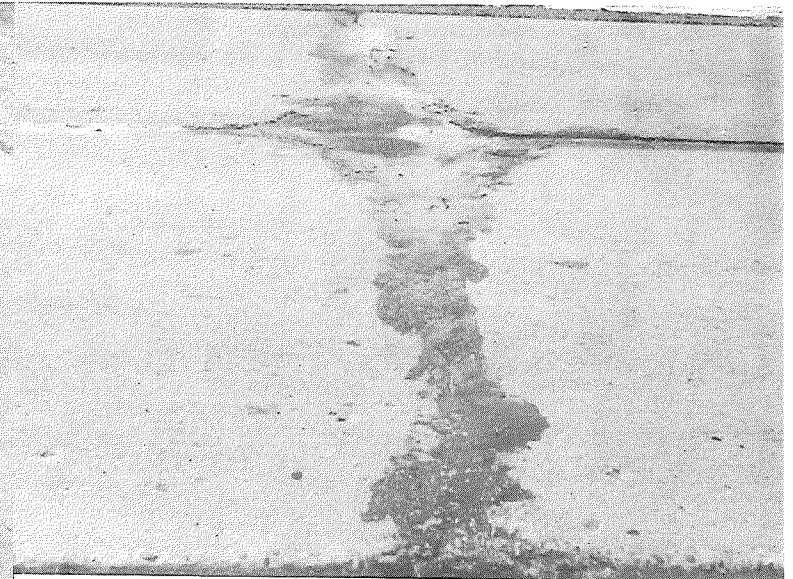
▲ Station 469. This joint subject to pumping, showed disintegration typical on Contract 5, with heavy spalling and corner breakage.

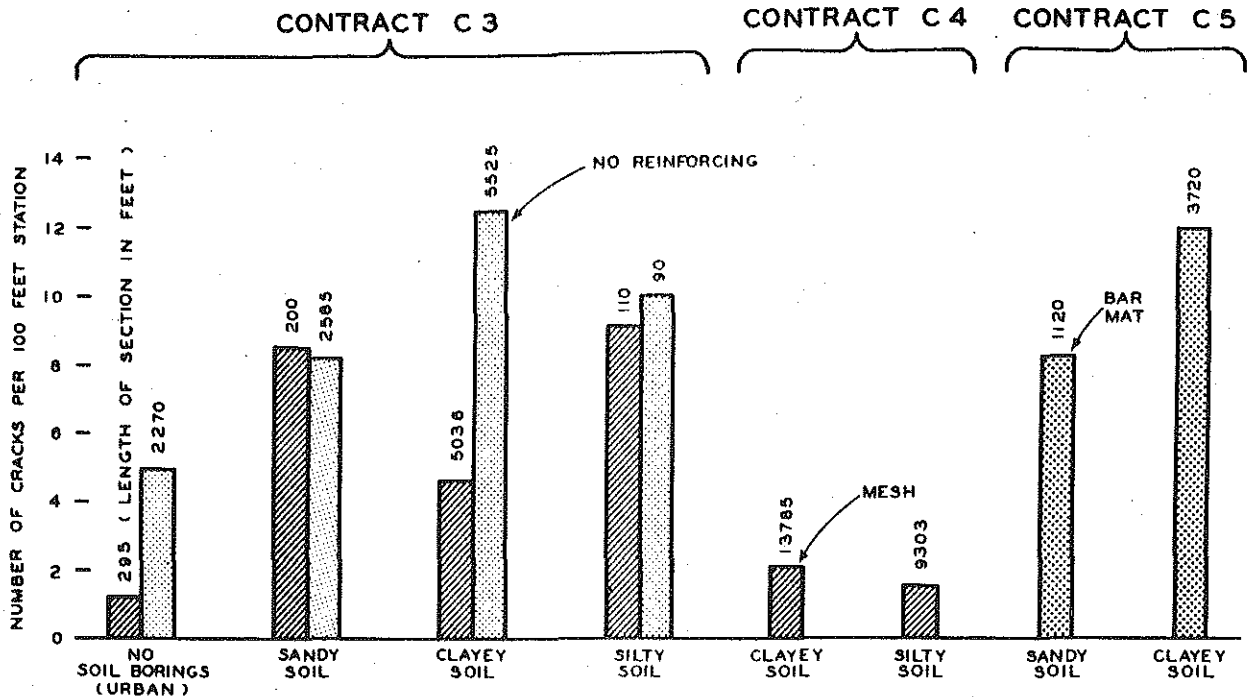
Figure 7. Comparison of Soil Type and Concrete Reinforcing with Pavement Cracking

Figure 7 shows relationships between amount of pavement cracking, soil type, and kind of concrete reinforcing used, for the three contracts. Similar relationships are shown in Figure 8, in which soil type and reinforcing are compared with the amount of pavement patching; here, the patched areas included both surface and deep patching as well as replaced slabs.

For example, Figure 7 indicates that for conditions of comparable test (where significant lengths are involved), considerably less cracking occurred in those areas where the concrete was reinforced with wire mesh. A study of the variable soil types in the areas involved leaves little doubt that this reinforcement contributed considerably to good surface condition. This is also shown in Figure 8, where a relative absence of patching may be noted in those areas of Contract 3 where wire mesh reinforcement was used. Although performance of the reinforcement was not always clearly related to the supporting soil type, sandy soil generally gave the best results, other variables being equal.
