Sept. 30, 1952

SUBJECT: France Stone as a Material for Bituminous Concrete  
Surfacing. Research Project 51 A-13: Report No. 182

This report covers a field survey of eleven bituminous resurfacing projects in which France Stone from different sources was the predominant aggregate used in the surface course of all except one project which contained American Aggregate Corp. material from Green Oaks. This work is the continuation of a study requested by Mr. C. J. Olsen, Materials Engineer, to determine the service performance of different limestones in bituminous concrete resurfacing projects. A previous report (No. 179) concerning Lincoln Stone was presented on July 3, 1952.

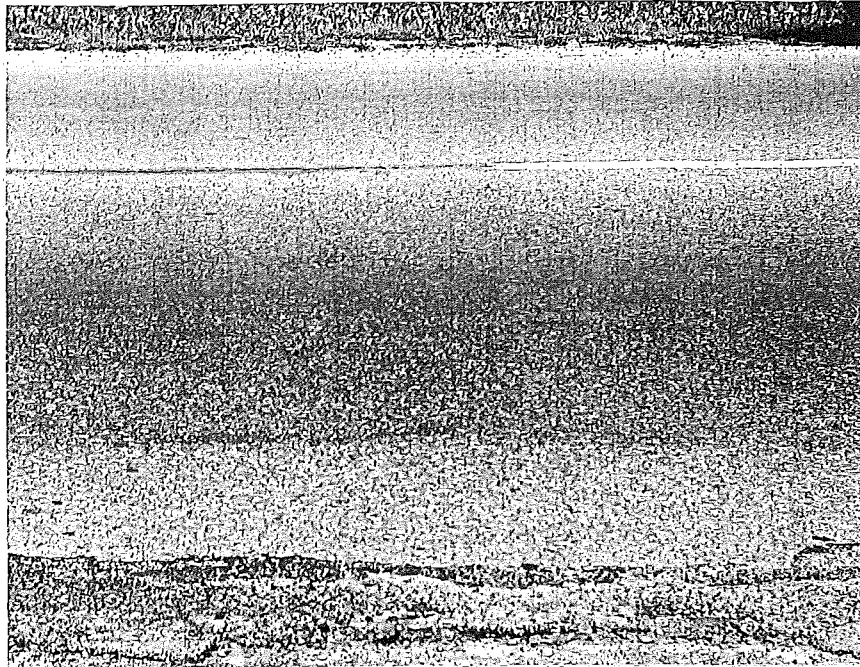
A. Typical condition of surface. No pitting.

France Stone 26A; F 58-25, C7 - 1941  
US-25 from Erie So. to state line

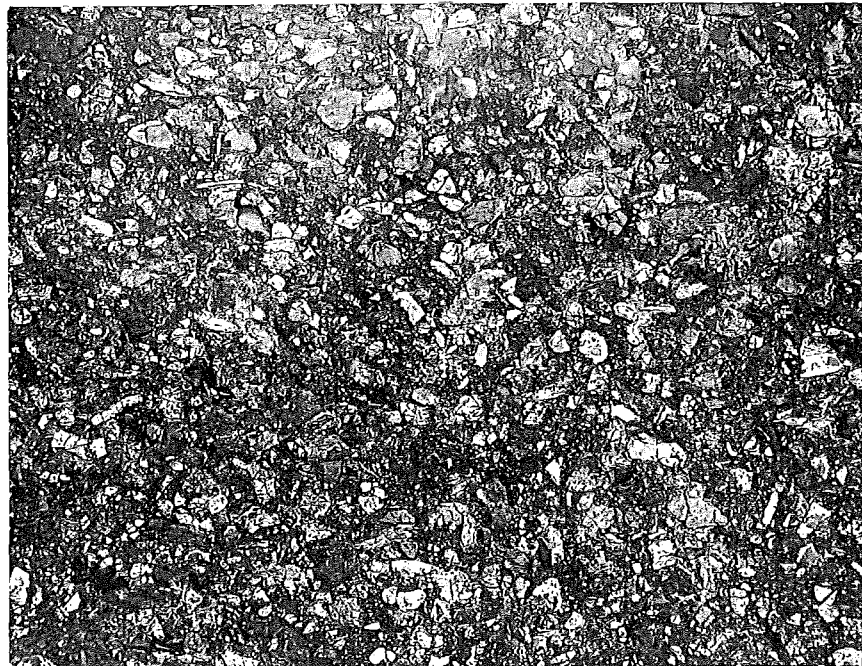
B. View of surface showing typical condition of aggregate.

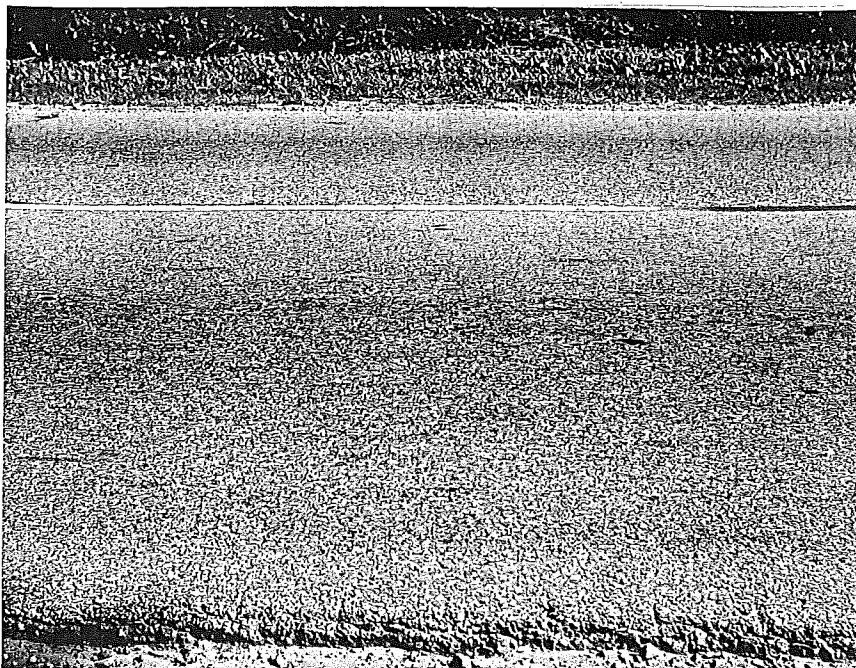
A. Typical condition of surface. No pitting.

France Stone 26A; F 14-15, C6 - 1943  
US-112 from M-205 East to Union

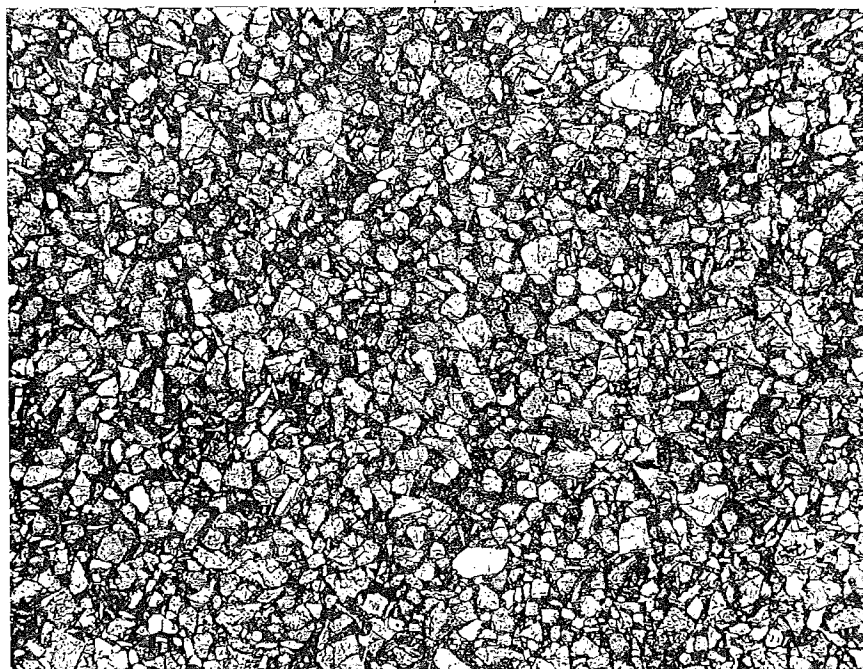
B. View of surface showing condition of aggregate.

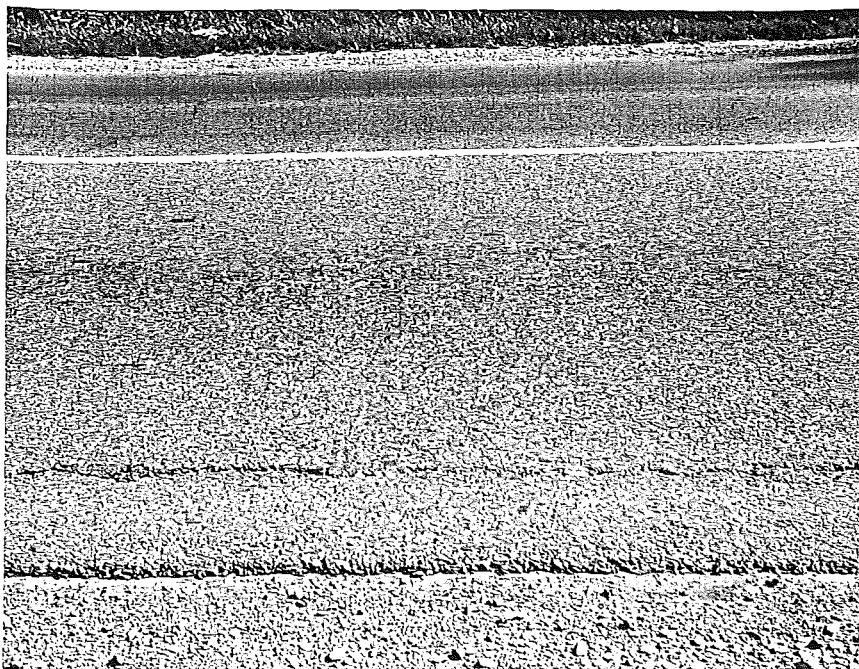
A. Typical condition of surface. Slight pitting.

France Stone 26A; F 14-15, C7 - 1943  
US-112 from Union East

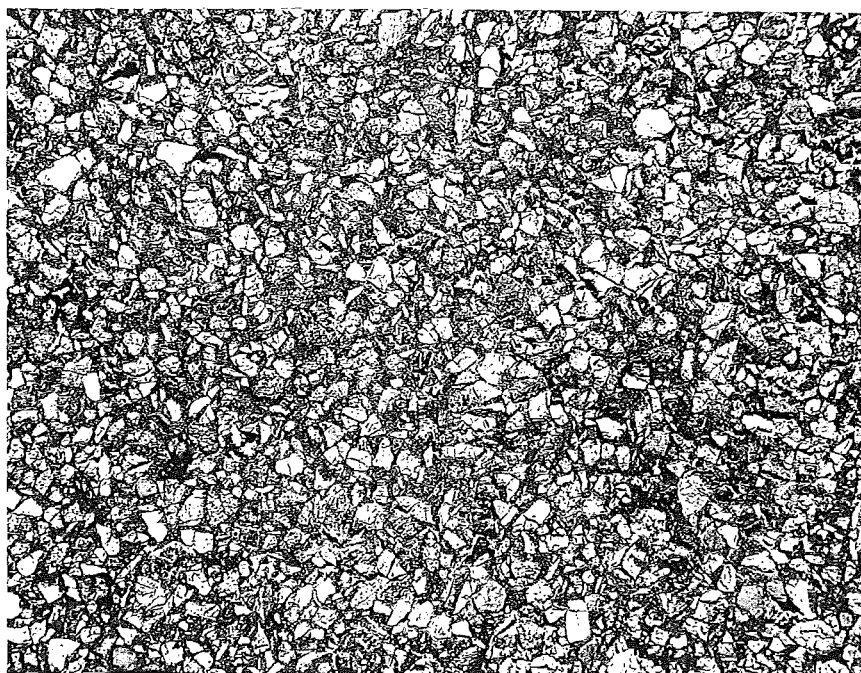
B. View of surface showing typical condition of aggregate.

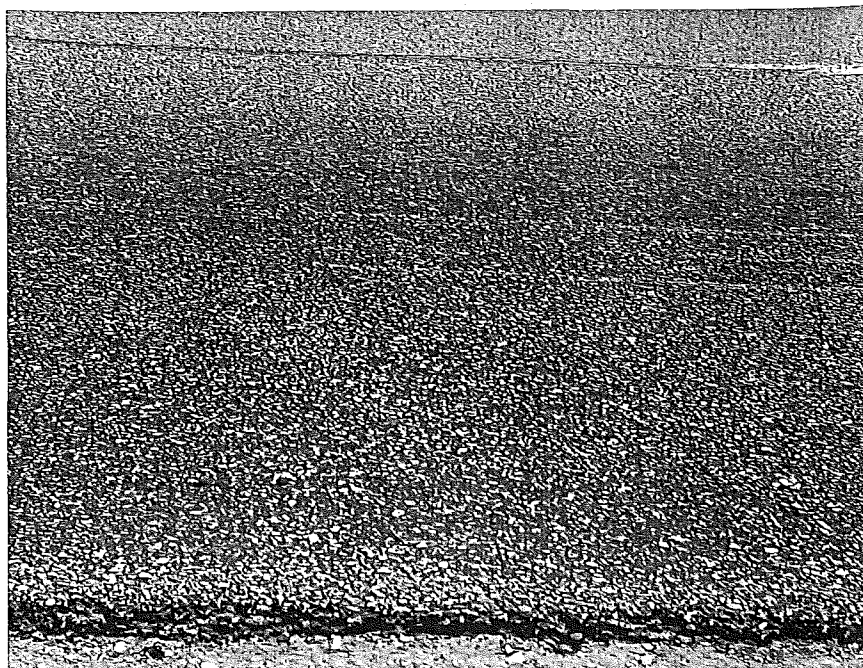
A. Typical condition of surface. No pitting.

France Stone 26A; SNF 30-6, 04 - 1943  
US-112 from Jonesville N.C. to US-127

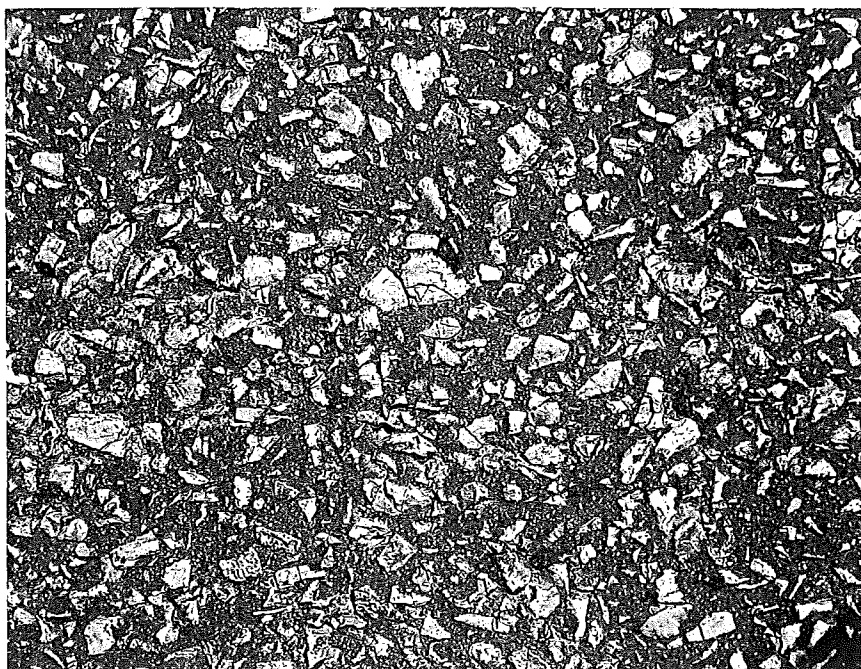
B. View of surface showing typical condition of aggregate.

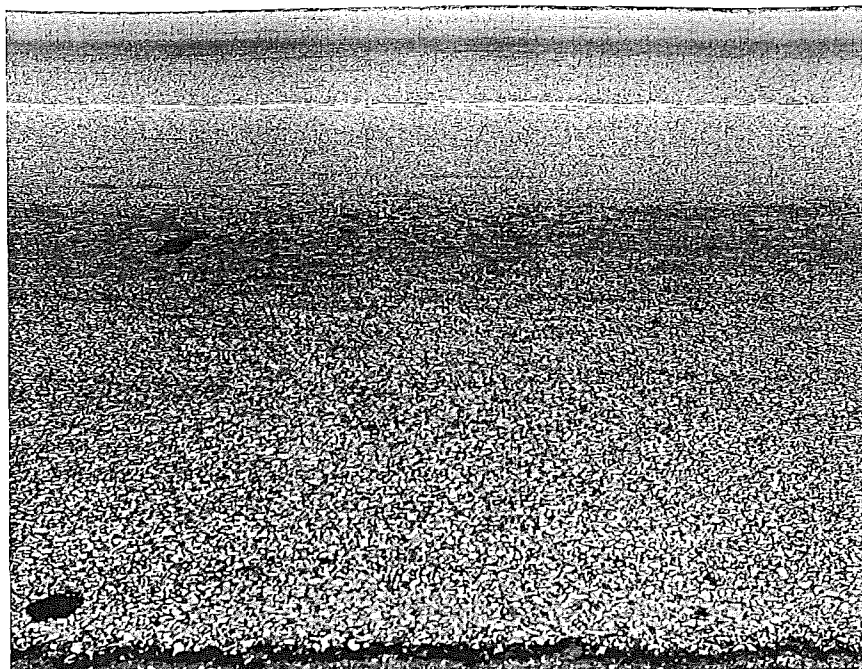
A. Typical condition of surface. No pitting.

France Stone 26A; SNF 30-6, 05 - 1943  
US-112 from US-127 East to Co. line

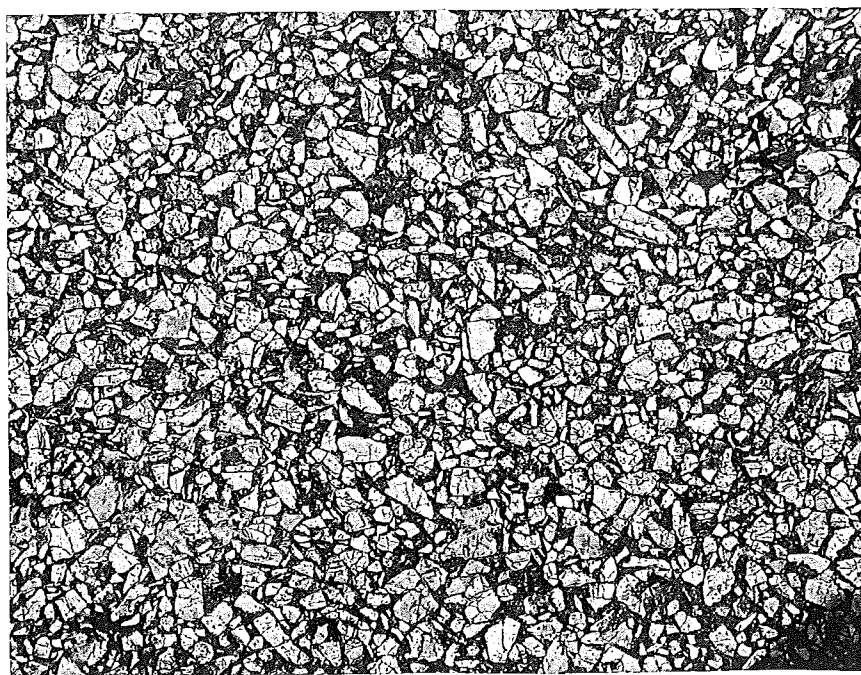
B. View of surface showing typical condition of aggregate.

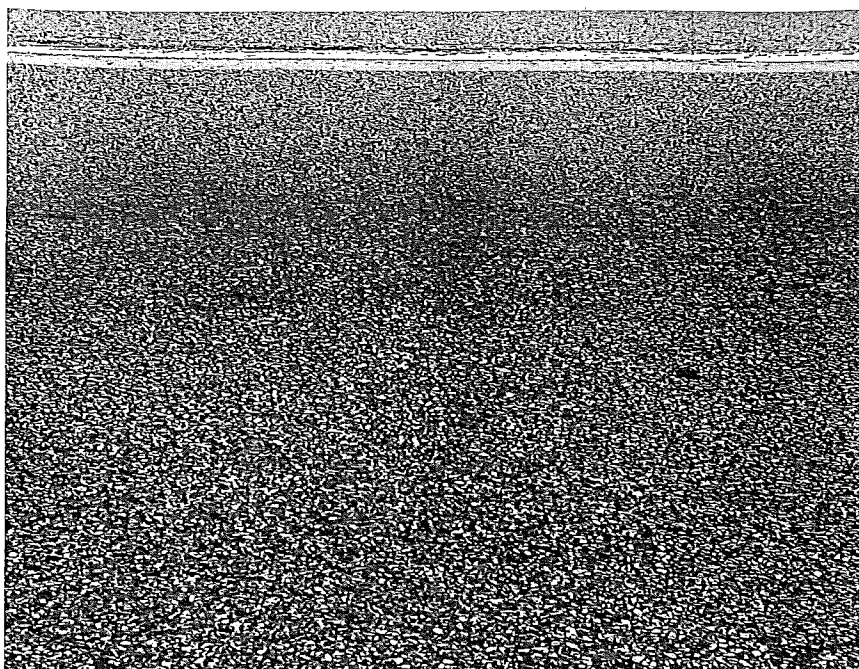
A. Typical condition of surface. Very slight pitting.

France Stone 26A; SNF 46-4, C13 - 1943  
US-112 East from Co. Line to M-50

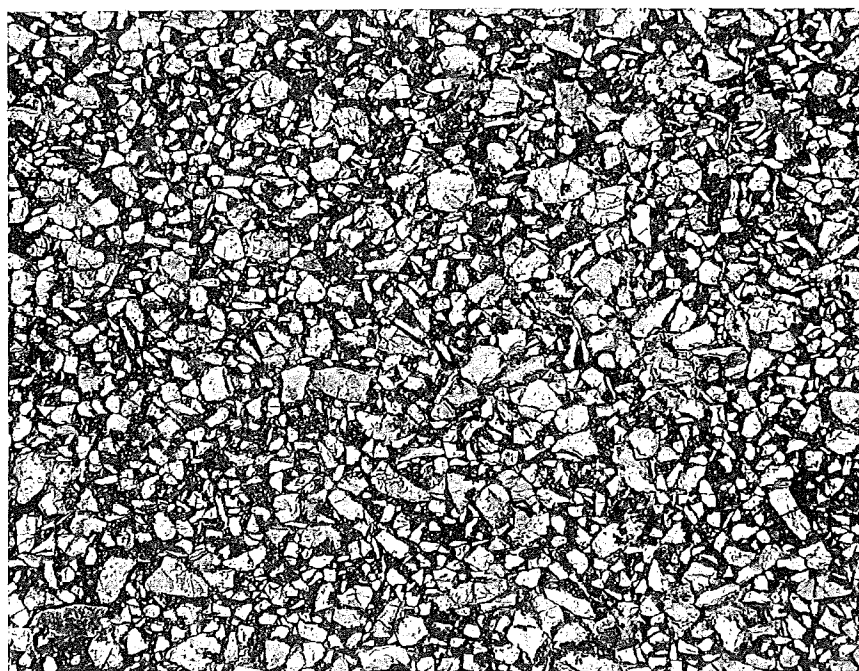
B. View of surface showing typical condition of aggregate.

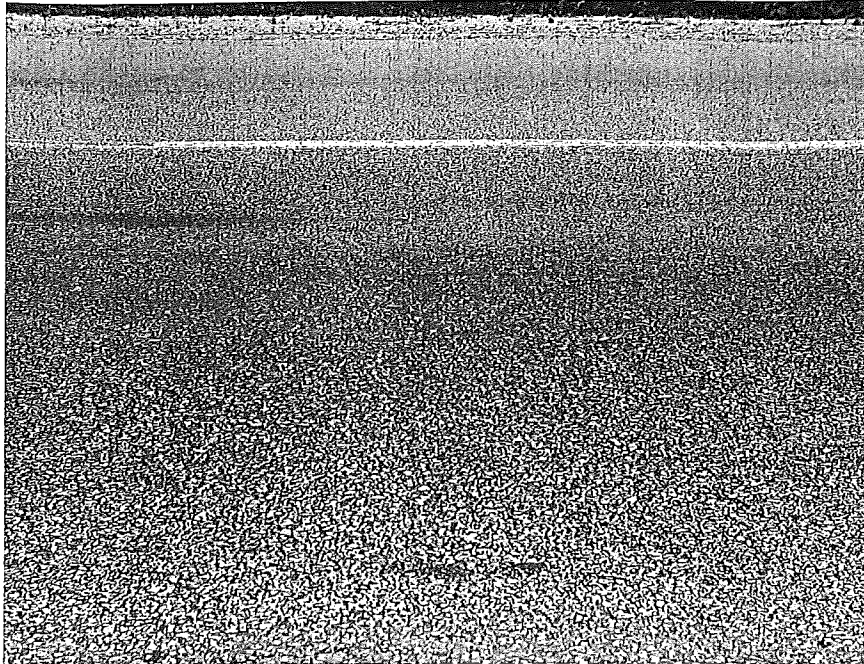
A. Typical condition of surface. No pitting.

France Stone 26A; SNF 30-6, C7 - 1945  
US-112 from Jonesville S.W. to Co. Line

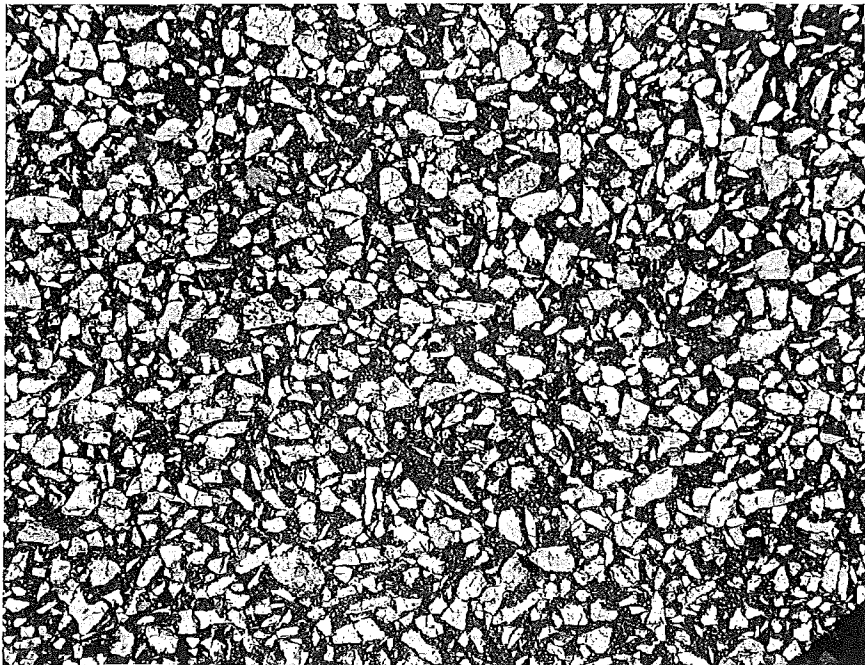
B. View of surface showing typical condition of aggregate.

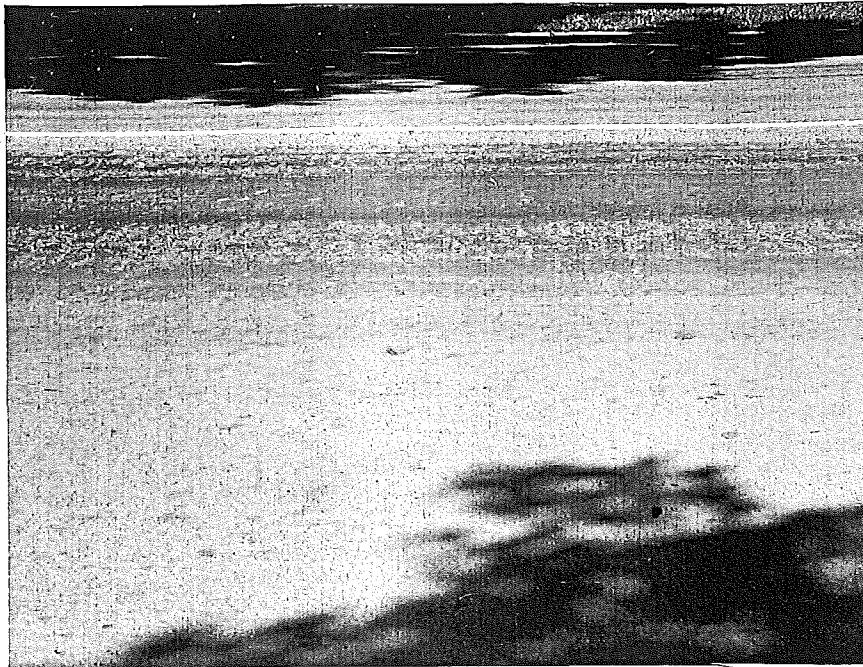
A. Typical condition of surface. Rough texture.

France Stone 25A; Mod. F. 78-8, C5 - 1950  
US-112 in Sturgis and East

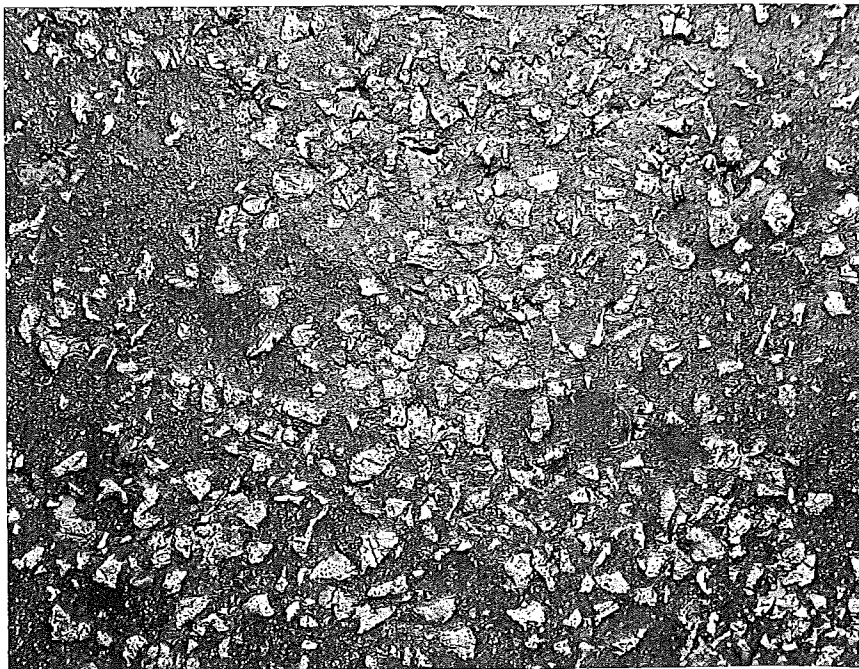
B. View of surface showing typical condition of aggregate.

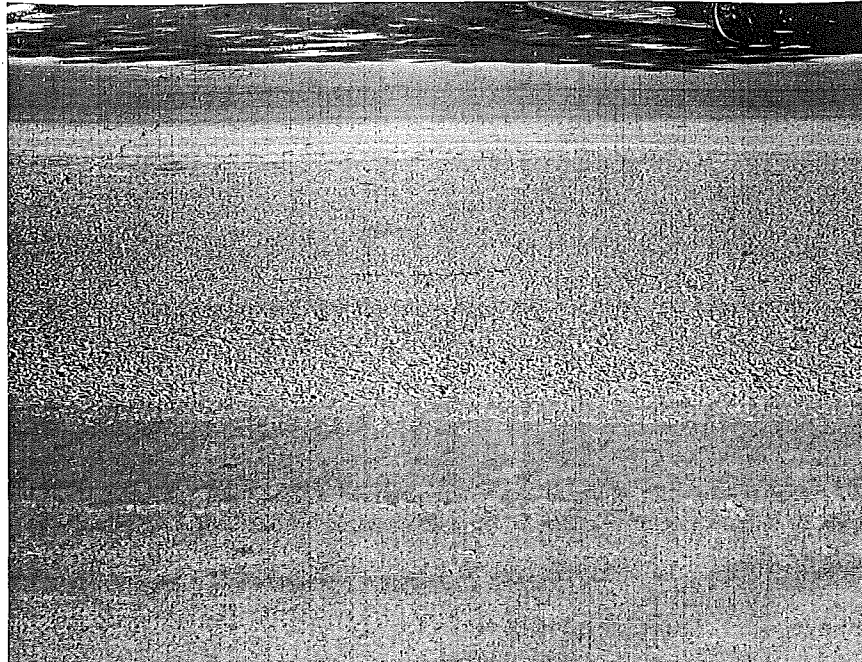
Slight pitting was noted in certain instances, however, especially in or near a city, such as the projects on US-112 in or near Sturgis. This condition was also noted in the case of Lincoln Stone used in Battle Creek and Nashville and could be caused by excessive use of de-icing salts. The pictures show the cracked condition of surface aggregate but no significant tendency of the broken aggregate to become dislodged through frost action or traffic.

A. Typical condition of surface. Slight pitting.

France Stone 25A; M 78-7, C2 - 1950  
US-112 in City of Sturgis

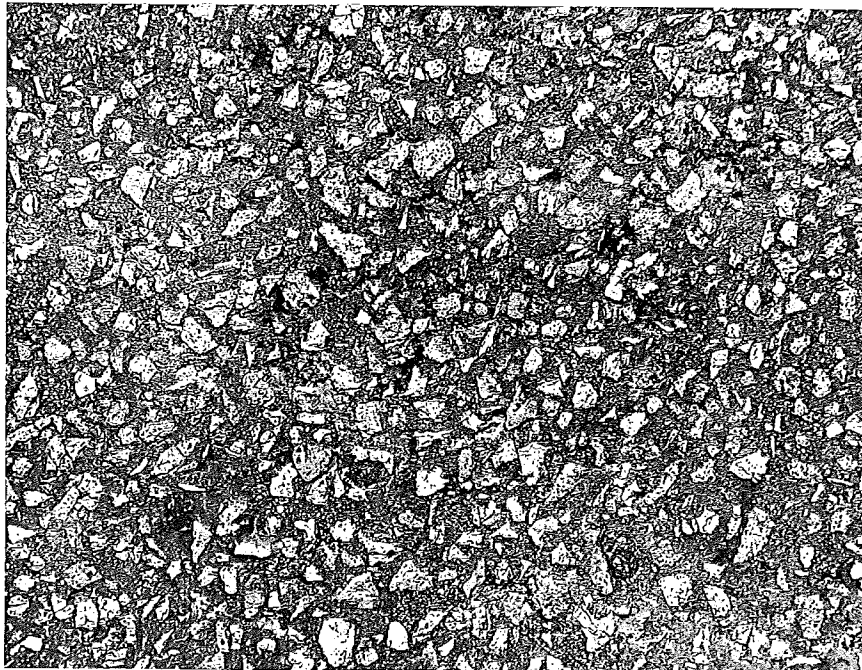
B. View of surface showing typical condition of aggregate.

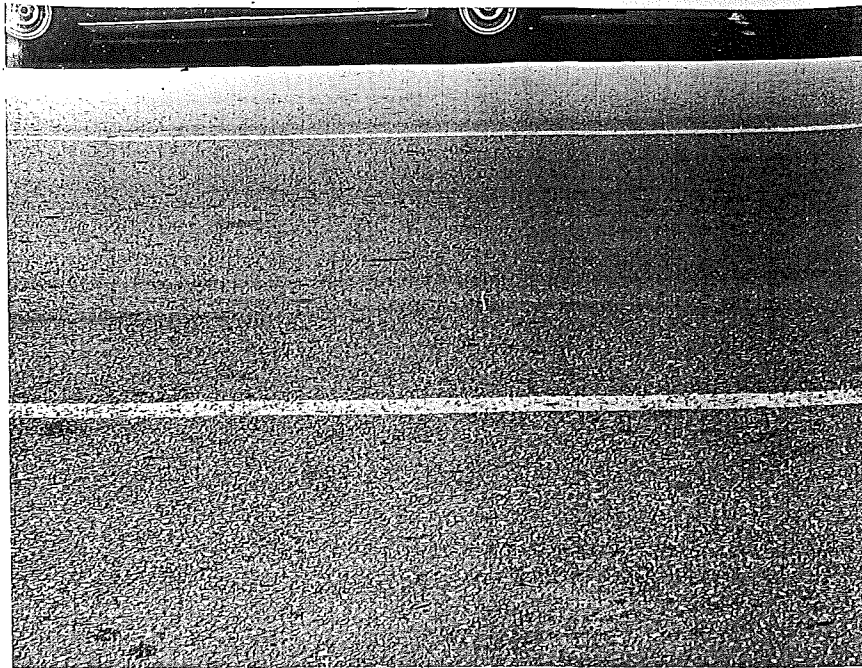
A. Typical condition of surface. Slight pitting.

France Stone 25A mod.; F.78-18, G2 - 1950  
M-78 from US-112 to No. limits of Sturgis

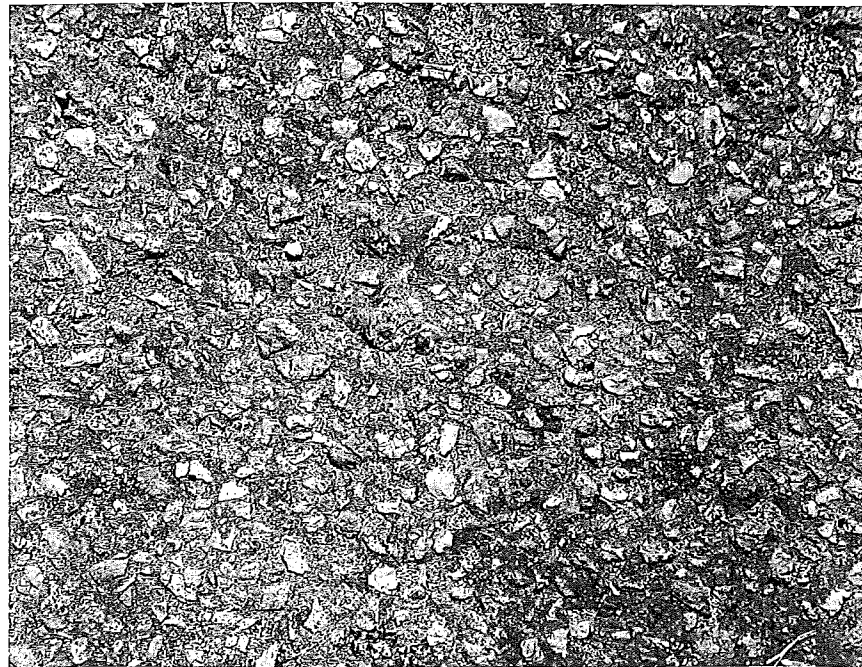
B. View showing typical condition of aggregate.

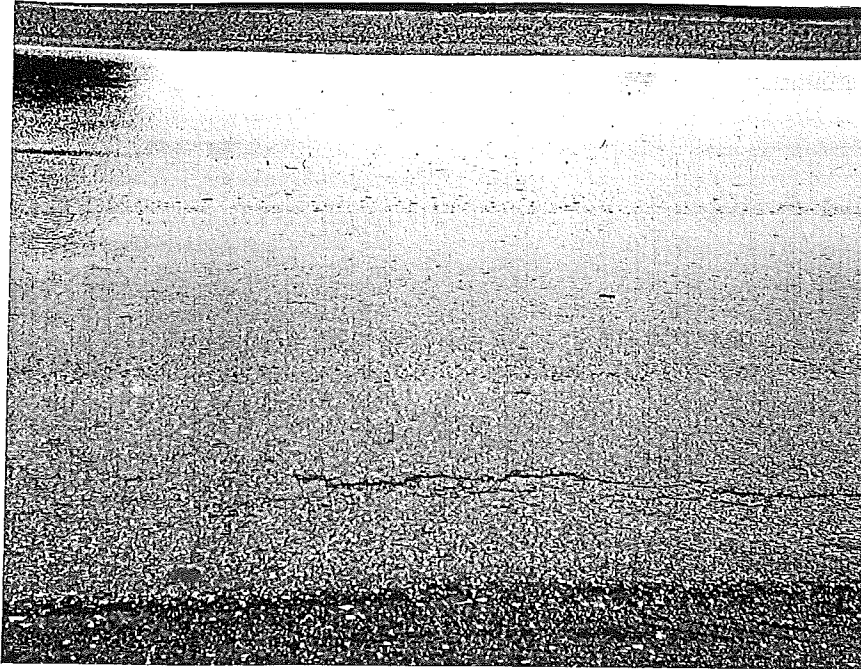
A. Typical condition of surface. Slight pitting (raining).

France Stone 25A mod.; F 78-8, C4 - 1950  
US-112 West from Sturgis

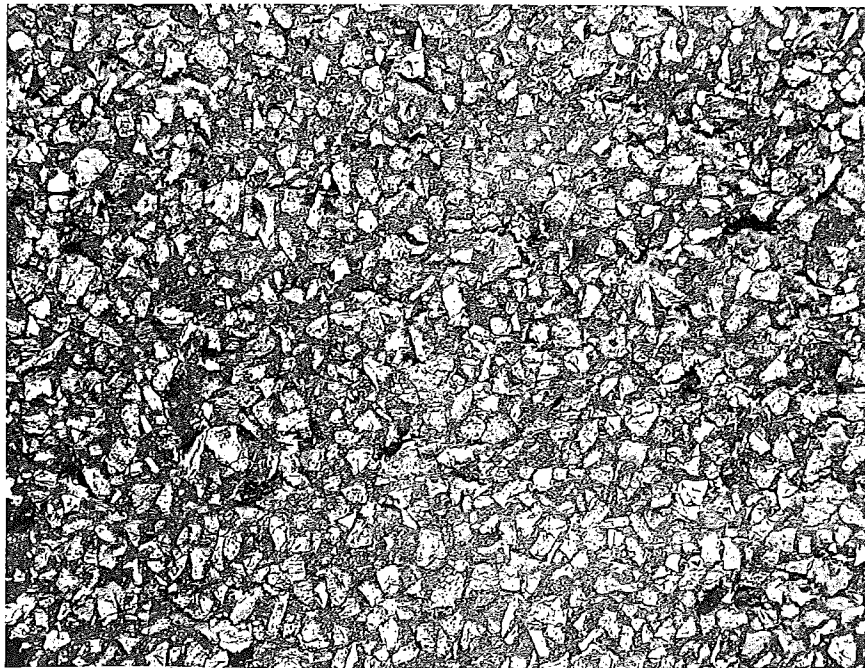
B. View of surface showing typical condition of aggregate.
