DESIGN, MAINTENANCE, AND PERFORMANCE OF RESURFACED PAVEMENTS

AT WILLOW RUN AIRFIELD

William S. Housel

January, 1962

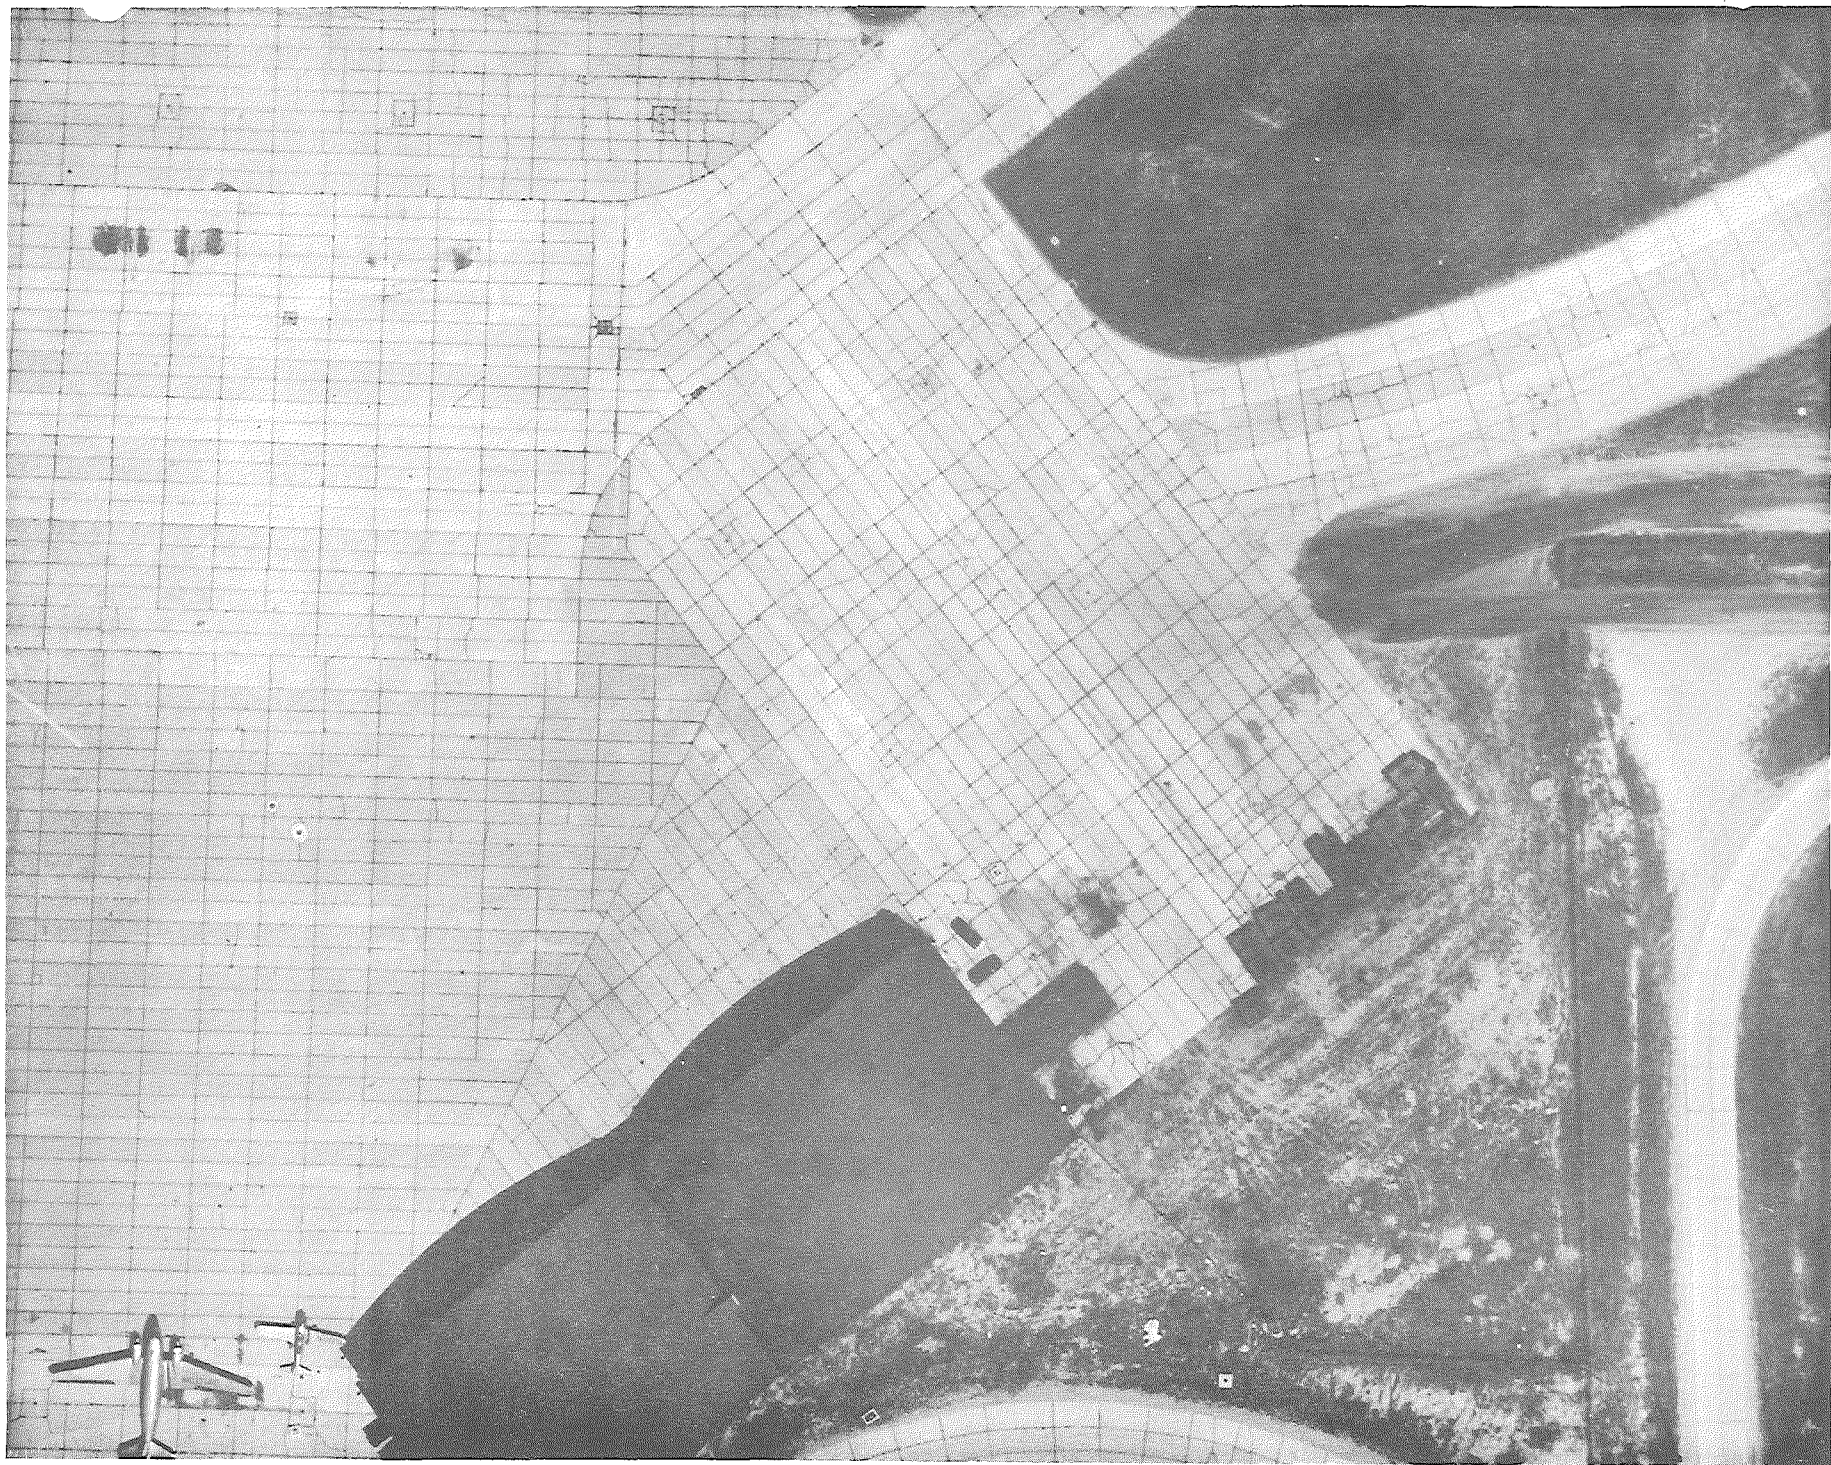
FIG. 2

However, there were some significant variations in construction practice, between the 1941 and 1943 construction, which developed some sharp contrasts in performance, revealed by subsequent pavement condition surveys. Fig. 2 is an aerial photograph taken at the south end of the main west apron showing typical sections of the 1941 apron and the additions to the apron and the curved taxiway constructed in 1943. This photograph was taken in 1946 when the University of Michigan acquired title to the airfield, and shows the condition of the paving at the beginning of the 15 year service period discussed in this paper. Although the pavement at this time had been subjected to almost negligible service in terms of load

repetition, the 1943 additions and the curved taxiway are beginning to show a considerable amount of transverse cracking, with virtually no cracks having developed in the 1941 construction.

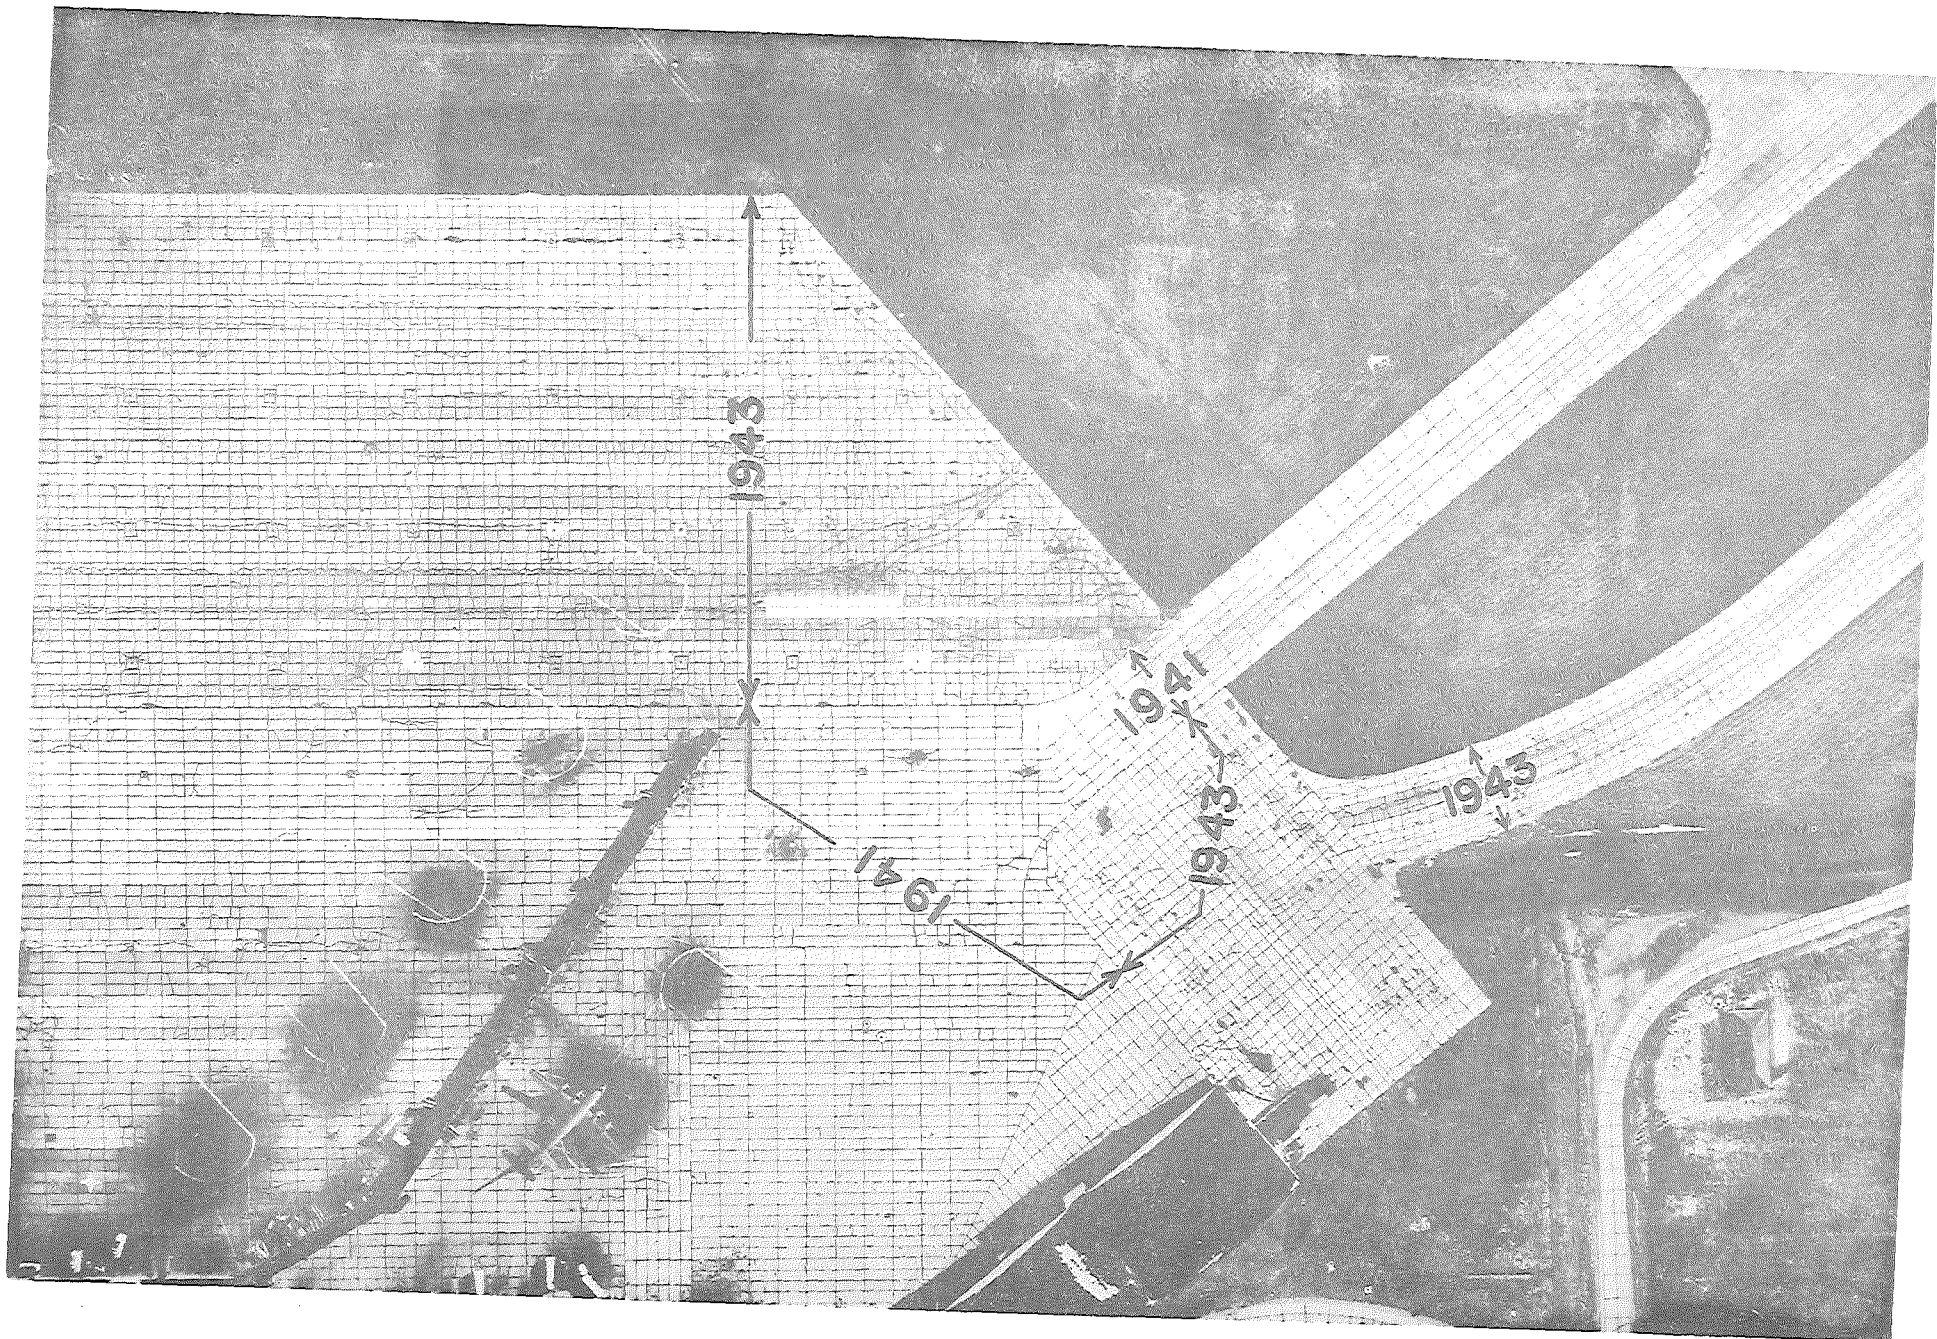
FIG 3

Fig. 3 is an aerial photograph of the same general area taken in November, 1950, after four years of service under commercial airline operation. The 1943 construction already shows serious crack development, with transverse cracks in the center of a large percentage of the 25 foot slabs and an unusual pattern cracking developing in certain lanes, with some slabs having already been replaced, as shown by the light colored areas. The 1941 construction, on the other hand, shows very limited development of single transverse cracks subdividing the 25 foot slabs into two slab lengths. A survey was made in 1950 of cracking over the entire airport to make an approximate evaluation of the type of cracking developing in the two different paving projects. Cracks were classified as transverse, longitudinal, or diagonal, as summarized in Table 1, with no attempt being made at this time to isolate the special pattern cracking referred to above.

One of the most interesting developments shown in Fig. 3 is this pattern cracking developing along the edge of every fourth lane in the 1943 apron. The cause of this incipient cracking was traced to the fact that this section of the apron was poured in alternate 20 foot widths and the concrete mixer was permitted to travel on the recently completed slab while adjacent lanes were being poured. This weakness was also associated with the fact that the paving was done during the fall of the year, under unfavorable weather conditions. The concrete on which the mixer traveled had not been completely cured and its strength was not sufficient to carry the concentrated load of the mixer at the edge of the slab. As a result, these

frequently accepted compromises in paving practice contributed more to the deterioration of this badly cracked pavement than any other factors in design or construction.

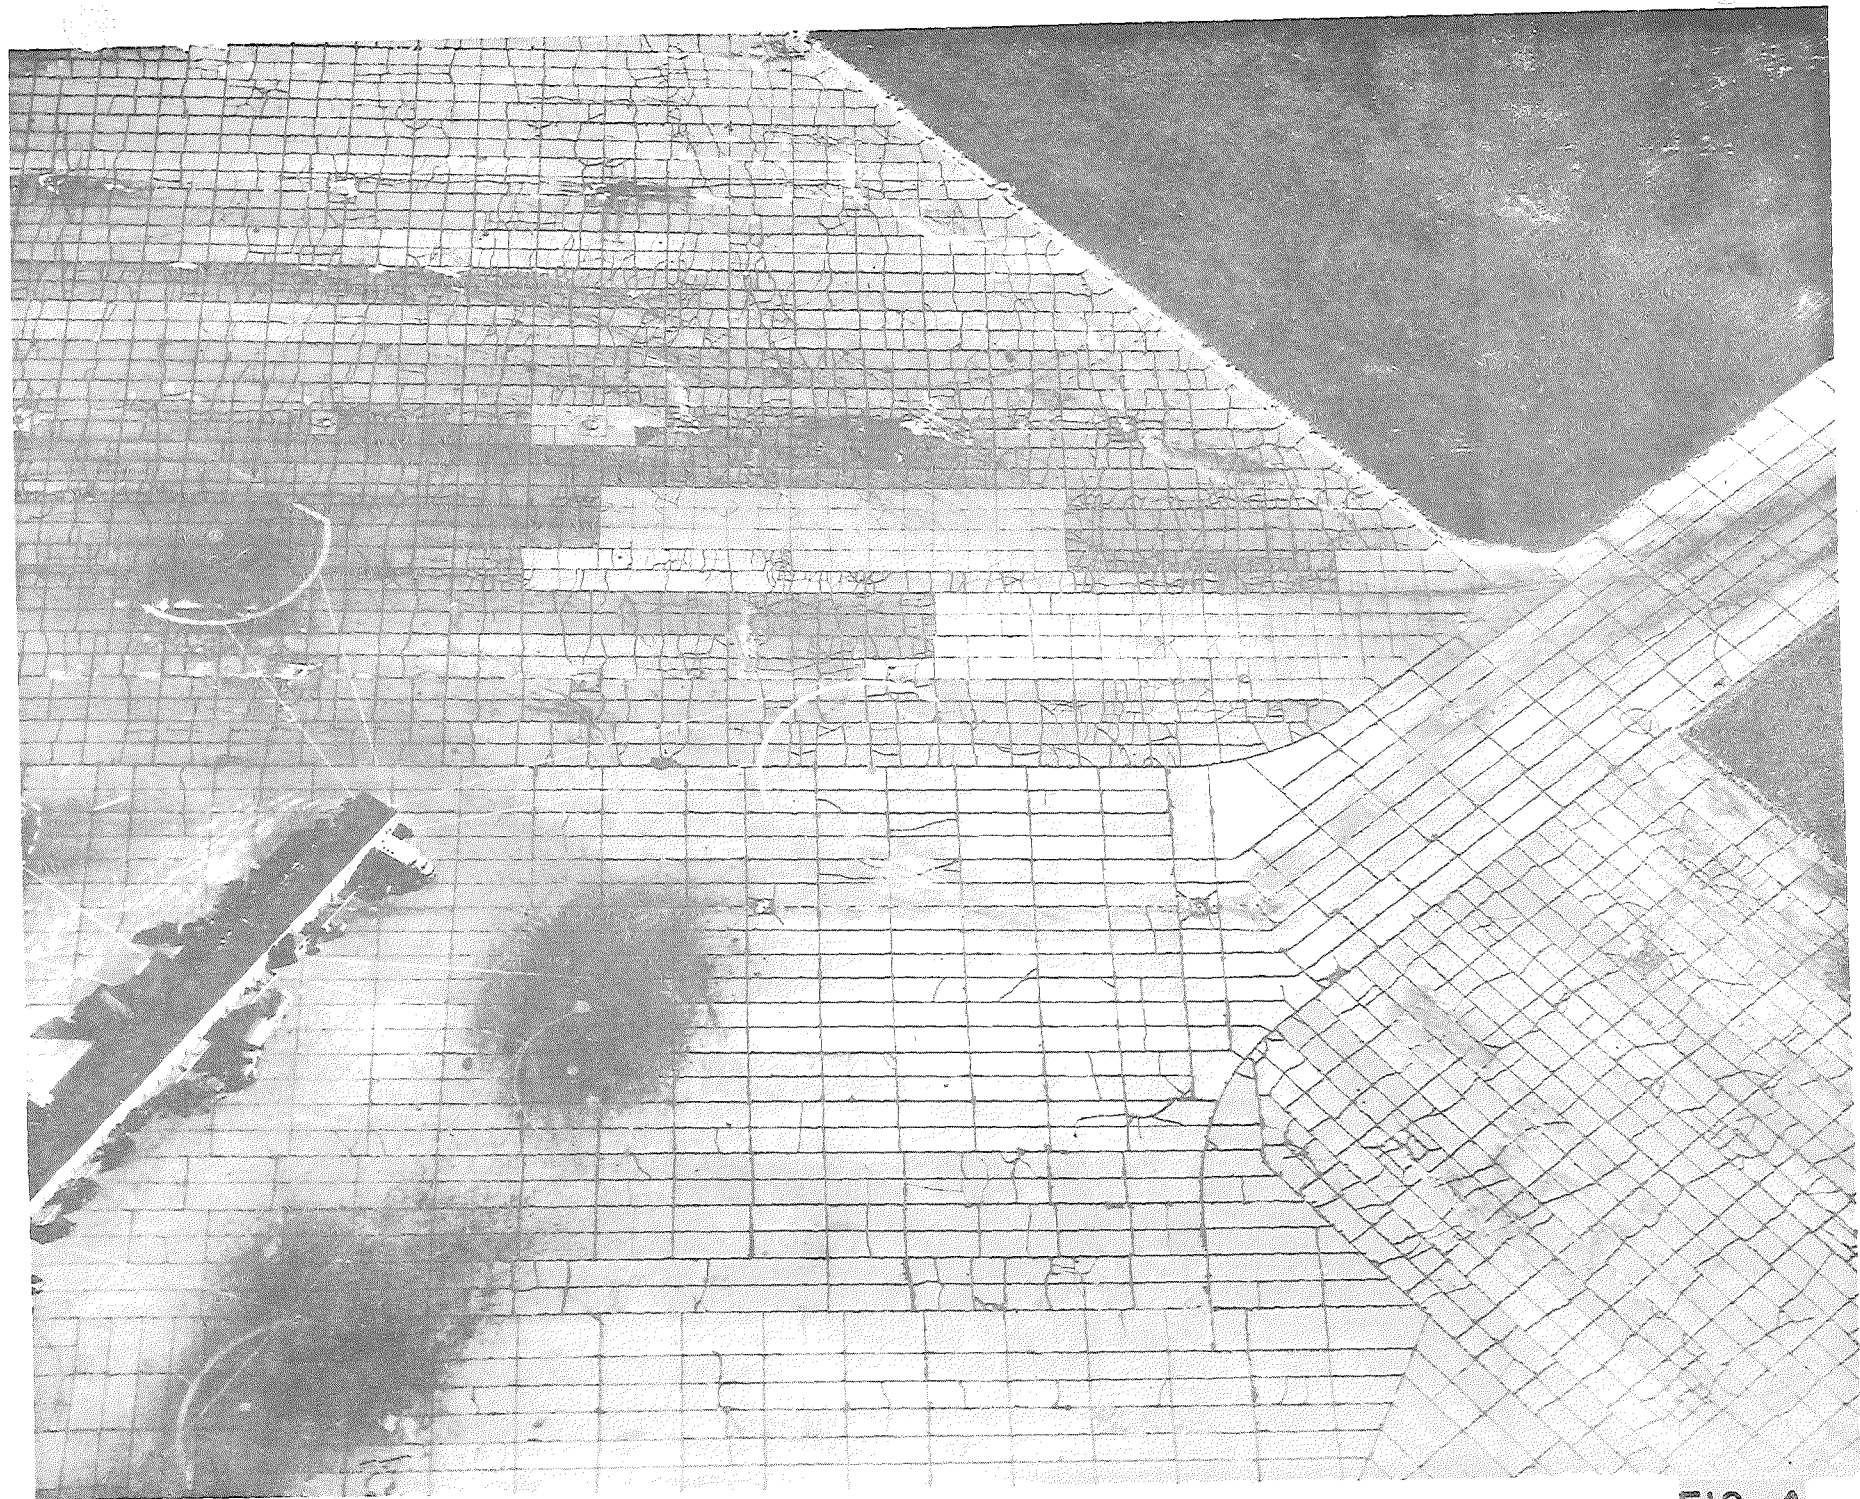
FIG. 4

Fig. 4 is another photograph of the same area taken in 1954, just prior to the first resurfacing project which is the main subject of this report. After some eight years of airline service, the apron built in 1943 has been reduced to a block pavement over a considerable portion of the area, with very little structural continuity in the original slabs. Some of the earliest slab replacements, which were also unreinforced, have also been badly cracked in this area of heavy traffic concentration just off the end of the south loading ramp in a path traveled by a large percentage of the planes going to the main taxiway.

The first resurfacing project, in 1955, included the center taxiway and the most badly cracked portion of the main apron where the annual filling of cracks and joints had become a prohibitive maintenance procedure. While it will not be discussed in detail as part of this paper, it may be noted in passing that additional bituminous resurfacing of the concrete pavement has been done in 1959, 1960, and 1961 to maintain efficient operation in spite of the continued deterioration of the unreinforced concrete pavement and to reduce the cost of annual maintenance. Ultimately, if justified by the continued operation of the field as a major airport, it is planned to resurface most if not all of the concrete pavement.

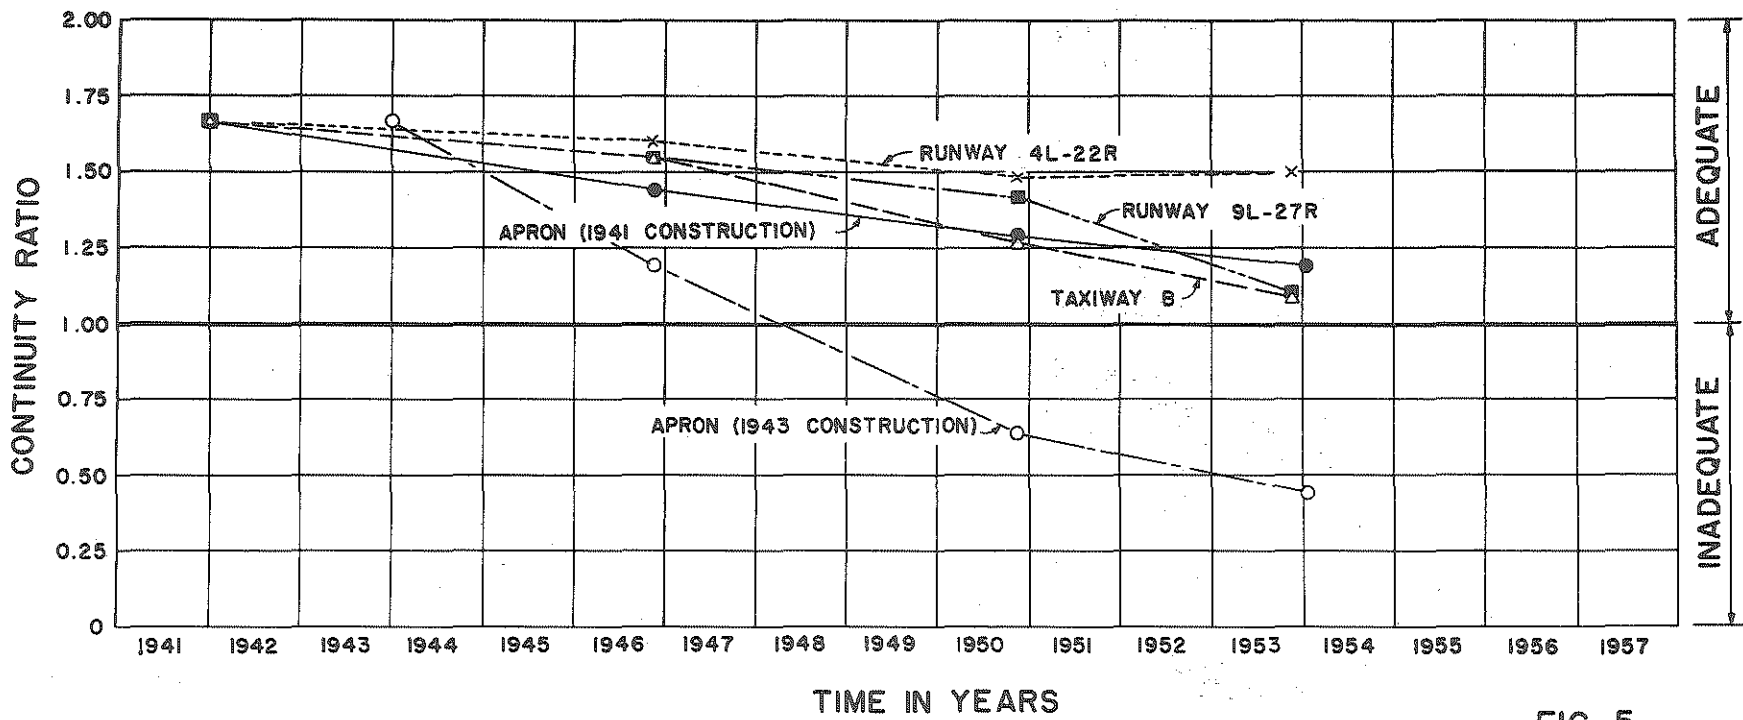
FIG. 5

Summarizing the results of the periodic pavement condition surveys, Fig. 5 shows the change in continuity ratio of typical paved areas during the period from 1946 through 1954. Runway 4L-22R is one of the main diagonal runways of the 1941 construction, considered representative of the well-built pavement with excellent subgrade conditions and good construction control. By 1954, the continuity ratio had only been reduced from 1.67 to 1.50; this good performance can be considered as a basis for comparison with the other areas to be considered. Taxiway B and Runway 9L-27R, with continuity ratios reduced from 1.67 to approximately 1.10, were still in reasonably good condition, but these were areas of known subgrade deficiency due to the inclusion of unstable organic material in the subgrade during the grading operation. The 1941 apron, with a continuity ratio of 1.19, may be showing some influence of greater load repetition, but is still

rated as satisfactory and representative of the better 1941 construction. This performance is in marked contrast to that of the 1943 apron, where the average continuity ratio has been reduced to 0.44, indicative of excessive cracking and loss of structural continuity.

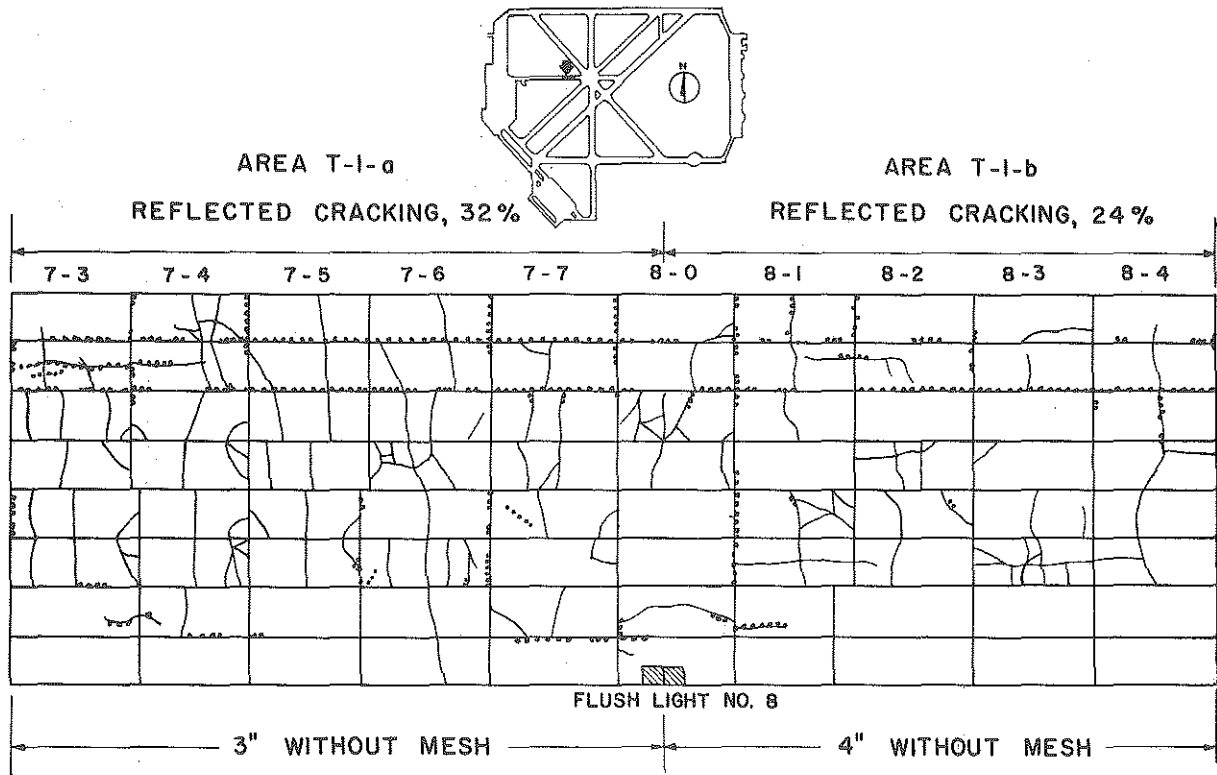
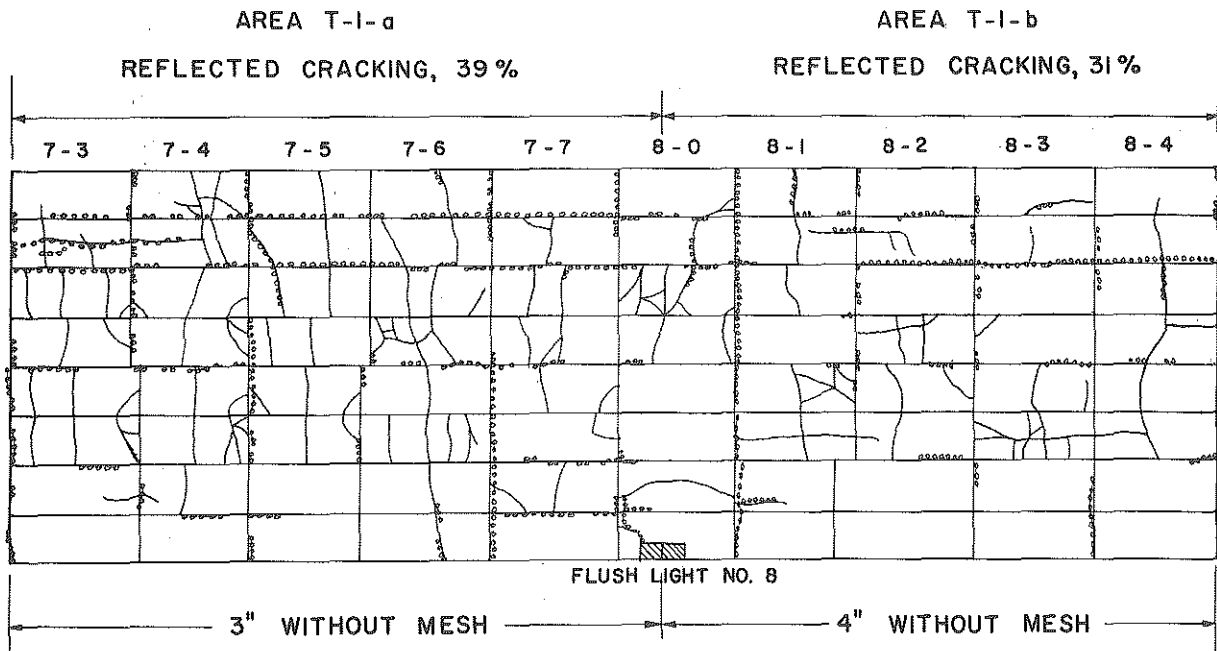
FIG. 7

Test Area 1, shown in Fig. 7, is on the center taxiway and was intended to show the effect of varying the thickness of the bituminous surface from 3 inches in Area T-1-a to 4 inches in Area T-1-b, both without mesh or welded wire fabric. In the 1957 survey, shown at the top of the figure, the reflected cracking was 32 per cent in partial Area a and 24 per cent in partial Area b, with an 8 per cent differential in favor of the greater thickness of bituminous surfacing. It should also be noted that a large percentage of the reflected cracking was at pavement joints, with very little of the slab cracking being reflected through the surface. The results of the 1961 survey, after the surface had been sealed in 1960, show a moderate increase in reflected cracking in both areas, with the same differential of 8 per cent in favor of the greater thickness of bituminous surface. The pattern of reflected cracking in both surveys is closely comparable, with the same cracks showing up in 1960 that were observed in 1957 with some increase which is mostly over pavement joints rather than the slab cracking pattern.

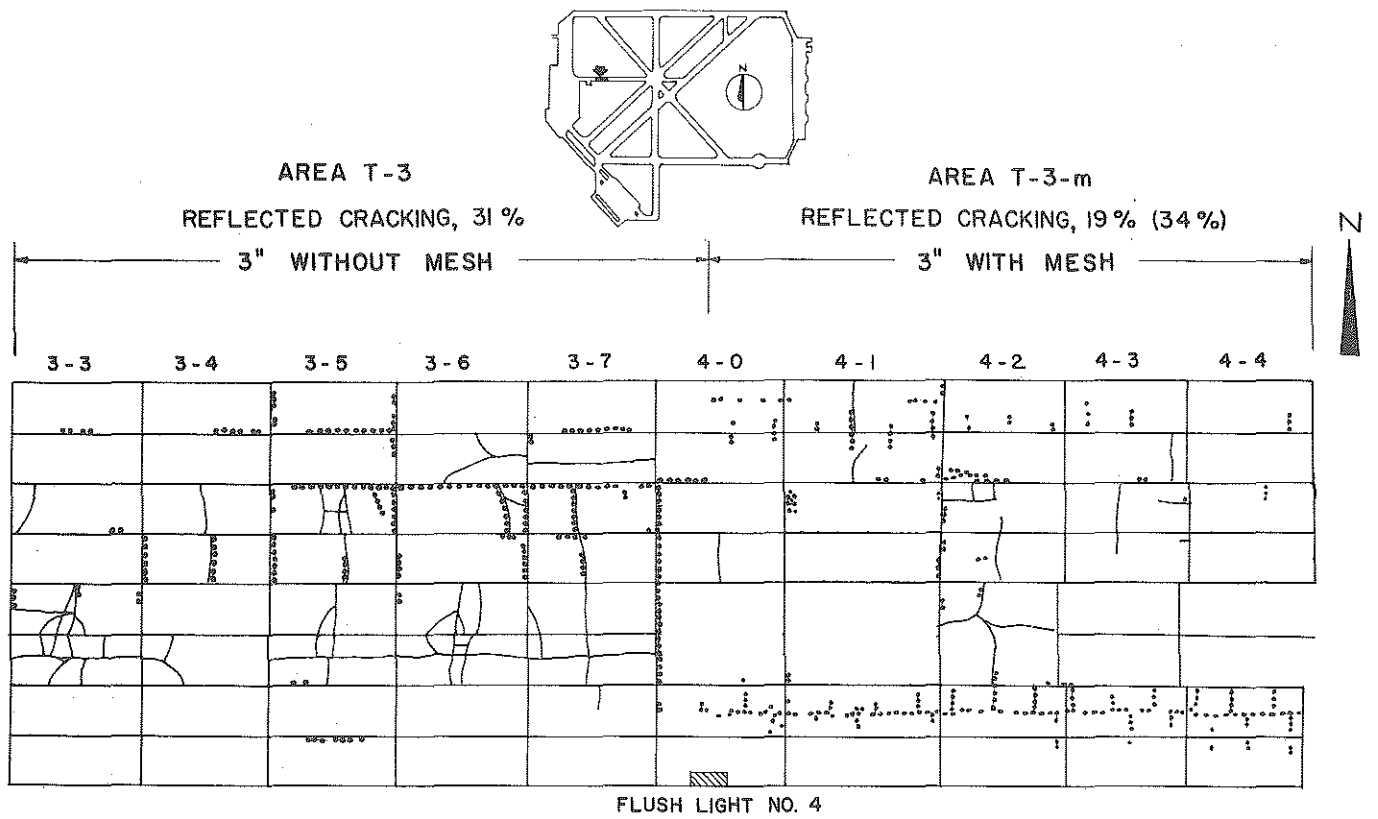
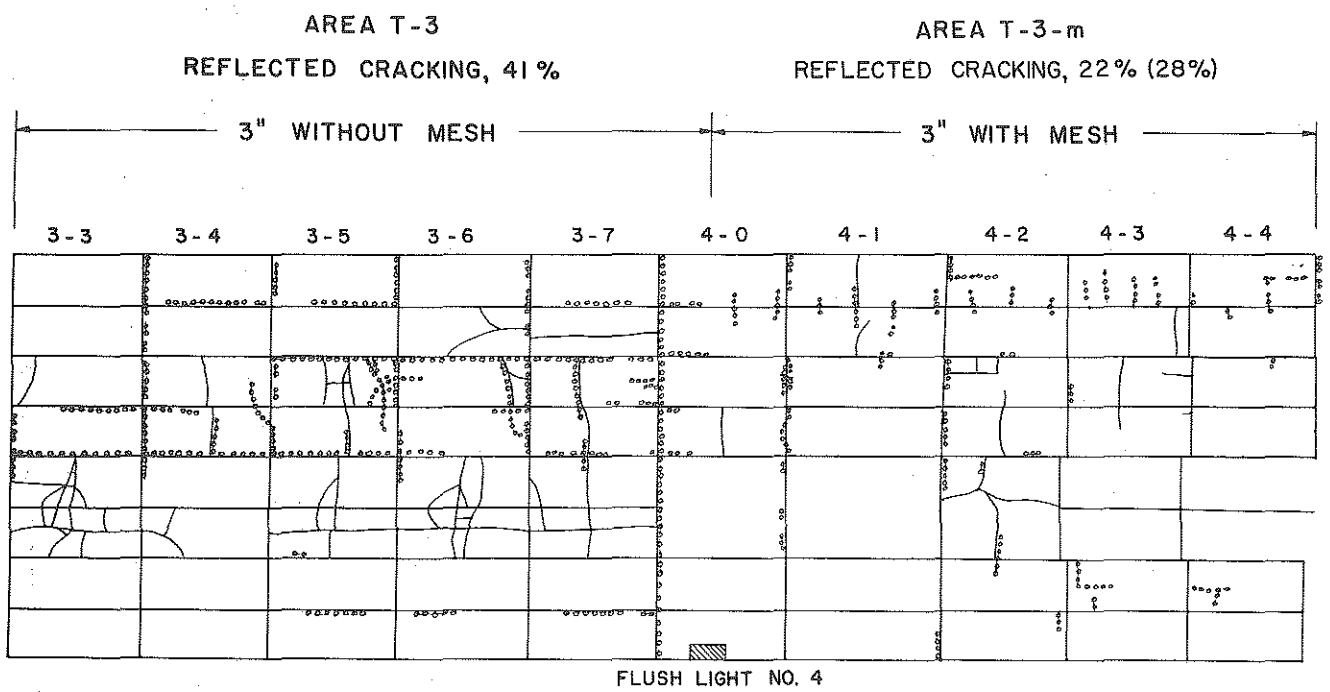
FIG. 9

Test Area T-3, shown in Fig. 9, duplicates the test conditions in Area T-2, providing another comparison between areas with and without welded wire fabric. However, in this case, the benefit of the wire mesh is much more apparent in both the 1957 and 1961 surveys and the differentials in percentage of reflected cracking substantially greater. Again, the pavement

joints are the primary source of reflected cracking which the wire mesh converts to the ladder type of translated cracking, a considerable portion of which is eliminated in the 1961 survey after sealing in 1960.

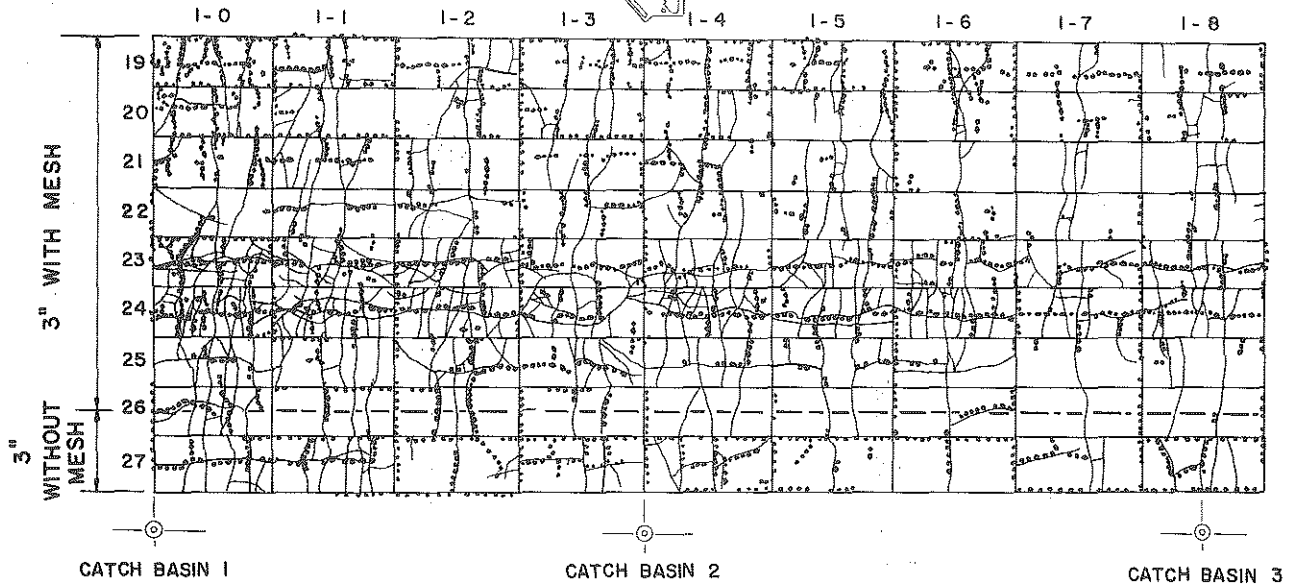
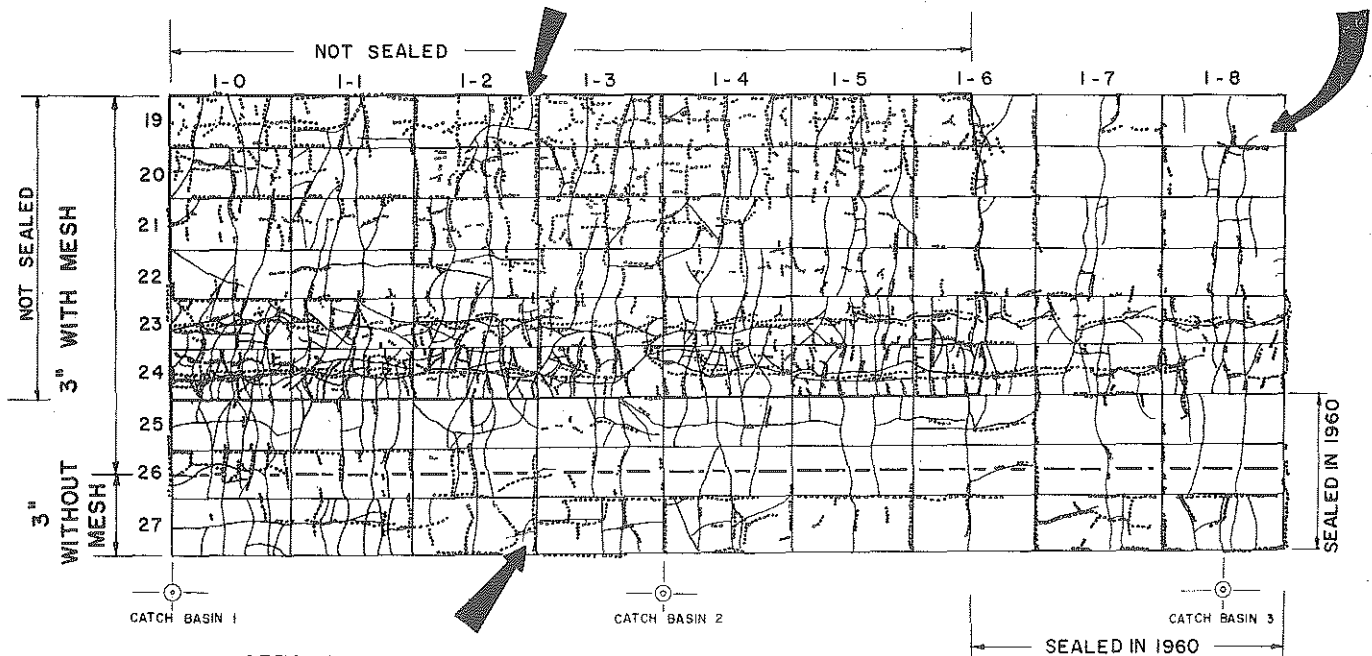
FIG. 10

Area A-1, shown in Fig. 10, is located in the badly cracked portion of the 1943 apron where the cracking pattern is so complex that it practically defies accurate analysis. It must also be kept in mind that this is an area probably subjected to the heaviest concentration of load repetition of any location on the airfield. A large percentage of the planes moving to and from the main runways traverse this area, involving slow moving planes with load application close to the static conditions most severe on airport paving. Under these conditions, it must be presumed that the 1955 cracking pattern in the underlying concrete pavement has also been modified by additional cracks hidden by the bituminous surface.

As a matter of fact, the most pertinent observation that could be made about this 6 inch unreinforced concrete pavement of inferior construction, subsequently reduced to a series of concrete blocks, is that it has made a remarkable showing in terms of general pavement performance. Furthermore, from the standpoint of pavement design, it is hard to imagine a more spectacular demonstration of the dominant role of unlimited subgrade support supplied by the natural sand and gravel subsoil on which the pavement rests.

In spite of the complicating factors noted, the percentage of reflected cracking shown by Area A-1 is comparable to those of the other test areas, particularly when the greater concentration of load repetition is given due weight. The comparison is again between 3 inch bituminous resurfacing, with and without welded wire fabric. It should be noted also that

the area without mesh is relatively small and does not include one of the double lanes of advanced pattern cracking.

In the 1957 survey, shown at the top of Fig. 10, the unreinforced area showed a reflected cracking of 44 per cent; in comparison, the reinforced area had 33 per cent direct crack reflection, or (38) per cent including the translated cracking. In both cases, there was a measurable differential in favor of the reinforced area. At the bottom of Fig. 10, the results of the 1961 survey of the areas sealed in 1960 show the unreinforced area having a reflected cracking of 47 per cent, as compared to a direct reflection in the reinforced area of 29 per cent, or a total of (30) per cent including translated cracking.

The marked differential in favor of the reinforced areas is again related to the effective sealing of the translated cracks of decreased width, illustrating the most apparent benefit of the welded wire fabric. A considerable portion of Test Area A-1 was not sealed in 1960 and thus, as a special case, provides some measure of the total reflected cracking in the six years from 1955 through 1961. The direct crack reflection is estimated as 49 per cent and the total cracking, including translated cracking, as (75) per cent. As previously pointed out, there are several indeterminate factors involved in this complex crack pattern that can not be eliminated. The figures are nevertheless interesting for comparison, even though qualified by unavoidable uncertainties.

AREA A-1-m-a
REFLECTED CRACKING, 33% (38%)

AREA A-1-b
REFLECTED CRACKING, 44%

AREA A-1-m-a'
REFLECTED CRACKING, 49% (75%)

AREA A-1-m-a''
REFLECTED CRACKING, 29% (30%)

AREA A-1-b
REFLECTED CRACKING, 47%

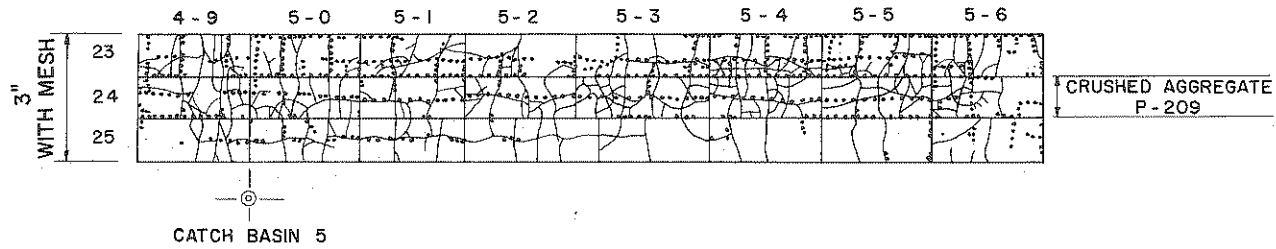
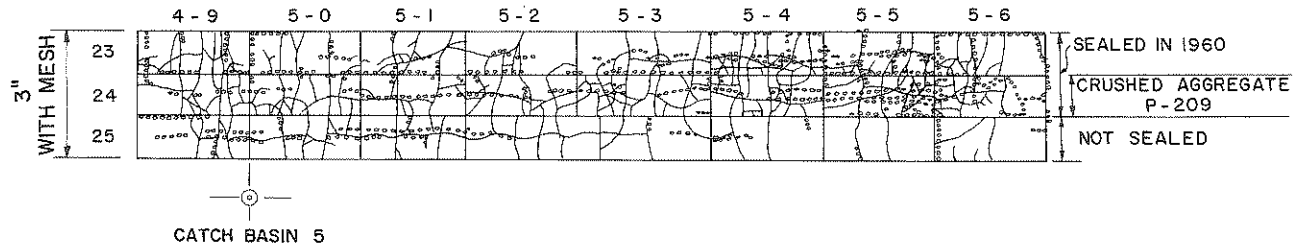
FIG. 11

There are two special test areas yet to be discussed where experiments were made which go somewhat beyond the main investigation of reflected cracking. In Test Area A-2, shown in Fig. 11, an experiment was

tried on a somewhat limited scale which might serve as an example of uninhibited exploration typical of the freedom sometimes associated with academic circles. In this case, it was decided to remove the badly cracked concrete in one lane and replace it with a crushed aggregate base which, at any rate, was well compacted to give it every chance for survival. The results are shown in Fig. 11 and really turn out to be quite interesting.

In order to maintain a common basis for comparison, the cracking pattern of the original concrete pavement was retained as a common denominator. Even though this is a rather tenuous hypothesis, it is directly related to the total lineal feet of cracks and retains some relationship to the badly cracked pavement in the lanes with which it is compared. The area involved is supplied with wire mesh and is at a location subjected to heavy load repetition, just off the end of the center taxiway. The results of the 1957 survey indicate that the relative performance of the crushed aggregate base is close to that of the concrete pavement. In the 1961 survey, after sealing in 1960, the comparison is still quite close although there is a moderate increase, 7 to 8 per cent, in the cracking with the aggregate base.

AREA A-2
 REFLECTED CRACKING
 LANE 23, 46% (51%)
 LANE 24, 32% (35%)
 LANE 25, 14% (17%)

AREA A-2
 REFLECTED CRACKING
 LANE 23, 30% (32%)
 LANE 24, 32% (35%)
 LANE 25, 19% (22%)

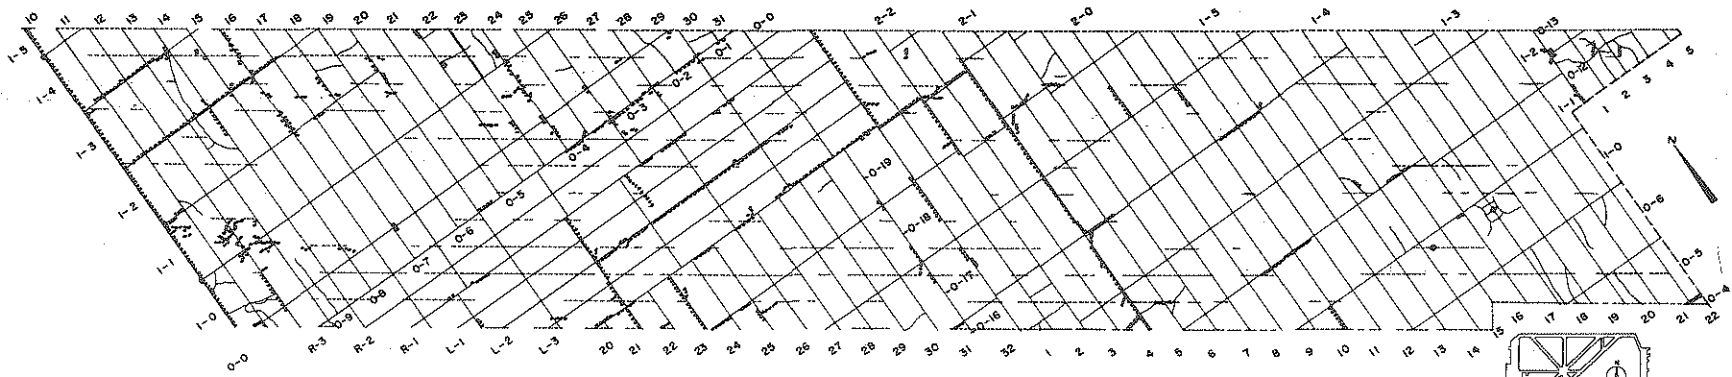
AREA A-3

Area A-3, shown at the top of Fig. 12, was supplied with a 1 inch wearing course, using an Epon asphaltic binder in place of the conventional asphaltic material. Representatives of Shell Oil Company participated in the experiment, designed the mixture, and supervised the laying. From the standpoint of resistance to spillage, its performance has been good for the one year it has been in service. There has been some evidence of softening in spots where compaction of the mixture was inadequate during rolling. These spots are generally at the junction between lanes in which the surface mixture was laid. This represents a construction defect yet to be overcome and it has been recognized as such by those interested in its development. The same defect at the junction between lanes shows up in the cracking pattern in Fig. 12.

concrete pavement laid in 1941 has a very moderate cracking pattern. Most of the cracking in both areas is over pavement joints; the differential in cracking after the first year of service is quite striking. The Epon area has direct reflected cracking of 13 per cent, as compared to 54 per cent in the conventional bituminous surface. If the special cracking between lanes is included in the Epon area, the total cracking would be 30 per cent, still leaving a substantial differential in its favor.

REFLECTED CRACKING, 13% (30%)

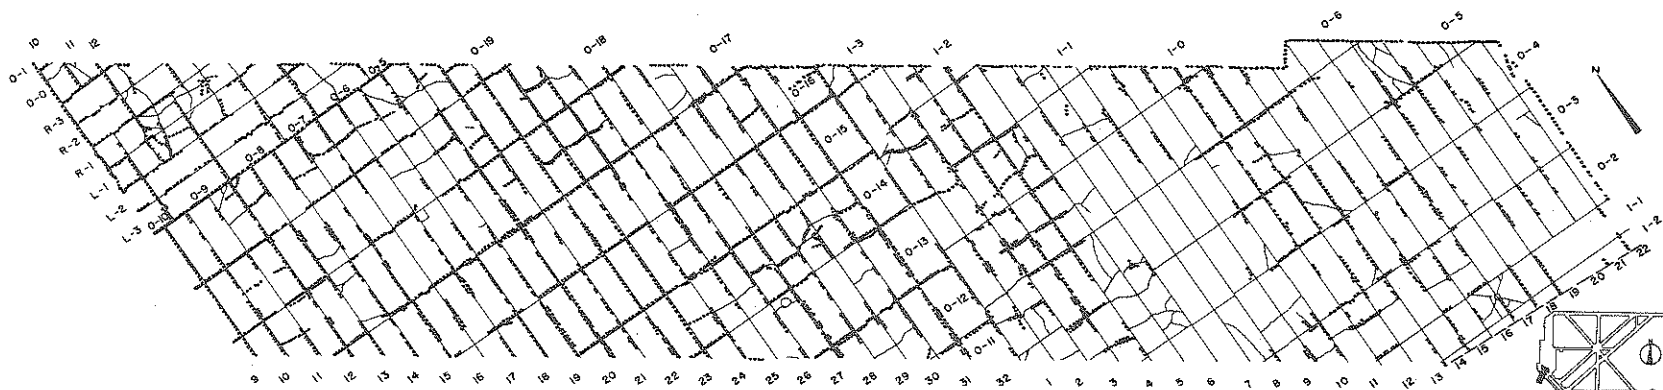
AREA A-4

With respect to reflected cracking, the Epon surface in Area A-3 is compared with the adjoining Test Area A-4 with the conventional 3 inch bituminous resurfacing. No welded wire fabric was used in either area; thus, there is some basis for comparison with other test areas, conditioned by the shorter period of service and the fact that the underlying

REFLECTED CRACKING, 54%
