GUARDRAIL WOOD POST DETERIORATION

A. R. Gabel
J. L. McKenna

Research Laboratory Section
Testing and Research Division
Research Project 71 G-178
Research Report No. R-954

Michigan State Highway Commission
E. V. Erickson, Chairman; Charles H. Hewitt,
Vice-Chairman, Carl V. Pellonpaa, Peter B. Fletcher
John P. Woodford, Director
Lansing, January 1975

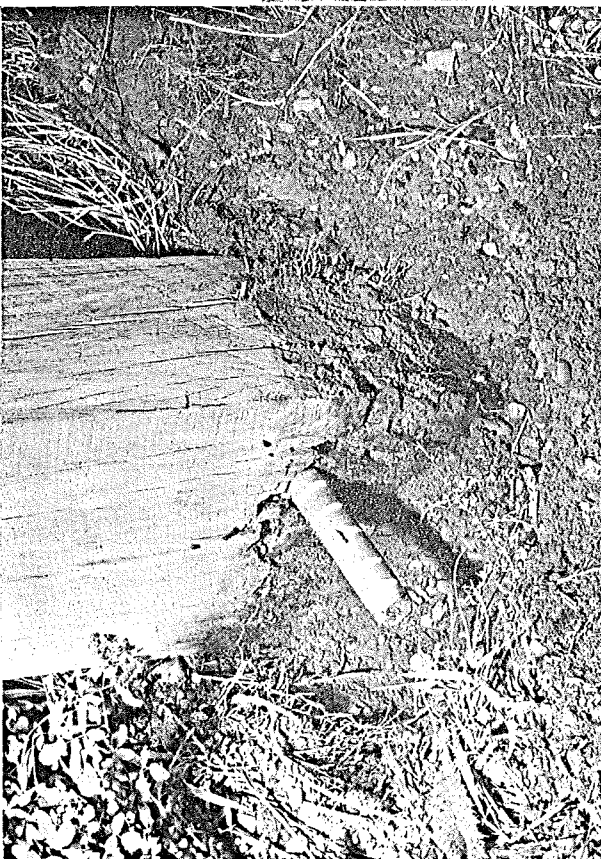
A survey area containing 20 adjoining posts was selected in an installation as representative of it. Each post was then examined for deterioration at and below ground line by removing surrounding earth and probing the post with an ice pick to determine depth of decay (Figs. 1 and 2). The type of treatment being surveyed was identified either visually or by laboratory analysis of a core sample. The examination results were recorded, with the averaged results listed in Tables 1 through 3, covering the three treatments.

2) Water-borne preservative treated wood posts, used in a majority ratio, on Department guardrail installations showed 100 percent cross-sectional loss at ground-line on some posts after 11-years of service. Since they also showed a higher incidence of decay, the older specification water-borne treatment is significantly inferior to the creosote and pentachlorophenol treatments, though there were a few exceptions in surveyed installations where the performance was about comparable.

Figure 1. Water-borne treated post allows full penetration of probe through rot and crack. The crack develops in some badly decayed posts presumably from lateral pressure exerted by snowplows. Post is 18 years old on southbound US 27, north of St. Johns.

we recommend that the Department endeavor to obtain these types for new installations and as replacements rather than the currently allowed water-borne treatment containing the chromated copper arsenate formula, until the latter proves to give equivalent protection in the Michigan environment.

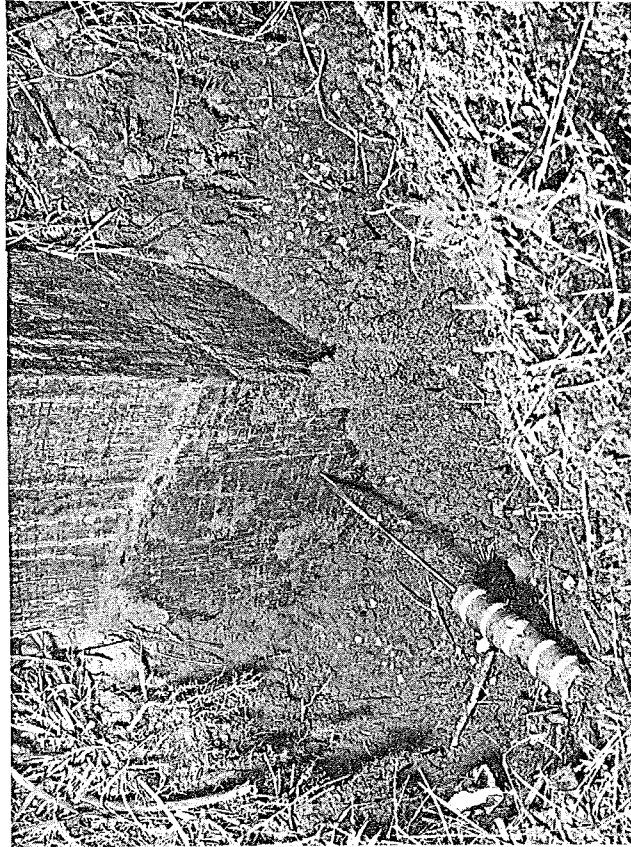
1) Creosote and pentachlorophenol preservative treated wood posts, used in a minority ratio, on Department steel beam guardrail installations showed a maximum cross-sectional loss at ground line of 15 percent after 12-years of service on any of the surveyed posts, and generally less after longer service, and thereby are considered as providing good resistance against decay.

Figure 2. Creosote treated post allows only minor penetration of probe below ground line signifying sound wood. Post is 18 years old on southbound US 27 near north Clinton Co. line.

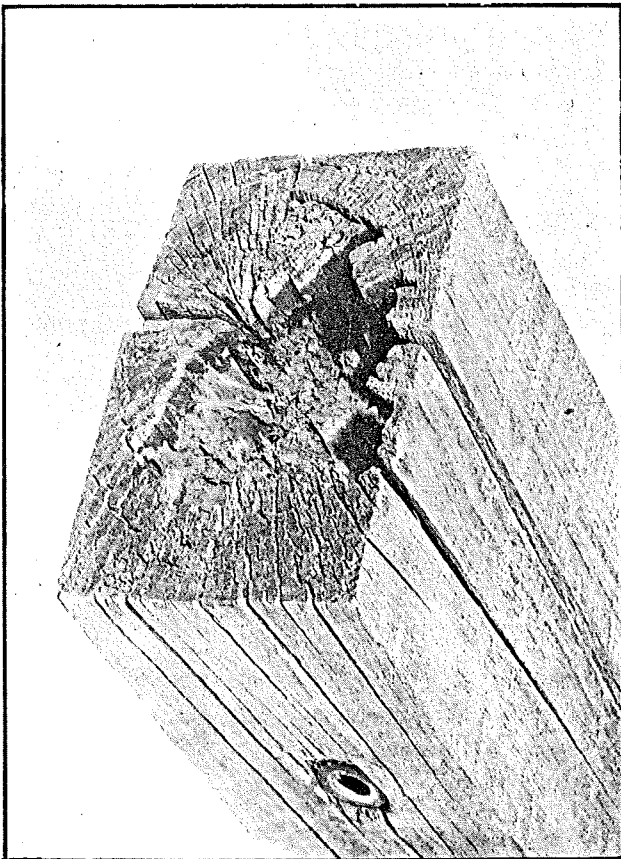
Though the surveyed wood posts were apt to show decay confined to the ground line, a small percentage also showed some rotting at the top as shown in Figure 3.

Figure 3. Water-borne treated post that had rotted out at ground line during 14 years of service also shows decay on top. Post was on M 82 near Newaygo.
