REPORT ON THE USE OF COLD
PLASTIC PAVEMENT MARKING MATERIALS

TSD-0-148-70

**DEPARTMENT OF STATE HIGHWAYS
STATE OF MICHIGAN**

December, 1970

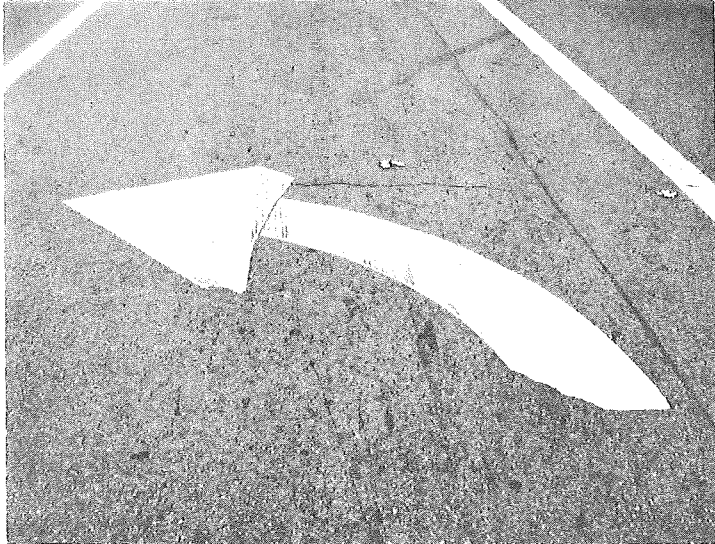
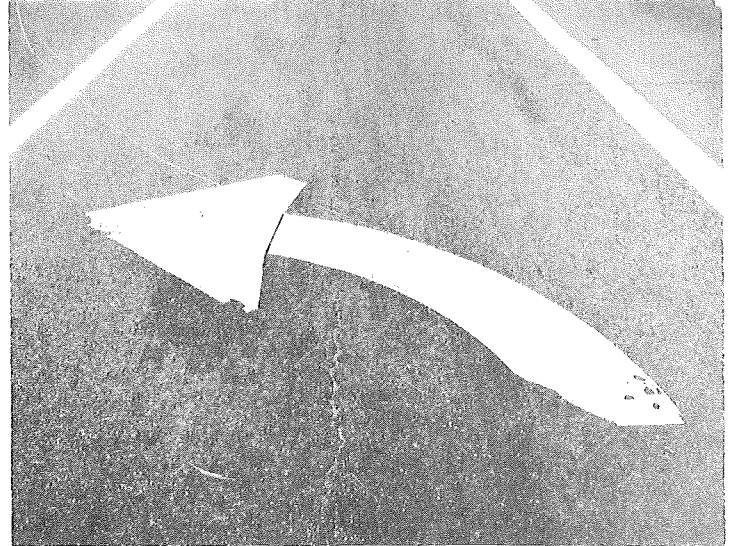
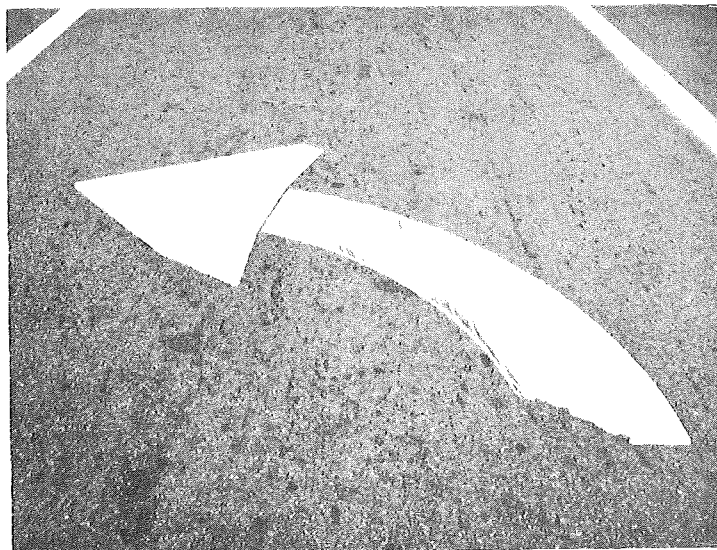
Location A (See Figure #11)

After three years of service, the three arrows at this location have maintained excellent operational quality. Each arrow has only small pieces of the material missing. There are some tire marks on each arrow but not enough to impair the operational quality.

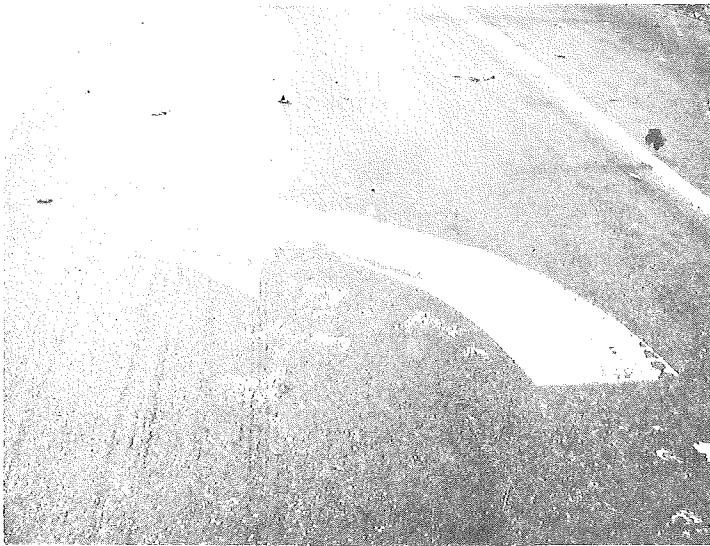
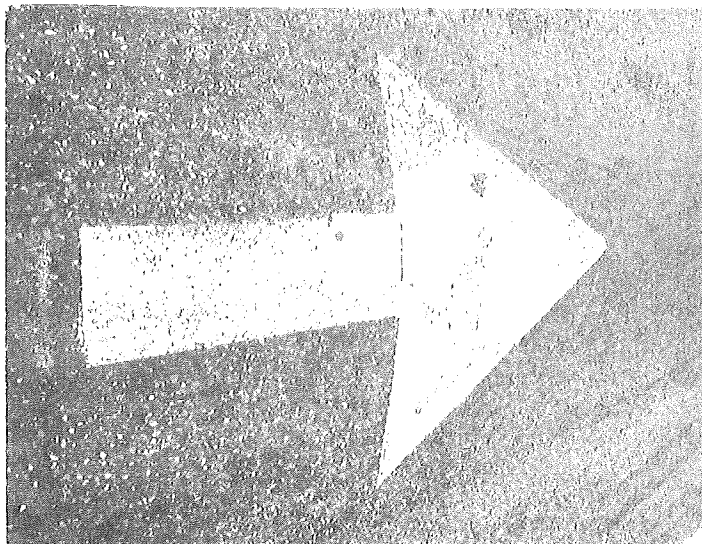
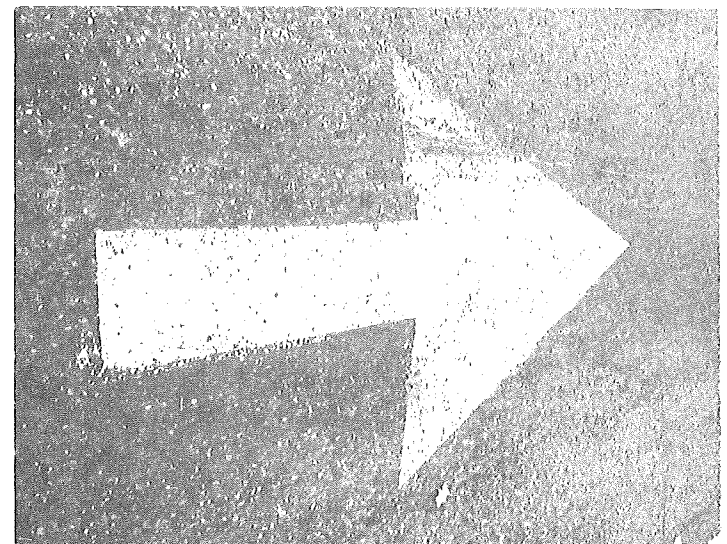
Location B (See Figure #12)

The six arrows at this location were painted over subsequent to installation. However, the photographs depict the remaining cold plastic material. Arrow #6 is completely

missing, and arrows #1 through #5 are practically all missing. Probably due to the older, uneven surface upon which they were installed, these arrows were completely ineffective after two months of service. After the first snow plow activity of December 1968, the arrows looked about like they do today.

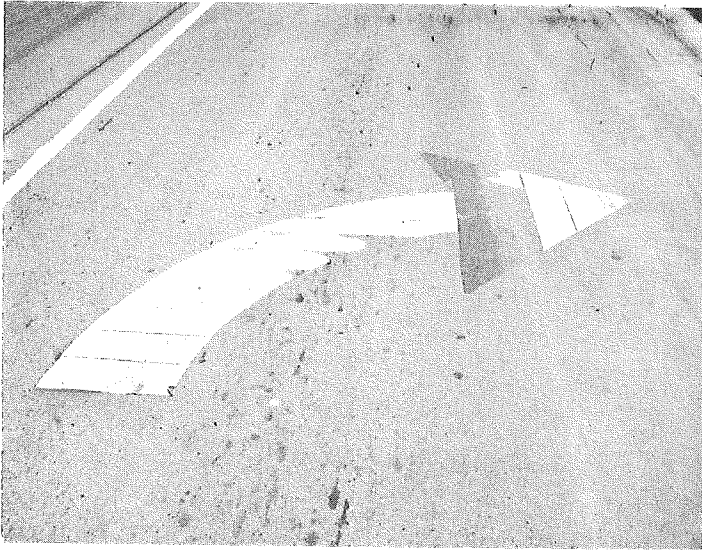
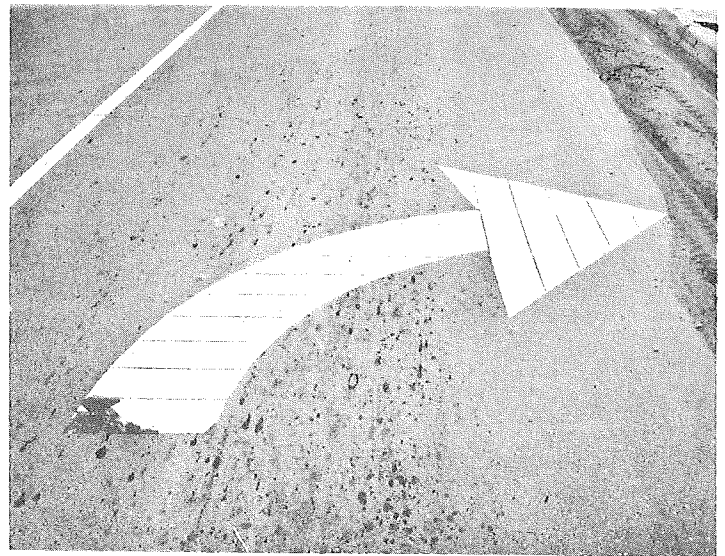
Location D (See Figure #14)

After two years of service, Arrow #2 maintained excellent operational quality. Arrow #1 showed considerable loss of material from the head. The material was lost shortly after installation and, since that time, has remained nearly 100% intact. This was probably due to a poor initial bond.

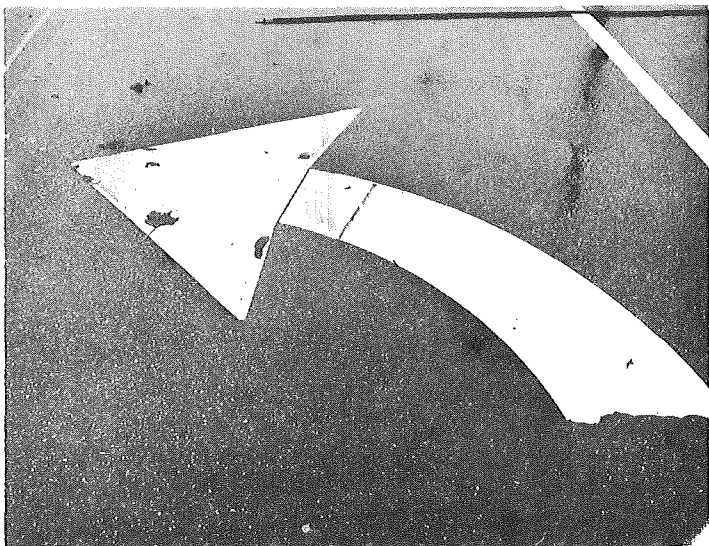
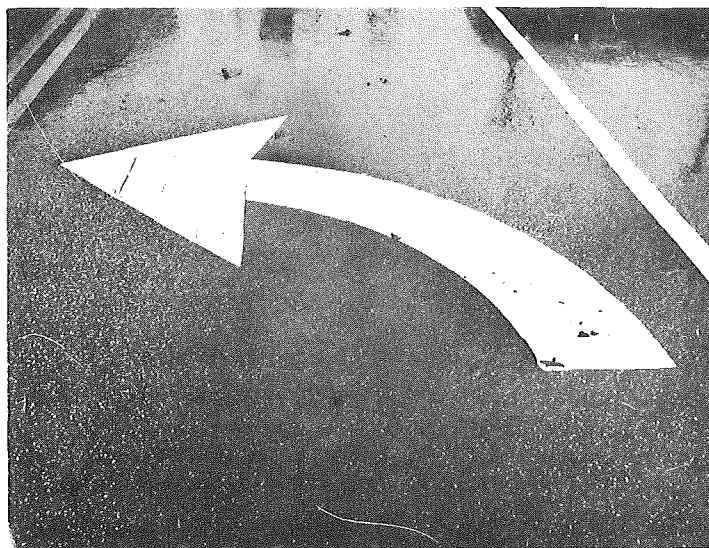
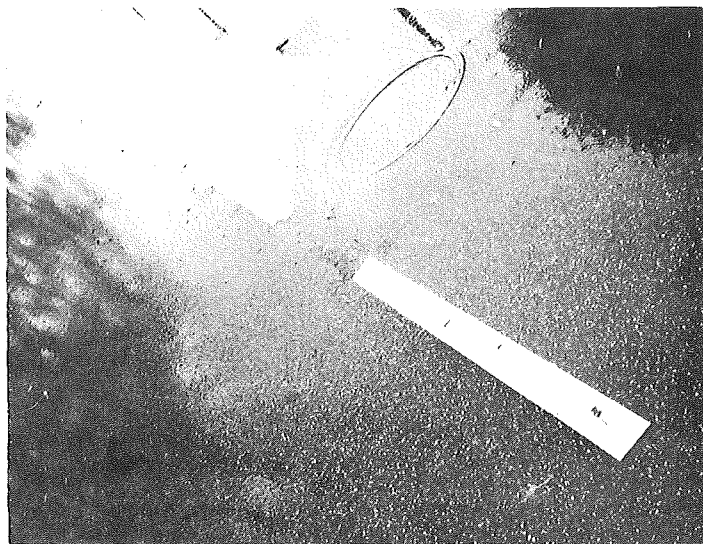
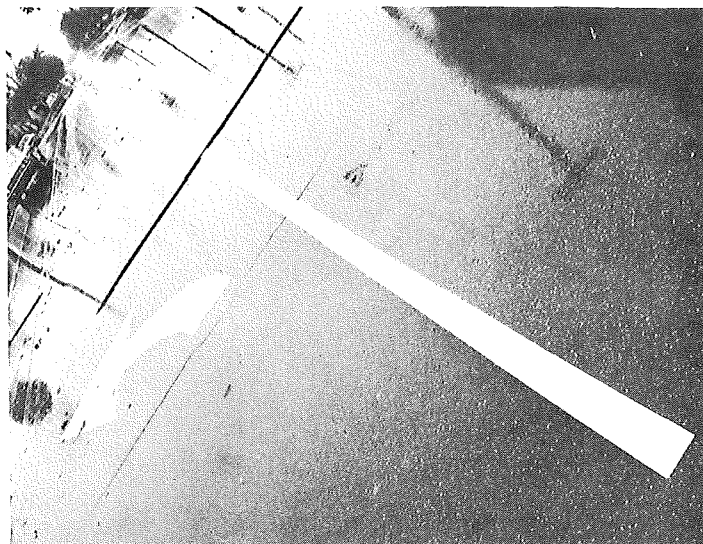
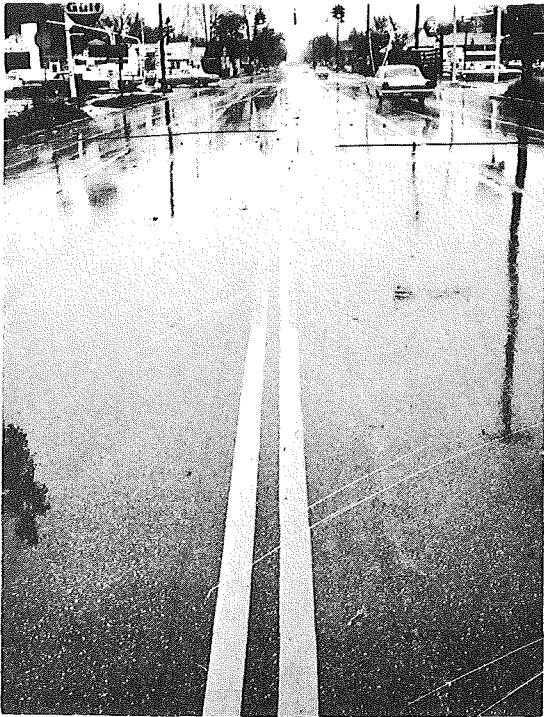
Location E (See Figures #15 and #16)

After fourteen months of service, the results at this location were very good. There were only three noticeable failures at this location. The 4" yellow Prismo transition line (Item #6 in Figure #16) shows a 15-foot section of raveling, and the Holland-Suco 4" white skip line (Item #3 in Figure #15) shows a small removal of material on the leading edge. A small portion of the leading edge of Arrow #1 (Figure #15) was missing. All the remaining materials at this location were 100% intact.

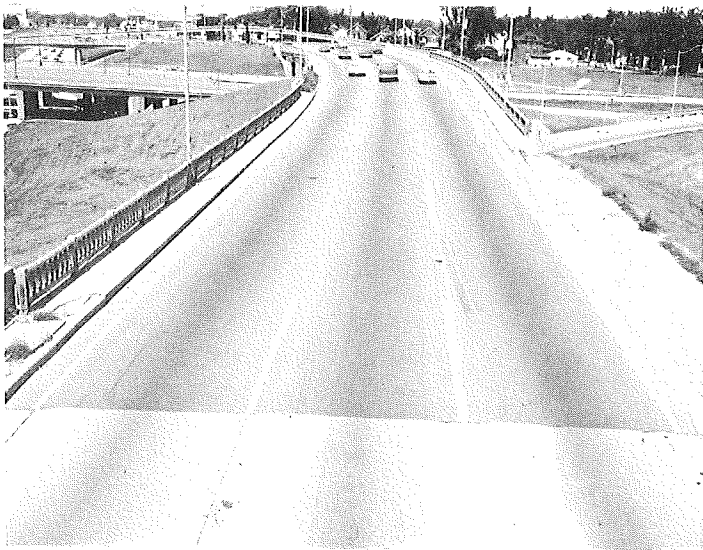
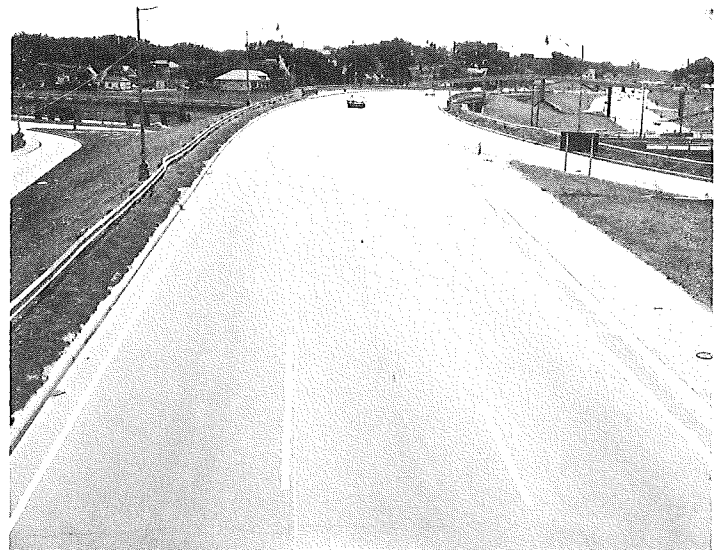
Location F (See Figure #17)

After fourteen months, the cold plastics at this location were in excellent operational quality. There was only a loss of three feet of material at this location. All of the material was free from tire marks.

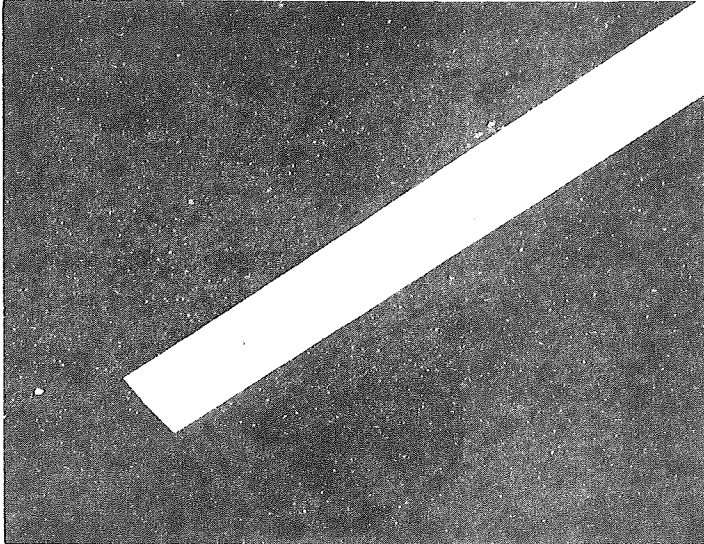
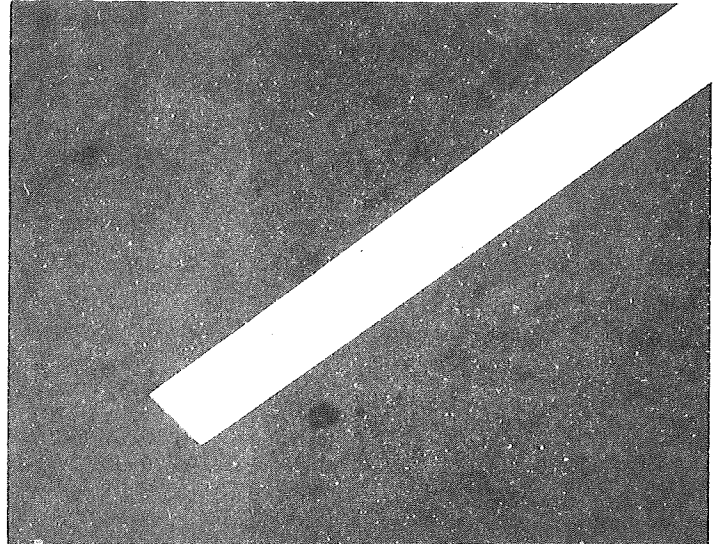
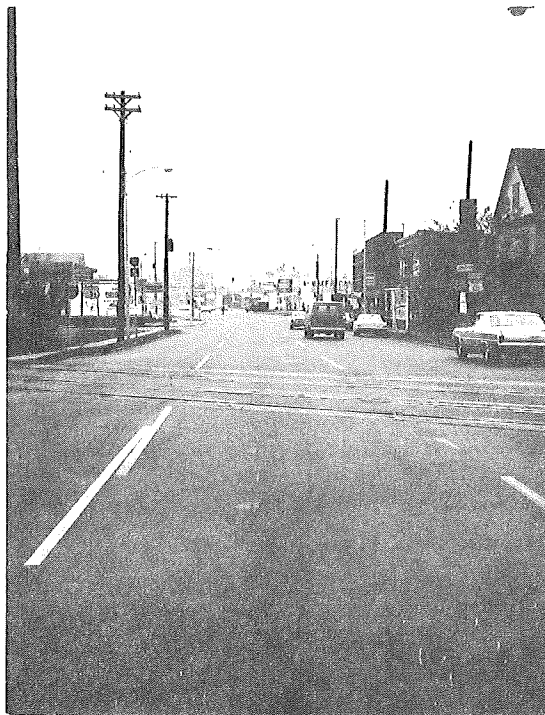
Location G (See Figure #18)

After four months of service, the Prismo and Holland-Suco 4" lane lines maintained excellent operational quality. All the materials at this location were 100% intact and completely free from tire marks.

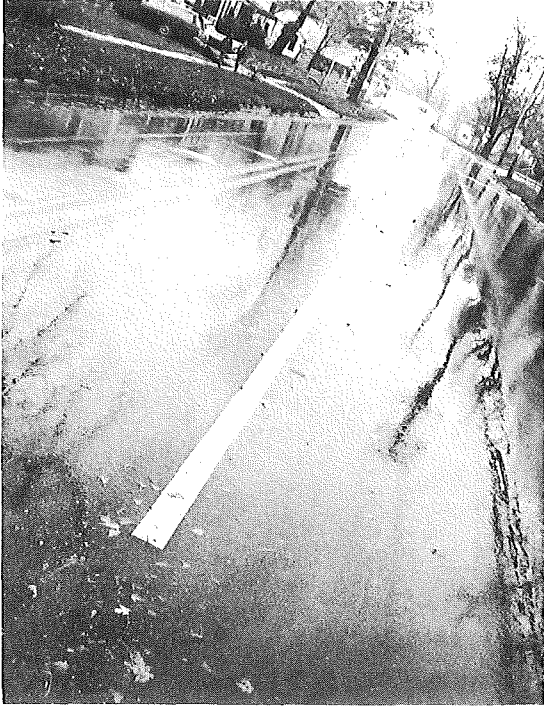
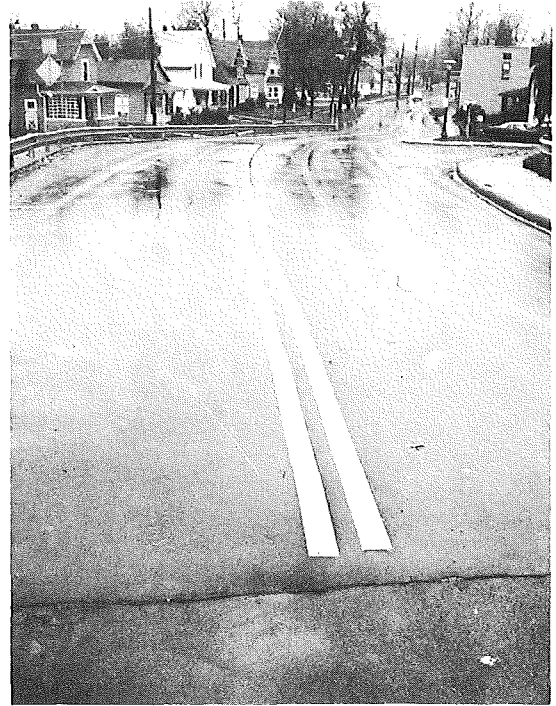
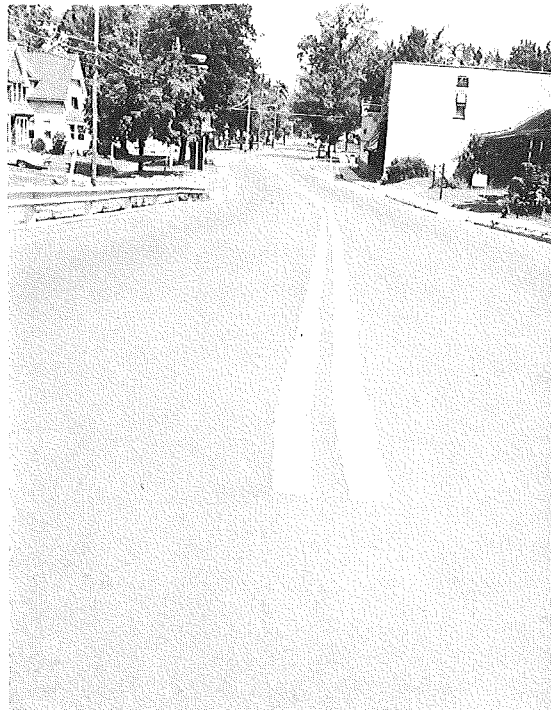
Location H (See Figure #19)

After four months, the lane lines at this location were 100% intact and free from tire marks.

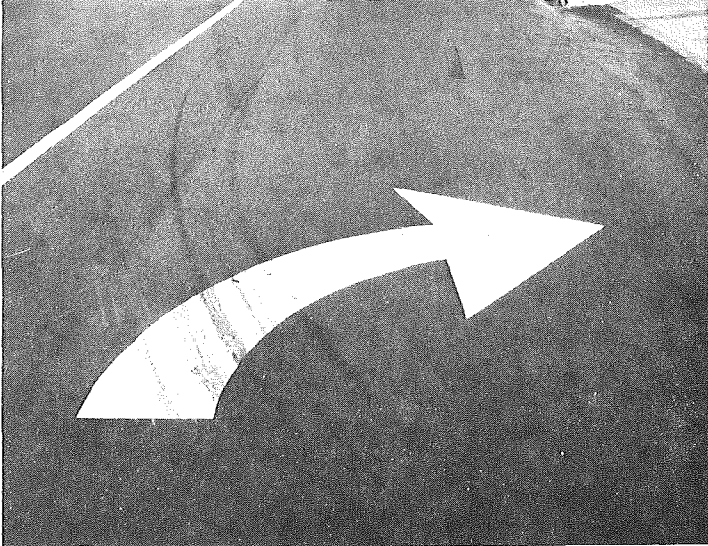
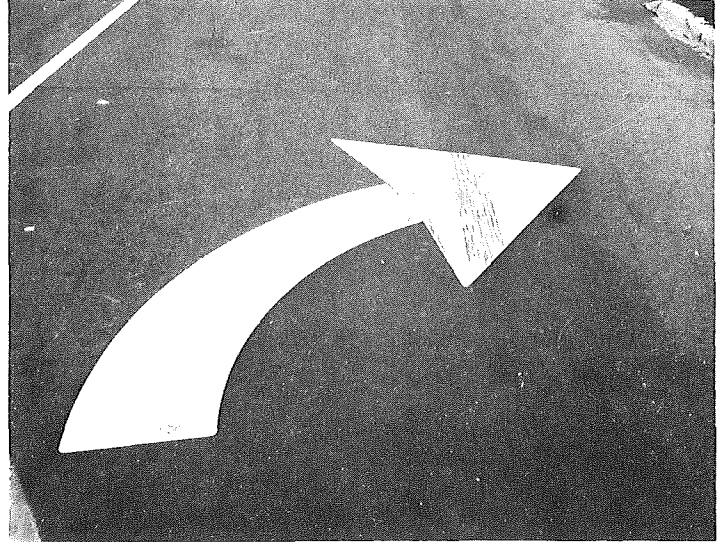
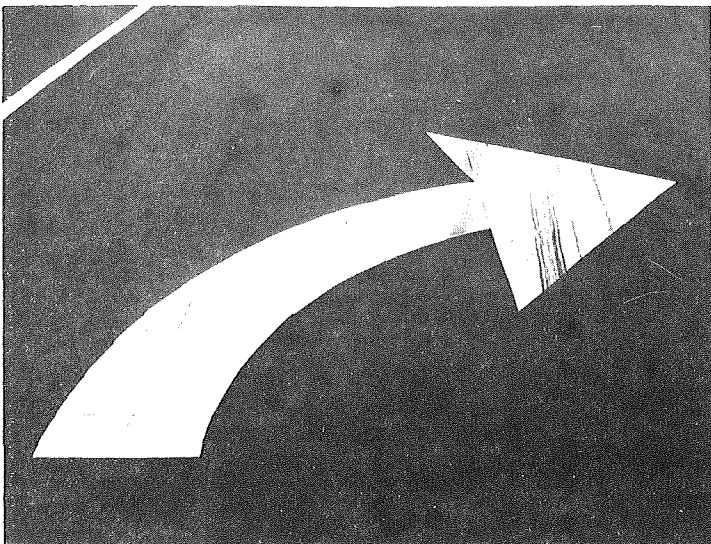
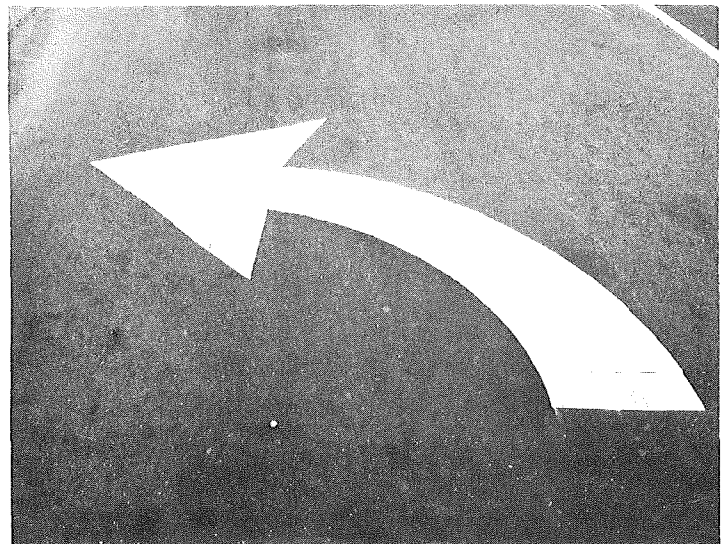
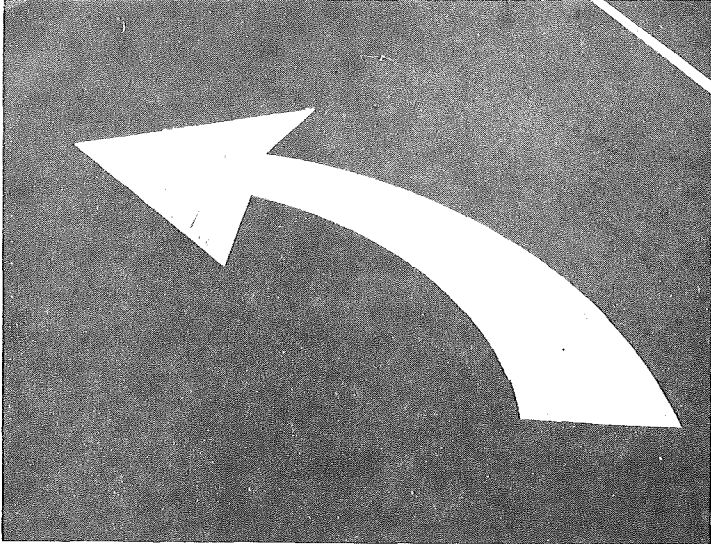
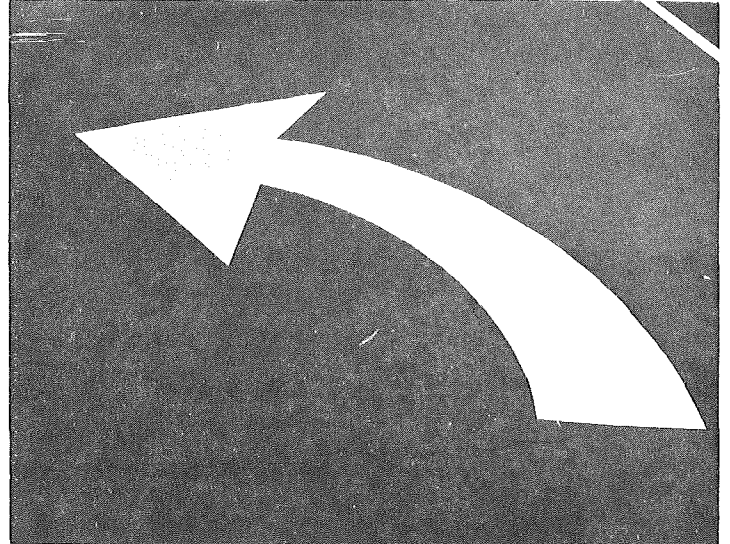
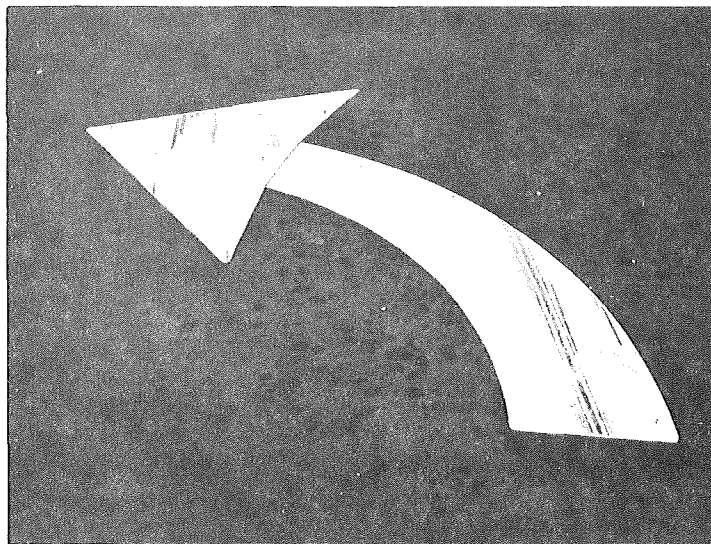
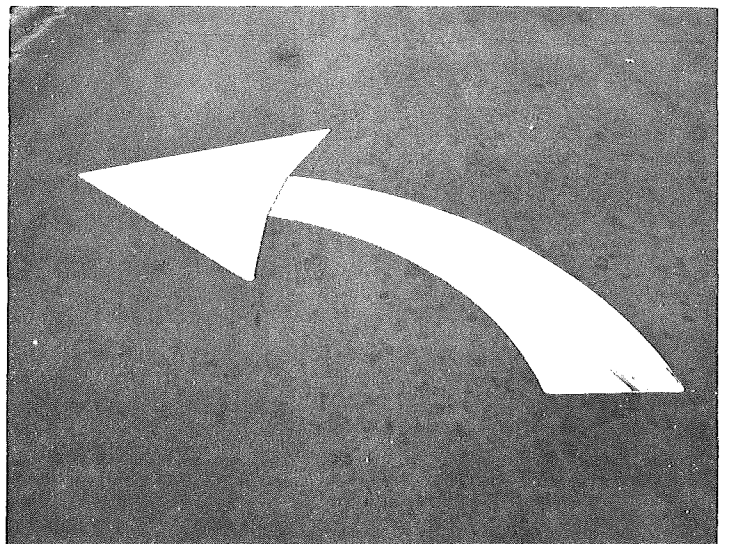
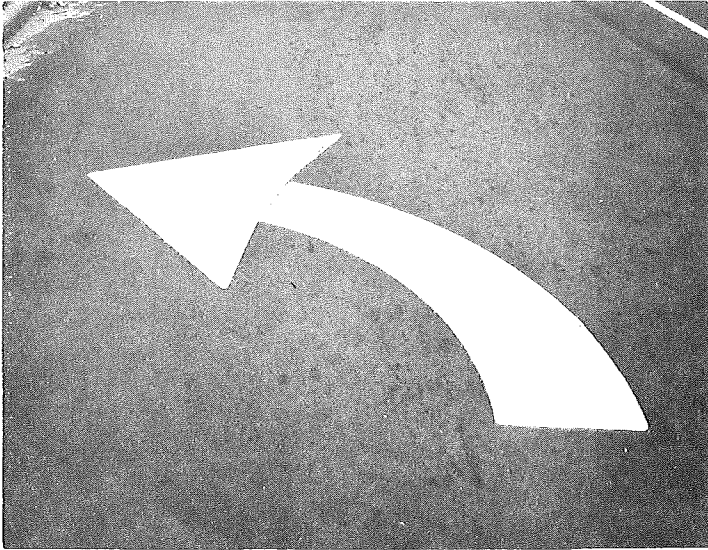
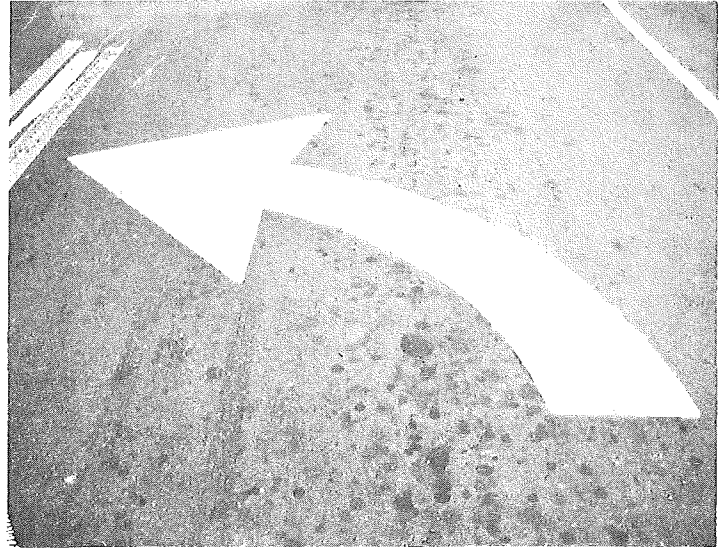
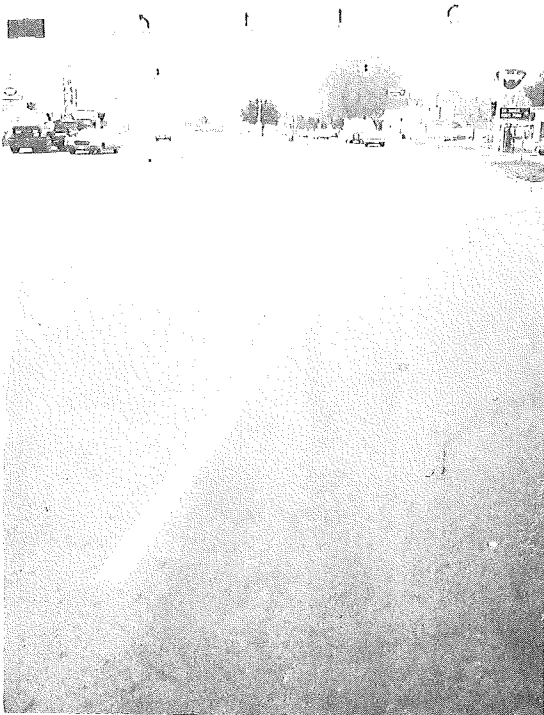
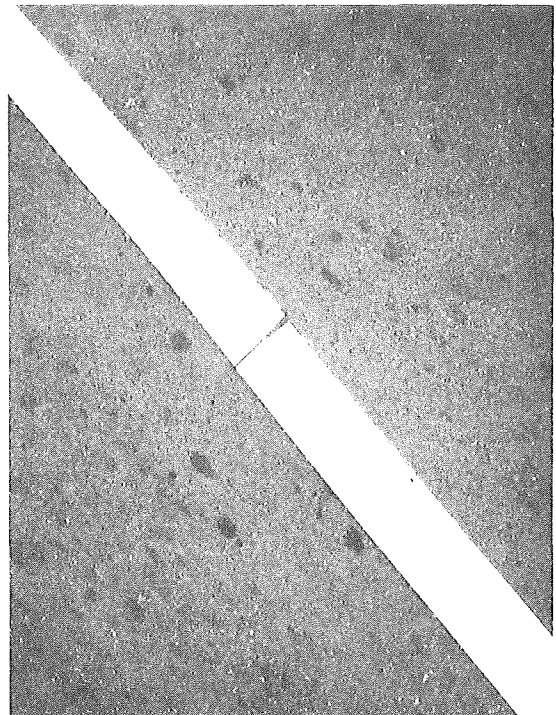
Location I (See Figures #20, 21, and 22)

After four months, the cold plastic materials at this location were 100% intact. There was minor tire-marking on some of the arrows but not enough to impair their operational quality.

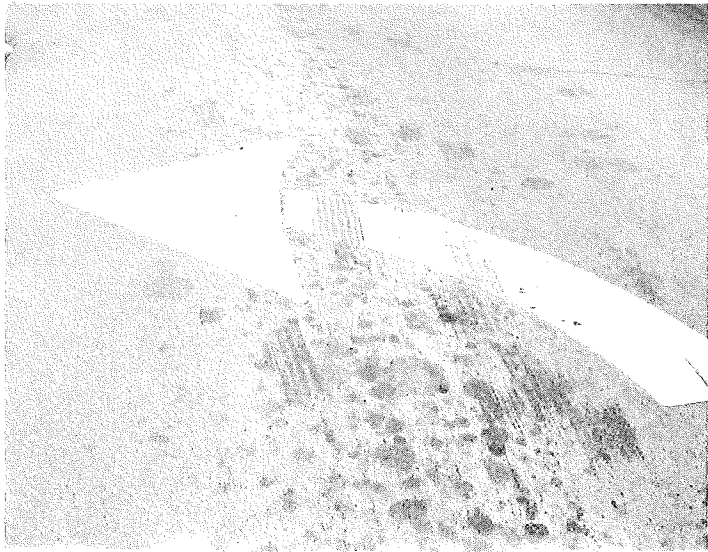
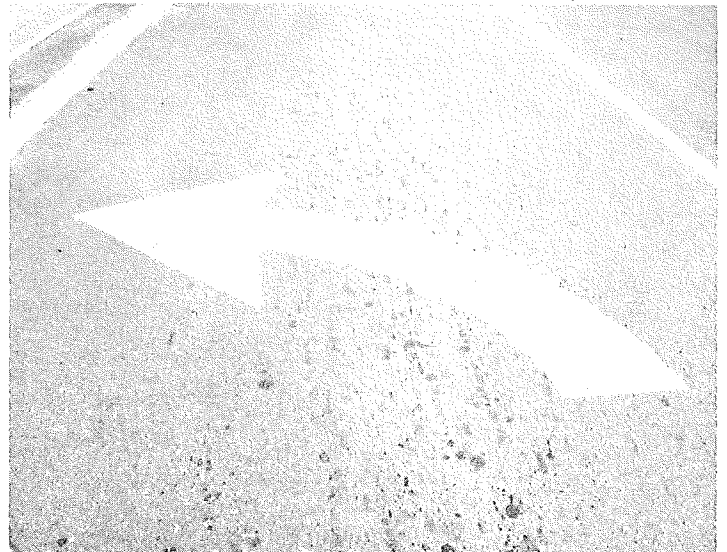
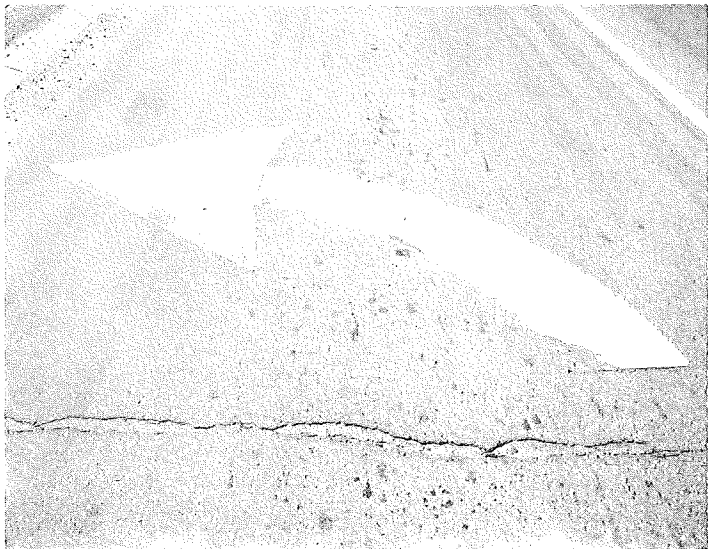
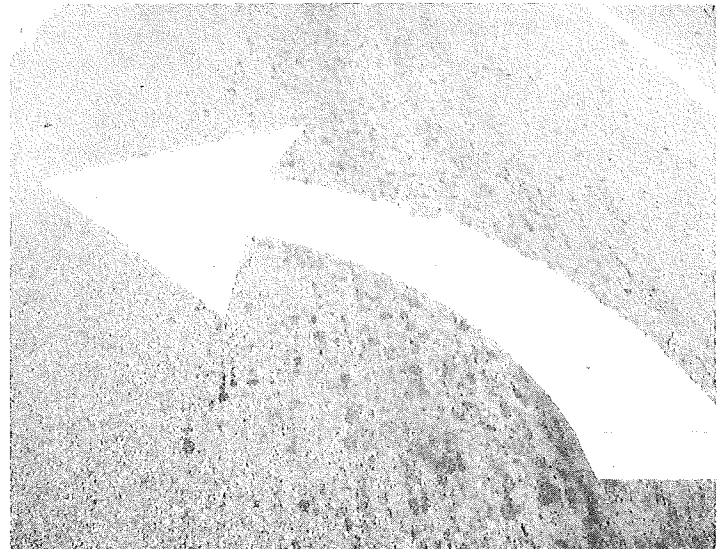
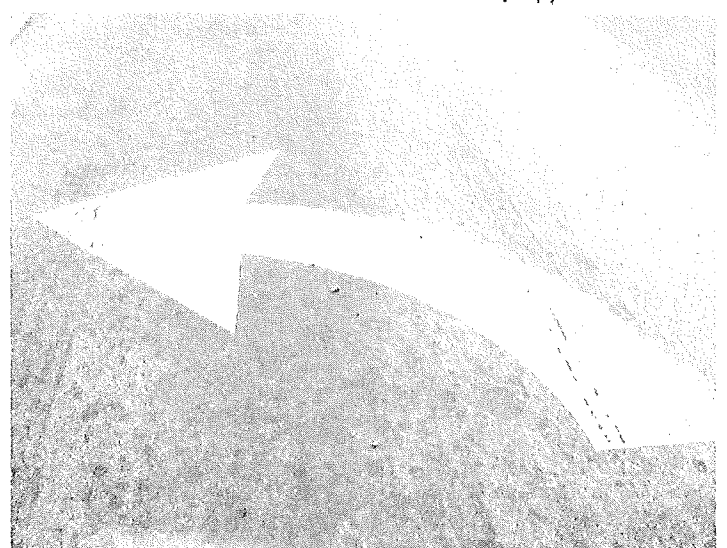
Location J (See Figure #23)

After fourteen months of service, the six arrows at this location were in excellent condition. Arrow #3 was the only arrow that had lost any material. There was very minor tire-marking on some of the arrows at this location.
