Michigan Department of Transportation

Pavement Demonstration Program Project Finalization I-75 Northbound Unbonded Concrete Overlay (MDOT Job Number 73873)

May 2020

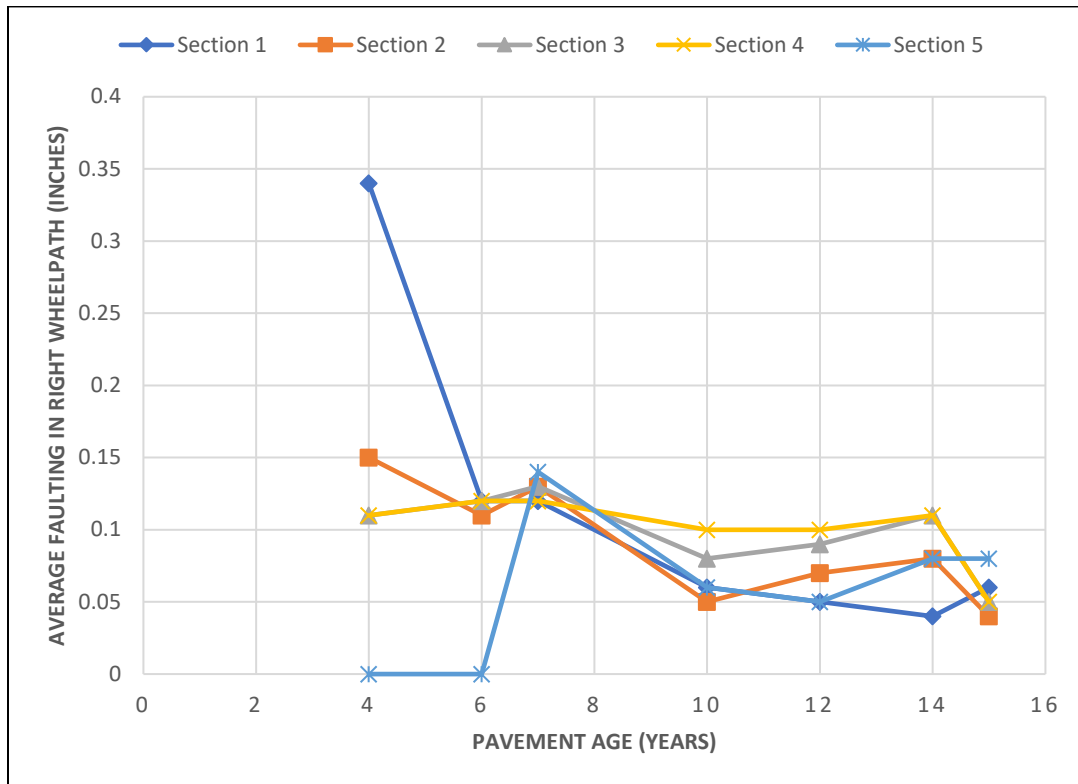
Figure 3. Right Wheel Path Average Fault Yearly Progression Per I-75 Test Section

As shown, Sections 2, 3, and 4 exhibited the highest number of recorded faulted locations per mile with final totals before maintenance of 500, 455, and 474, respectively. Section 5 consistently had the lowest number of recorded faulted locations per mile with the final total before maintenance of 157. The average faulting measure was somewhat inconclusive for all sections over the timeseries of data. For IRI, Sections 3 and 4 exhibited the highest (worst) and the most rapid increase with final IRI before maintenance of 118 and 134, respectively. Section 5 had the lowest rate of IRI increase with final IRI before maintenance of 93. For DI, Section 5 exhibited the highest (worst) and the most rapid increase followed by Sections 3 and 1 with final DI before maintenance of 23.9, 14.0, and 13.9, respectively. Section 2 had the lowest rate of DI increase with final DI before maintenance of 1.9. It should be noted that these DI measurements are not consistent with the number of repairs per mile, faulting measurements, or IRI, so per further investigation, it was found that Section 5 had minor corner cracking that added to the DI value (as shown in the Appendix, Figure A16). This type of distress may not require repair, contribute to faulting, or add roughness. Other DI inconsistencies may be due to the location of sampling. Moreover, Section 5 has a lane reduction from 3 lanes to 2 lanes near its midpoint, so some of the DI measurements may have been taken in the outer lane that was tapering, unlike the other sections that were all taken in a single continuous lane. While this does not invalidate the DI, it is a variable that may impact the DI measurement.

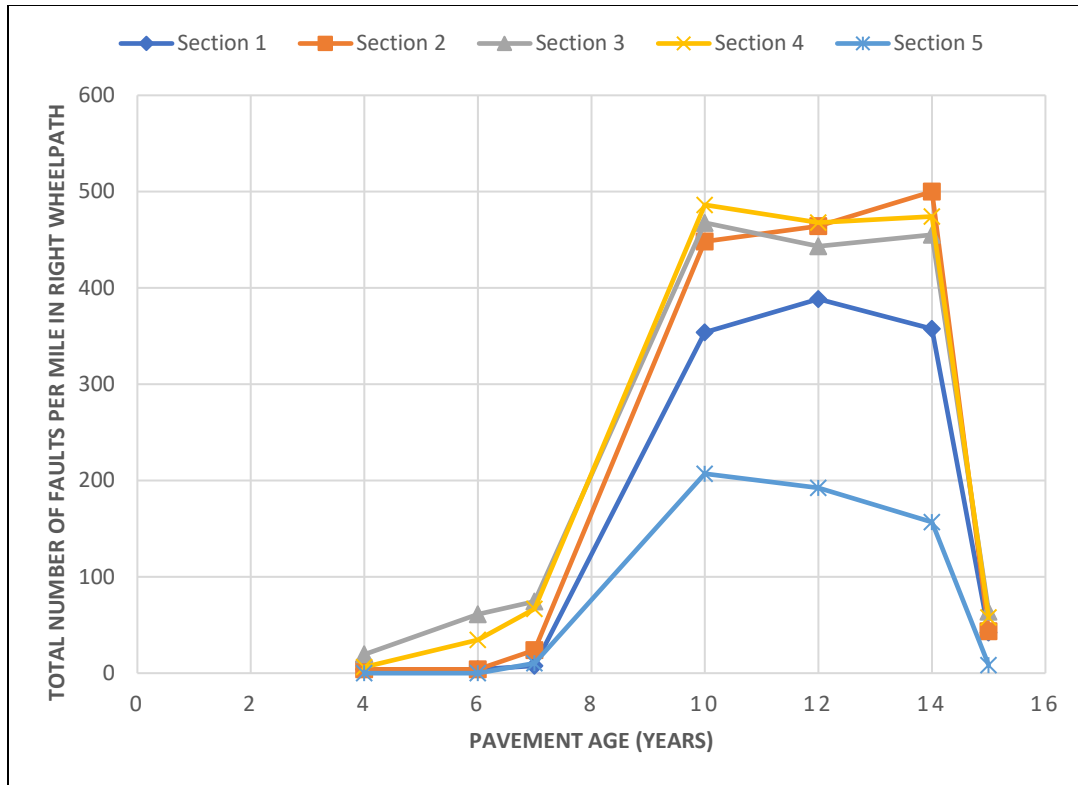
Figure 4. Right Wheel Path Total Number of Faults Per Mile Yearly Progression Per I-75 Test Section

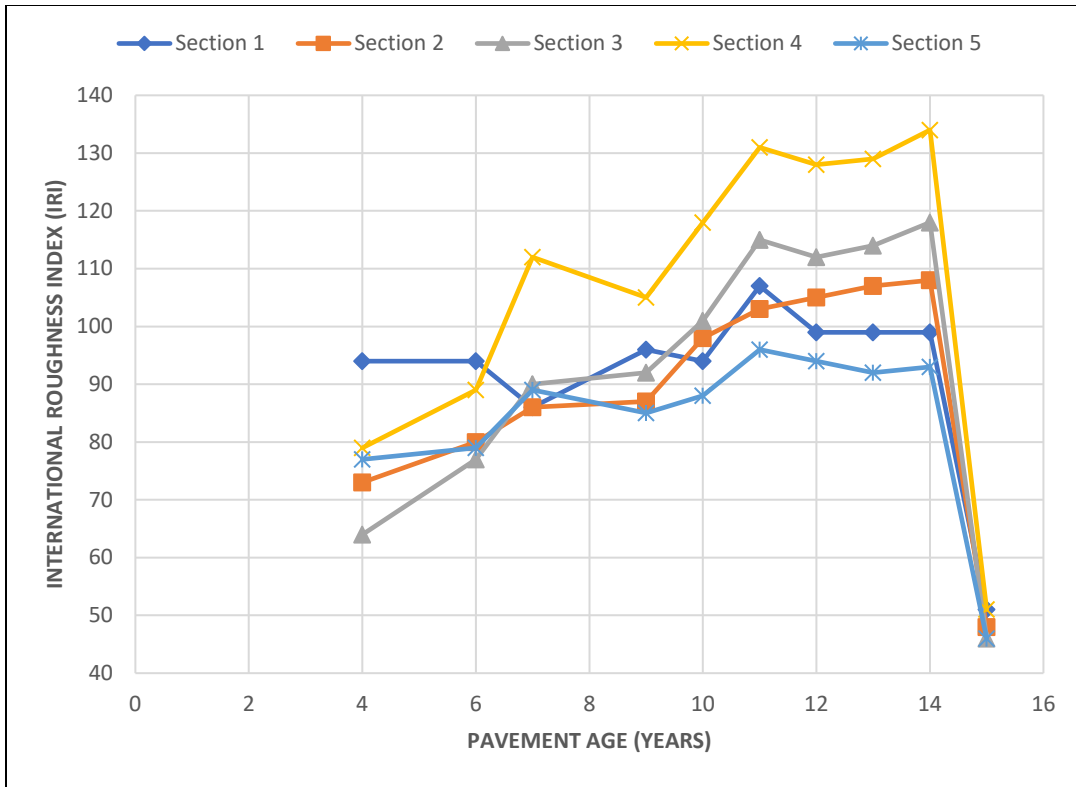
Figure 5. IRI Yearly Progression Per I-75 Test Section

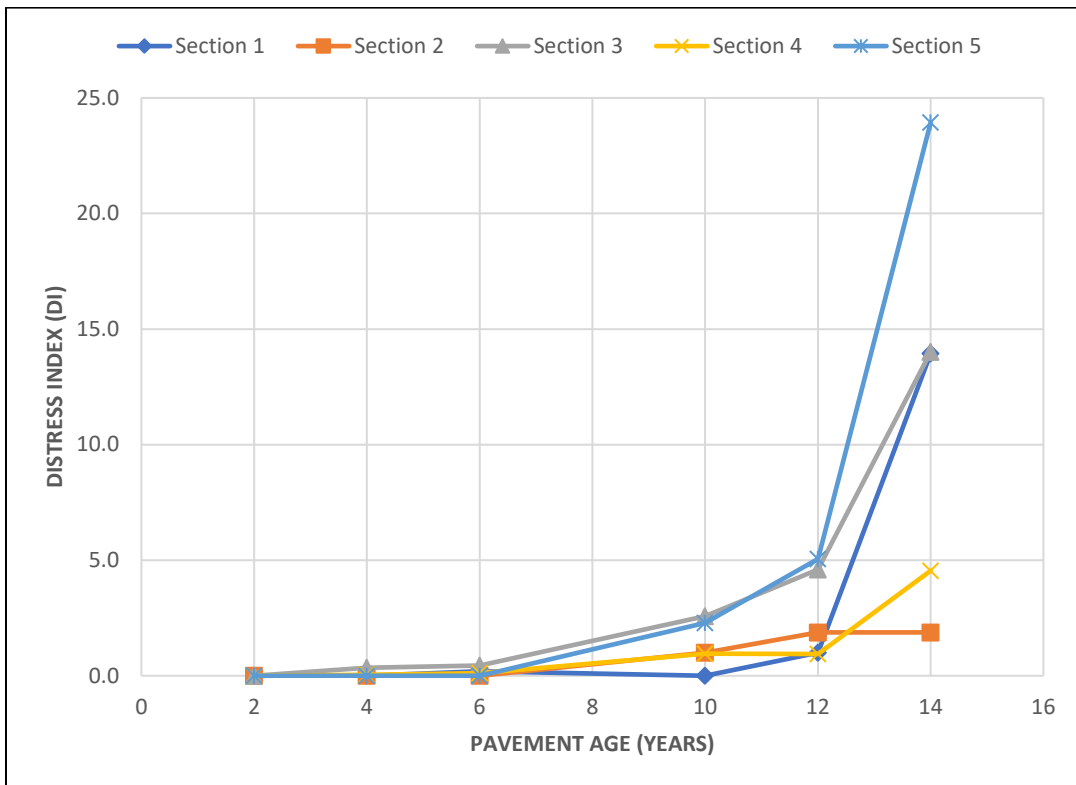
Figure 6. DI Yearly Progression Per I-75 Test Section

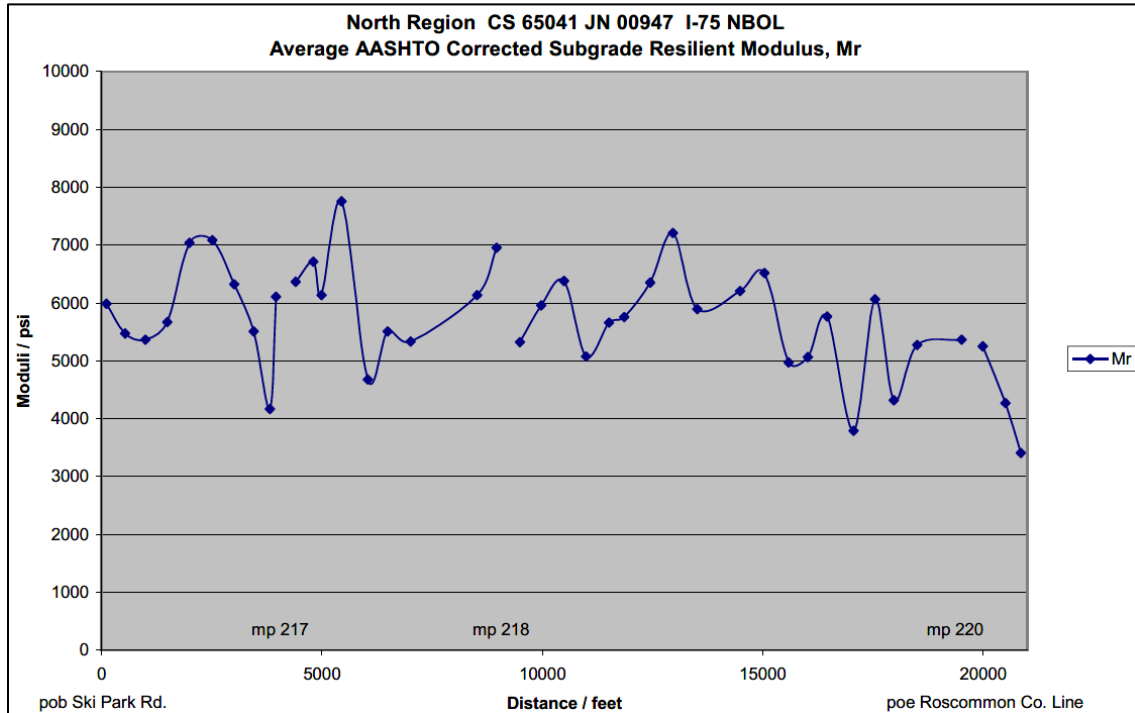
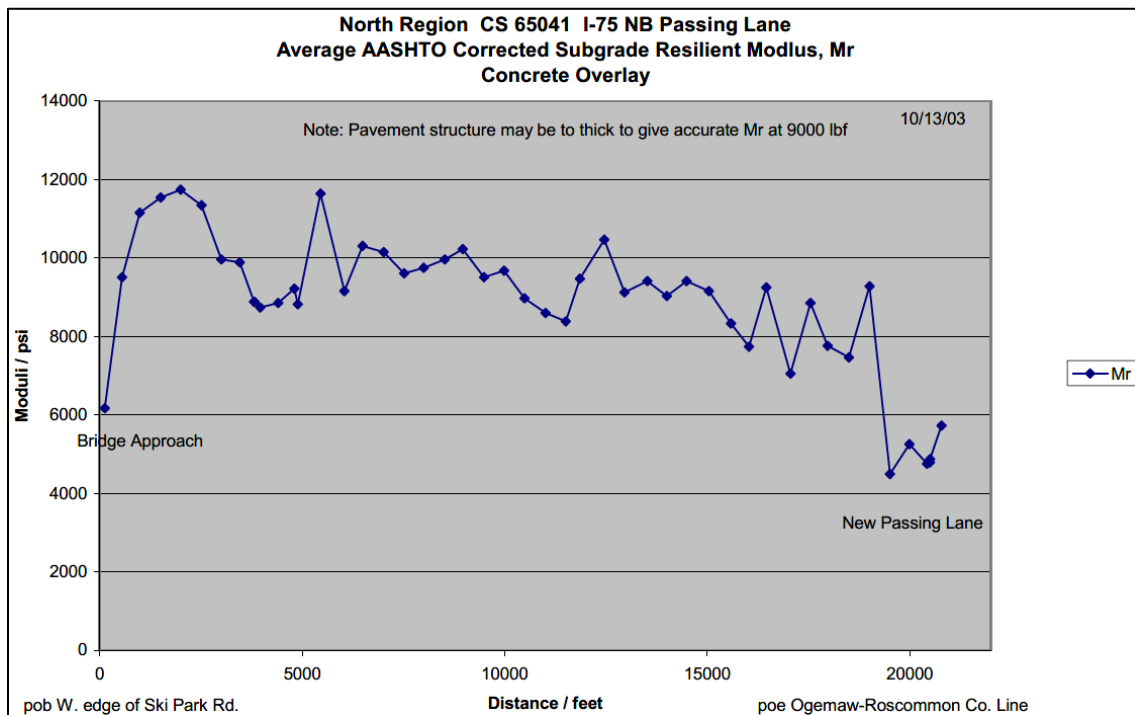
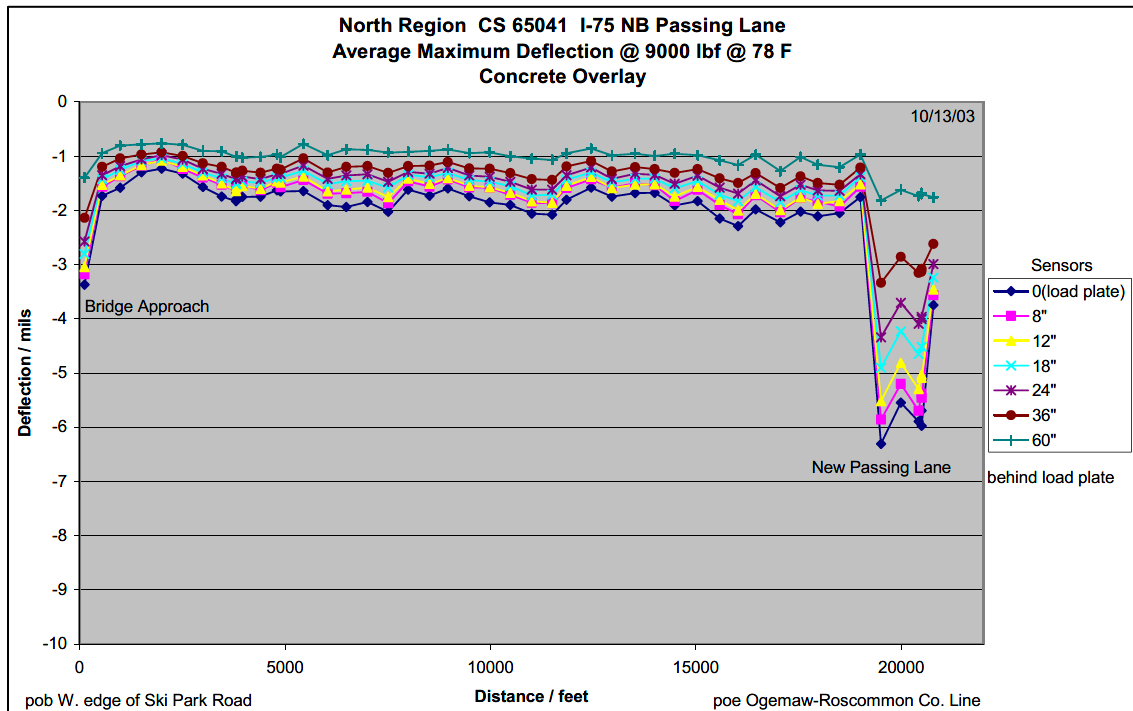
Per MDOT Report # R-1465, falling weight deflectometer (FWD) testing was conducted before and after the unbonded concrete overlay was constructed. This is a non-destructive test used to evaluate in-situ stiffness of the pavement cross-section layers and characterize the structural condition. As a result of this testing, it was observed that Section 5 has a noticeable increase in deflection measurements, indicating a reduction in layer stiffnesses. Therefore, the base and subgrade conditions are most poor in Section 5 as compared to all other sections. The FWD

measurements are shown in Figures 7, 8, and 9. Note that per these figures, Section 5 approximately begins and ends at distance 18,250-feet and 20,800-feet, respectively.

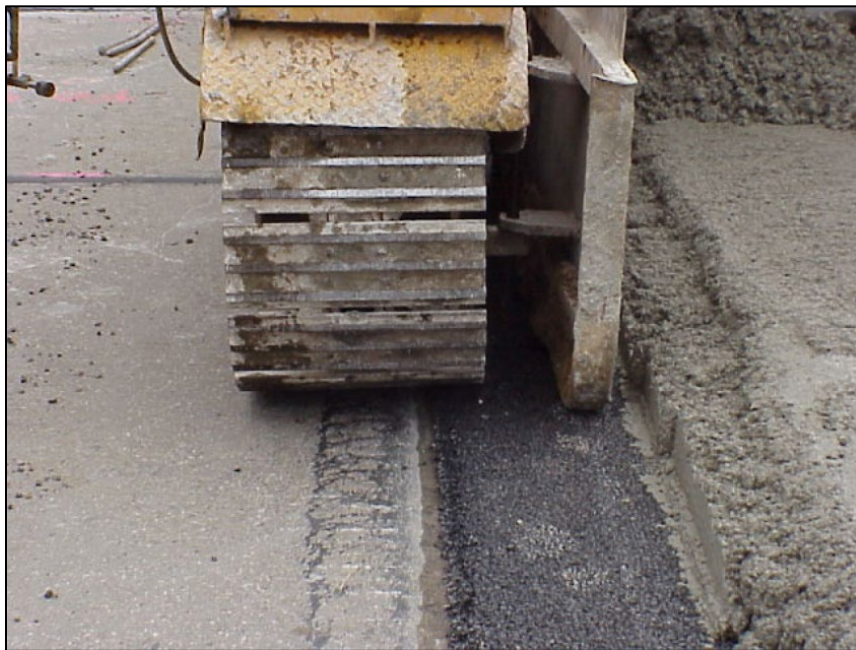
Figure A9. MDOT Report # R-1465, Figure 5, Paver Track Running on Asphalt Separator Layer

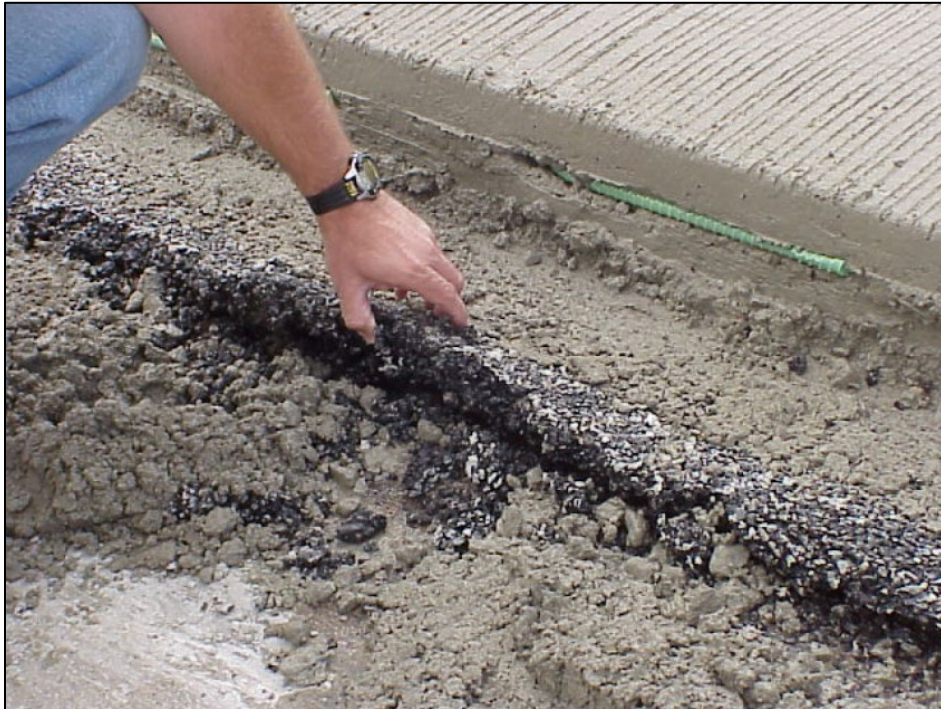
Figure A10. MDOT Report # R-1465, Figure 7, Loose Asphalt Separator Layer. Note Embedded Lane Tie That Can Not Be Straightened for The Adjacent Lane

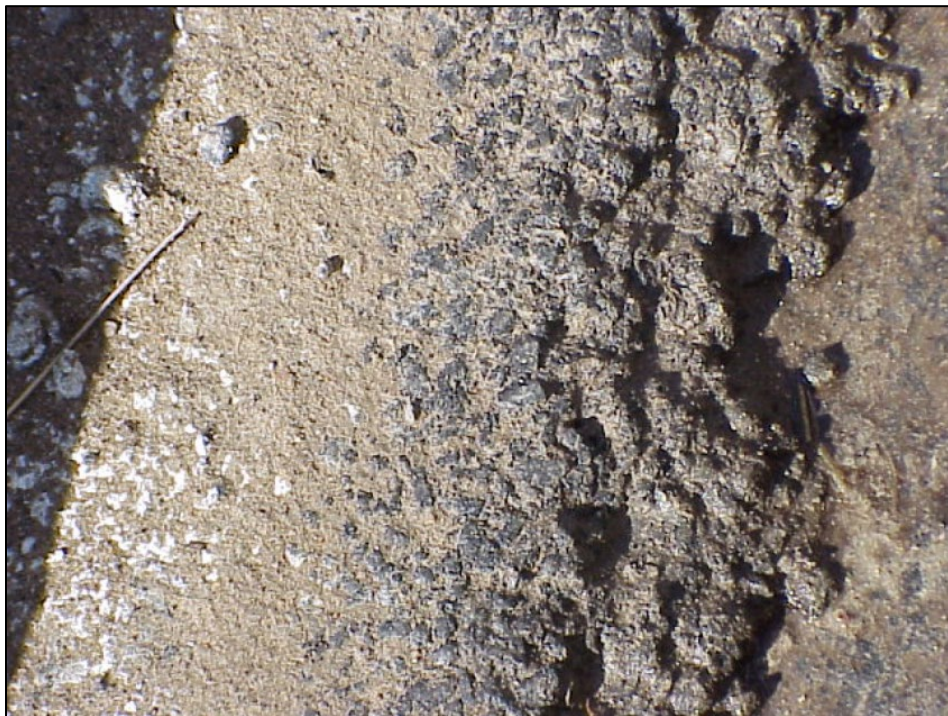
Figure A11. MDOT Report # R-1465, Figure 9, Voids in The Separator Layer Are Plugged with Construction Debris

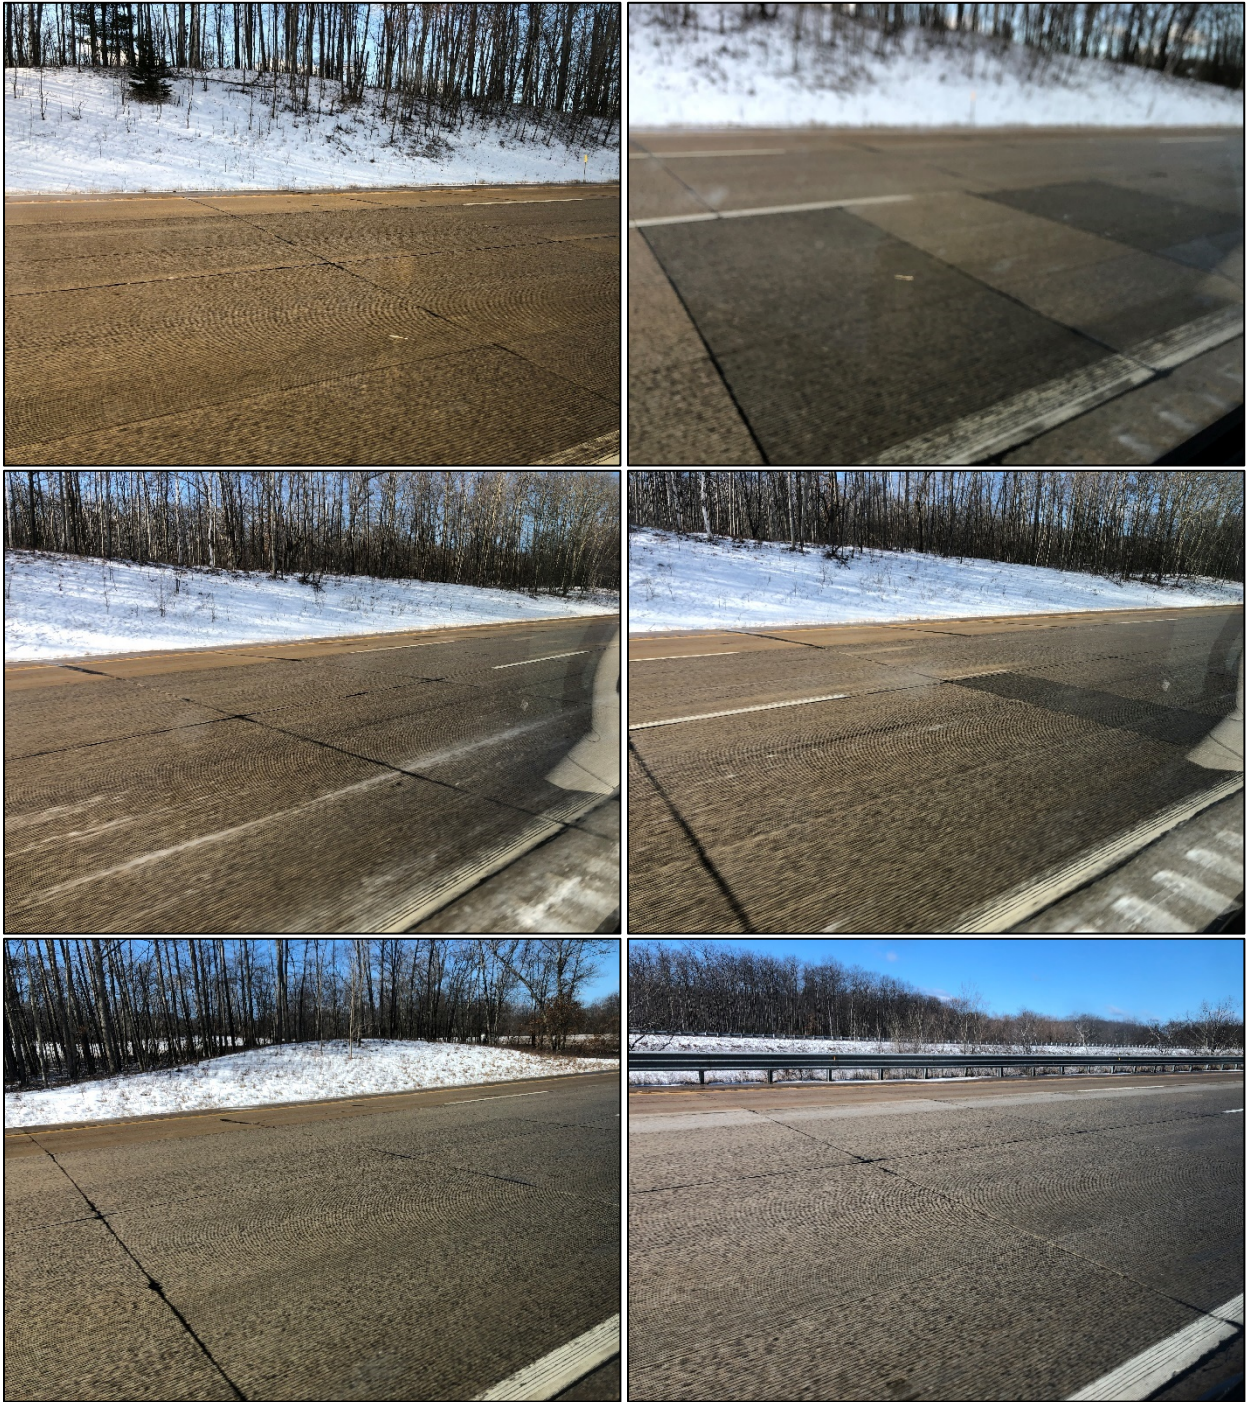
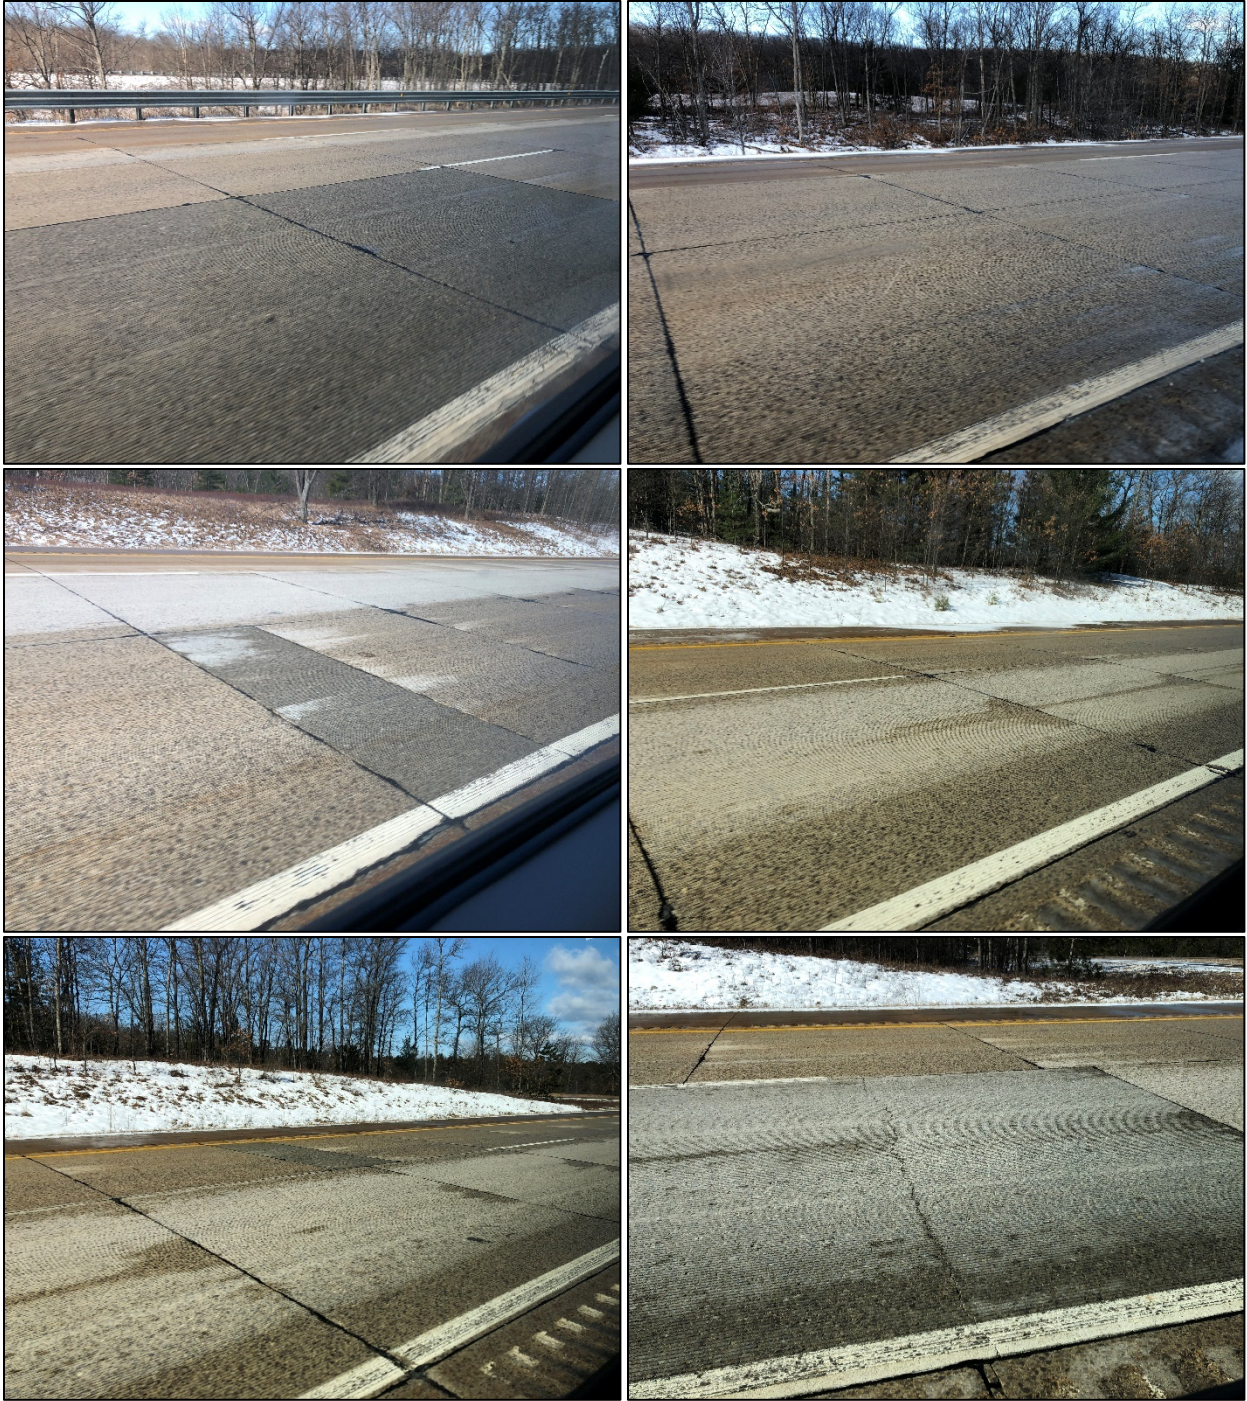
Annual site condition field surveys were conducted and reported on in the annual MDOT Demonstration Program Legislative Report, *Pavement Demonstration Program Status Report Public Act 457 of 2016*. Per the latest field visit in April 2019, (field evaluation shown in the Appendix, Figure A12) it was noted that all sections were repaired with intermittent full-depth slab replacement in 2018. No new cracks were observed. However, the number of slabs repaired was tracked as an indication of those slabs that had some type of distress in need of repair, which may include faulting, cracking, or spalling. Accordingly, for Section 1, the number of repaired slabs (22) may indicate a slight increase in distress (84 repairs/mile). Section 2, which was distress-free until 2016, had a fair number of slabs replaced (37), which may indicate a moderate increase in distress (147 repairs/mile). Section 3 had the most slabs repaired (39), which is consistent with past reviews (27 repairs/mile). For Section 4, the number of repaired slabs (20) indicates that this section remained stable (14 repairs/mile). For Section 5, the number of repaired slabs (12) may indicate a slight increase in distress (25 repairs/mile). The number of replaced/distressed concrete slabs for the entire project is approximately 7 percent. The number of slabs repaired per mile (repaired slab number divided by section length) are shown in Table 2. Pictures of the unbonded overlay project taken during the latest field review are shown in the Appendix, Figures A13 and A14.

Spalls in leftmost lane are filled with a mastic repair. The repairs look good.
 The full-depth repairs look good.
 Grinding and grooving of center and rightmost lanes. Shoulder has tapered grind.
 All joints have been resealed. Most joints look tight.
 The ride quality has greatly improved due to the repairs.

Figure A13. April 2019 Field Evaluation Pictures of Northbound I-75 (Latest, 1-6)

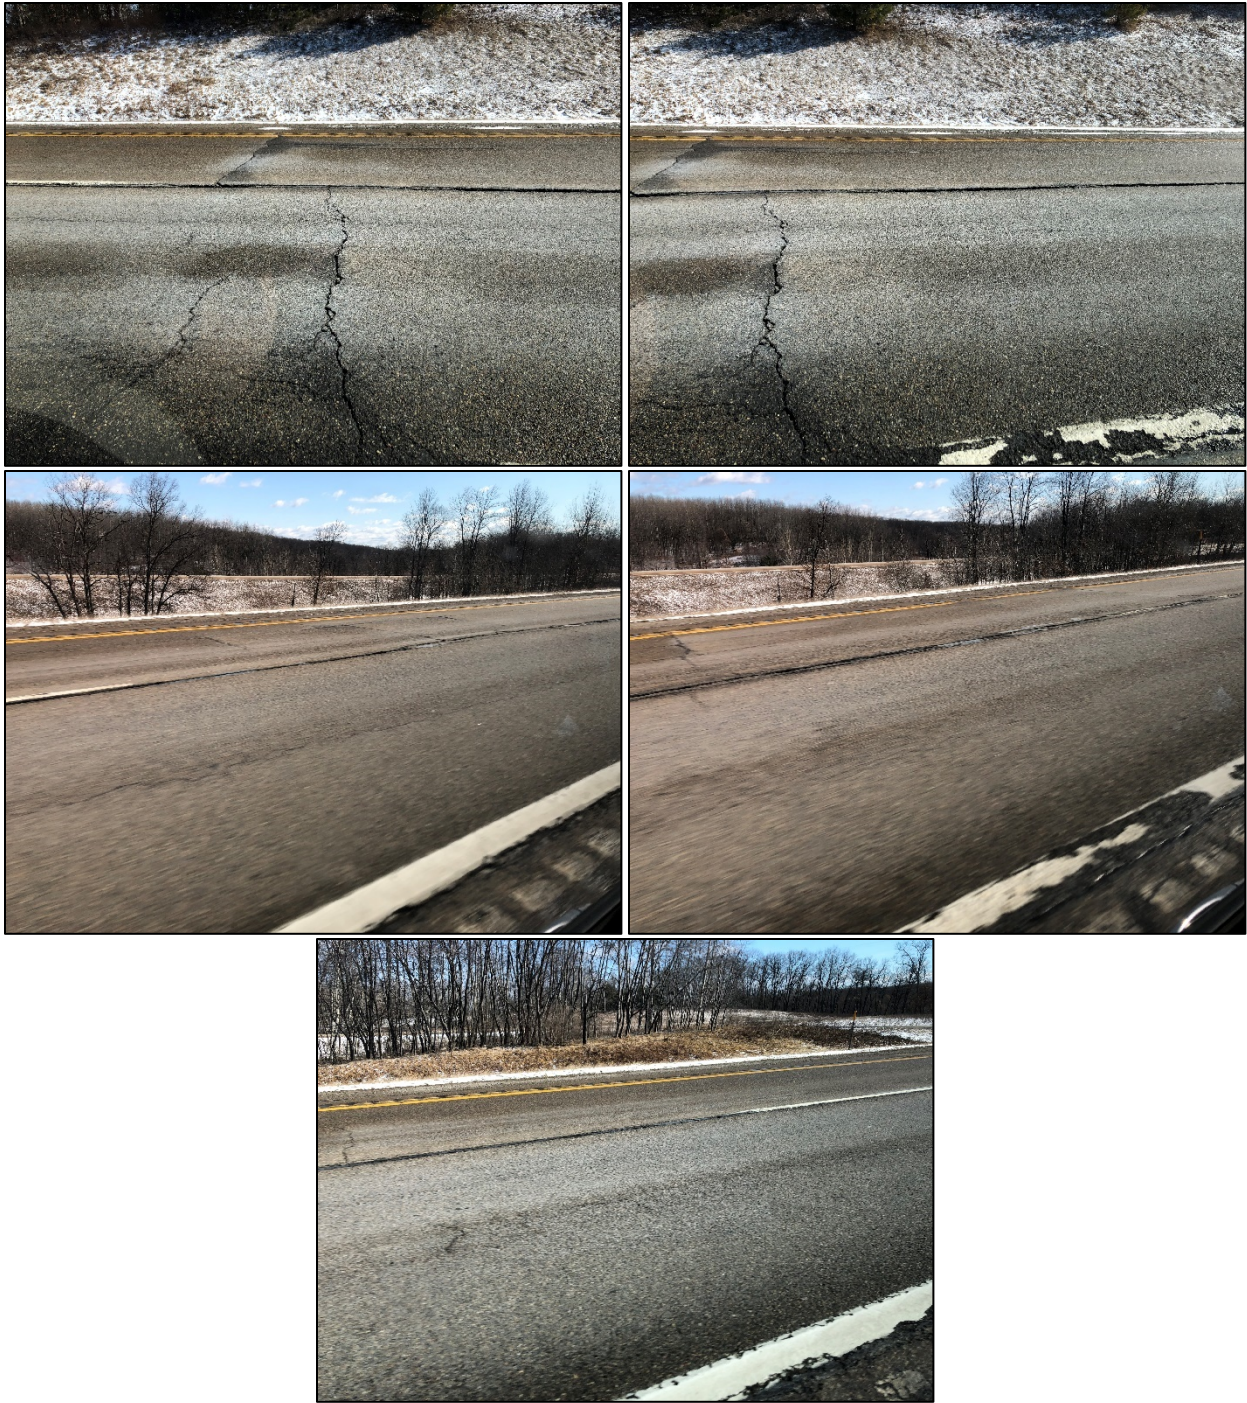
Per that same site visit (April 2019), it was observed that the rubblized project in the southbound direction continued to exhibit longitudinal and transverse cracking, with more new transverse cracks being observed. There was also evidence of heaving at some of the transverse cracks. The joint at centerline appeared to be widening, possibly indicating poor joint construction. The heaving of the cracks has been the most problematic condition of this pavement section. Initial investigations indicated that the concrete base in the area of joints/cracks may not have been fully rubblized, which may be inhibiting drainage, resulting in the surface heaving due to freezing. Therefore, to mitigate the transverse crack heaving and longitudinal joint quality issues, a major rehabilitation project was constructed after the field review in 2019 for southbound I-75. Pictures of southbound I-75 taken during the latest field review (2019) are shown in the Appendix, Figure A15.

Full-width transverse cracking appearing in both lanes. Transverse crack spacing varies from 12' - 40'. Intermittent longitudinal cracking in the wheel path. Longitudinal cracking appearing off of the longitudinal joint, (~2' off joint in one lane or the other). The centerline joint itself has continued to open. There is faulting at the

Figure A15. April 2019 Field Evaluation Pictures of Southbound I-75 (Latest, 1-5)

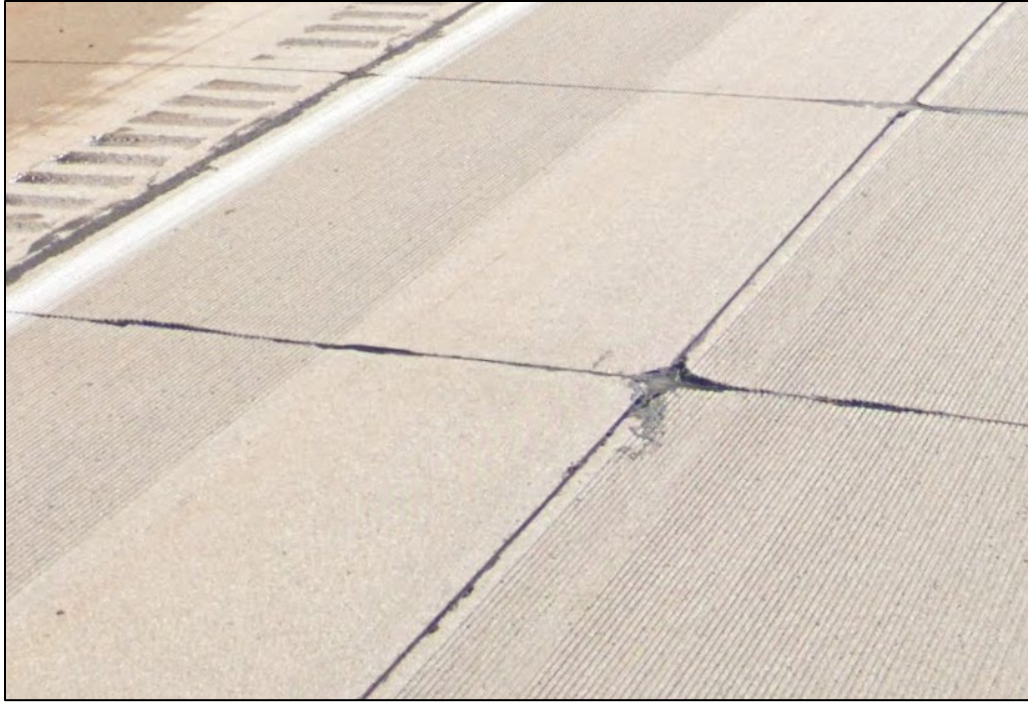
Figure A16. Minor Corner Cracking in Section 5 on Northbound I-75 (Google Maps, Image Capture: September 2019)

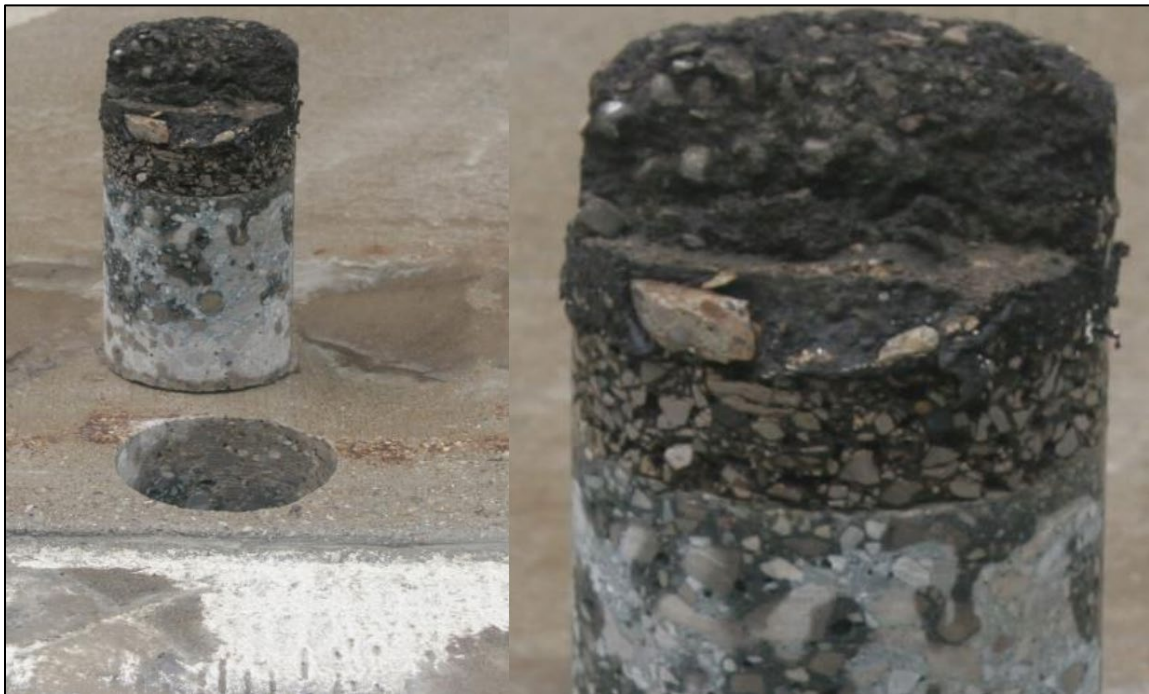
The open-graded HMA separator layer could not be adequately evaluated due to previously noted issues with the existing dense-graded HMA shoulder not being removed and blocking gravitational drainage out of the cross-section.

Figure A17. MDOT Report # RC-1574, Figure A3, Dense-graded HMA Not Milled Off During Construction

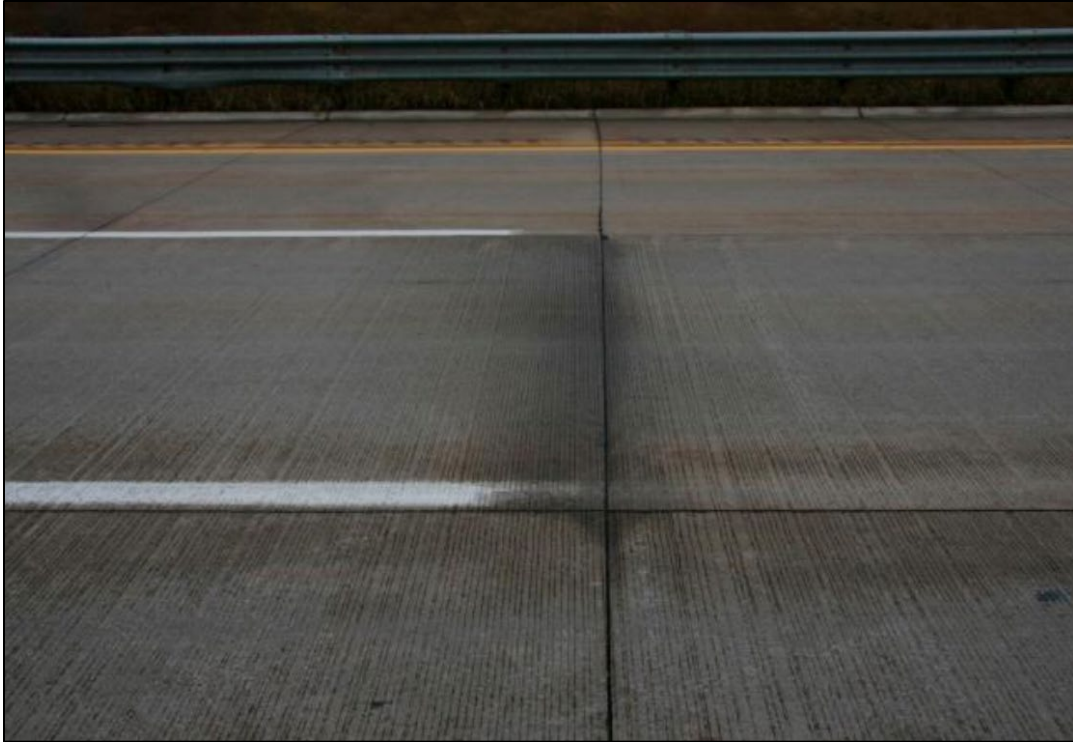
Per a review of the MDOT condition surveys, overall, Sections 1 and 2 had the most repairs per mile, which would seem to indicate that they had the most cracked, spalled, and/or faulted slabs. Most of the distressed slabs were in the innermost lane. Both sections are superelevated or banked for the curvature of the road, so water is draining and moving to the low, inner side of the pavement, mostly likely causing this observed distress. However, the pavement performance measurements for faulting, IRI, and DI do not correlate with this observation. This is because these measurements are taken (typically) in the outermost lane (where most loading and damage typically occurs), so these measurements are not reflective of the inside lane. Therefore, Sections 1 and 2 seem to be performing the worst, even though not all pavement performance measurements are reflective of this.

Figure A18. MDOT Report # RC-1574, Figure A4, Pumping in Super Elevation Part of Section 1 Sloping to The West (*away from the photographer*)

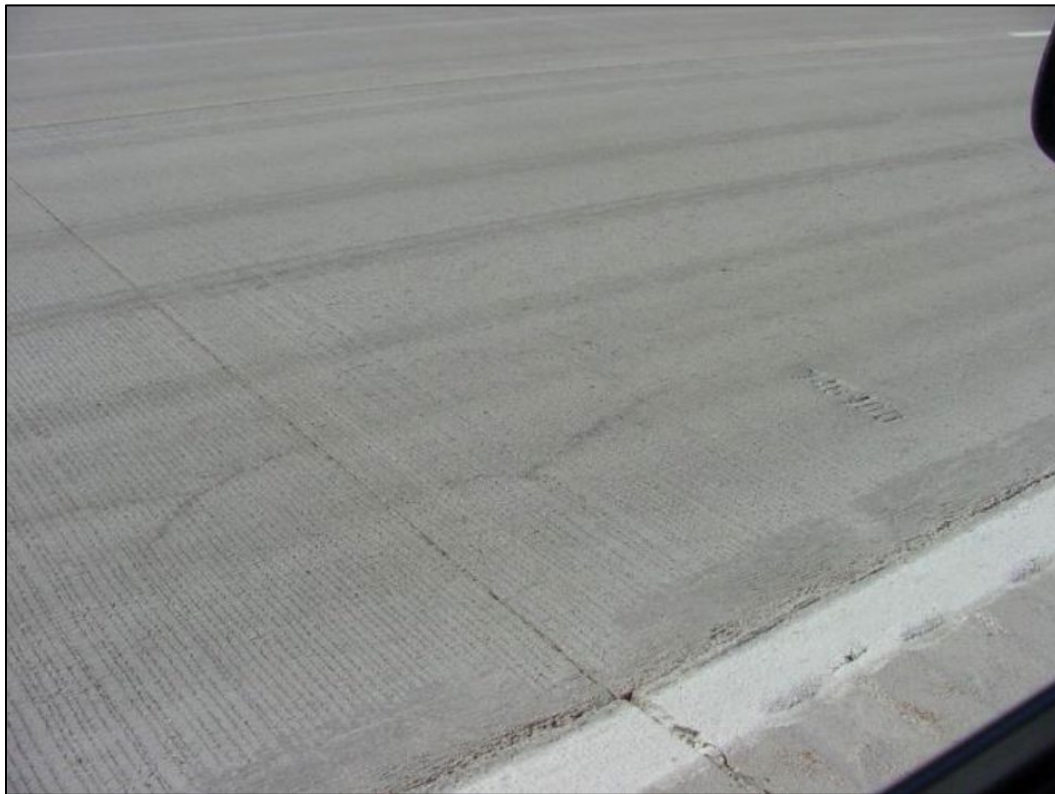
Figure A19. MDOT Report # RC-1574, Figure A11, Start of Longitudinal Cracking at Joints in Section 3 Within Year 1 (October 2004)

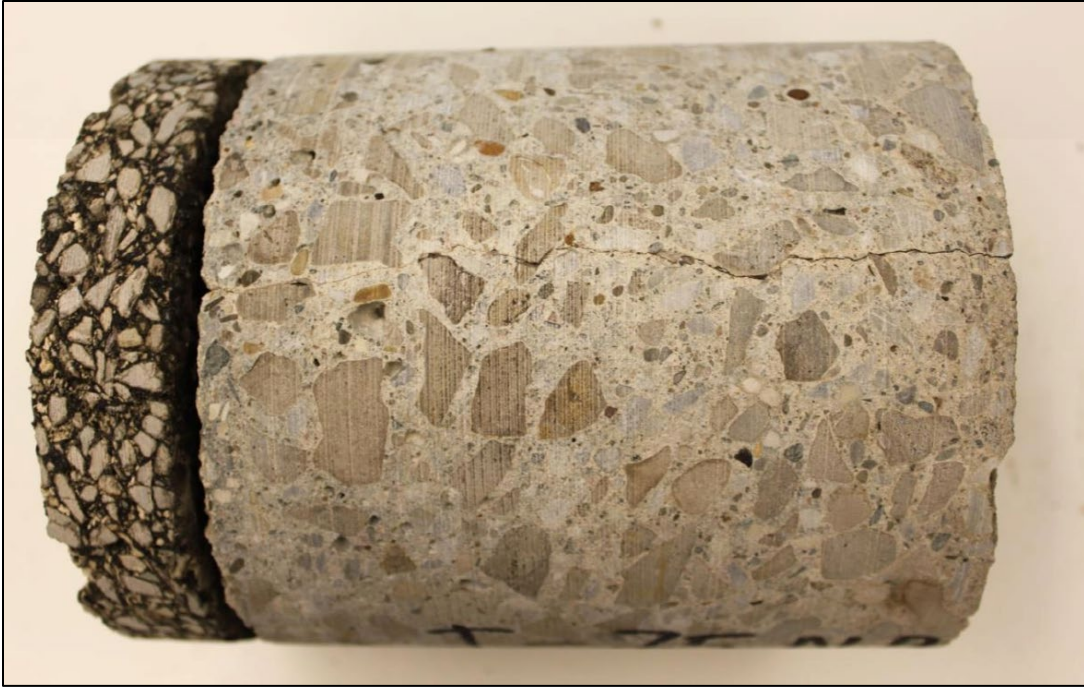
Figure A20. MDOT Report # RC-1574, Figure A12, Top-Down Longitudinal Cracking Starting at Transverse Joint Station 709+08 (Section 3)
