OFFICE MEMORANDUM

STATE HIGHWAY DEPARTMENT

Subject: Fifth Progress Report on Special Painting of Steel Bridge Girders Under Project "Bridges and Bridge Railings--Construction and Maintenance." Research Project R-49 G-50(4). Research Report No. R-460.

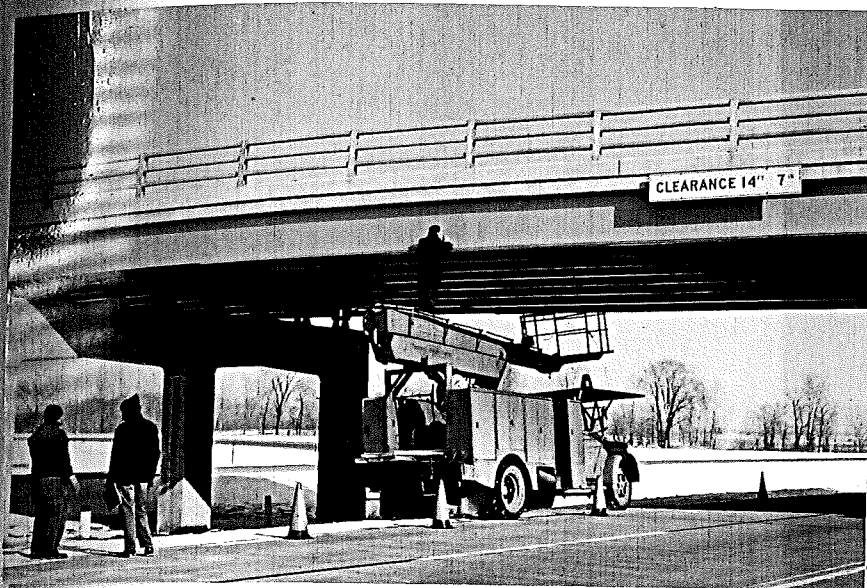
Laboratory personnel made this inspection on February 25, 1964, assisted by J. Badalucco of the Office of Maintenance (Fig. 1). They report that after about 3-1/4 years of service the test coatings were generally in fair to good condition and did not show significant deterioration except in the following areas:

2. The galvanized coating on the M 71 overpass, especially on the fascia beam, showed a few small 1/4-in. nodules, but no base corrosion. These nodules probably resulted from a reaction with cement drippings or from flux inclusions concentrated near the overlap of the double-dip during galvanizing of the beams. White rust has appeared on the bottom face of the lower flange of beams, due to the joint leakage.

Figure 1. Condition of bridge coatings inspected using Office of Maintenance Strato-Bucket on M 71 over M 78.

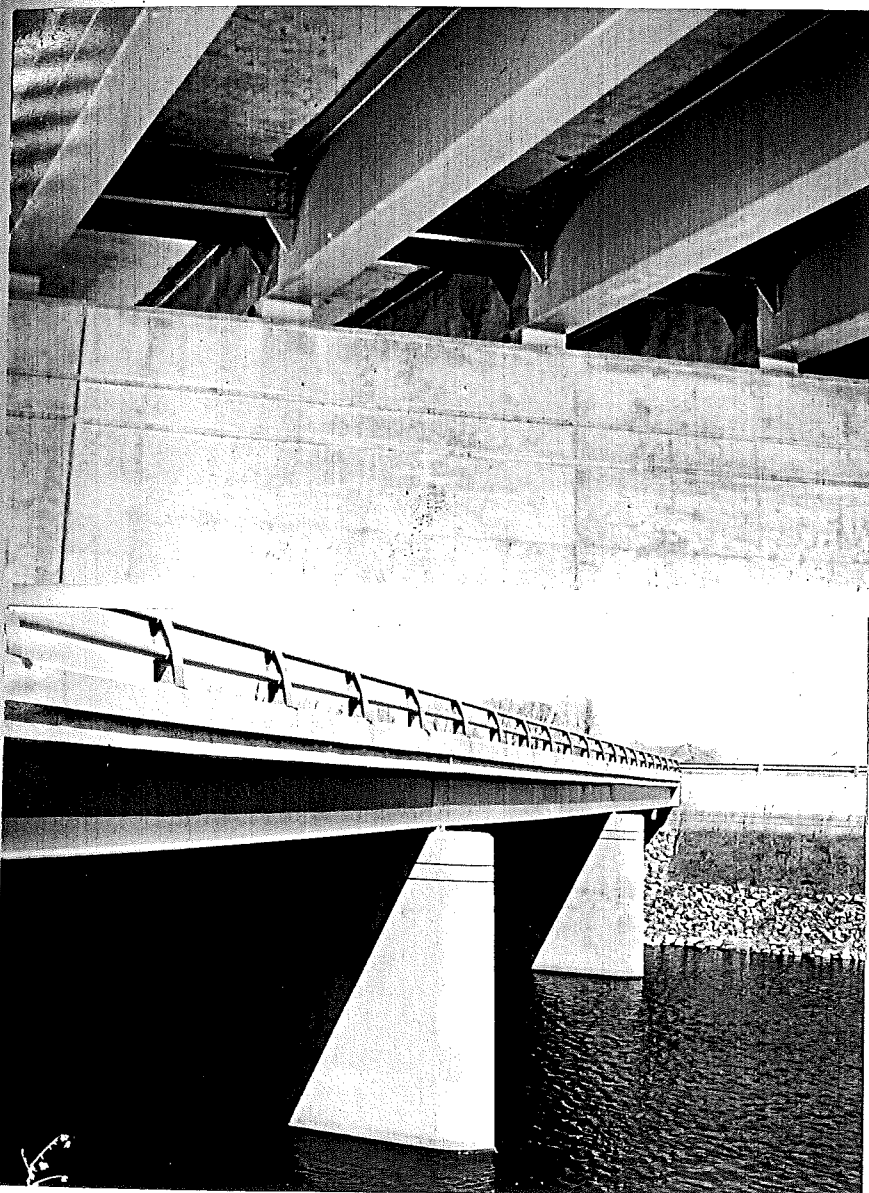
2. Significant and increased deterioration was present under the deck transverse joints since the sealer has progressively failed in performing its function, especially outside the roadway tire tracks. Leakage through the joints has significantly corroded the ends of most girders, some diaphragms, and most pier bearings. A complication from this is that the leakage has collected on the bottom surface of lower flanges, run down the slope of the girders (sometimes nearly their full length) before dripping off, and has left an increasing accumulation of salts in its wake as the moisture evaporates (Fig. 2).

3. The tar enamel intermediate coat of Systems 4 and 5 on the Shiawassee River bridge showed increased bleeding and objectionable discoloration of the top-coat, especially on interior beams (Fig. 2). The fascias showed significantly less bleeding, but did show increased distress from cracking and alligating. However, this system showed almost no corrosion on beam edges.

Figure 2. Area of east pier on westbound lanes of Shiawassee River bridge, showing salt deposits on lower flange of beams, with discoloration of System 4 coating on interior beams in background.
