**INTERIM REPORT ON  
EFFECTS OF CORROSION ON BRIDGES OF UNPAINTED  
A588 STEEL AND PAINTED STEEL TYPES**

**J. D. Culp  
G. L. Tinklenberg**

**Research Laboratory Section  
Testing and Research Division  
Research Project 78 G-241  
Research Report No. R-1142**

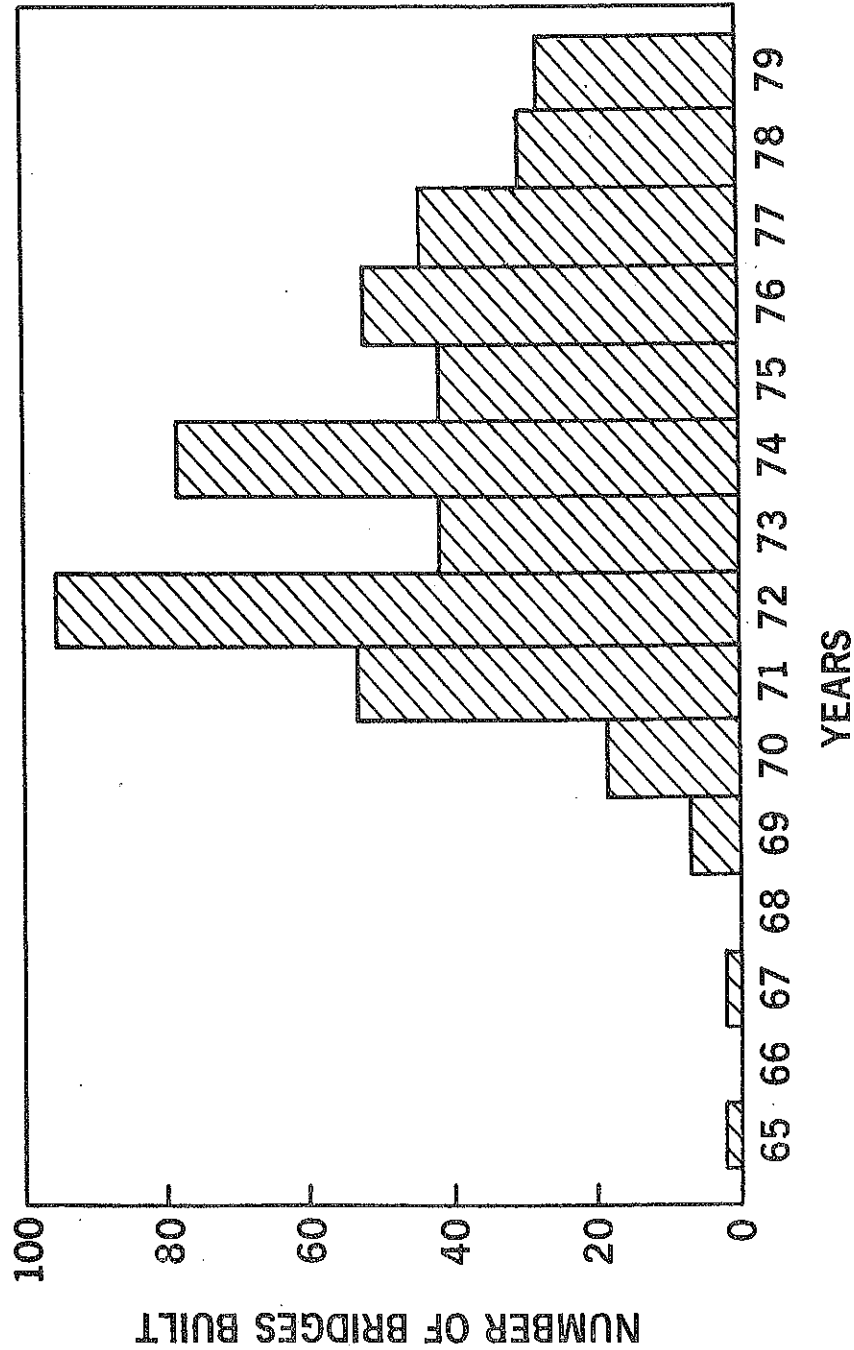
Figure 1. Histogram of bridges built by the Michigan Department of Transportation with unpainted "weathering" steel. Total number of unpainted bridges is approximately 500 (nine bridges built in 1980 of A588 are to be painted).

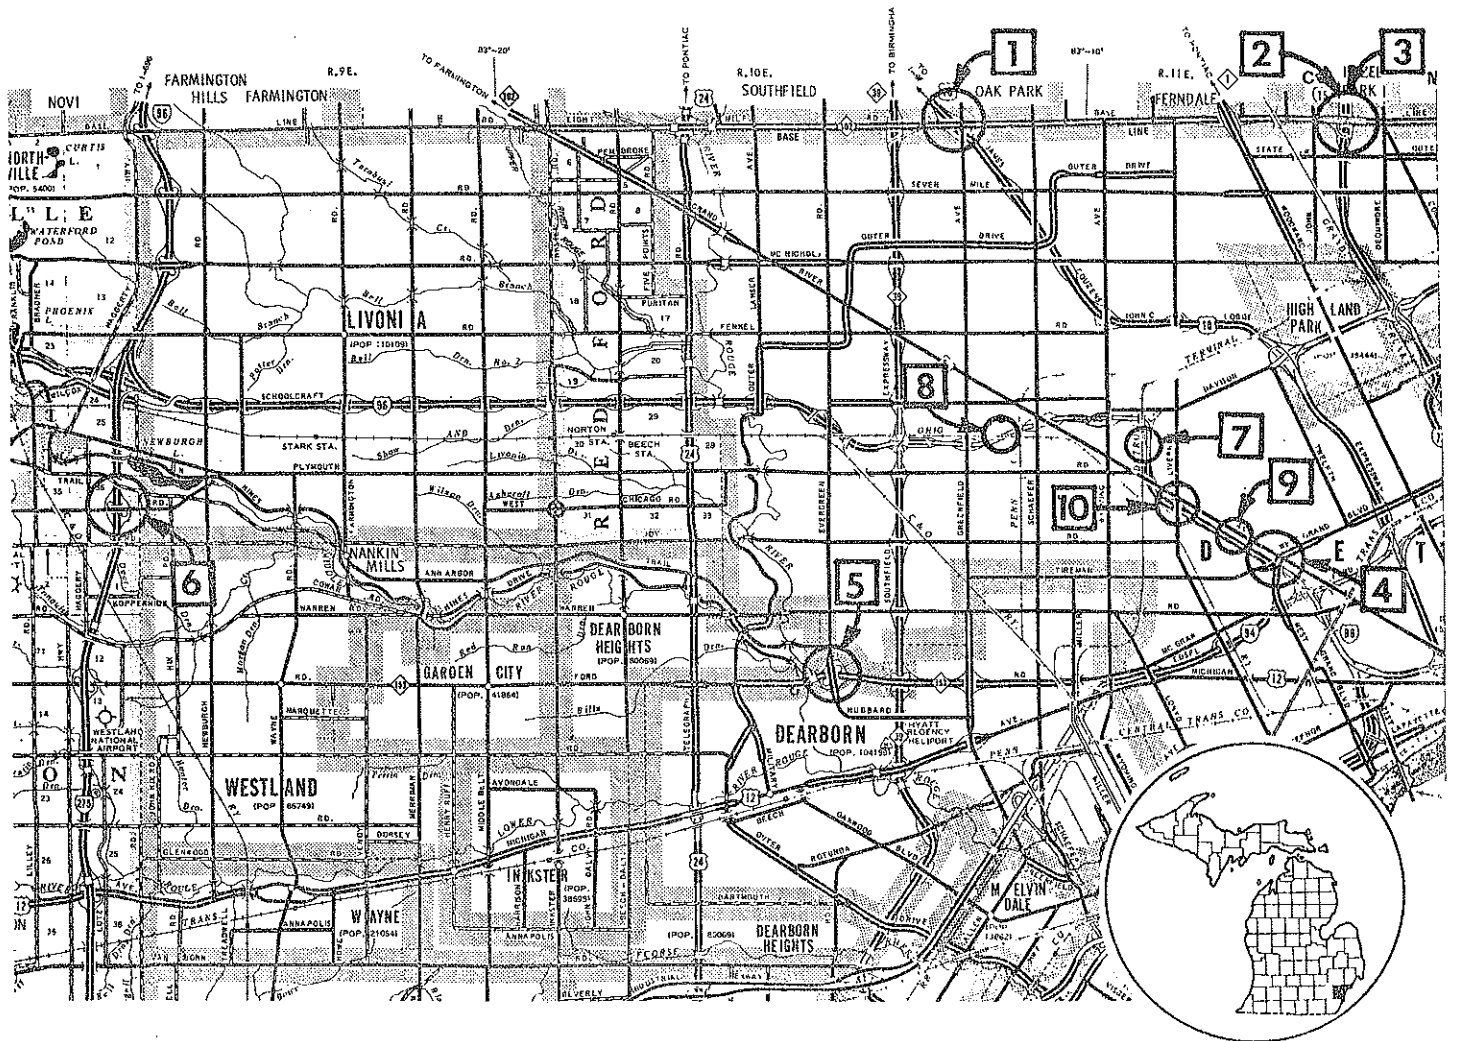
Figure 2. Results of salt analyses (sodium chloride) of beam corrosion samples taken from bridges in the Detroit Metro District.

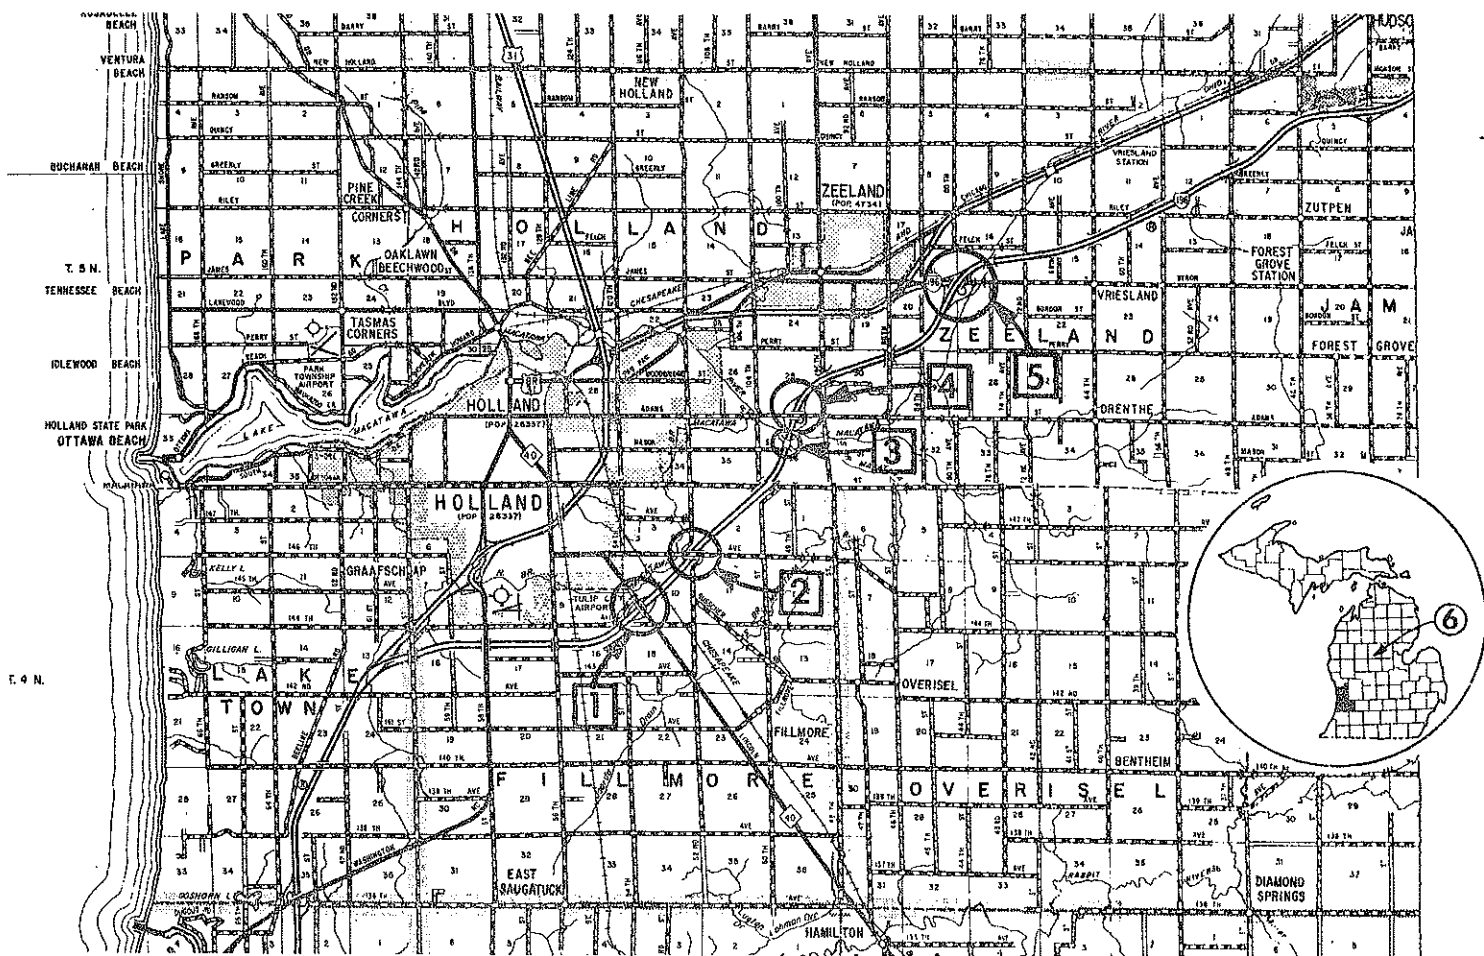
Figure 3. Results of salt analyses of beam corrosion samples taken from bridges in the rural area around Zeeland, Michigan.

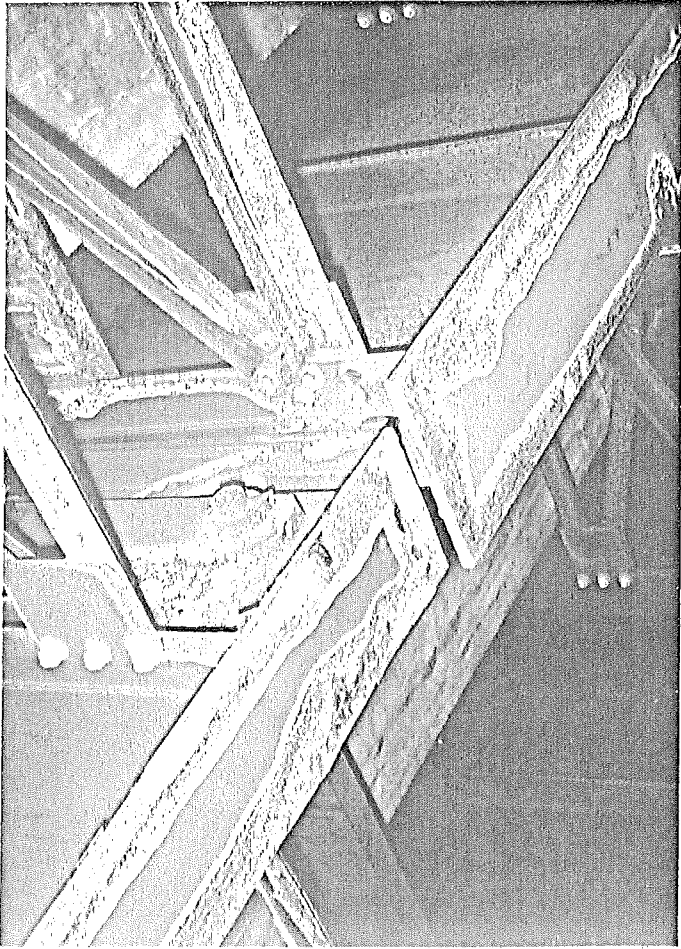
Salt leakage through a bridge deck expansion joint is illustrated in Figures 4 through 6. As can be seen in these pictures, the saltwater runs for long distances along the beam flanges from the joints and coats cross bracing, diaphragms, and stiffeners in the vicinity of the joints. This type of salt contamination occurs on nearly all bridges regardless of location. Even many of the better types of bridge deck expansion joints which have been in service are beginning to leak after six or seven years of service life. As a result of this problem, around 1972, the Department initiated the policy of painting all steel surfaces within 5 ft of the expansion joint. A newer type of continuous joint has been used since October 1977 and has performed satisfactorily to date. However, the improvement of joint seals is not considered a reliable method for excluding saltwater from the unpainted steel.

Figure 4. Salt deposits on unpainted steel under a leaking expansion joint.

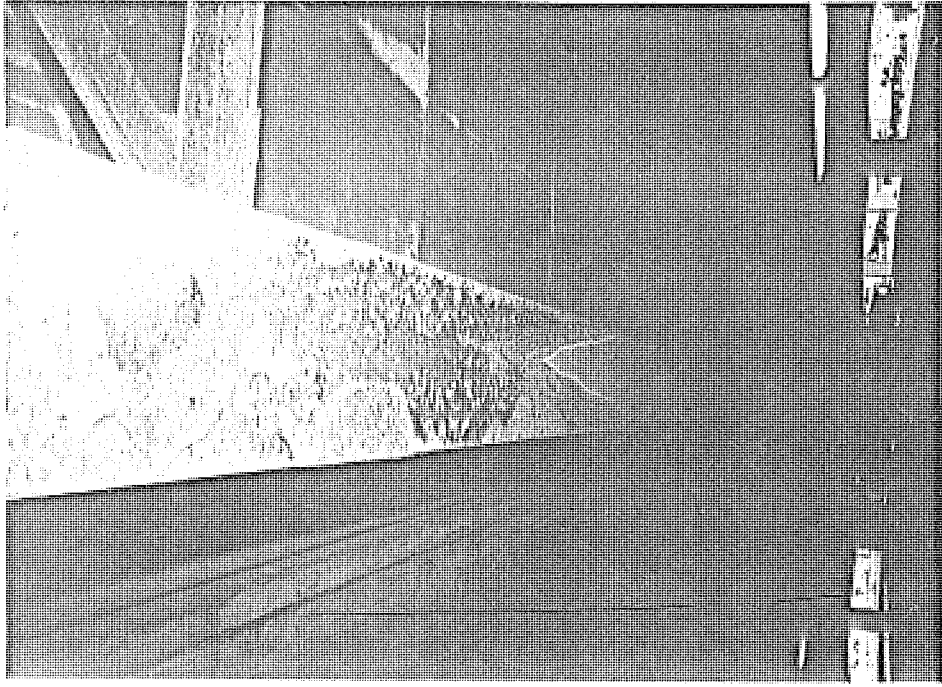
Figure 5. Saltwater runs along unpainted beams for long distances from the leaking joint.

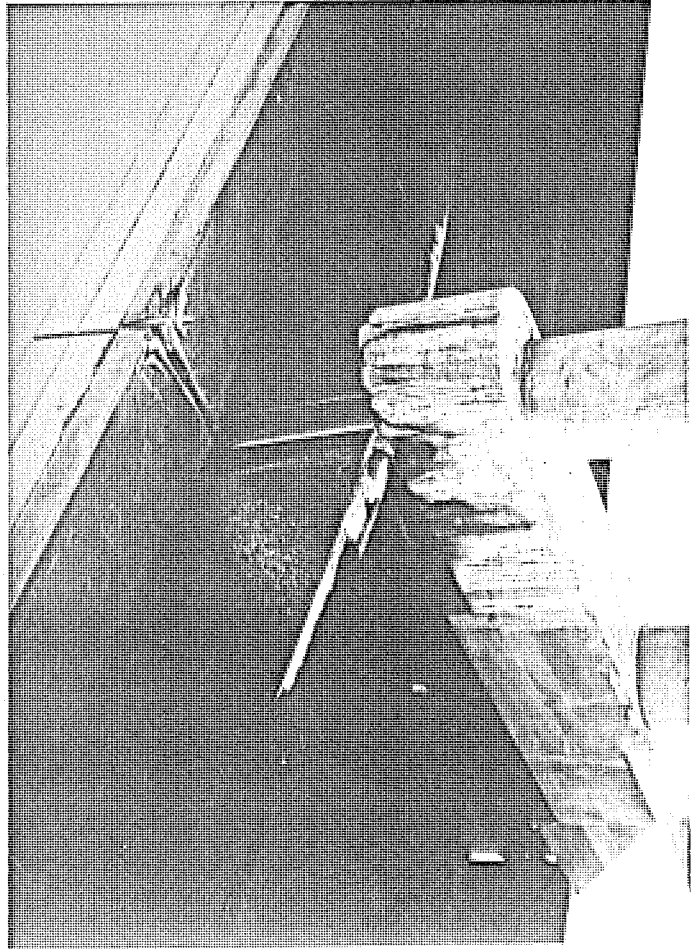
Figure 6. Saltwater leakage on a rural bridge after seven years of service.

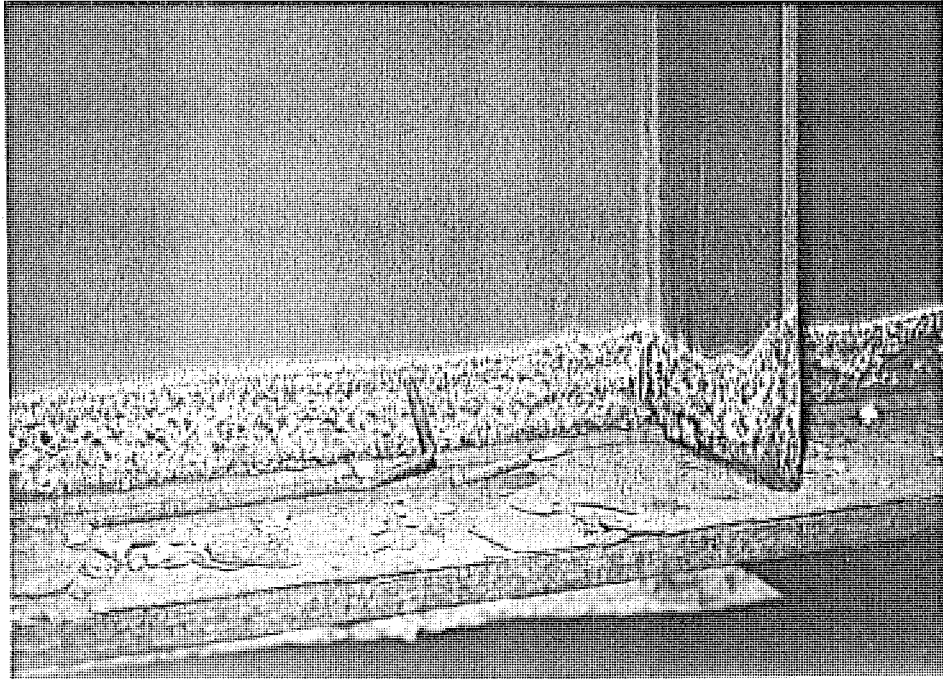
Figure 7 illustrates how the capillarity of the rust coating on unpainted A588 steel draws the saltwater vertically up the web surfaces. This salt-water line is most prevalent where leaking joints admit runoff water to the bridge beams. Significant losses of metal thickness have occurred in the webs and flanges where this type of salt contamination has occurred.

Figure 7. Capillarity of the rust patina on A588 steel causes saltwater to migrate up the vertical surfaces on beam webs as high as 10 in.

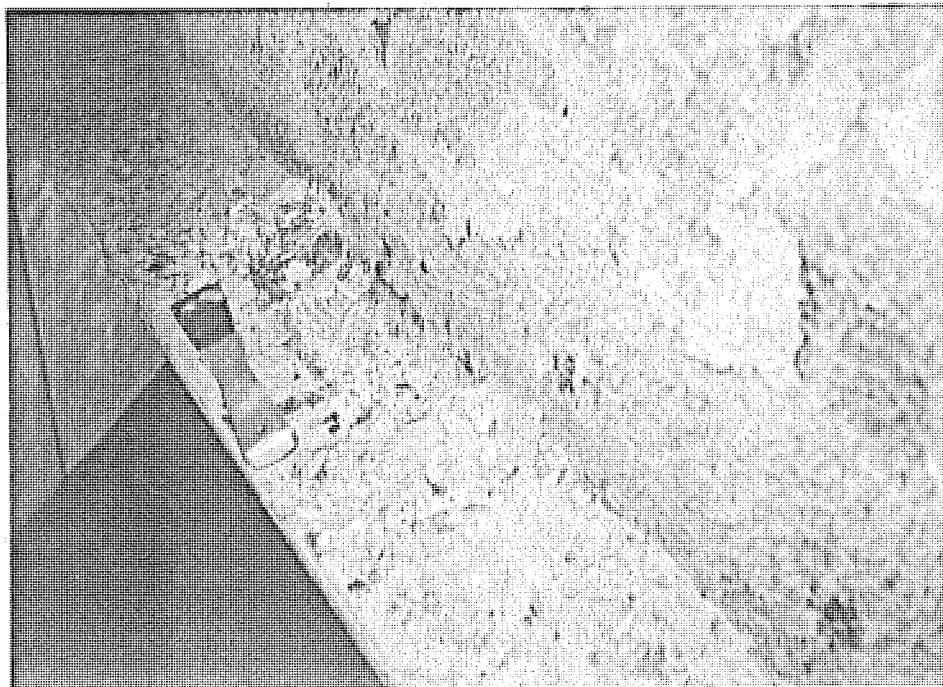
The top surface of the bottom flanges on bridge beams accumulate corrosive debris from road dirt, salt, rust products shed from the webs, birds' nests and droppings, and miscellaneous debris. This debris holds moisture on the flange surface for long periods of time and effectively prevents any chance for a protective rust coating to form. Figures 8 and 9 illustrate these conditions.

Figure 8. Rust products and salt collecting on the top of a beam flange as they are shed from the web. Corrosion pictured is due to traffic spray of saltwater (side opposite traffic).

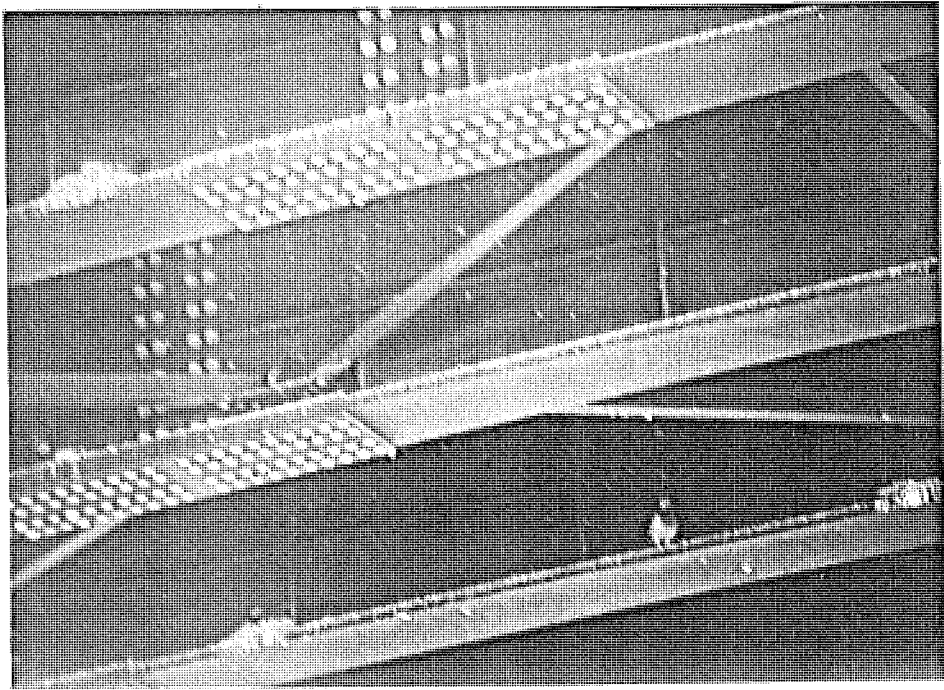
Figure 9. Bird nests on beam flanges of a high level unpainted A588 bridge.

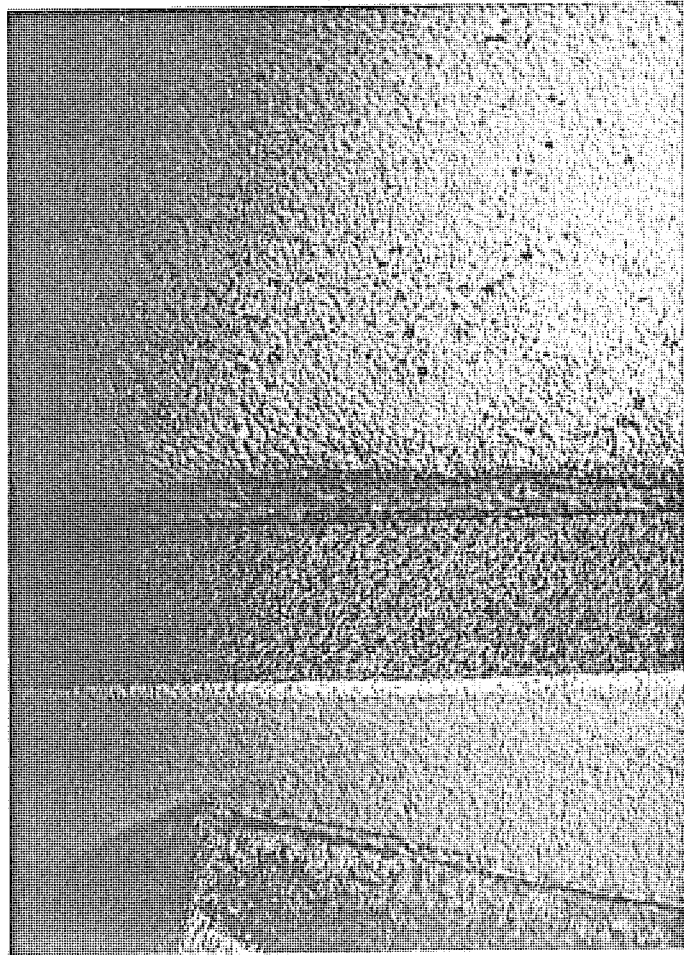
Crevice corrosion between the link plate and the beam end proceeds rapidly and results in the 'tight packing' of the space between the contact surfaces with a dense form of rust. This rust cannot be removed without disassembling the joint (Fig. 11). This rust packing, in combination with the link pins corroding tight to the link plate and beam holes, appears to prevent movement of the expansion joints and thus causes other structural damage to the bridge. This has occurred on unpainted bridges with seven years of service life. The Department's Maintenance Division removed the link plates on one such detail that had about 13 years of service. The condition of the web beneath the link plate is shown in Figure 12 before sandblasting and in Figure 13 after sandblasting and painting. Note in Figure 13 the outline of the link plate that has been imprinted into the beam end by the accelerated crevice corrosion.

Figure 11. Pack rust behind the link plate on a seven-year old expansion joint. Rust could not be removed by sandblasting and helps to fix the movement of the expansion joint.

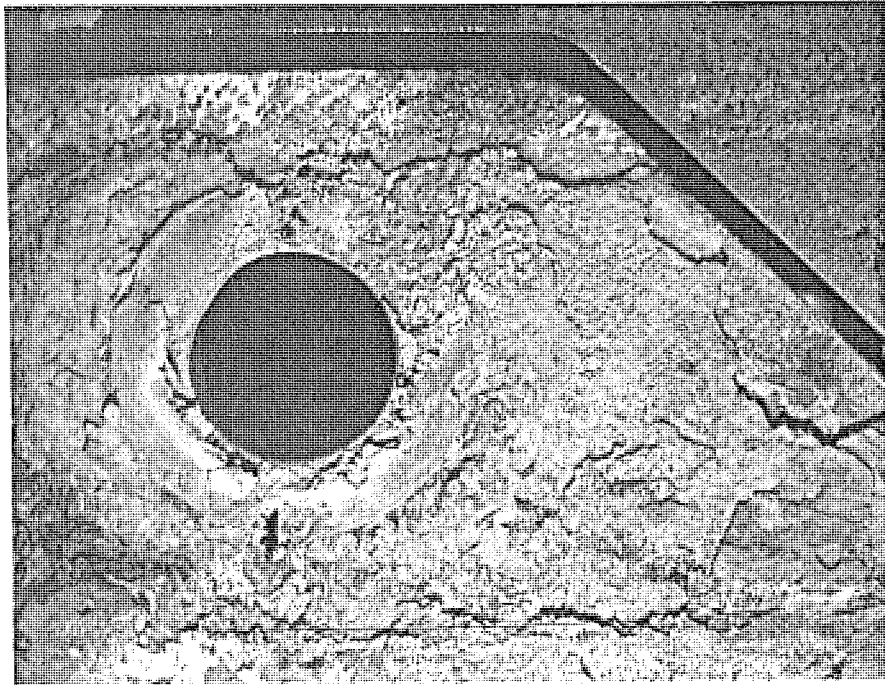
Figure 12. Pack rust deposits left on beam end after the link plate and pin were removed with a cutting torch.

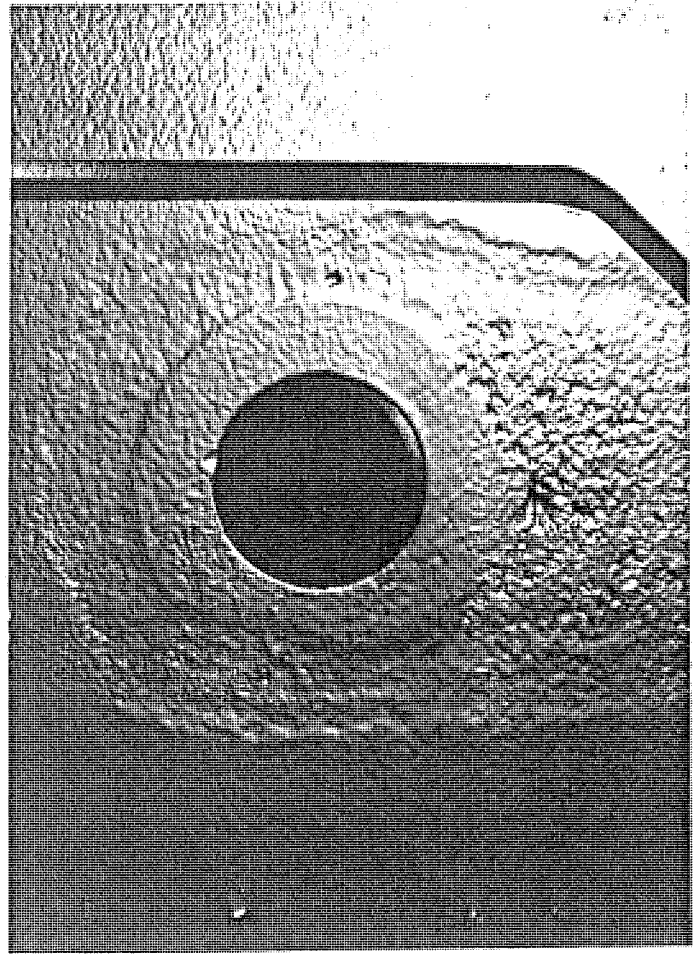
The smooth ring outlined around the pin hole in Figure 13 occurred by galvanic corrosion action of the bronze washer that was used between the beam end and the link plates. Since bronze is cathodic (i.e., electrically positive) to steel when these two metals are placed in contact in a corrosive environment, the steel corrodes sacrificially to the bronze. This accounts for the sharp step that can be seen at the edge location of the bronze washer. Pit depths as much as 0.25 in. occurred in the beam end behind the link plates. The pin plates and pins were in such poor condition that we recommend that any maintenance work on this type of assembly include the replacement of link plates and pins, the coating of all joint surfaces with high performance coatings (such as zinc-rich epoxy with an epoxy topcoat) and the provision of some type of self-lubricating bushing between the link plate and pin. Some work has been done to evaluate the performance of the standard link plate and pin expansion detail on painted bridges. The two joints that have been disassembled show some of the same types of corrosion damage occurring. However, after about 20 years of service life the joints were not in as bad a condition as those of less than half that age in the unpainted condition. The detail is not a good one from a corrosion perspective, painted or unpainted, since it is impossible to maintain or lubricate it. We recommend the elimination of this detail whenever possible. The Department's Design Division is currently implementing this recommendation.

Figure 13. Beam end after sandblasting and painting the area behind the link plate in Figure 12. Note the effects of crevice corrosion and galvanic corrosion behind the plate.

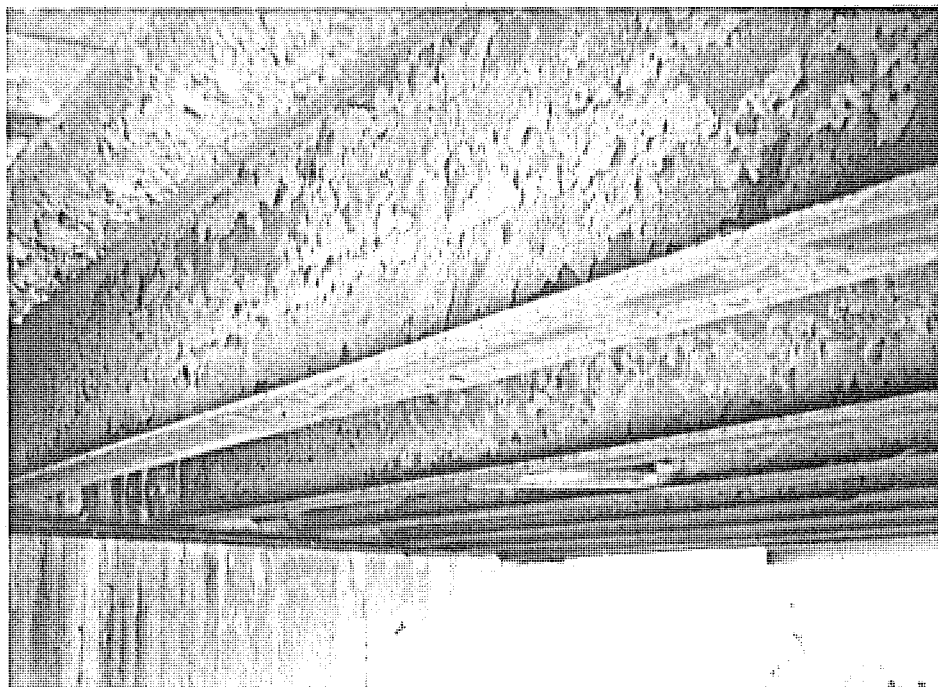
The effects of salt, sprayed and dusted on the bridge from highway traffic, are illustrated in Figures 14 and 15 for a bridge with 15 years of service life and Figures 16 and 17 for a bridge with 7 years of service life. This type of corrosion, where large sheets of rust build up and slough off, seems to have a periodic cycle that is related to the seasonal use of deicing salts. During the summer months a more normal rust layer may be observed in formation but the introduction of salt the next winter will penetrate this layer and again cause the sheet type failure. Any exposure of A588 steel that has previously developed a "tightly adherent patina" will not afford protection against corrosive contaminants since they can easily penetrate the rust layer and result in accelerated corrosion.

Figure 15. Appearance of steel on one end of bridge in Figure 14 after 15 years of service.

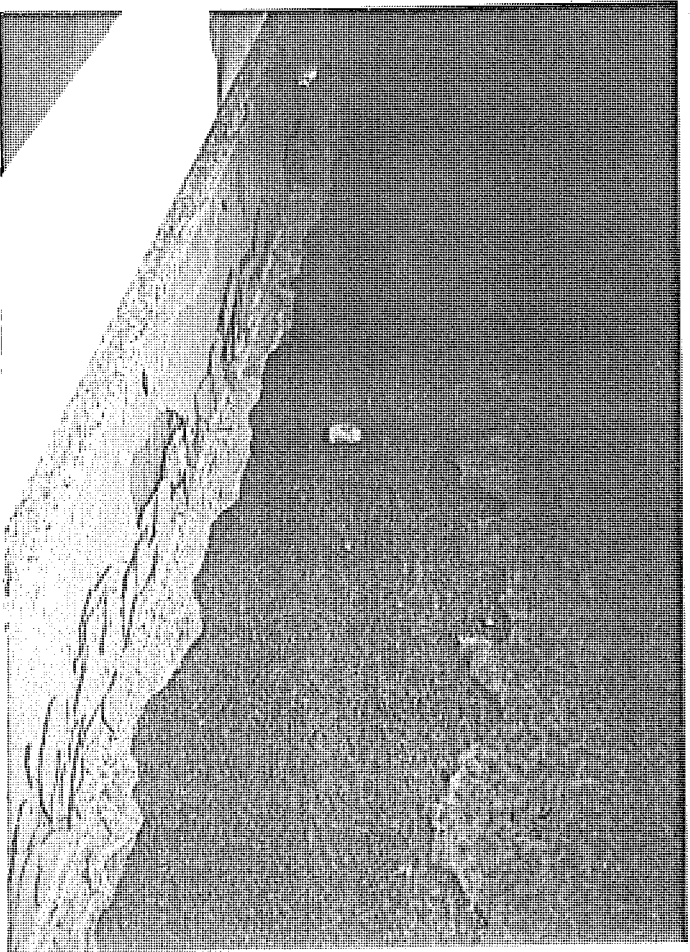
Figure 17. Appearance of interior beam on side facing traffic. (Bridge shown in Figure 16 after seven years of service.)

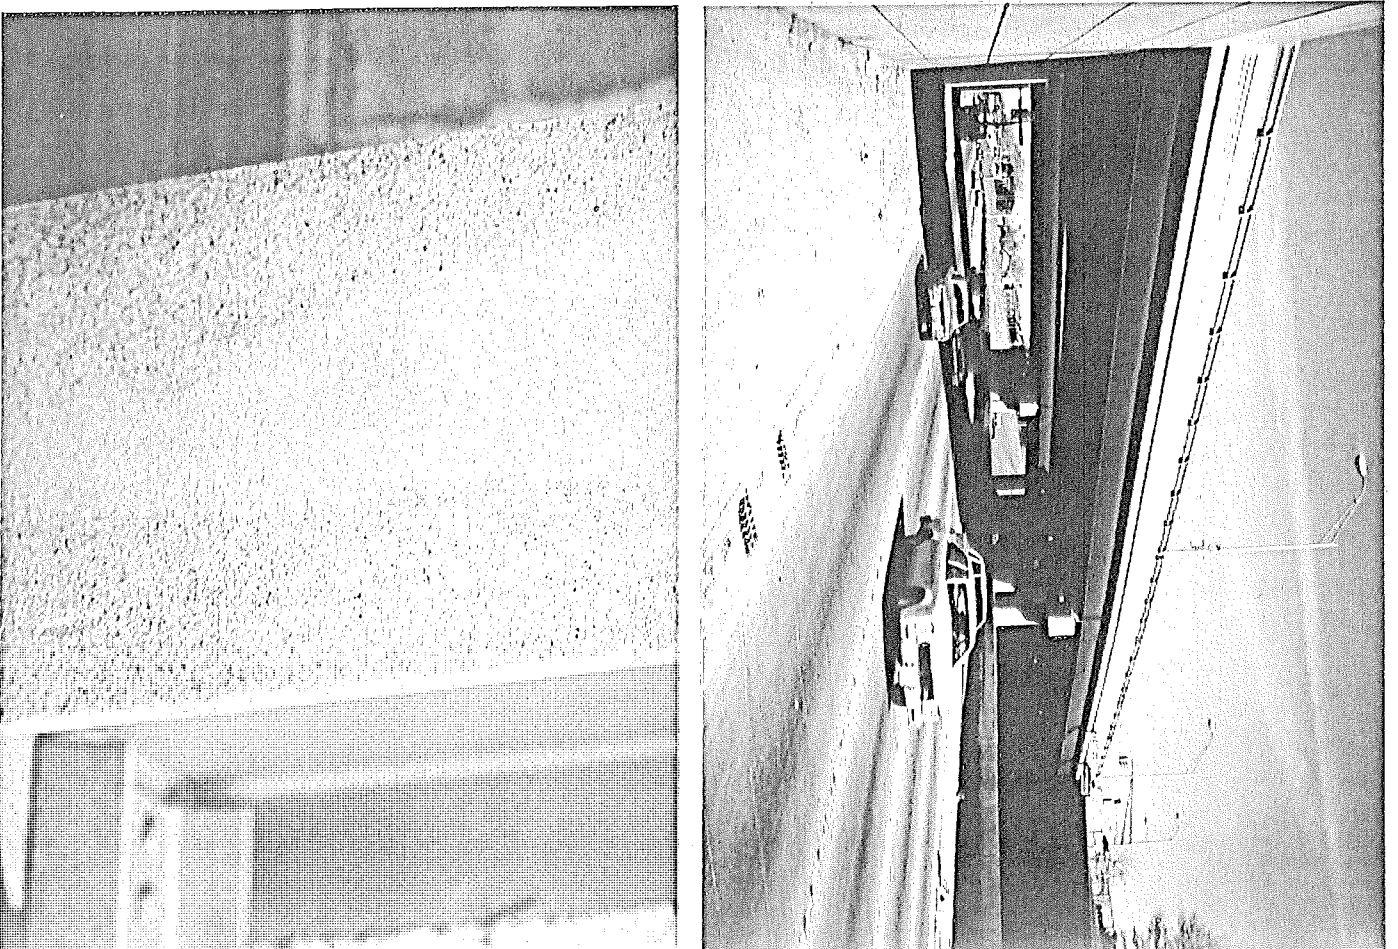
The most serious corrosion occurring due to salt contamination of unpainted A588 steel is pitting. Figure 18 illustrates the pitting typical of a beam flange exposed to seven years of service near a leaking expansion joint. The pit morphology presents a porous or honeycombed steel surface.

Figure 18. Pitting of beam flange caused by saltwater from a leaking expansion joint.

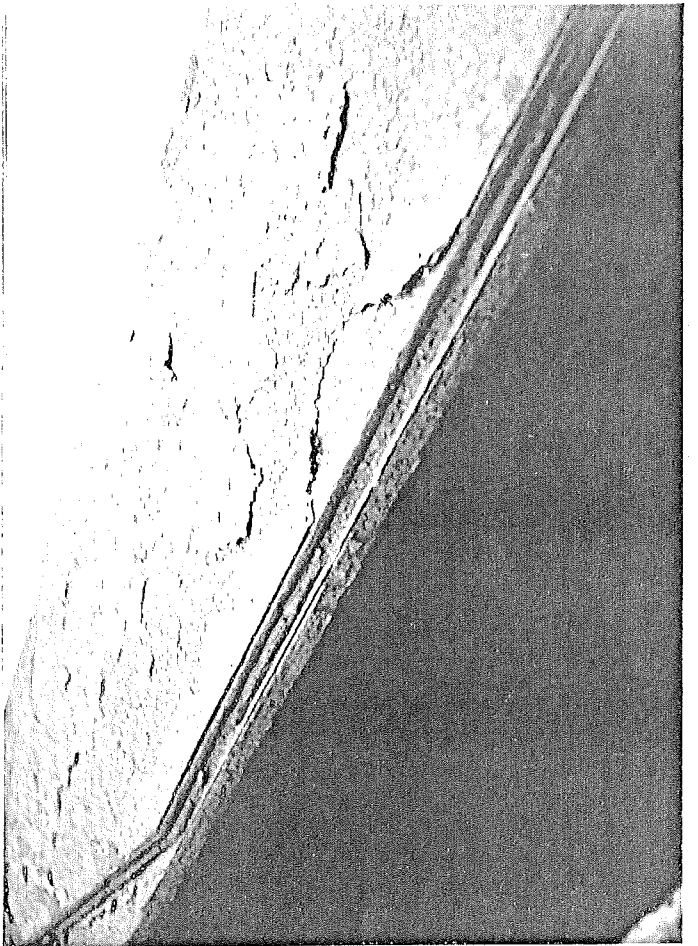
Figure 19. Corrosion of welded cover plate detail due to salt spraying after 14 years of service.

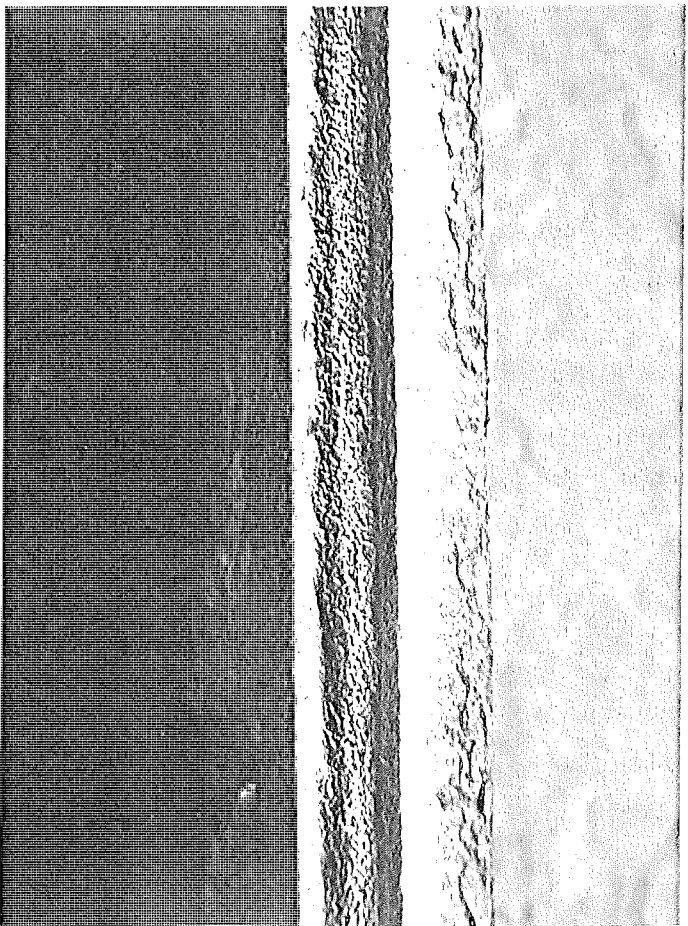
Figure 20. Wire-brushed fillet weld on a beam cover plate showing pitting after 14 years of service.

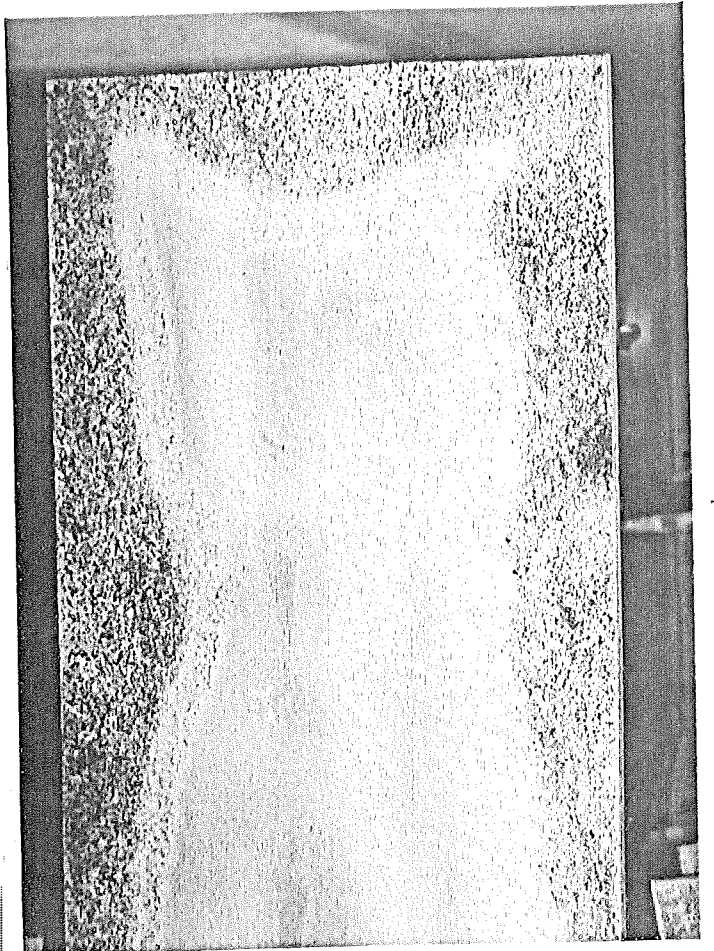
2) The "Green Mold Phenomenon" - After the steel had been blasted to a near-white or better, the steel developed a moldy green appearance in pitted areas in very short periods of time (1/2-hour if the humidity was very high, 1 to 2 hours with a 60 to 80 percent relative humidity). In most cases, the inspectors would not allow these surfaces to be painted and required

Figure 22. The "green mold phenomenon" of a blasted flange surface just before reblasting.

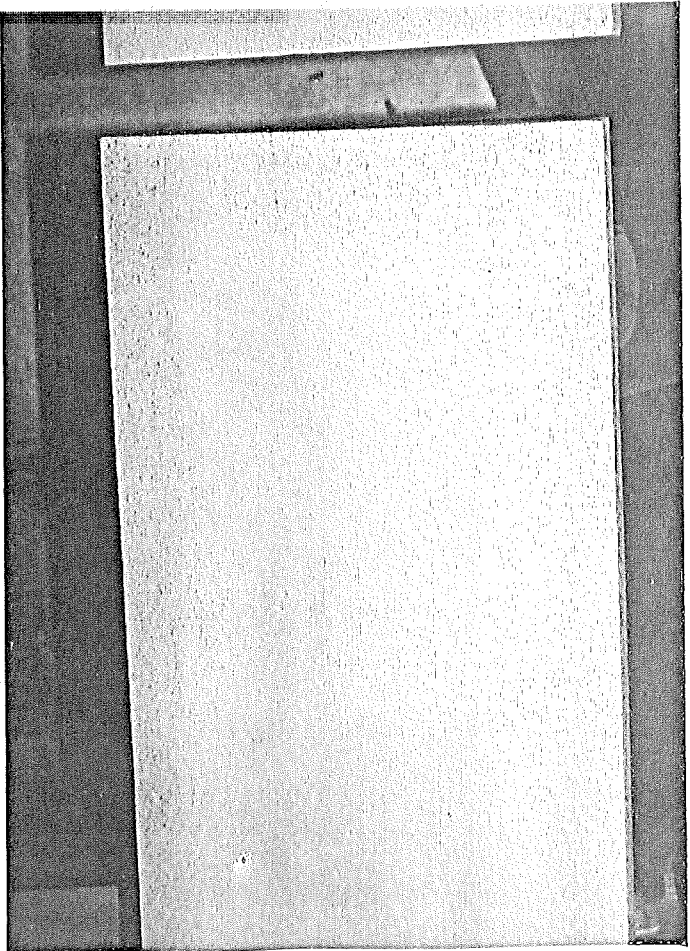
Figure 23. Condition of flange pictured in Figure 22 after a second blasting.

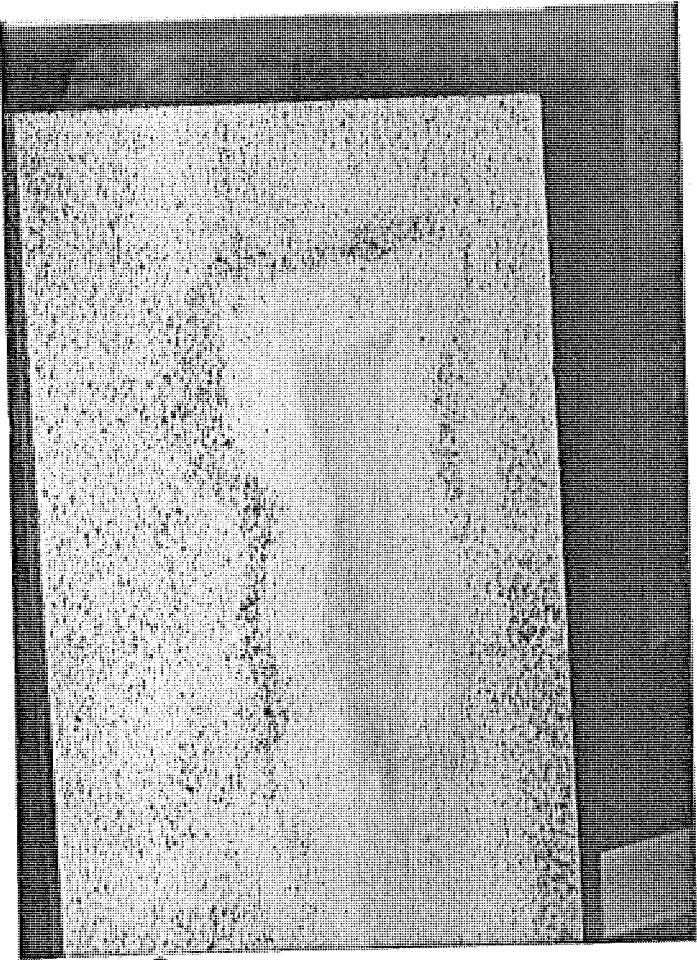
Figure 24. Typical condition of a flange after reblasting and just before coating.
