FIELD EVALUATION OF A FLEXIBLE
TRAFFIC GUIDE POST

TSD-TR-154-72

**DEPARTMENT OF STATE HIGHWAYS
STATE OF MICHIGAN**

October 1972

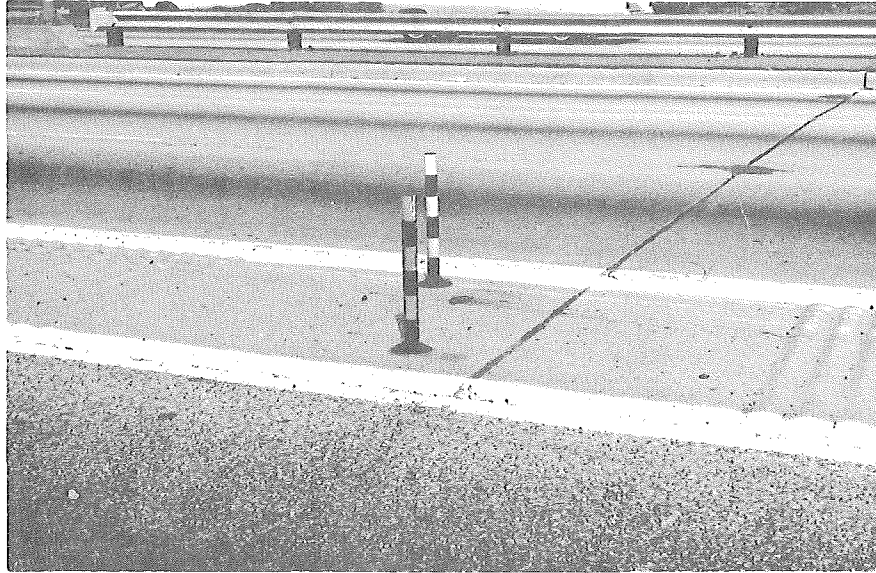
The visual inspection portion of the study was conducted by making periodic close inspections of the devices at each location. These inspections were scheduled at approximately three week intervals. The first two inspections of I-94 at Livernois Avenue showed the posts had been hit several times and had performed well. All posts were in an upright position with no apparent damage. The reflective sheeting which was applied to the posts showed some abrasion from being hit. (See photograph above)

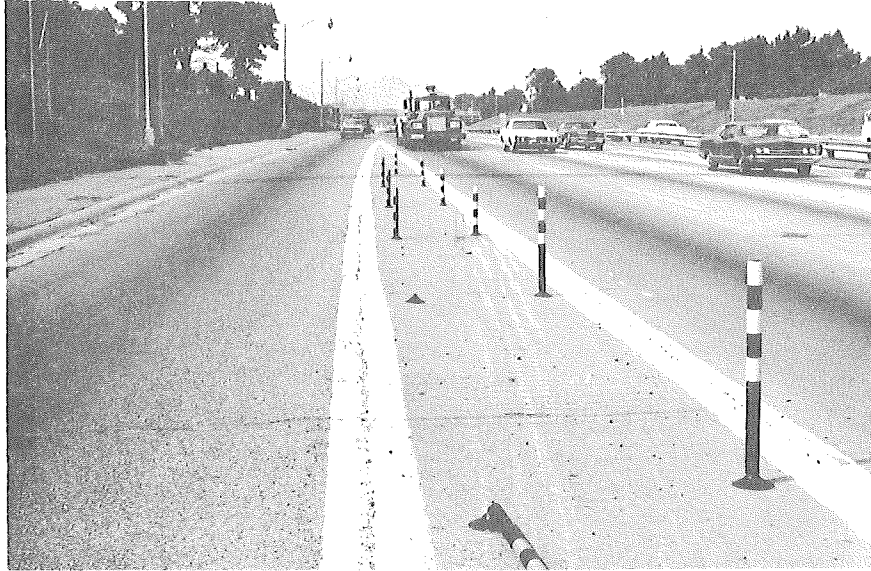
During the latter part of October the installation in the East-bound direction of travel was struck by a vehicle at an excessive rate of speed. (See photograph above)

As can be seen from the above photograph, the 26" posts performed very well. Two of the 36" posts failed and were sheared off at the shock cord as shown in the following photographs.

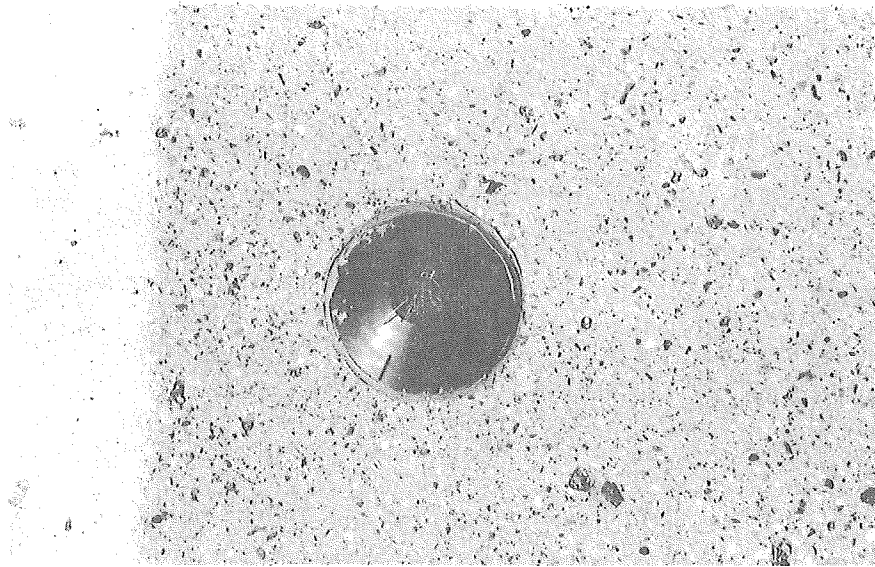
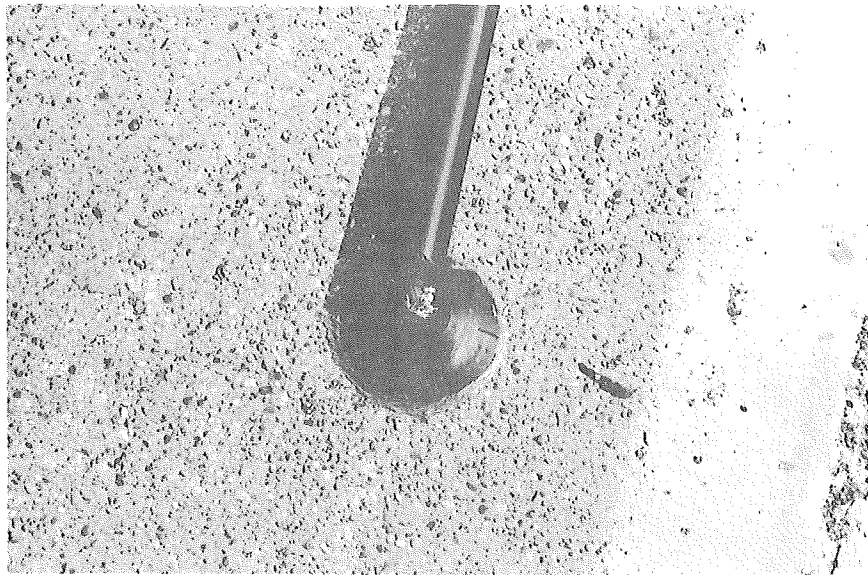
It is felt that the bumper of a vehicle makes contact at or just below the vertical center of mass of the 36" post, thereby exerting excessive sheer force on the shock cord, causing failure. (See Figure 15). By the latter part of December, with the beginning of winter and cold weather, shock cord failure was experienced in several of the units. The cord failure was more predominant in the 36" units. One case of epoxy failure was found. Almost all of the units had been hit once and many of them several times. One of the most important observations at this time was a cracking of plastic in the vertical direction on some of the units. This cracking has occurred to such a degree that the plastic cap was missing from three of the units. By the end of February all but a few of the units were broken or the shock cord had failed. Typical condition of the installation is shown in the following photographs.

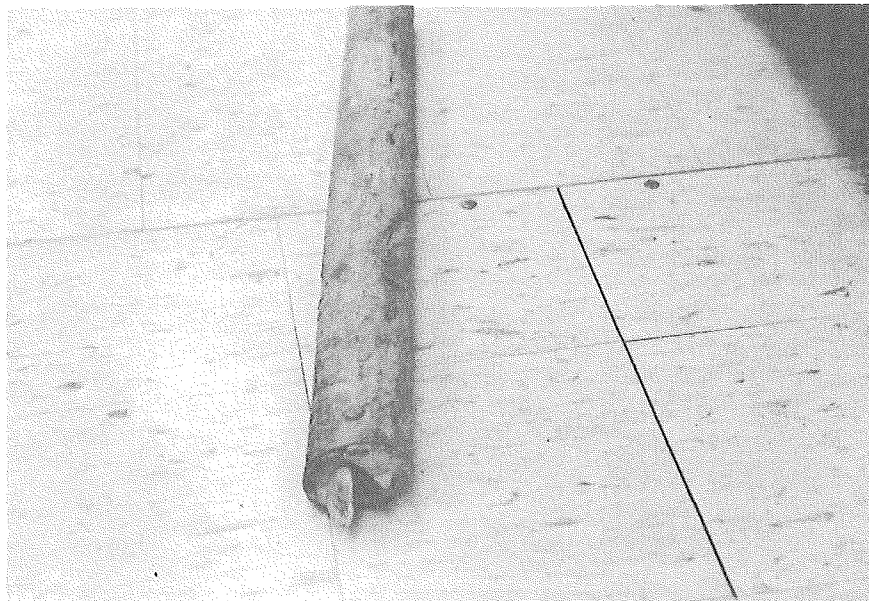
An inspection was made on September 25, 1970. The installation had been hit at least once. One unit had an epoxy failure and one was slightly deformed but not broken. The next inspection was made on November 27, 1970. One unit was missing from shock cord failure, the rest were in good condition. On January 5, 1971 the next inspection was made. The installation in the westbound direction had been hit very severely. Six units were missing from epoxy failure and five units were missing from shock cord failure. Some of the missing posts were found but no cracking of the plastic was evident even though they had been run over several times. (See following photographs)

In the eastbound direction, three units were missing; two due to epoxy failure, and one due to shock cord failure.

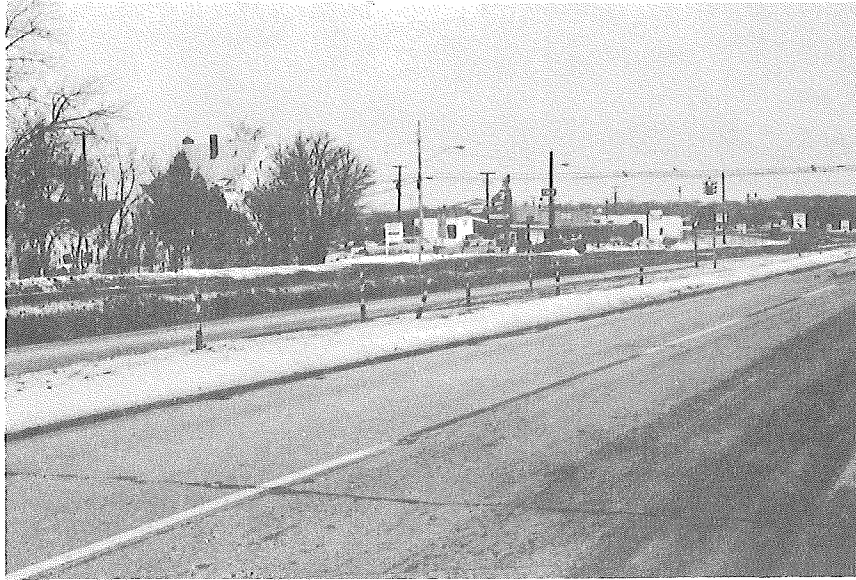
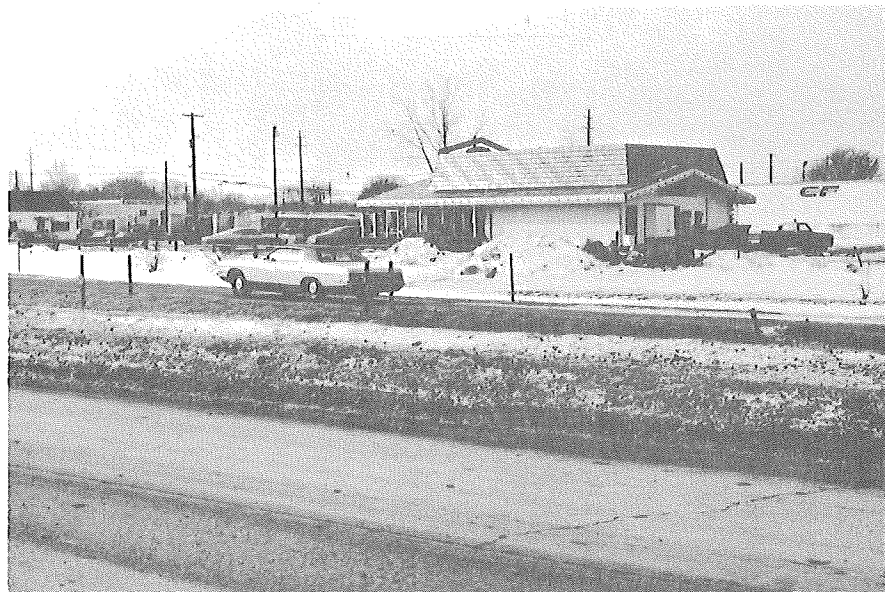
The two locations in the City of Kalamazoo were in low speed traffic areas. In February 1971, a close inspection was made of both locations. The condition of units at the B.L. I-94 at Lake Street location was excellent for two years service. One unit was broken as shown in the following photographs.

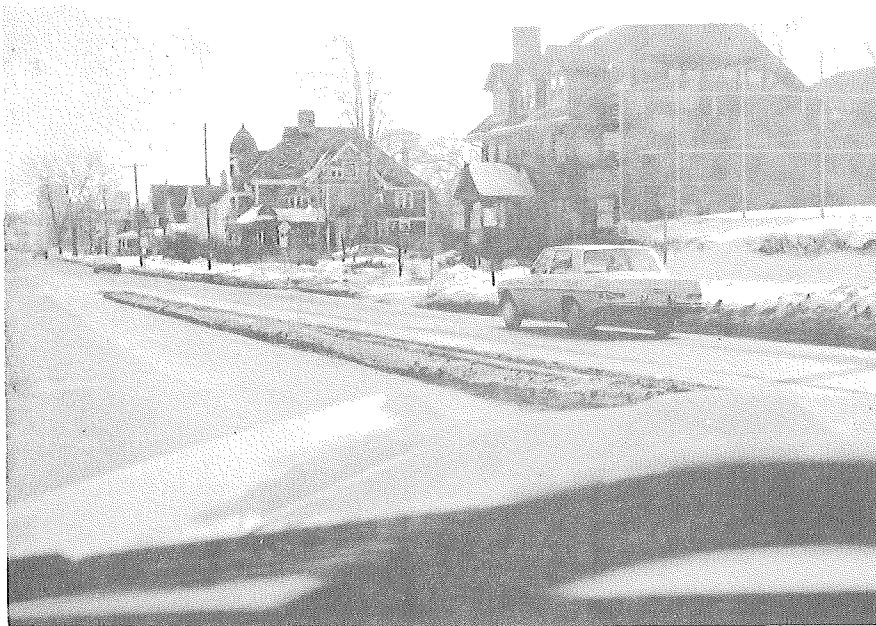
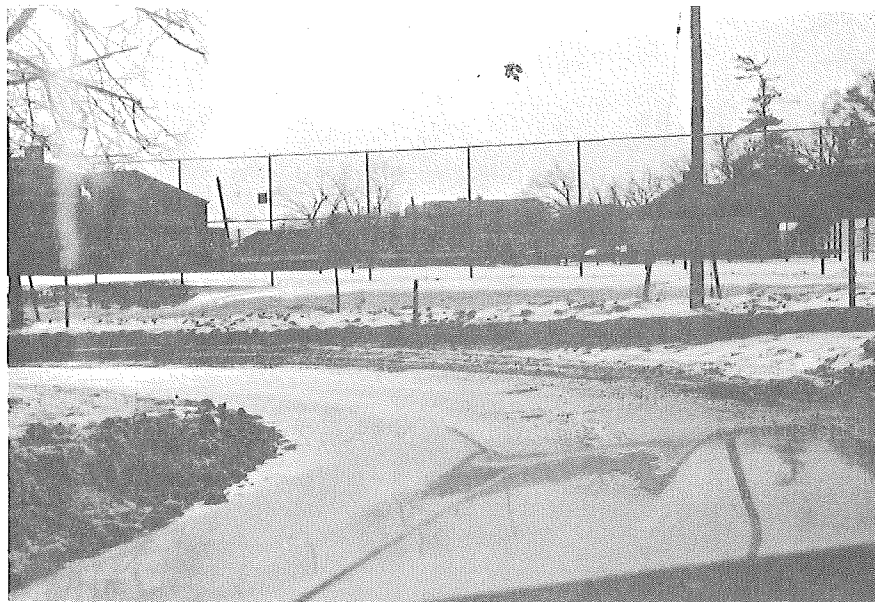
The M-43 (West Main) at Douglas Avenue has only one unit still standing. A close investigation showed over half of the missing units were due to epoxy failure. This location is in close proximity to Western Michigan University and some of the missing units show signs of vandalism. Photographs of location follow.
