OFFICE MEMORANDUM

Subject. Plastic Beads for Traffic Paint from Dow Chemical Company. Research Project 68 NM-206. Research Report No. R-757.

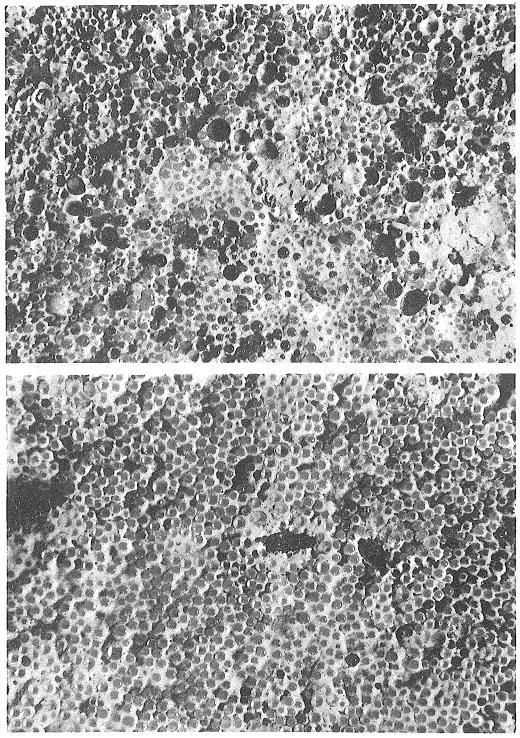
Comparison of above ratings, realizing the test area variable involved, and accelerated deterioration of test lines due to studded tires, shows that initial night visibility of the plastic beaded stripes was about equal to glass beading, but decreased at a faster rate thereafter. The final Service Factor ratings of the plastic beaded stripes were just slightly lower than for the glass, since apparently better bead retention (durability) partially offset the lower night visibility values (Fig. 1).

Figure 1. Beading in alkyd white paint stripes on concrete roadway in performance test area after 114 days of service. Specification glass beading (above) shows some black craters where larger beads have been dislodged, and the test plastic beading (below) shows better retention.

Though the plastic beads showed equivalent performance to the standard glass beads when initially applied, they are not recommended for use by the Department because of the above shortcoming.
