MICHIGAN  
STATE HIGHWAY DEPARTMENT  
Charles E. Ziegler  
State Highway Commissioner

INSPECTION OF CONCRETE PAVEMENTS

PROVINCE OF ONTARIO, CANADA

Research Laboratory  
Testing and Research Division  
June 13, 1945  
FW93

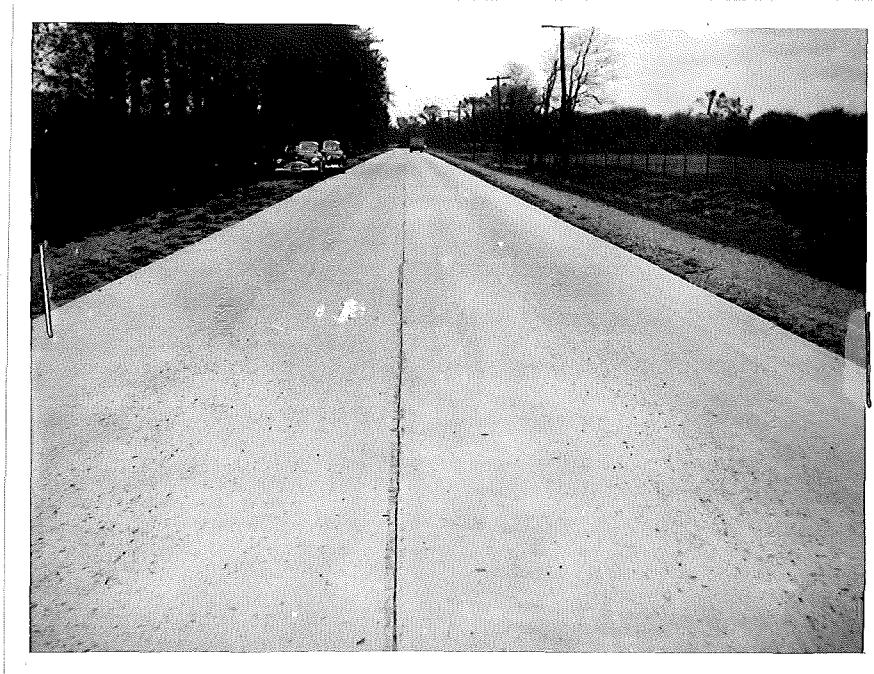
A. General view looking north showing general condition of pavement.

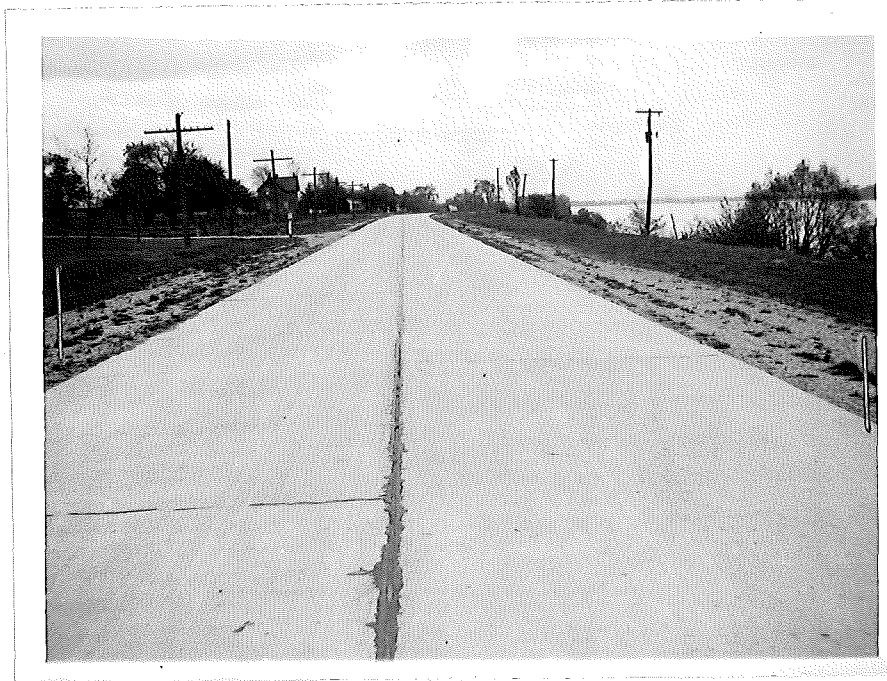
1. As illustrated in figure 1-B transverse cracking of the slabs was not the same in both lanes. The east lane was laid in August, 1943, the west lane in October 1943. In the west lane there were 2-3 cracks per 300 foot slab, while in the east lane the cracks averaged 5-6 for the same distance.

B. Same project looking south showing relative cracks in east and west lane.  
West lane 2 to 3 cracks per 300 foot slab  
East lane 5 to 6 cracks per 300 foot slab

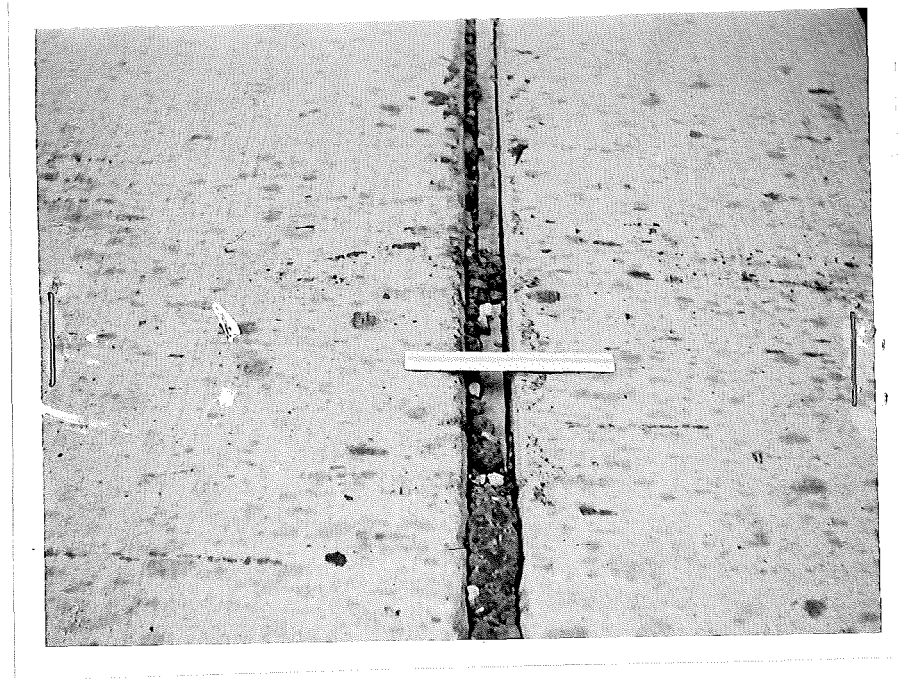
2. Typical condition of expansion joints may be observed in figure 2. This particular joint was 1-1/2 inches wide at surface. The 3/4 inch board filler was loose in the joint.

Figure 2. View showing typical condition of Expansion joints.  
3/4" wood board filler, width of joint at top  
1-1/2". Board filler was loose in joint.

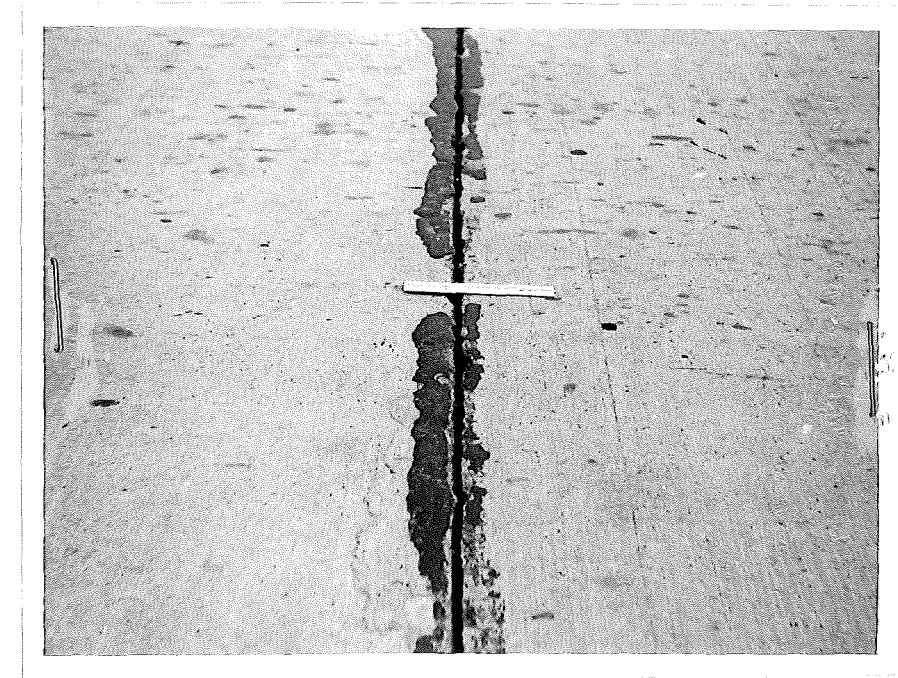
3. A construction joint approximately midway between expansion joints was observed to be open approximately 3/8 inch, see figure 3.

Figure 3. View showing opening of construction joint.  
Width of opening 3/8 inch.

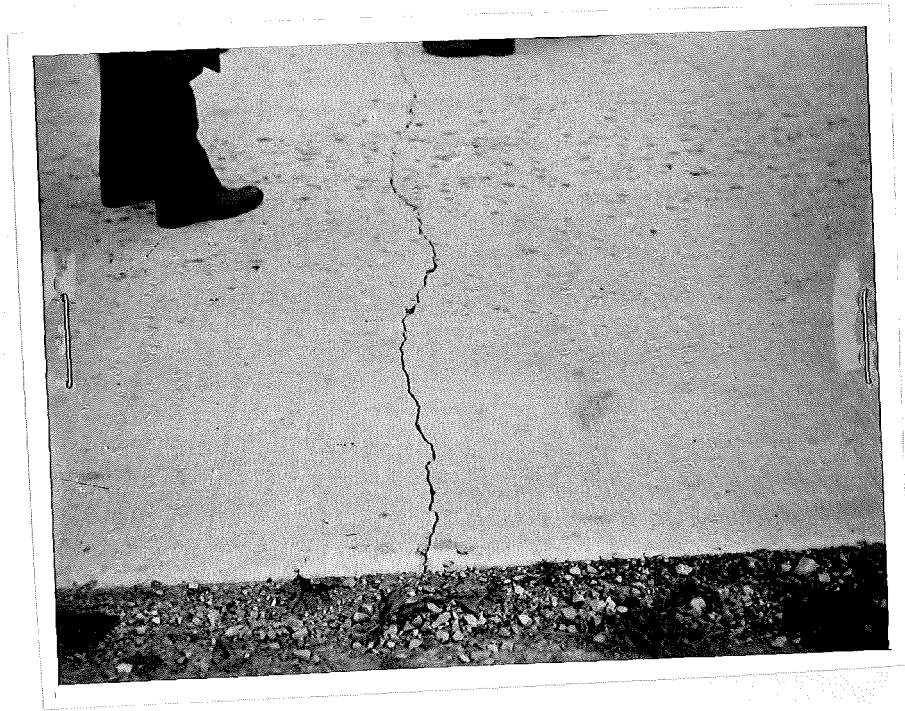
4. The width of crack opening varied with the number of cracks in each slab. The crack illustrated in figure 4 is approximately 1/8 inch wide which is typical of the crack opening in slabs containing several cracks per 300 feet. The crack openings were considerably wider in cases where only one or two cracks were observed per 300 foot slab length. See figure 5.

Figure 4. Typical condition of cracks in most slab lengths of 300 feet. Approximate width 1/8 inch.

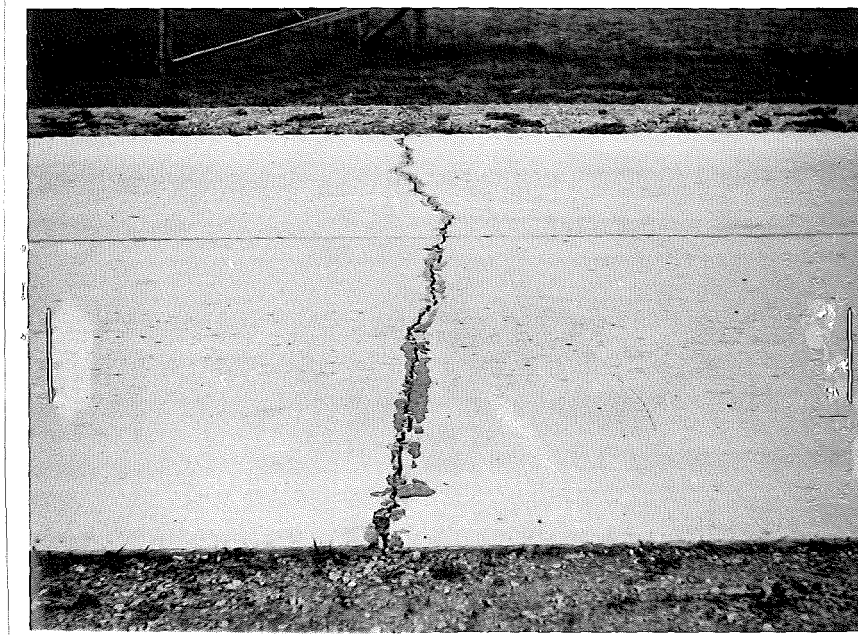
Figure 5. Typical condition of cracks when only one or two appear per 300 foot slab, approximately 1/8 inch opening.

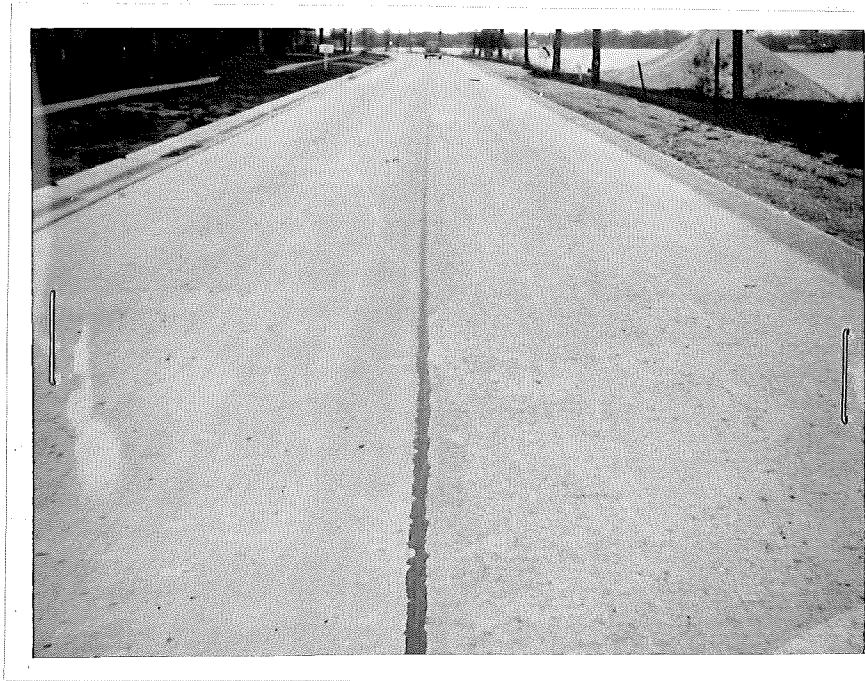
5. An interesting phenomenon was observed on this particular project. Vinyl resin cement was used throughout the project with the exception of a short section in the west lane, where due to lack of Vinyl resin cement at time of pouring, normal Portland Cement had to be used. The following winter, sand and chloride mixture was applied to both lanes in amounts of 100 pounds of calcium chloride per one yard of sand. As illustrated in figure 6 the lane without Vinyl resin cement (west lane) scaled completely, whereas the adjacent lane containing Vinyl resin cement was entirely free of scale.

A. General view looking south showing scaling of the west lane constructed with normal Portland Cement. East lane was constructed with Vinsol resin cement.

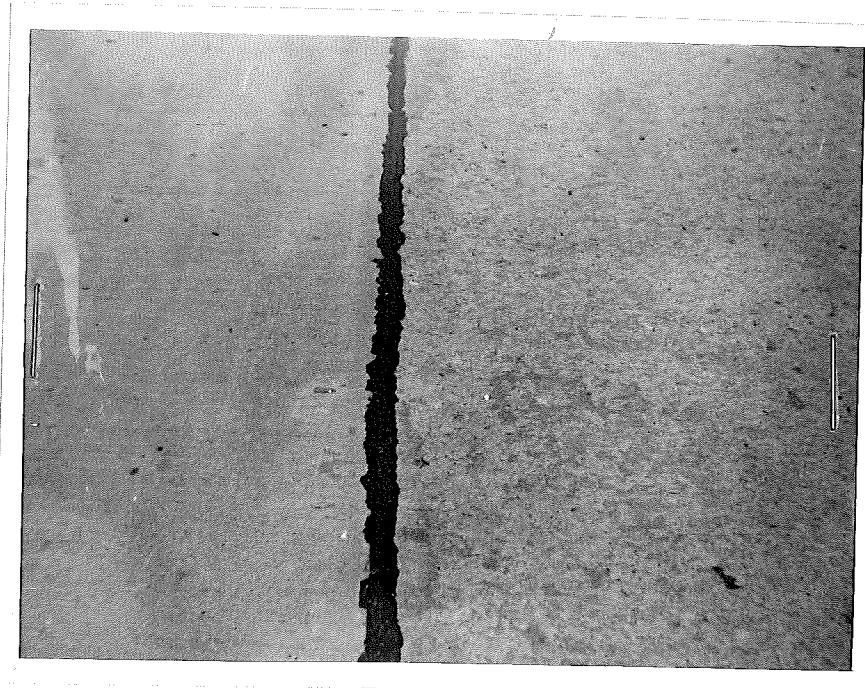
B. Close view showing general condition of adjacent sealed and unsealed surfaces.

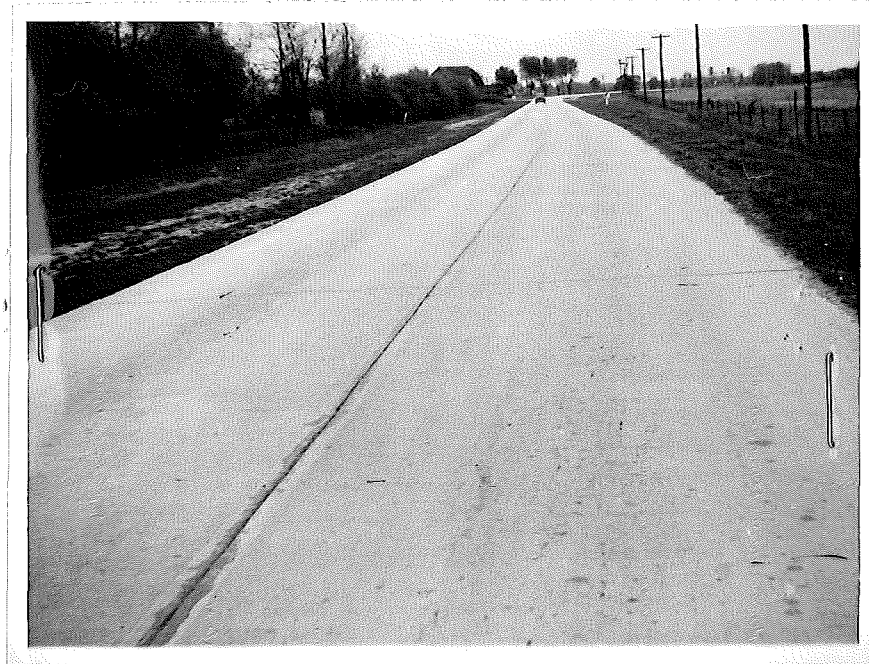
Additional information was gathered from other projects visited. It was observed that the number of cracks per 300 foot slab increase with age. The pavement illustrated in figure 7 is ten years old and the number of cracks per 300 foot slab is approximately 8 to 10. This cracking has not apparently affected the riding qualities of the pavement which are satisfactory at the present time.

Figure 7. Typical condition of pavement ten years old with 8 to 10 cracks per 300 foot slab length. Cracks have not been filled which would have made them quite discernable in photograph.

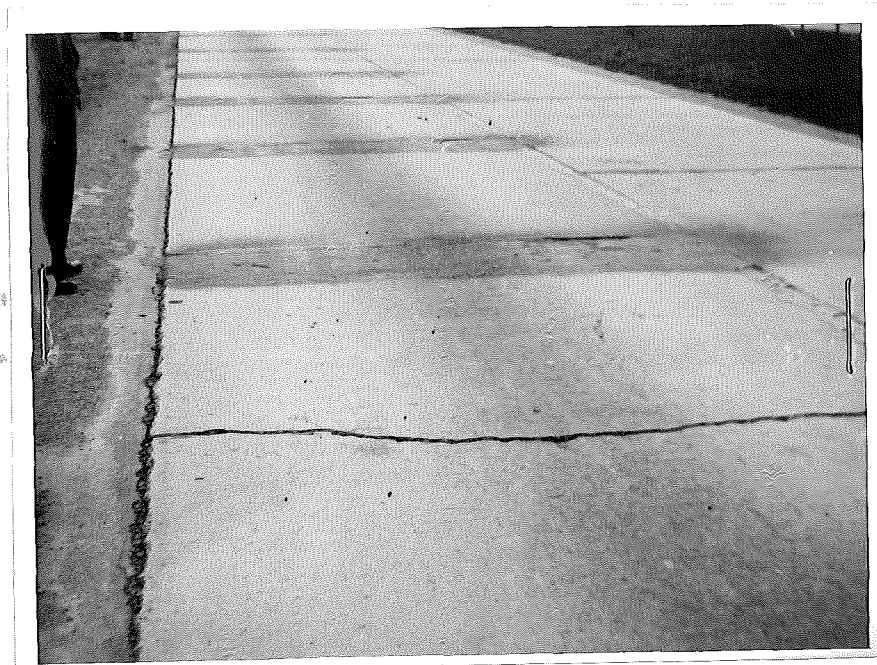
When soil type and drainage conditions are unfavorable bad surface failures have resulted. As witnessed on the Queens Highway just east of Hamilton, Ontario, see figure 8, the pavement in certain locations has broken into short slabs 7 to 10 feet in length and under heavy traffic each individual slab created by the cracks has faulted to the extent of 1/2 to 1 inch. This particular pavement is approximately ten years old and was constructed using the design features described at the beginning of the report.

Figure 8. Badly cracked and faulted area on Queens Highway, East of Hamilton, Ontario, looking east. This pavement carries west bound traffic to Hamilton. Faulting as much as 1" was observed in some instances.
