**EVALUATION OF THE URETEK
METHOD FOR PAVEMENT UNDERSEALING**

**An Experimental Project by the Michigan
Department of Transportation in Cooperation
With the U.S. Department of Transportation
Federal Highway Administration**

**Research and Technology Section
Materials and Technology Division
Research Project 93 G-294
Research Report No. R-1340**

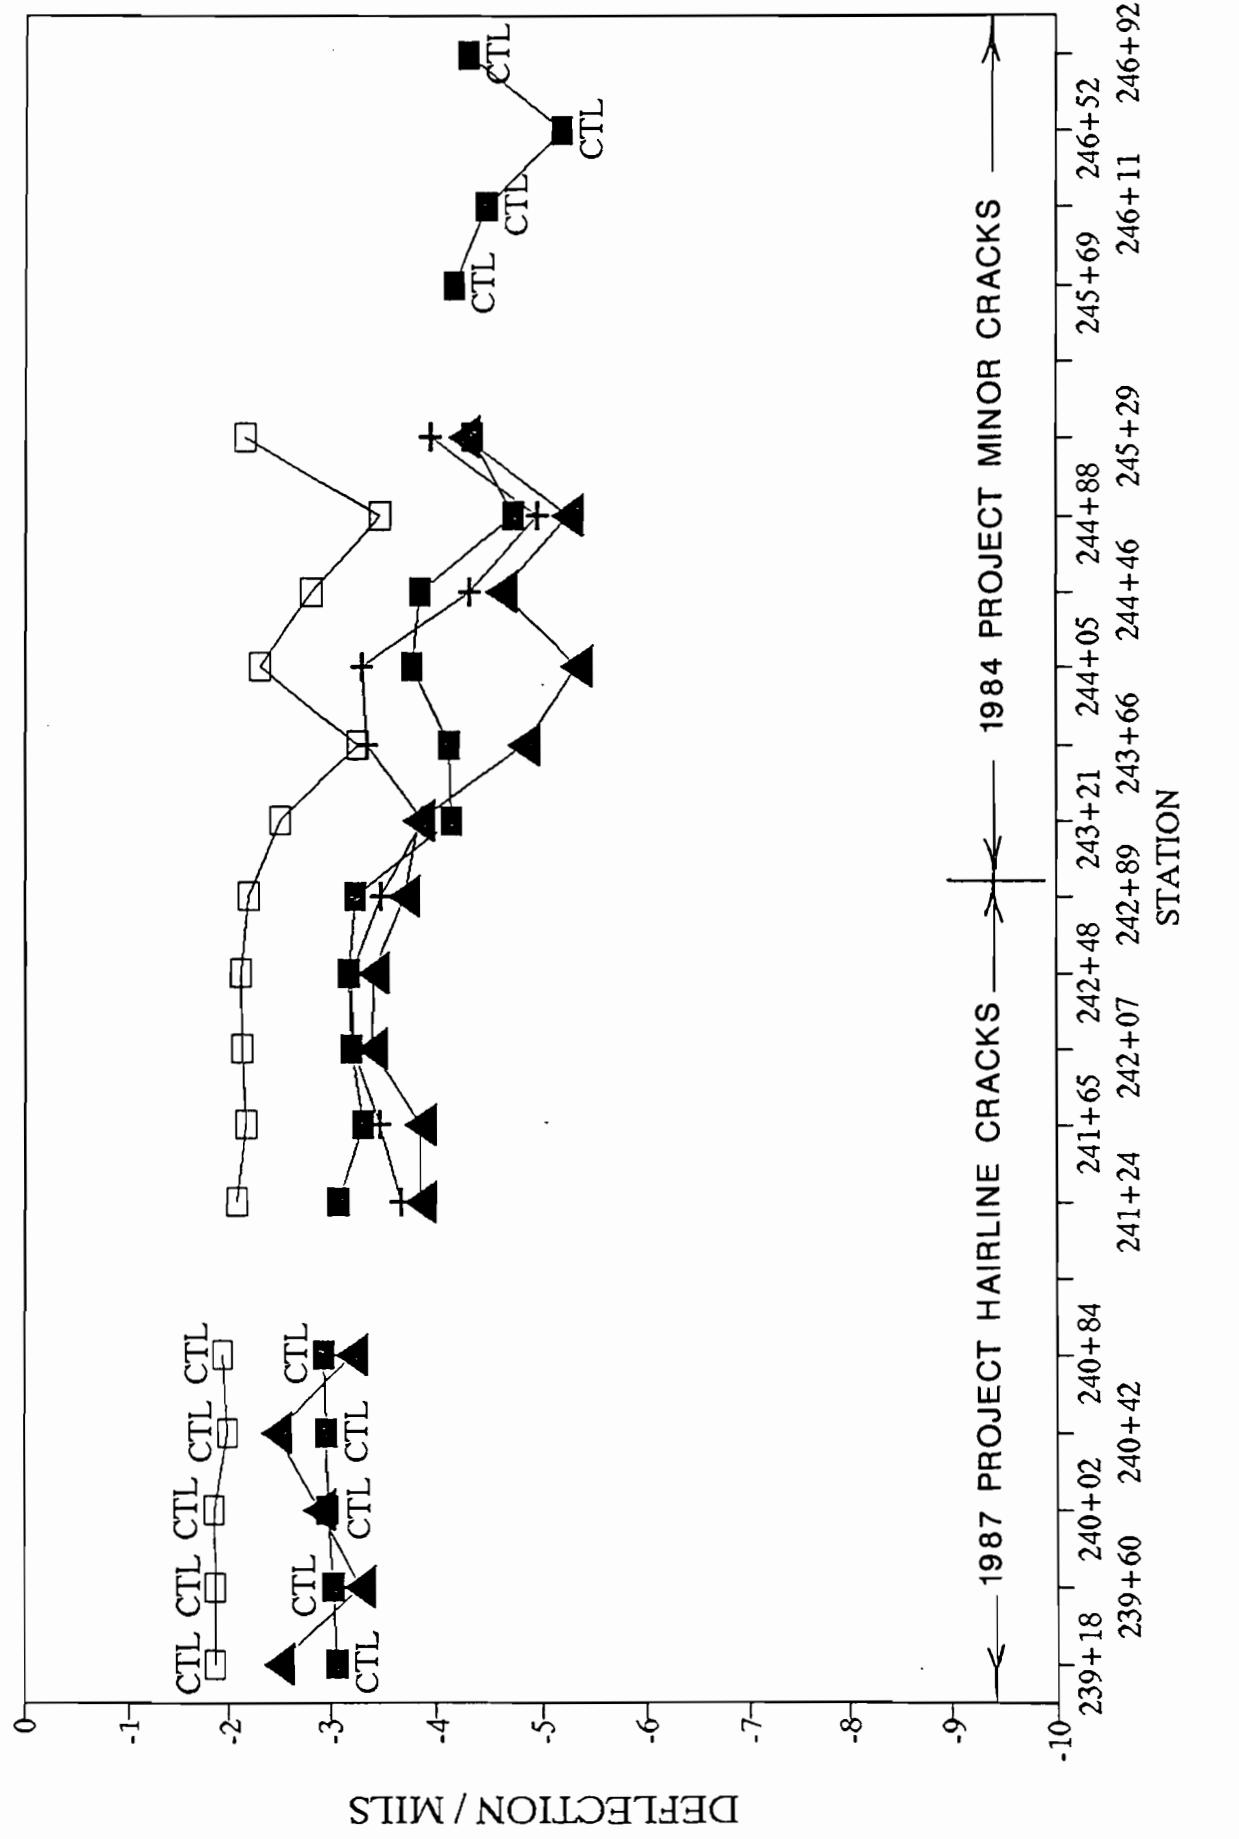
FIGURE 3
 I-75 NBOL URETEK TEST SITE NO. 1
 MAXIMUM FWD DEFLECTIONS AT MIDSLAB

Mid-Slab Locations - Generally the pavement had the best base support for both the 1984 and 1987 projects in the winter when the subbase was frozen. A slight decrease (from the values before URETEK placement) is shown in Figure 3 for the control and test areas for the 1987 project in the summer of 1994. The deflection values for the 1984 project increased during the summer of 1994 to the 4 to 6 mil range for the pavement.

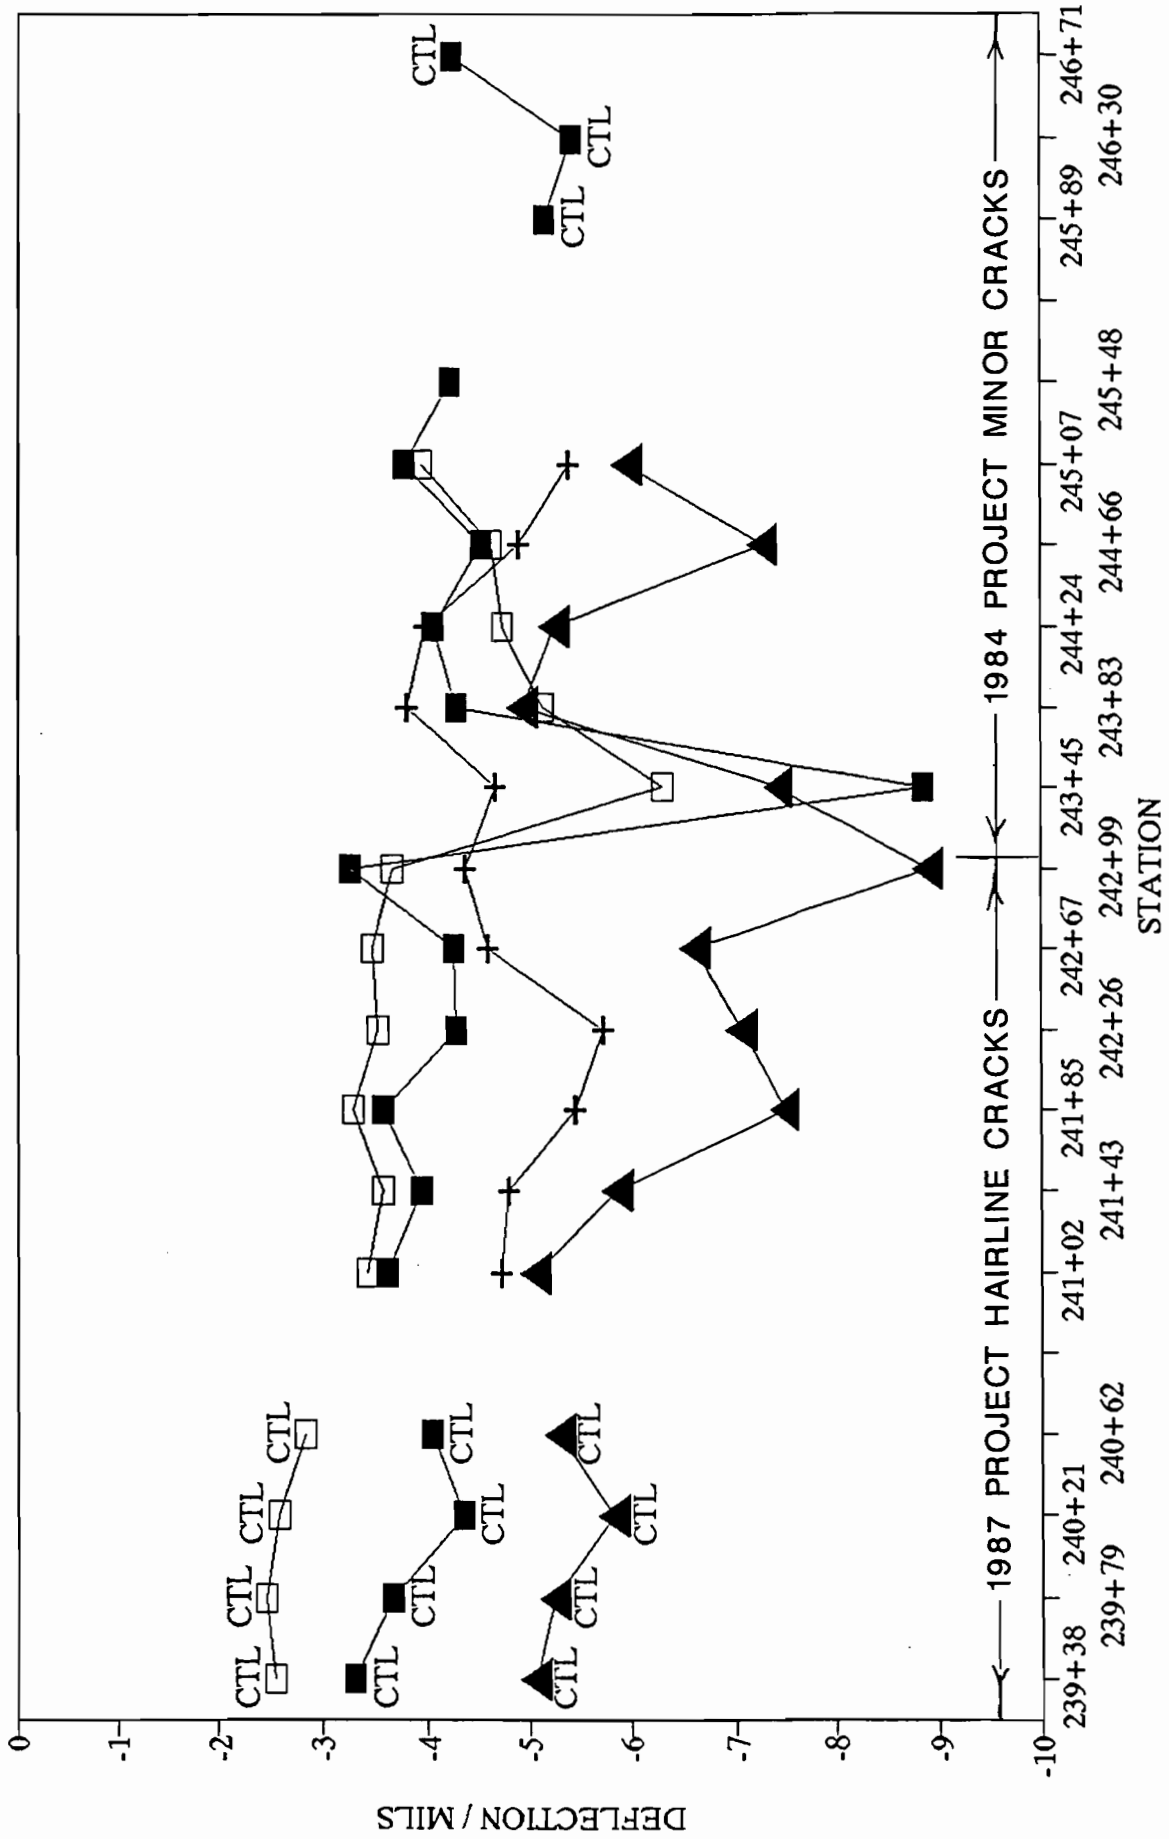
FIGURE 4
 I-75 NBOL URETEK TEST SITE NO. 1
 MAXIMUM FWD DEFLECTIONS AT JOINTS

Joint Locations - Figure 4 shows that the base support rose slightly as expected during the winter. Support decreased during the summer of 1994 for the control area, and the entire length of the test area for Site 1 to below the base support values after URETEK placement. Overall the deflection values varied about 5 to 9 mils between the 1993 and 1994 test periods.

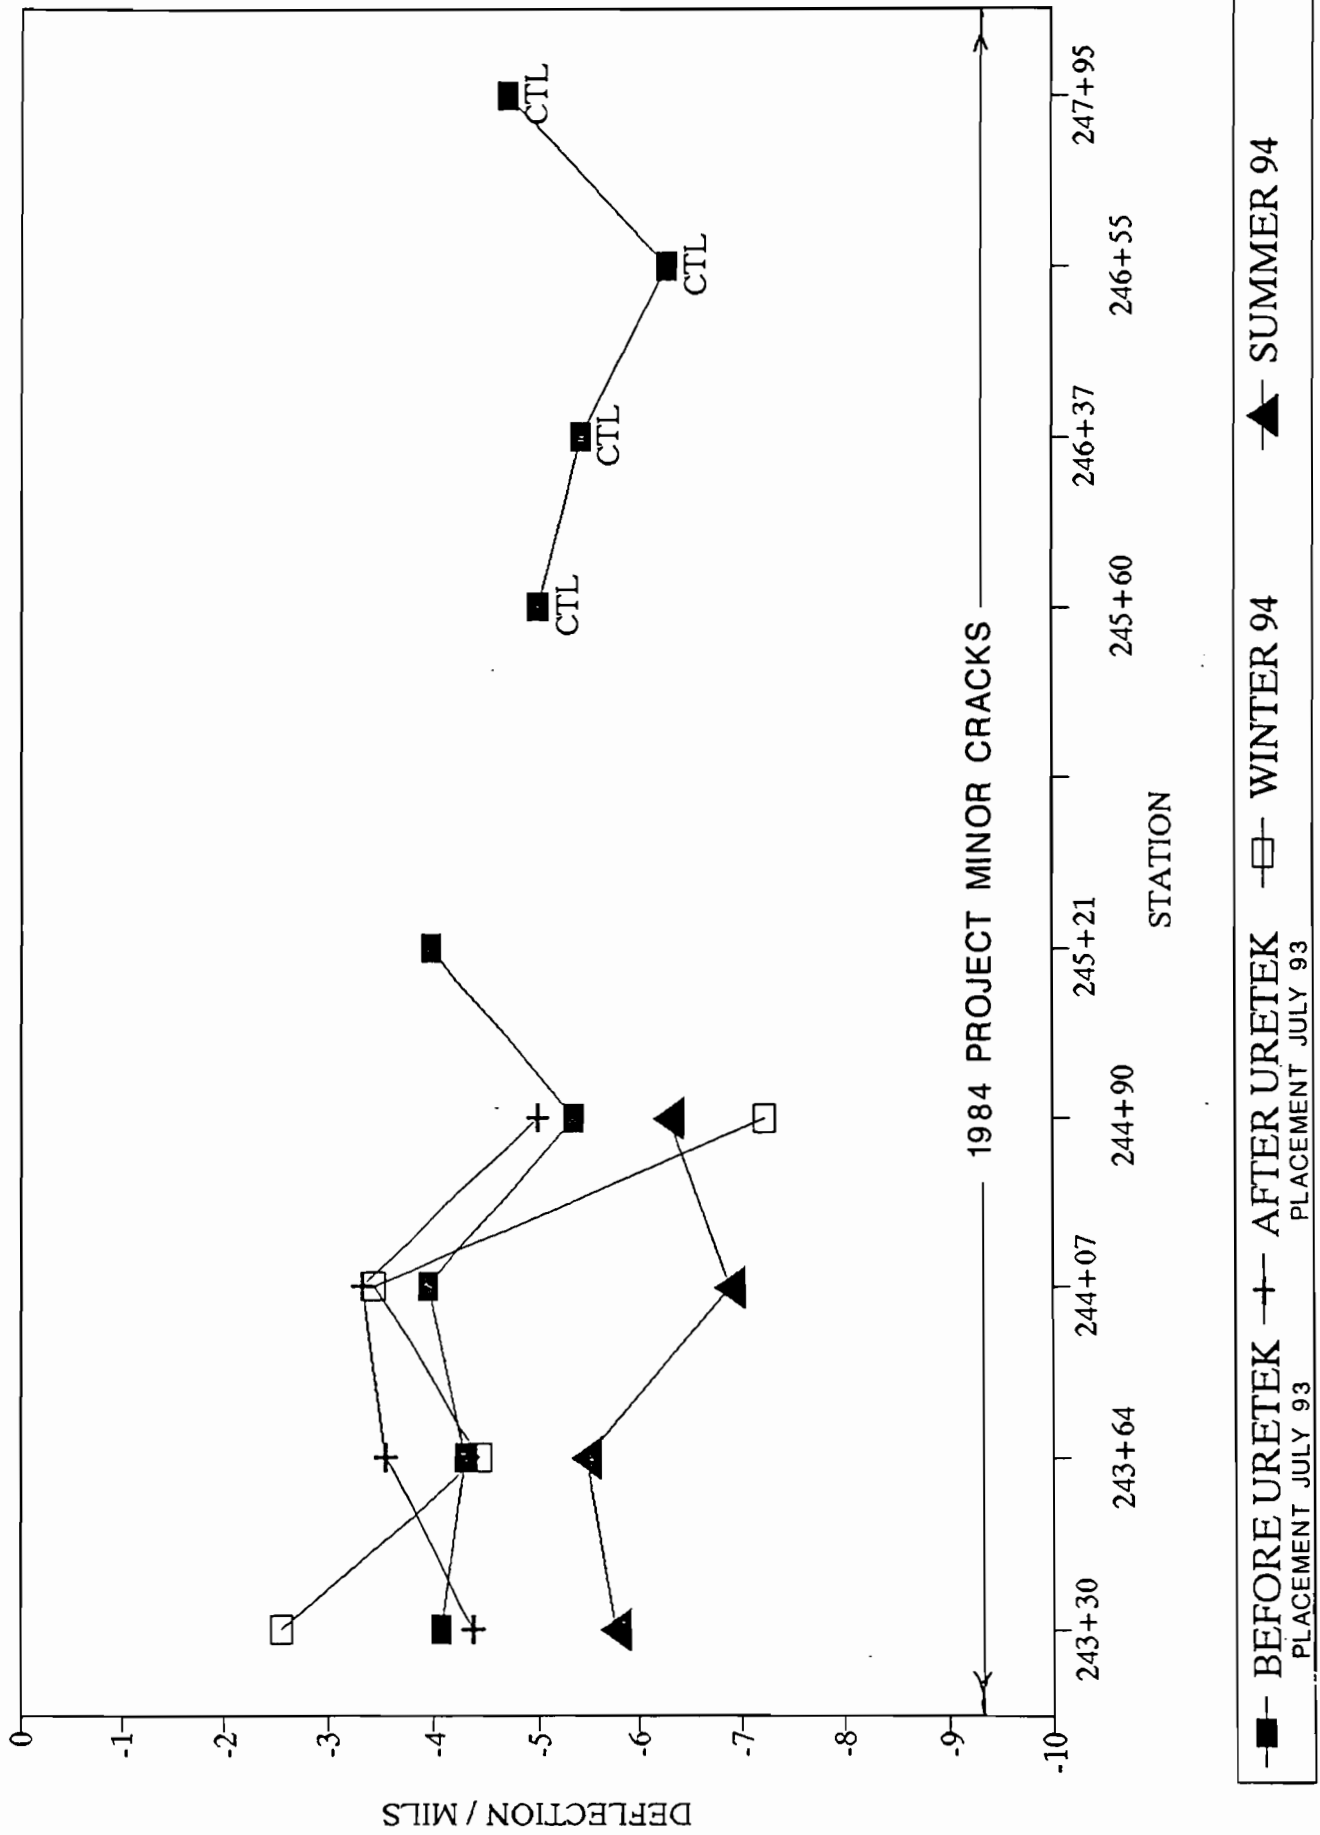
FIGURE 5
 I-75 NBOL URETEK TEST SITE NO. 1
 MAXIMUM FWD DEFLECTIONS AT CRACKS

Minor Crack Locations - Figure 5 shows the deflection values typically increased from 3 to 4 mils after placement of the URETEK to 6 to 7 mils during the summer of 1994.

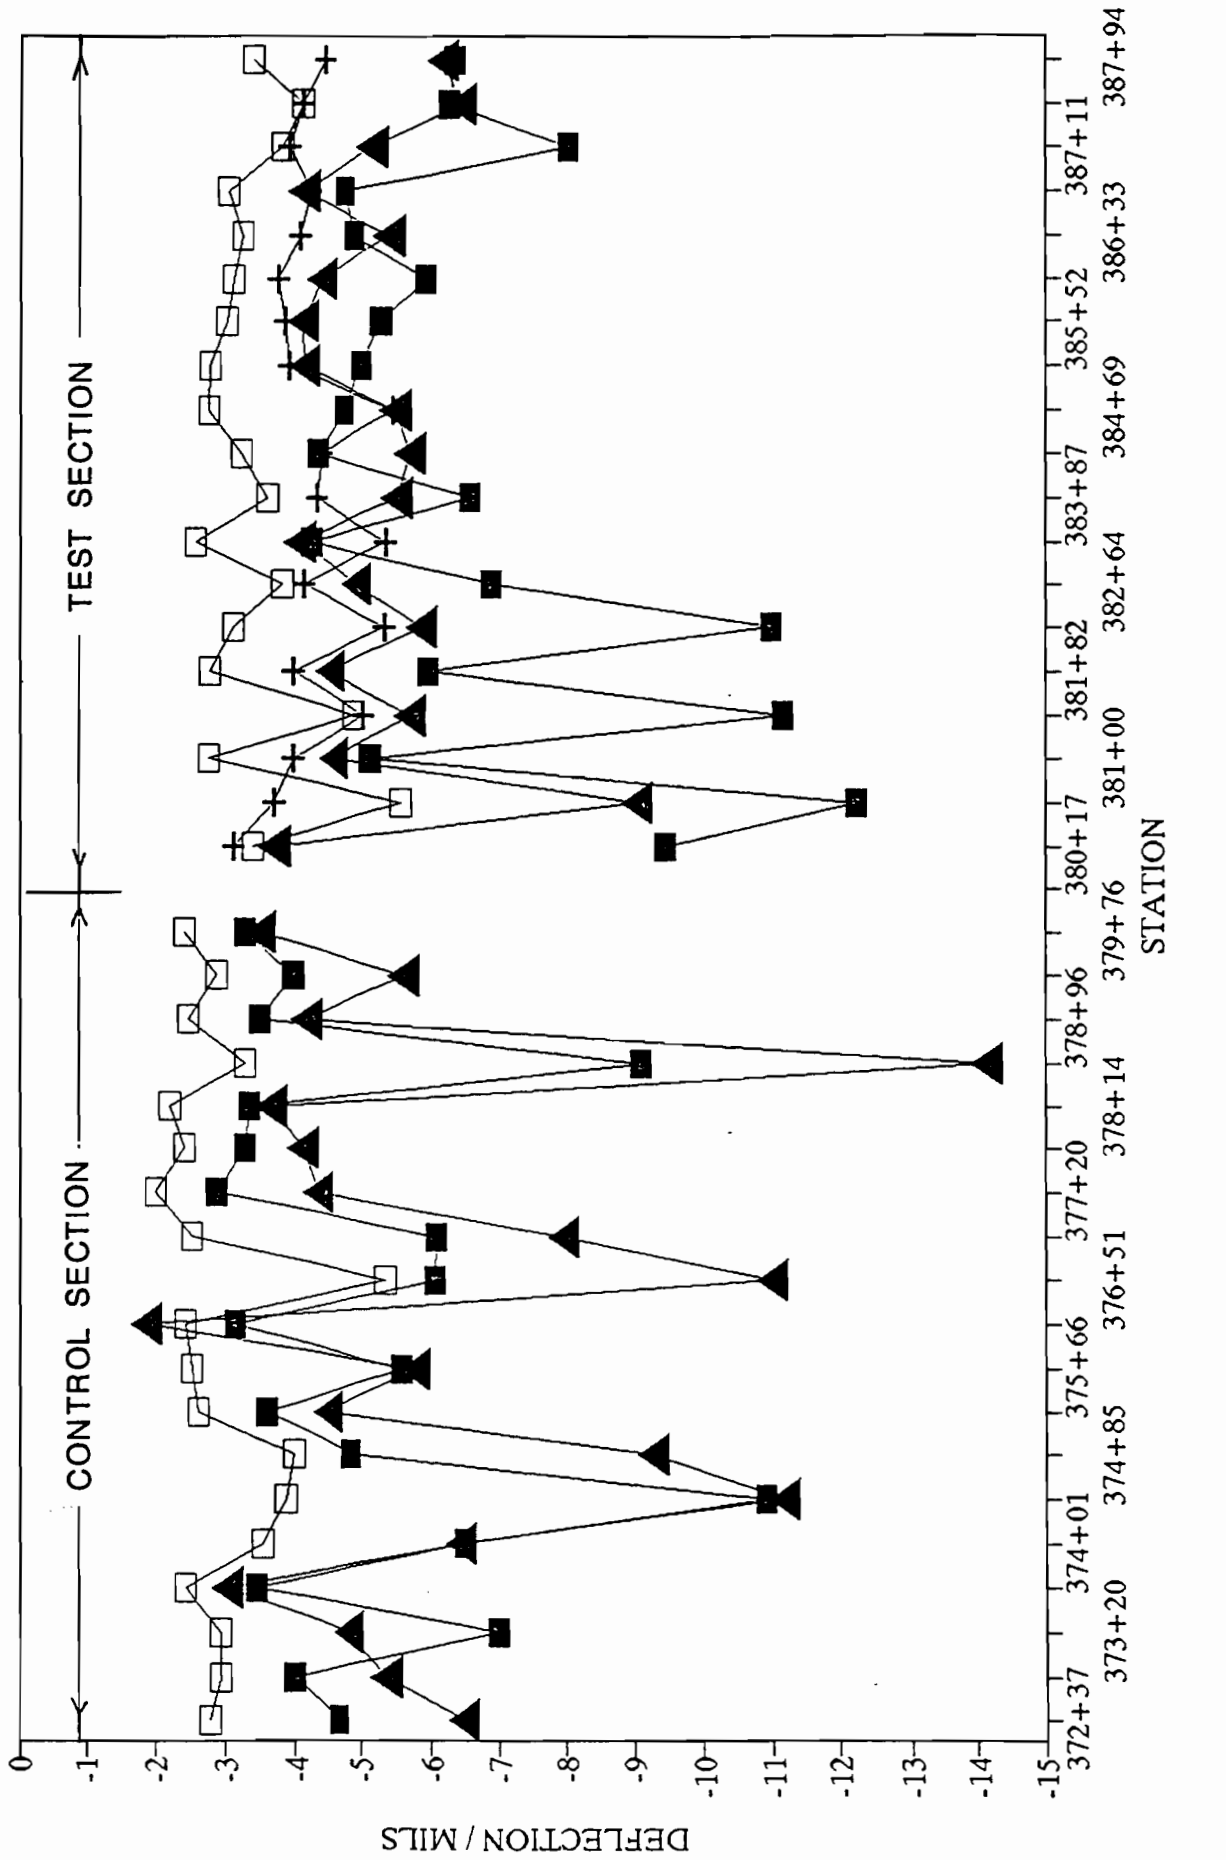
FIGURE 6
 I-75NBOL URETEK TEST SITE NO. 2
 MAXIMUM FWD DEFLECTIONS AT MIDSLAB

In general, Figures 6, 7 and 8 show that the deflection values at the mid-slabs, joints, and cracks after one year increased from the after URETEK values, but remains less than the before URETEK values.

Figure 6 shows that the worst mid-slab values (9 to 12 mils) in the test area before placement of the URETEK were in the 3 to 6 mil range one year after URETEK placement. The deflection values for the control area were generally in the 4 to 14 mil range in the summer of 1994.

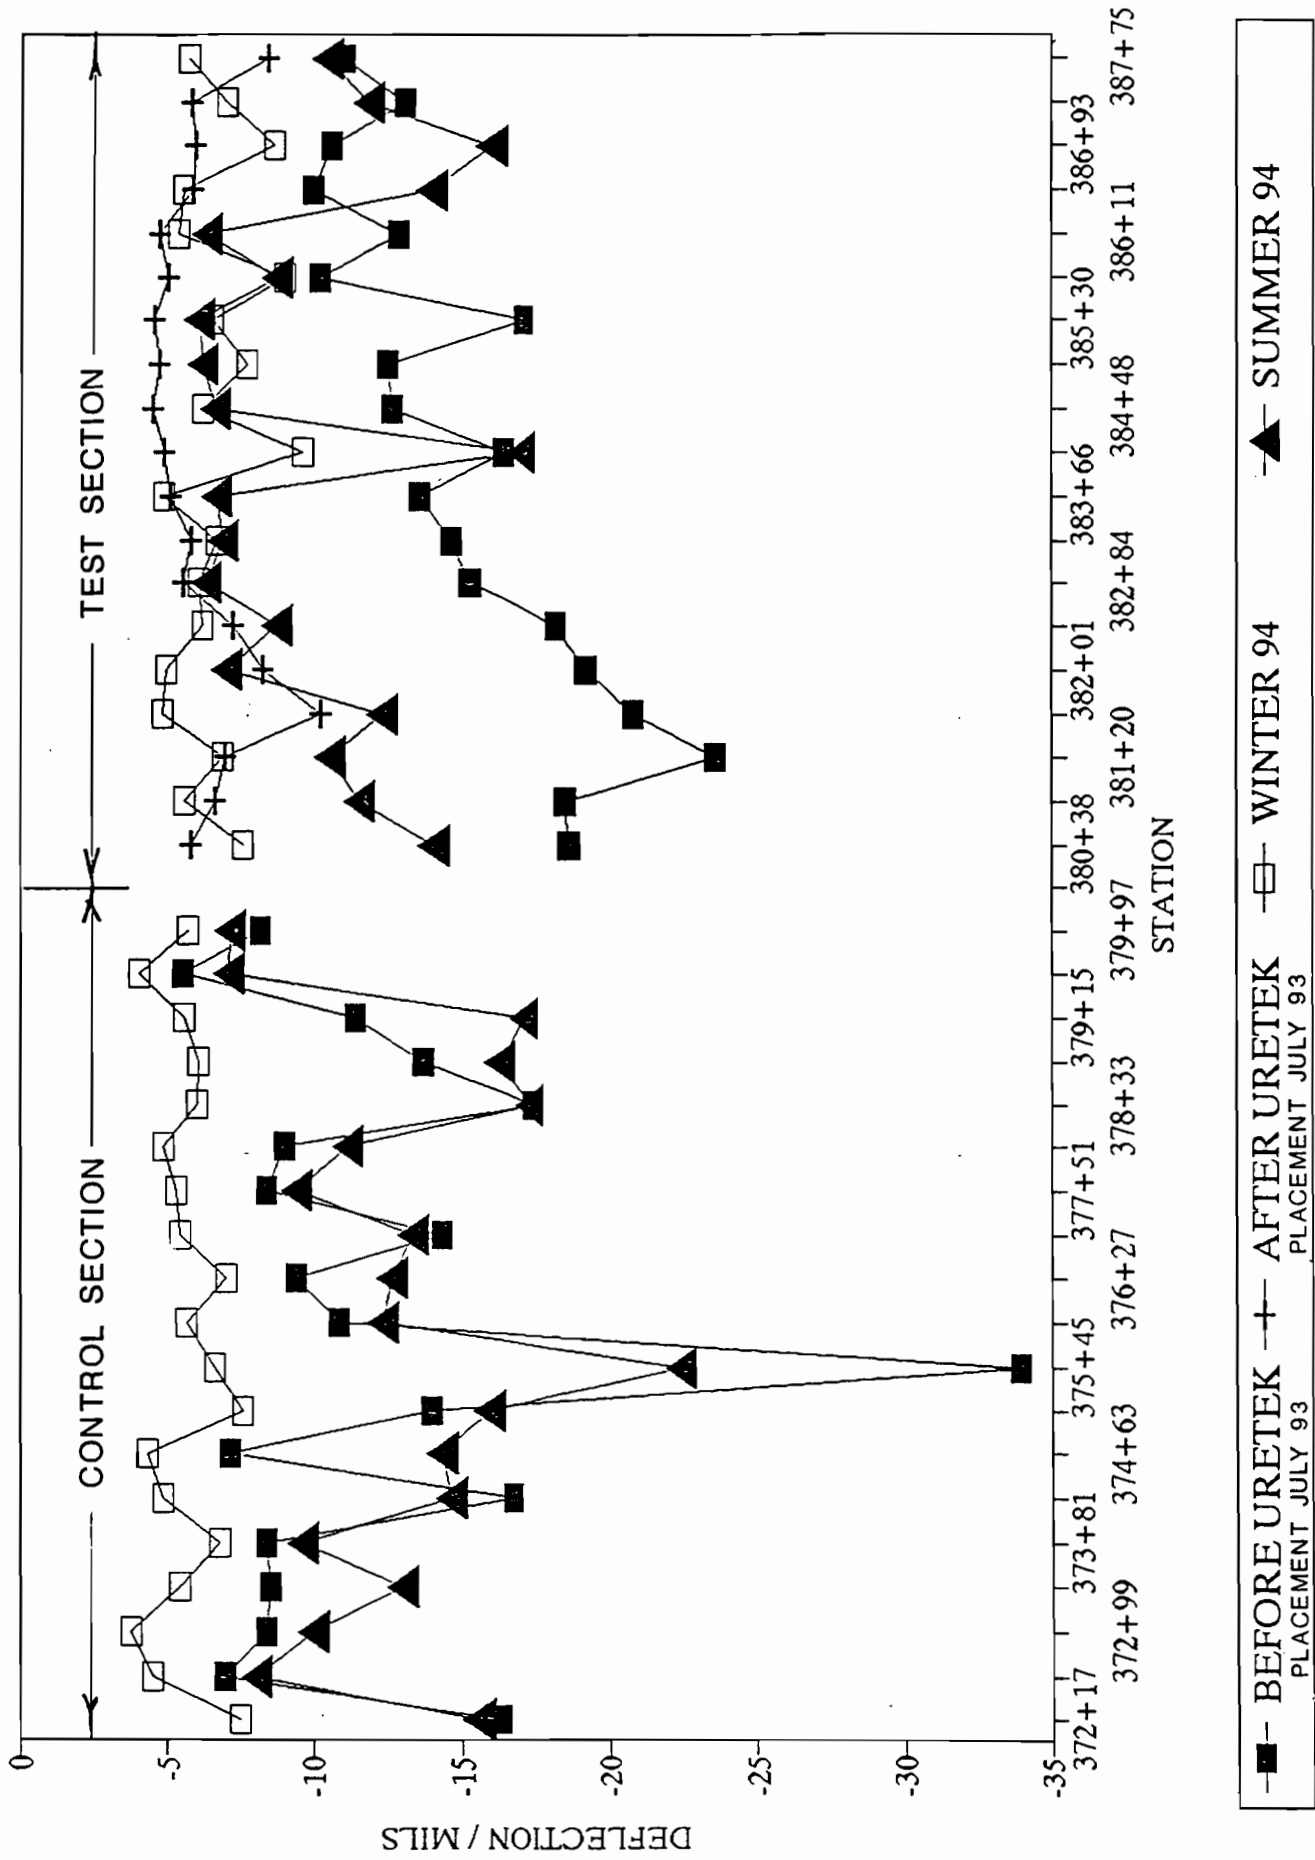
FIGURE 7
 I-75NBOL URETEK TEST SITE NO. 2
 MAXIMUM FWD DEFLECTIONS AT JOINTS

For the joint locations, Figure 7 shows test area values before URETEK placement varying between 10 and 24 mils, and one year later the values vary between 5 and 14 mils. The deflection values for the control area in the summer of 1994 were generally between 7 and 17 mils.

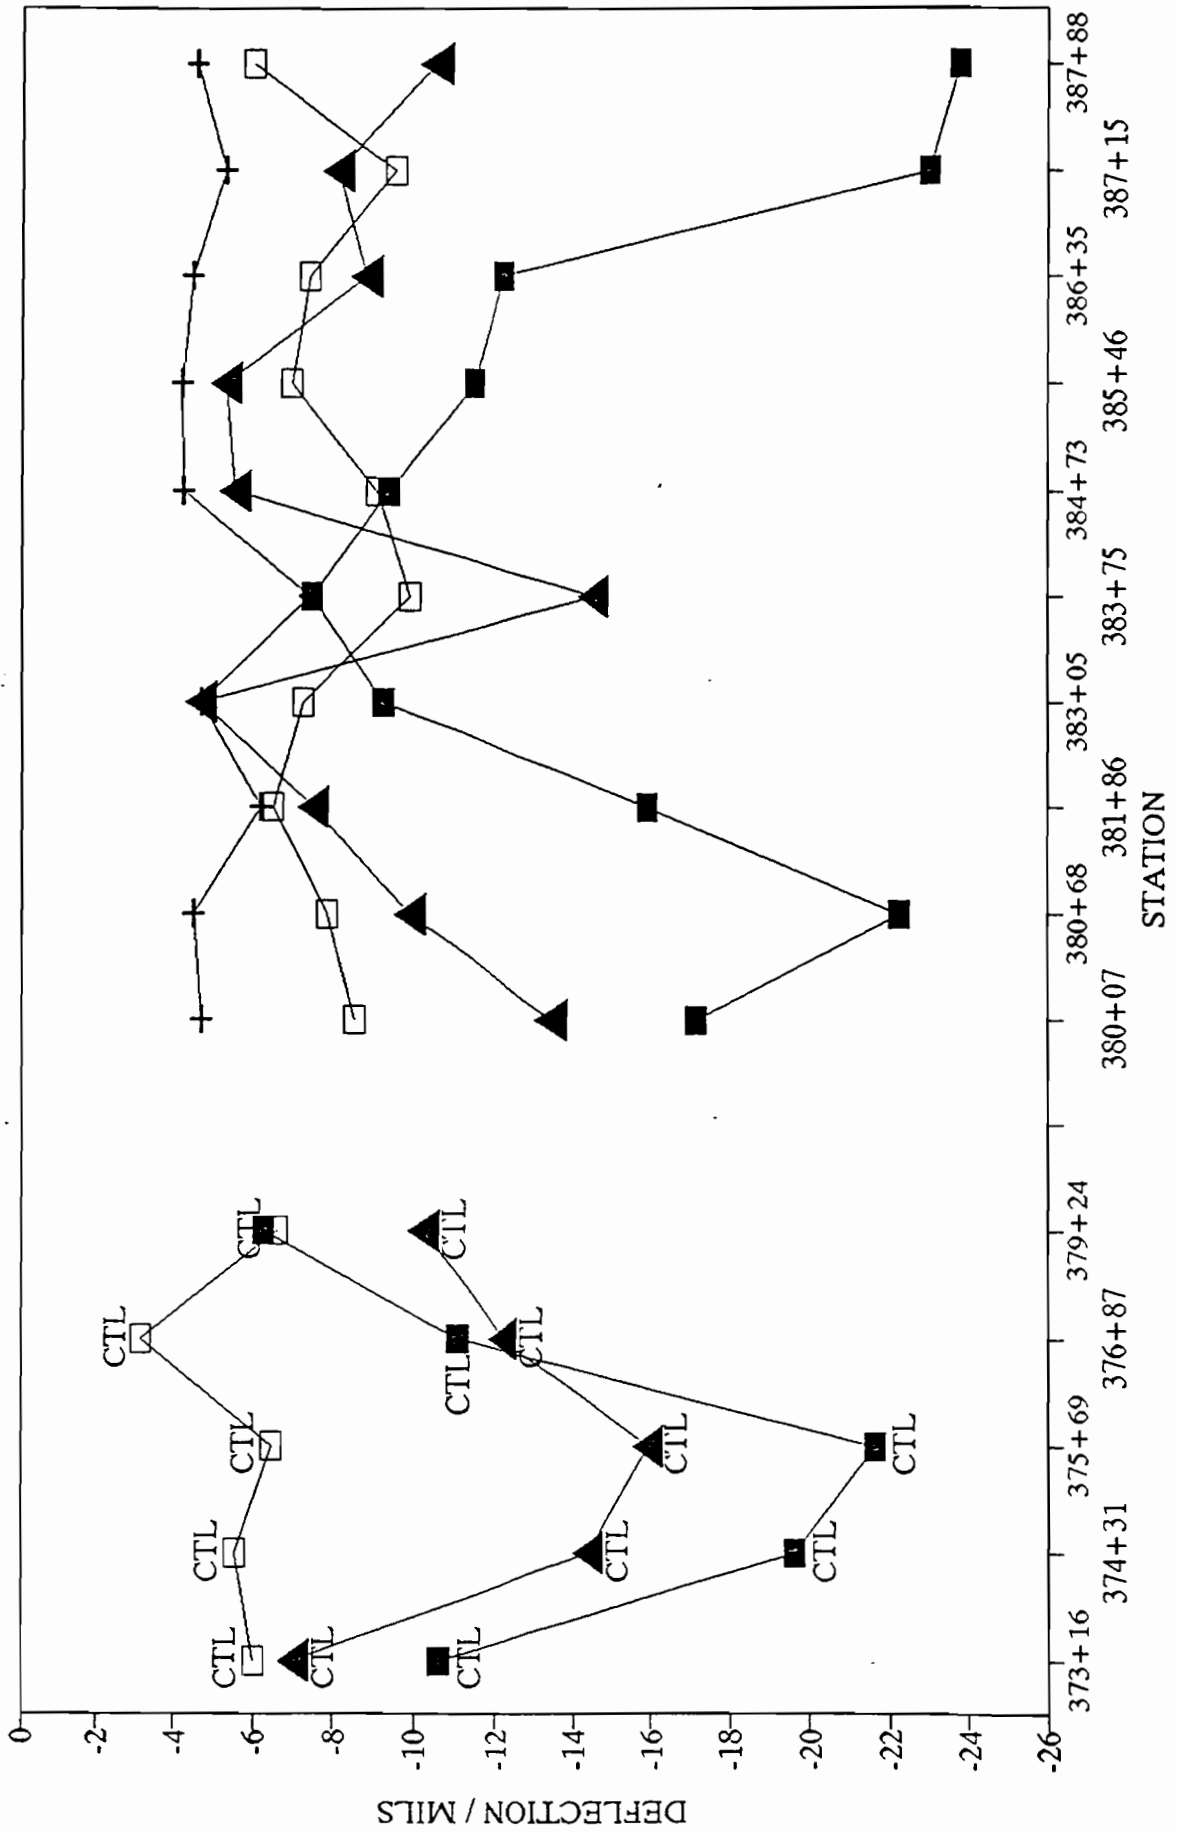
FIGURE 8
 I-75NBOL URETEK TEST SITE NO. 2
 MAXIMUM FWD DEFLECTIONS AT CRACKS

For the crack locations, Figure 8 shows test area values before URETEK placement varying between 7 and 24 mils, and one year later the values vary between 5 and 14 mils. The deflection values for the control area in the summer of 1994 vary between 7 and 16 mils.

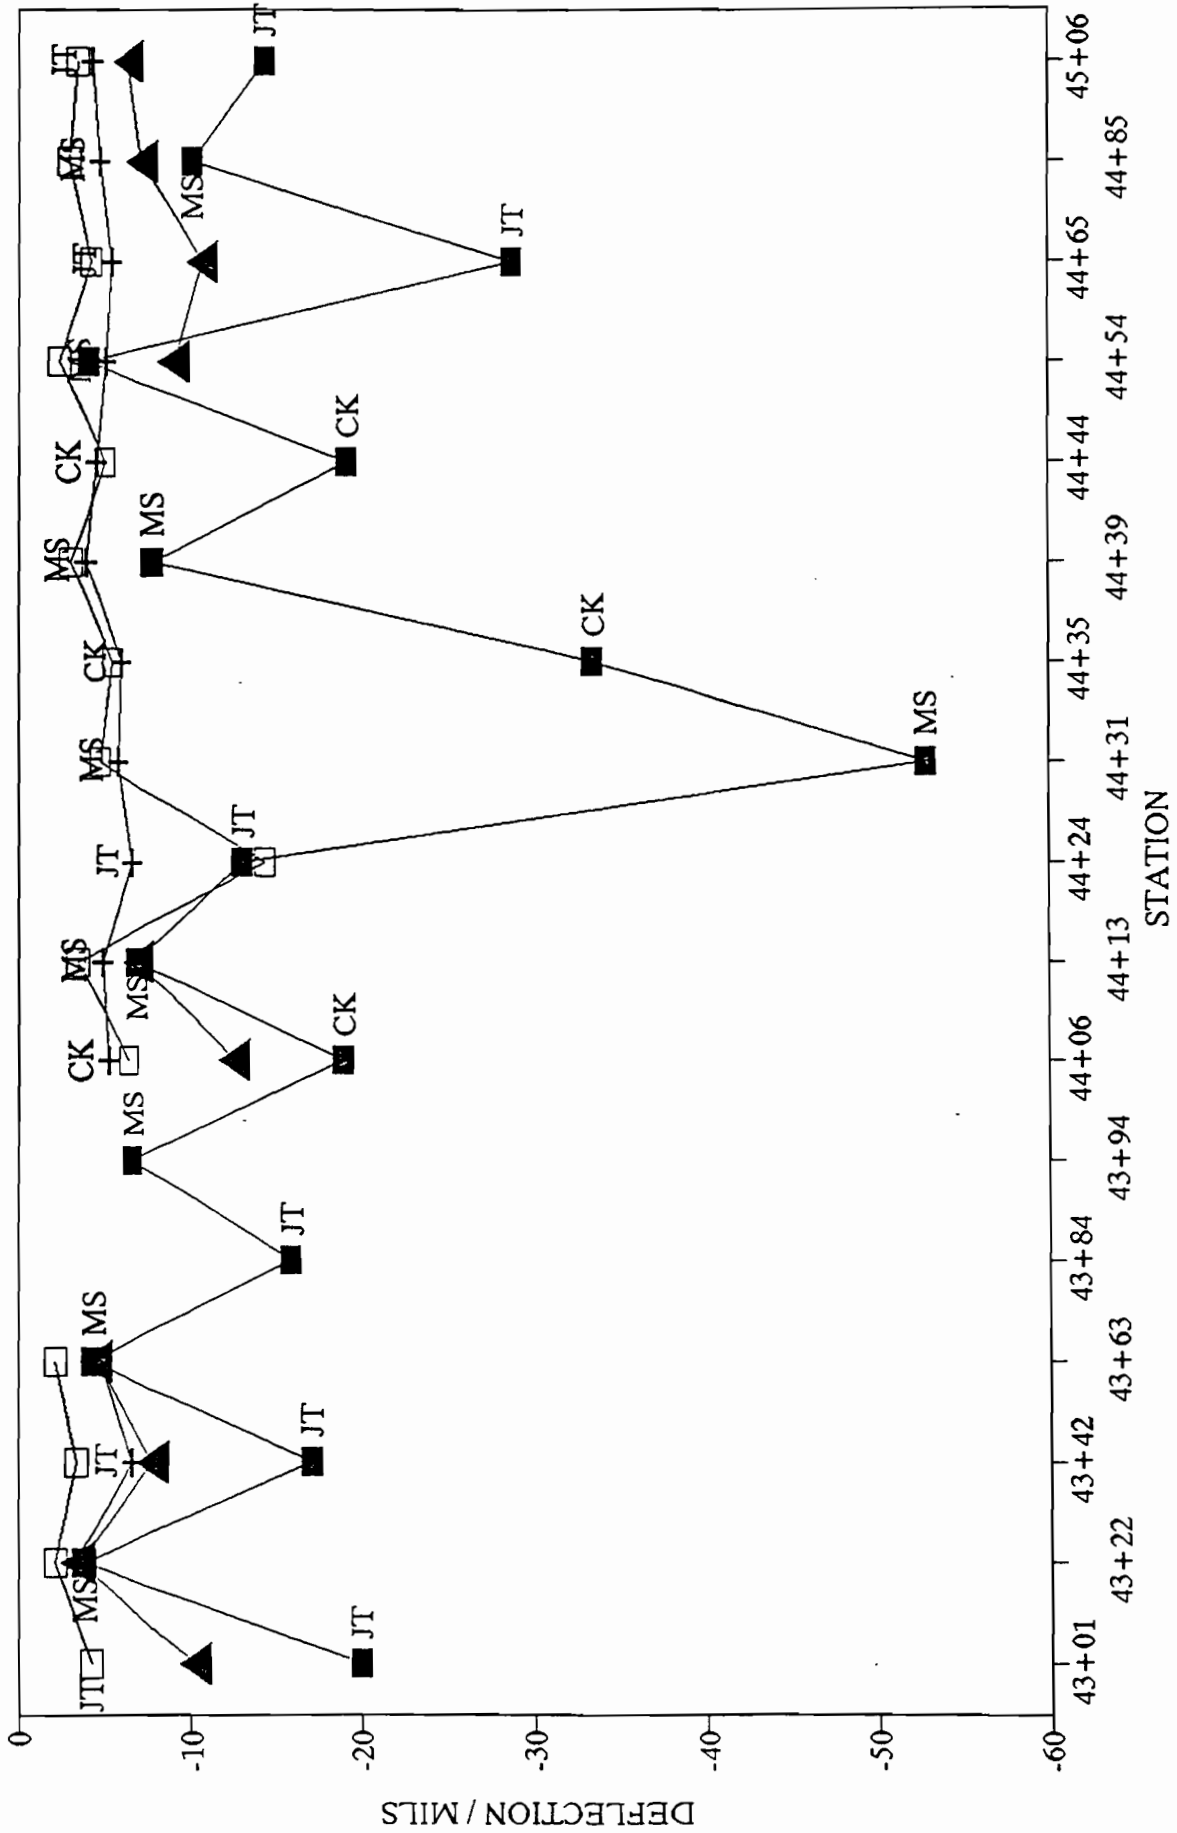
FIGURE 9
 I-75 NBOL URETEK UNDERSEAL TEST SITE #3
 MAXIMUM FWD DEFLECTIONS

A section of the pavement slab (approximately 25 feet in length) had settled about four inches below the shoulder, indicating the tie bars had failed with no load transfer along the longitudinal joint. The site was stabilized from Sta. 43+01 to 45+06.

The URETEK method raised the slab back to a reasonable grade until the spring of 1994 when the slab resettled. It was later replaced with a concrete patch. The remaining area of Site 3 preformed similarly to the 1987 project portion of Site 1.

Figure 9 shows the very high deflection values at Site 3 (53 mils at Sta. 44+31) before undersealing.

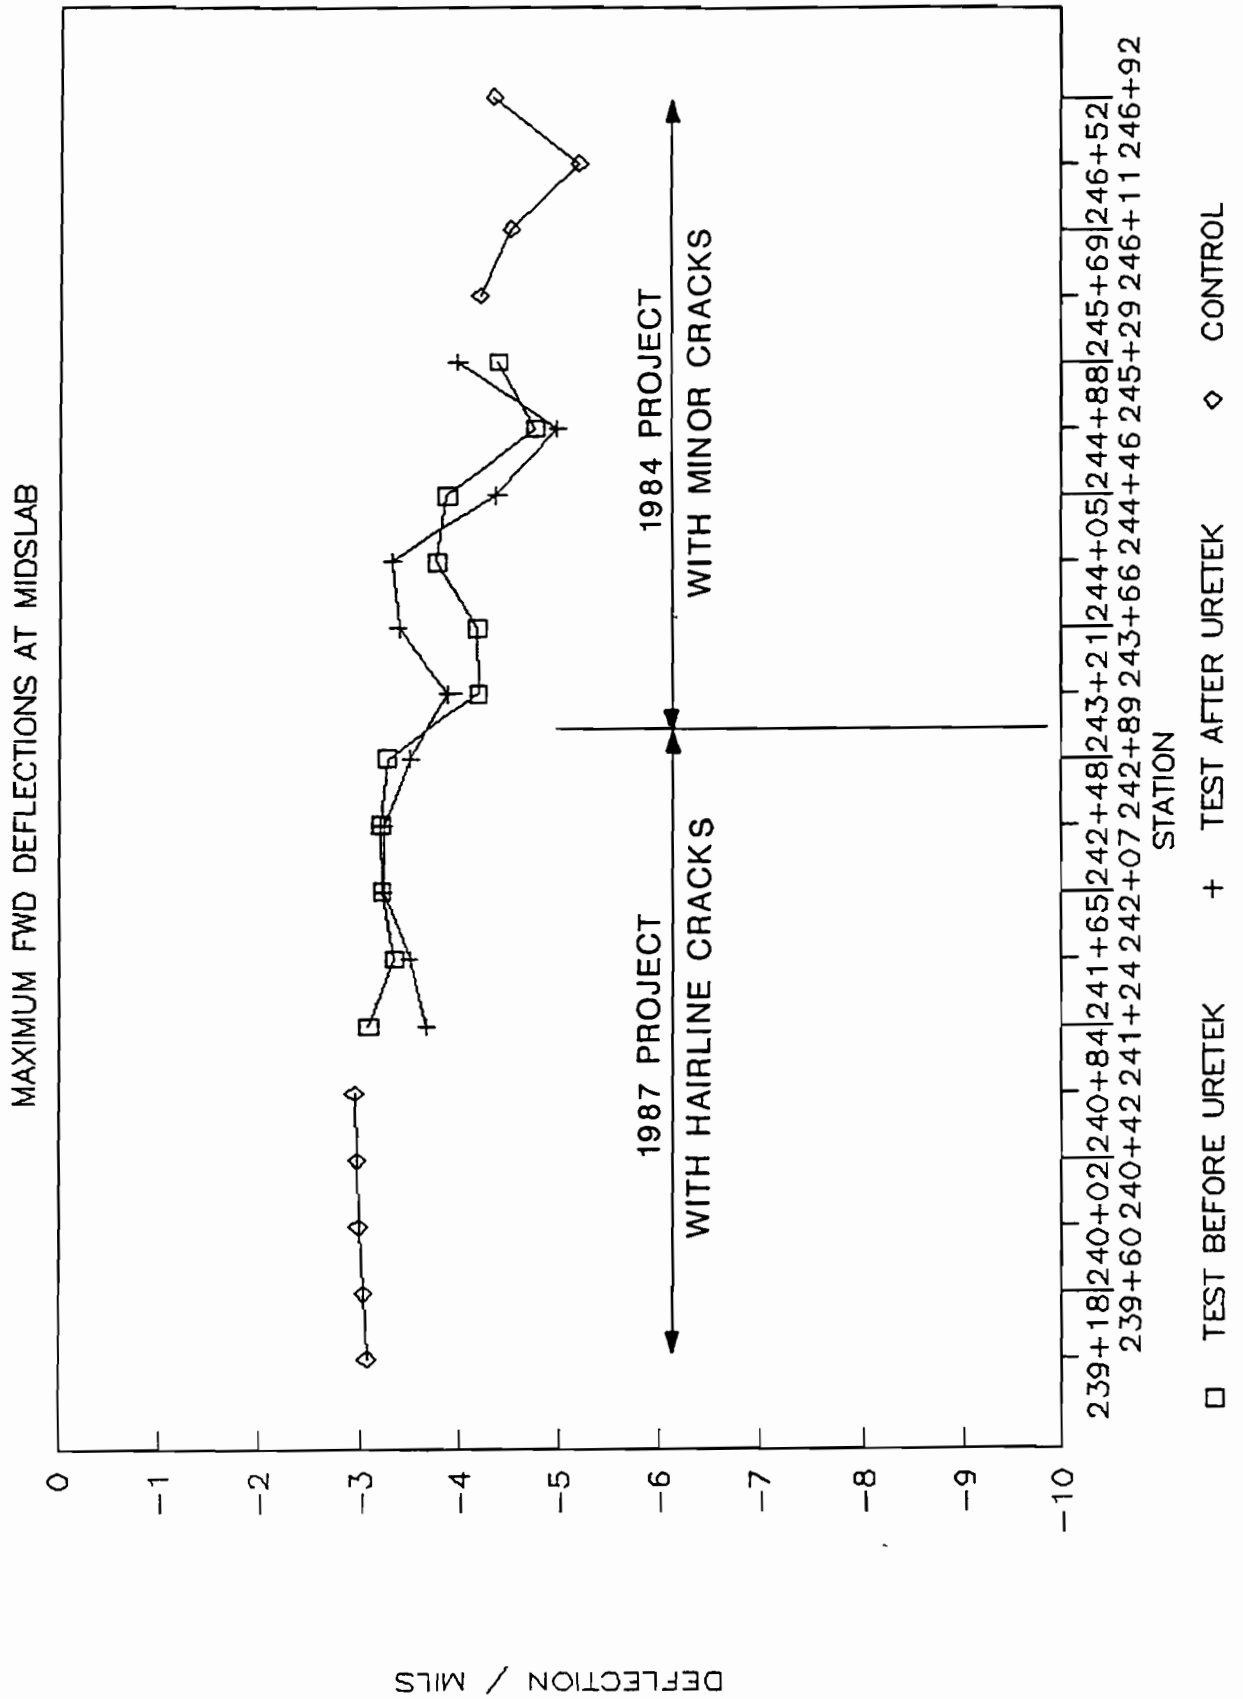
FIGURE 1
 I-75NBOL URETEK TEST SITE 1
 MAXIMUM FWD DEFLECTIONS AT MIDSLAB

The 1987 project (Sta. 241 to 243) had only a few minor hairline cracks. It was treated to determine if early undersealing is effective in preventing future cracking. At the mid-slab locations, Figure 1 shows that no significant changes occurred. At the joint locations, Figure 2 shows that the base support decreased slightly after undersealing.

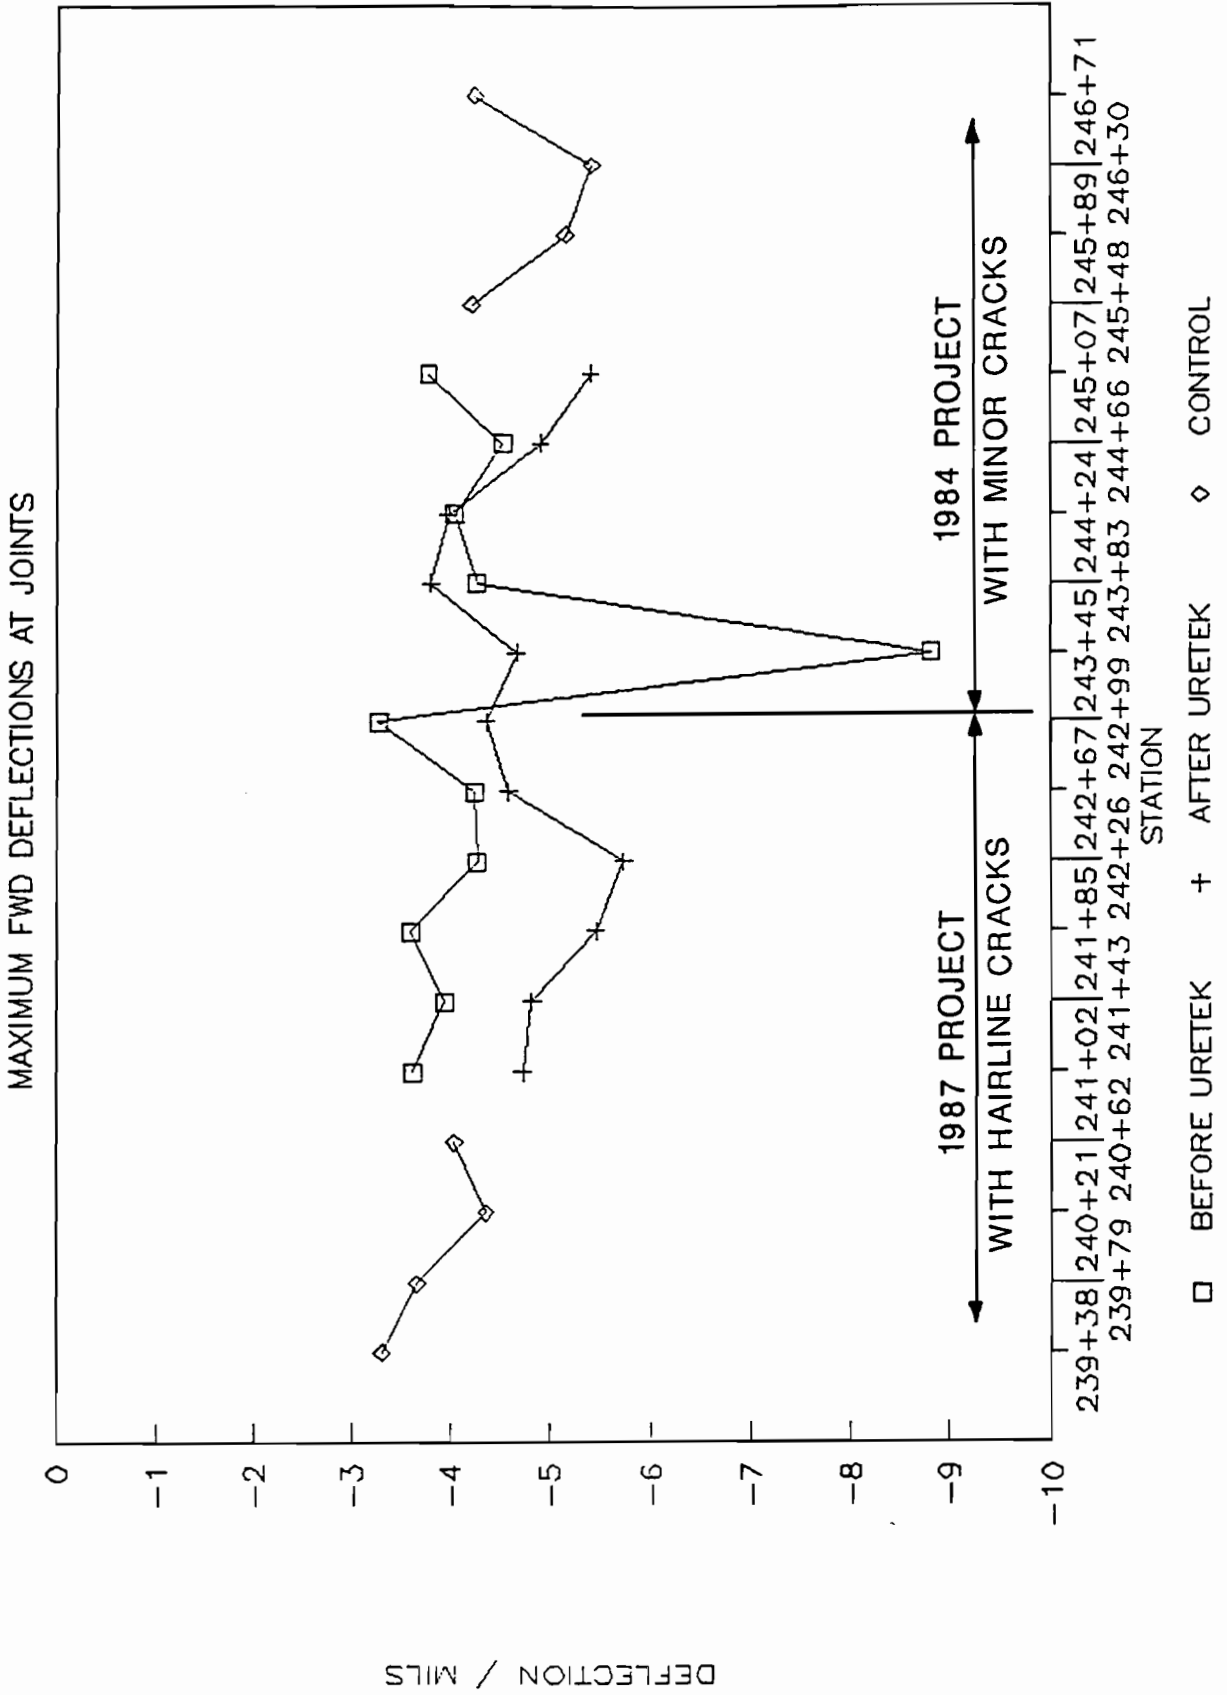
FIGURE 2
 I-75 NBOL URETEK TEST SITE 1
 MAXIMUM FWD DEFLECTIONS AT JOINTS

The 1984 project (Sta. 243 to 245) showed some minor cracking in this section. Figure 2 shows the Uretek treatment was effective in improving the base support at the one poorly supported joint (improved from 9 mils to 4½ mils). Figure 3 shows it also marginally improved the base support at the cracks (4± mils).
