**EVALUATION OF THE URETEK
METHOD FOR PAVEMENT UNDERSEALING**

**An Experimental Project by the Michigan
Department of Transportation in Cooperation
With the U.S. Department of Transportation
Federal Highway Administration**

**Research and Technology Section
Materials and Technology Division
Research Project 93 G-294
Research Report No. R-1340**

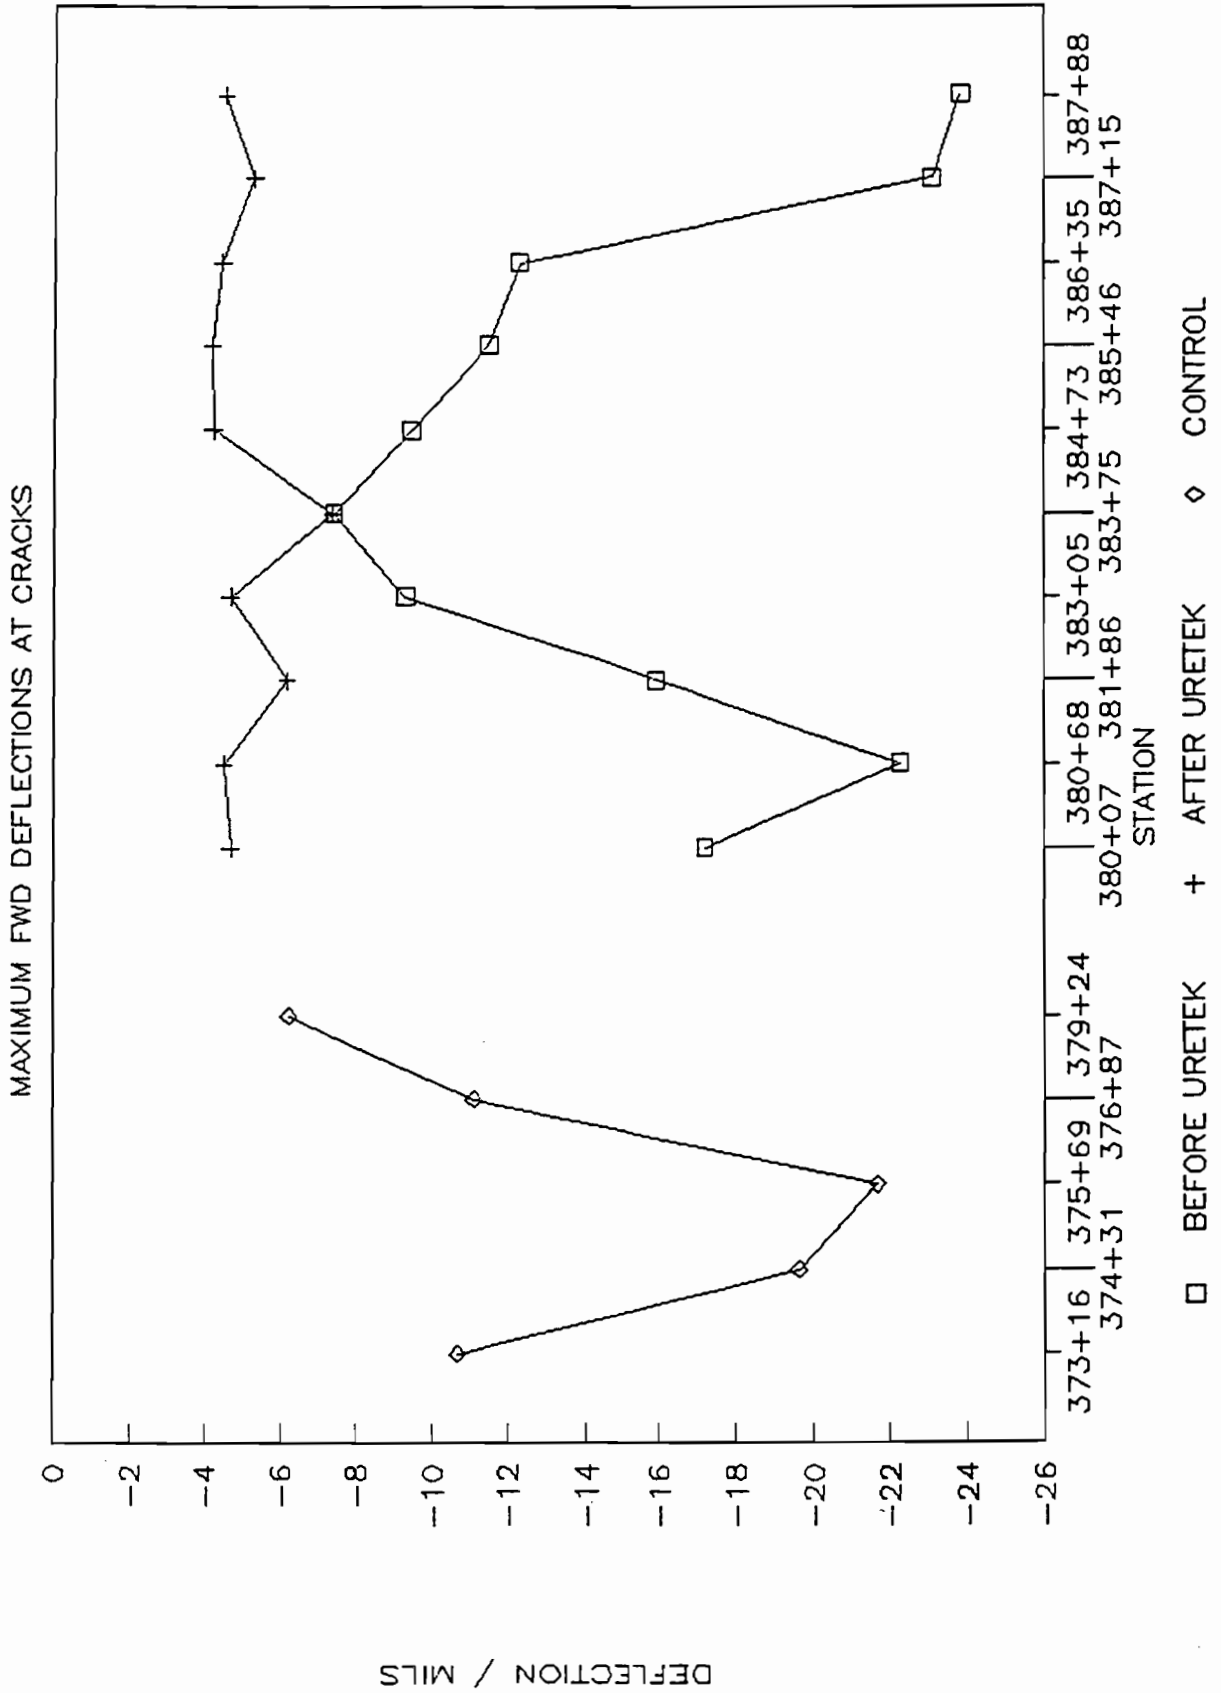
FIGURE 6
 I-75 NBOL URETEK TEST SITE 2

Figure 6 shows the data at the severe transverse cracks. The before data varied between 7 and 24 mils while the after data ranged from 4 to 7 mils.

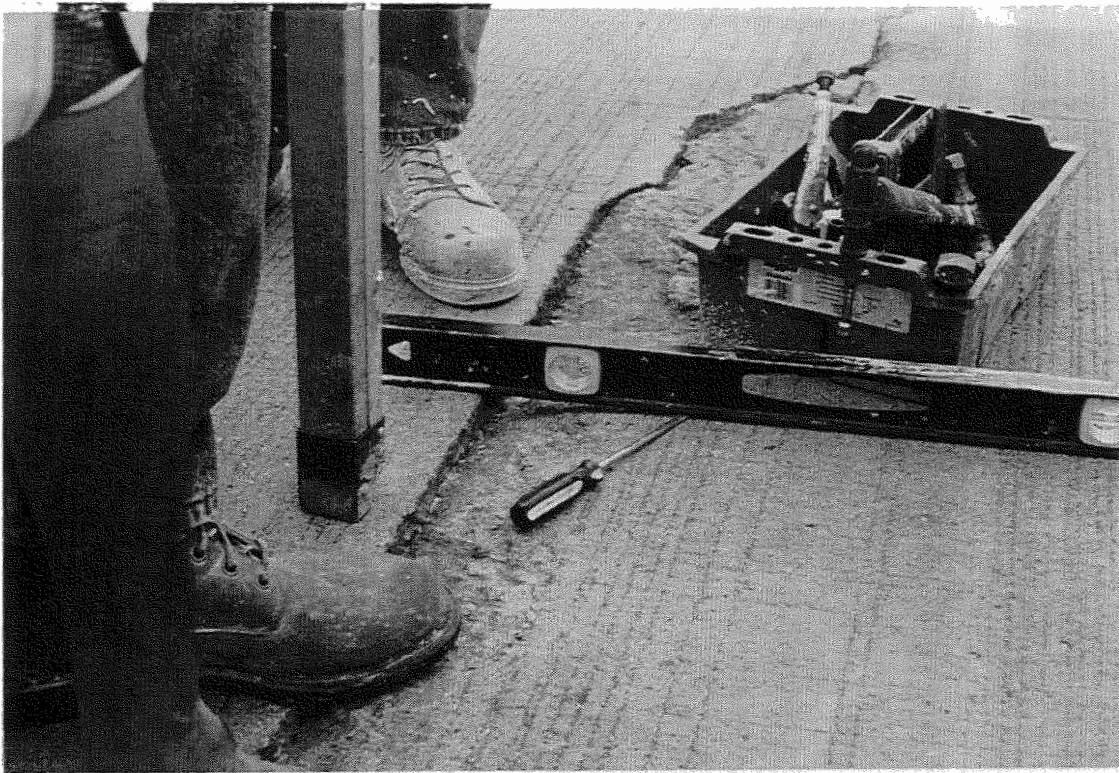
Figure 5. Faulted crack before treatment.

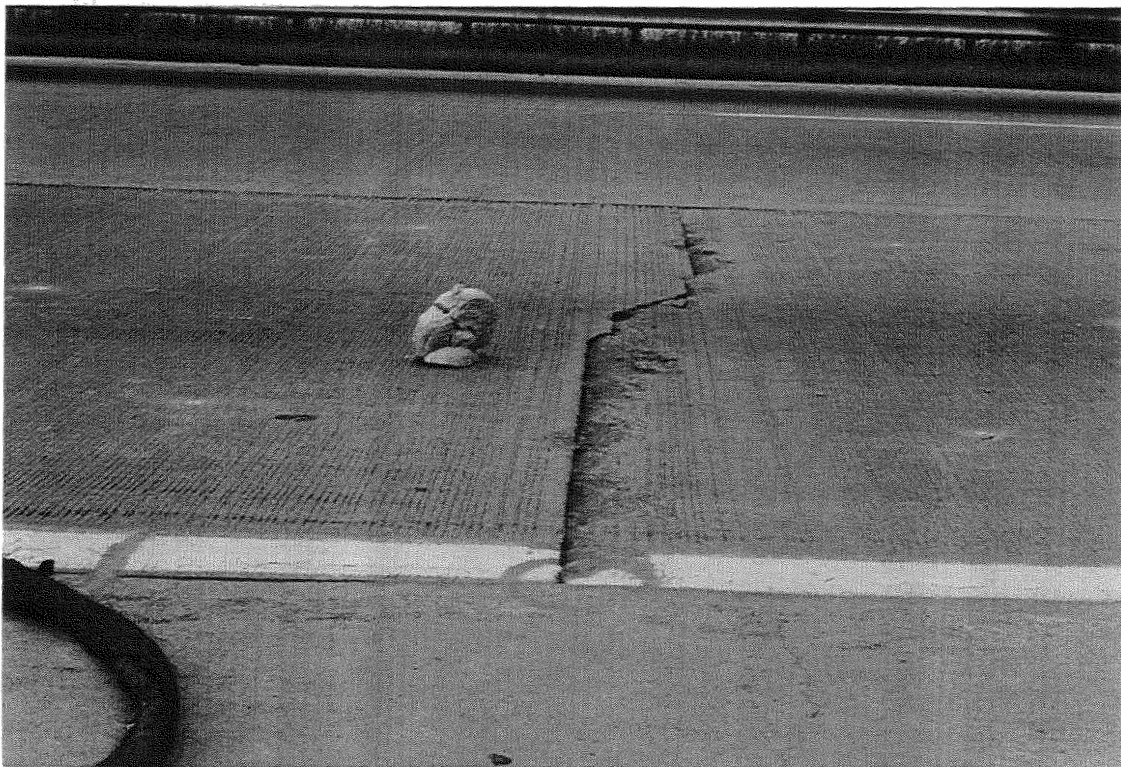
Figure 6. Faulted crack after treatment.

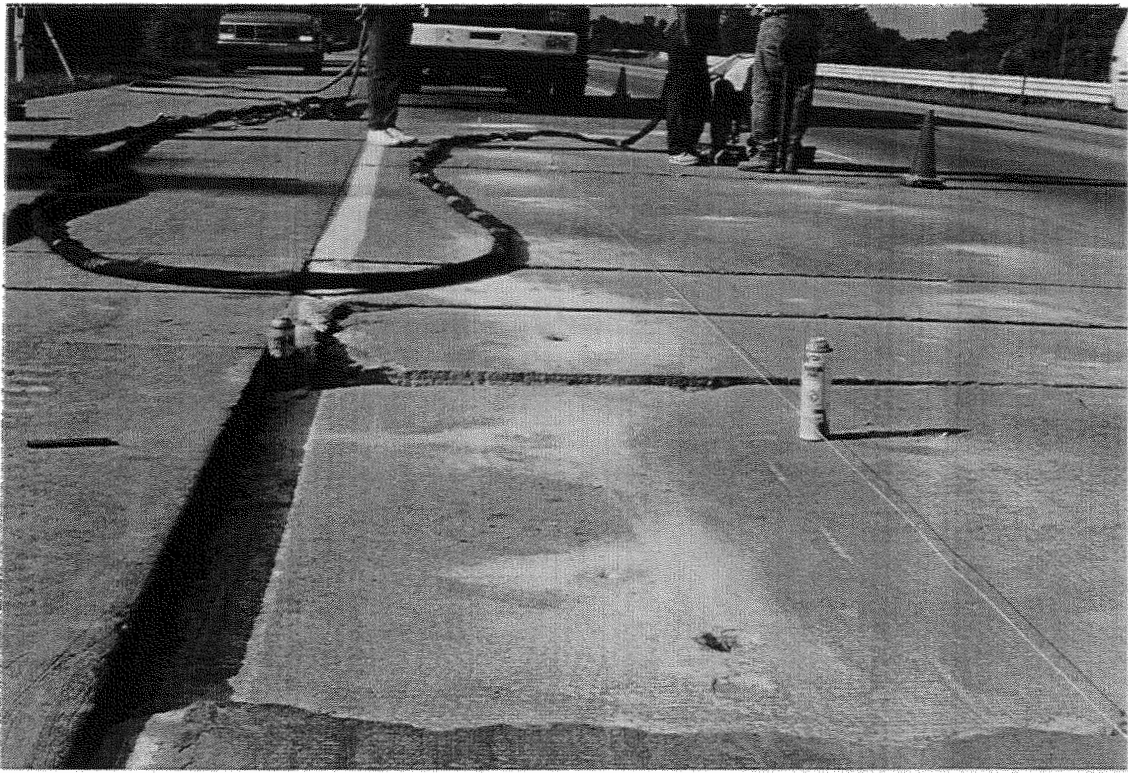
A section of the pavement slab (approximately 25 feet in length) had settled about four inches below the shoulder, indicating the tie bars had failed with no load transfer along the longitudinal joint. The site was stabilized from Sta. 43+01 to 45+06.

Figure 7. Four-inch settlement before treatment.

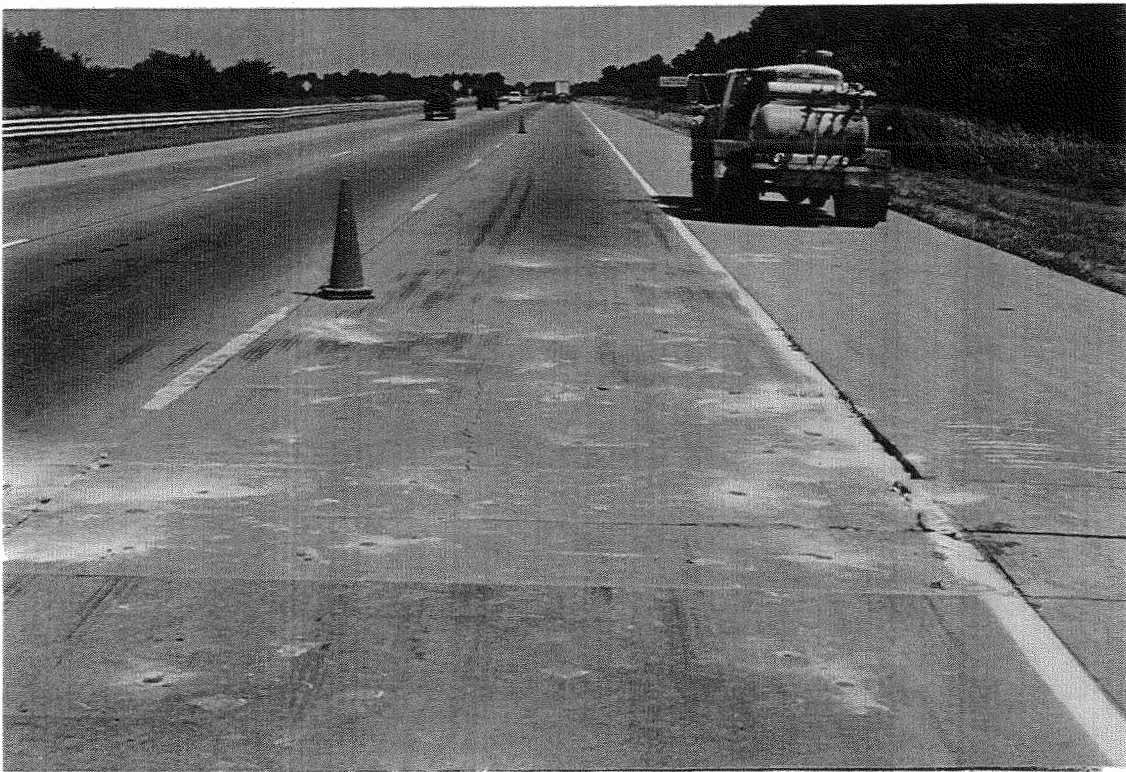
The URETEK method raised the slab back to a reasonable grade until the spring of 1994 when the slab resettled. It was later replaced with a concrete patch. The remaining area of Site 3 preformed similarly to the 1987 project portion of Site 1.

Figure 8. Raised slab after treatment.
