RESEALING OF OLD EXPANSION JOINTS WITH BITUMINOUS-  
RUBBER COMPOUND IN RELATION TO HIGHWAY MAINTENANCE

by  
Bryant W. Peacock  
and  
William Martin

Research Project 36 G-4 (3) F  
in conjunction with  
Research Project 36 G-4 (6)

Research Laboratory  
Testing and Research Division  
Report R-94  
March 14, 1947

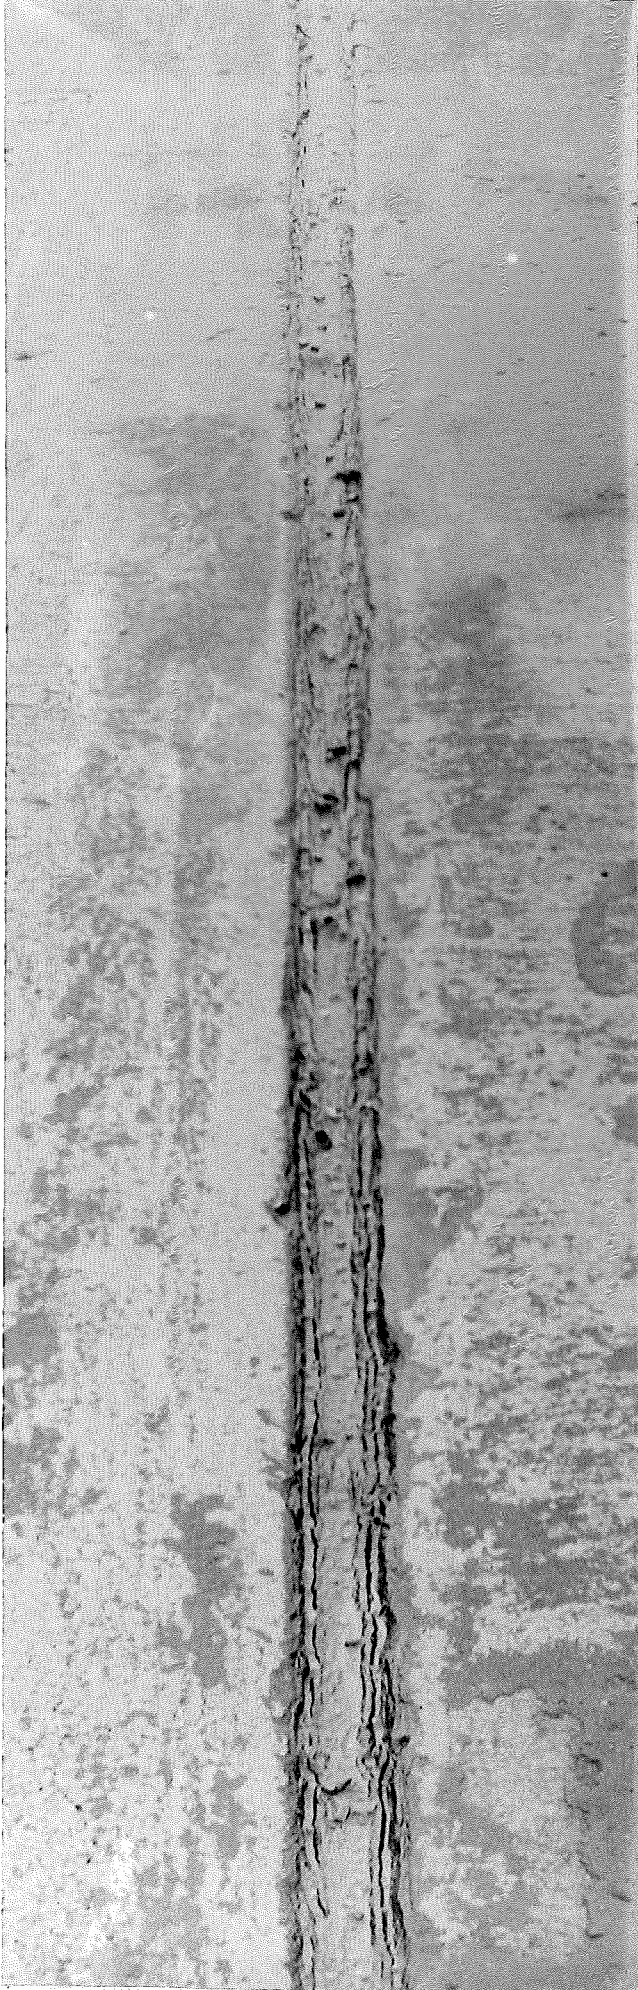
2332

Several interesting facts were brought to light as a result of this survey. For one thing, there were differences among materials. Figure 8, left, taken at Station 288+63, shows the wrinkled surface texture characteristic of all joints in this study which were sealed with material A. This wrinkled condition is quite different from the smooth surface of joints sealed with material C, as shown in the same figure, right, taken at Station 130+98. The surface of joints sealed with B is illustrated in Figures 9 and 10, right, taken at Stations 224+12 and 160+90, respectively. Material B, while wrinkled slightly, is much less so than is true of material A. Also, there appeared to be a greater tendency for stones to become embedded in A than in the other materials (see Figure 9, left, taken at Station 265+62).

Material A, Station 288+63  
No failure.

Figure 8 shows two of the very few joints having no failure in either adhesion or cohesion. The one on the left is material A, that on the right is material C. Figure 11 shows in the case of two different joints one of the most interesting facts brought out by the survey of February 17. These joints are located at Stations 285+61 and 268+62, respectively. They both show that failure in adhesion has occurred mostly along the far side of the joint with respect to the direction of traffic. Figure 9, right, at Station 224+12, shows an exception to this rule, where the seal has pulled away from alternate sides all along the joint. (All photographs were taken looking south.) Another exception is seen in Figure 10, of joints at Stations 177+80 and 160+90. This view shows two pronounced failures in cohesion. The seal on the left of this figure is material A, that on the right is material B.

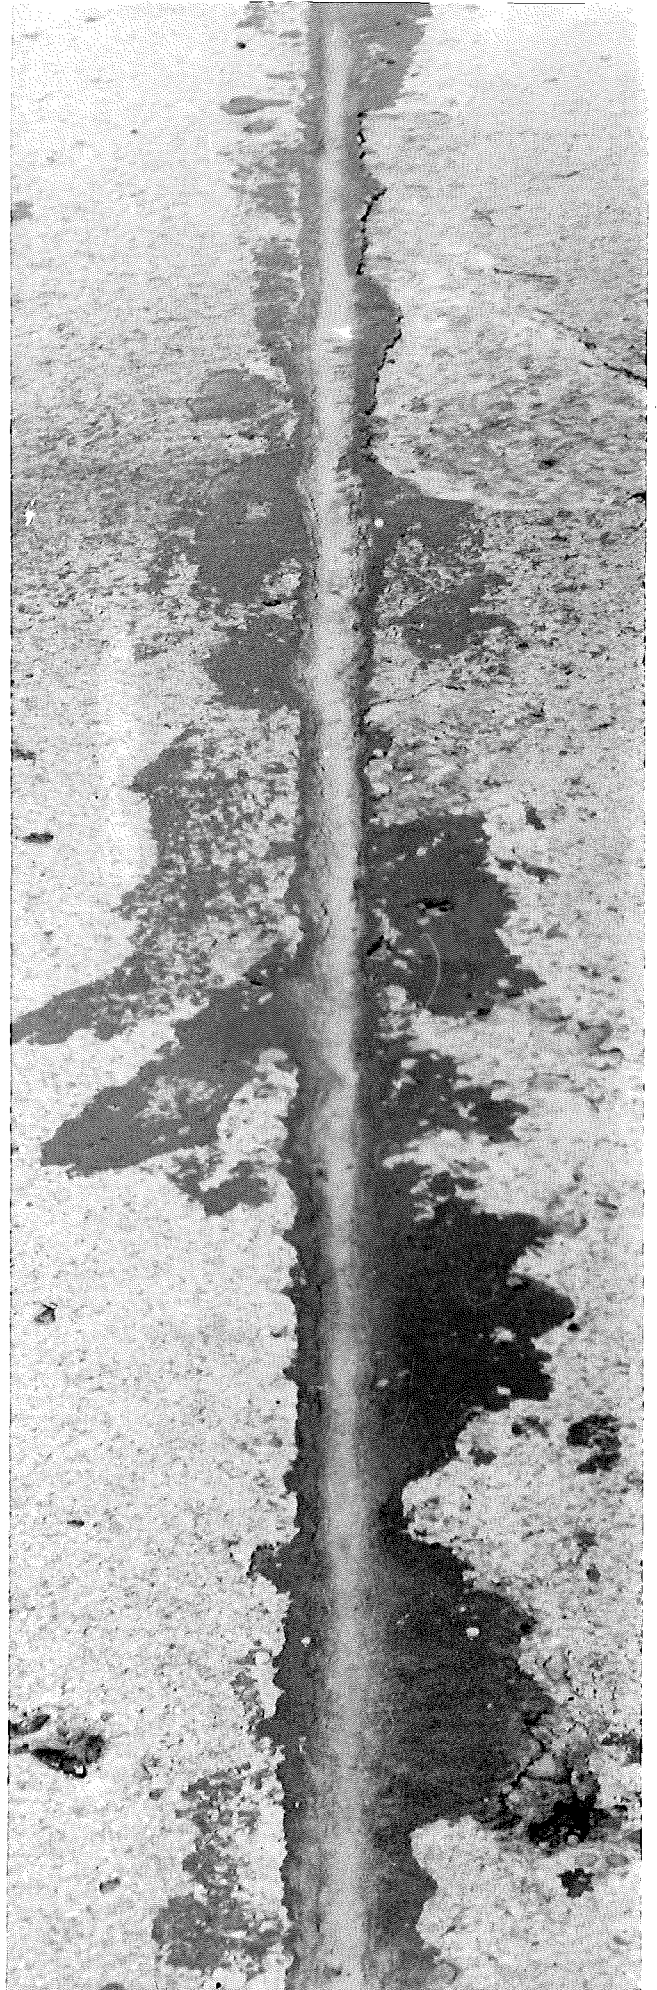
2340

Material C, Station 130+98  
No failure.

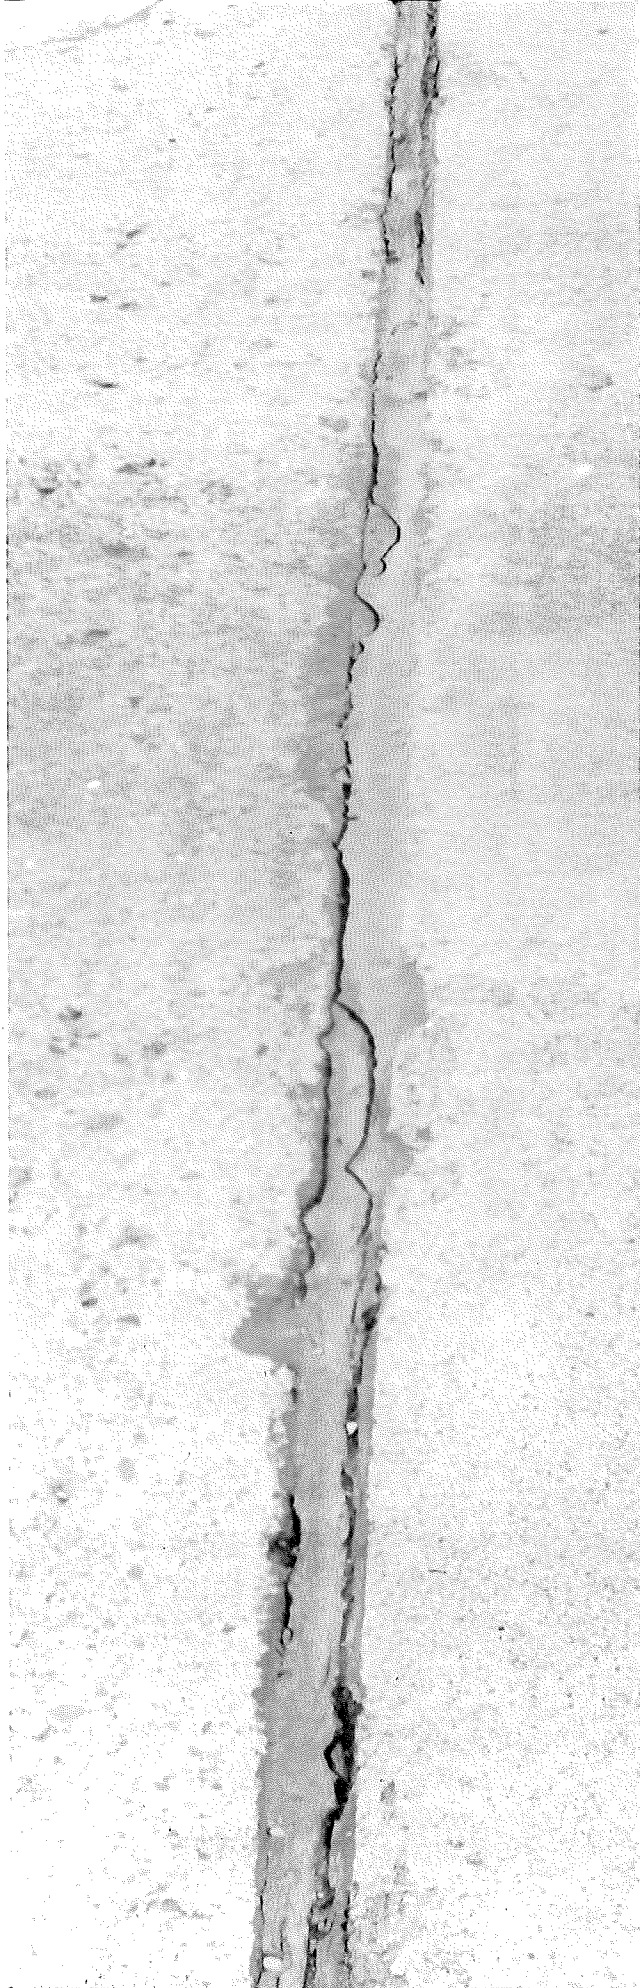
2339

Material A, Station 177+80  
Failures in cohesion.

Failures in cohesion were relatively few in number and extent compared with failures in adhesion, as shown in Table II. Typical of the worst such failures are those illustrated in Figure 10. The total linear footage of cohesion fracture for 294 joints amounted to 0.041 percent, or 2.43 feet

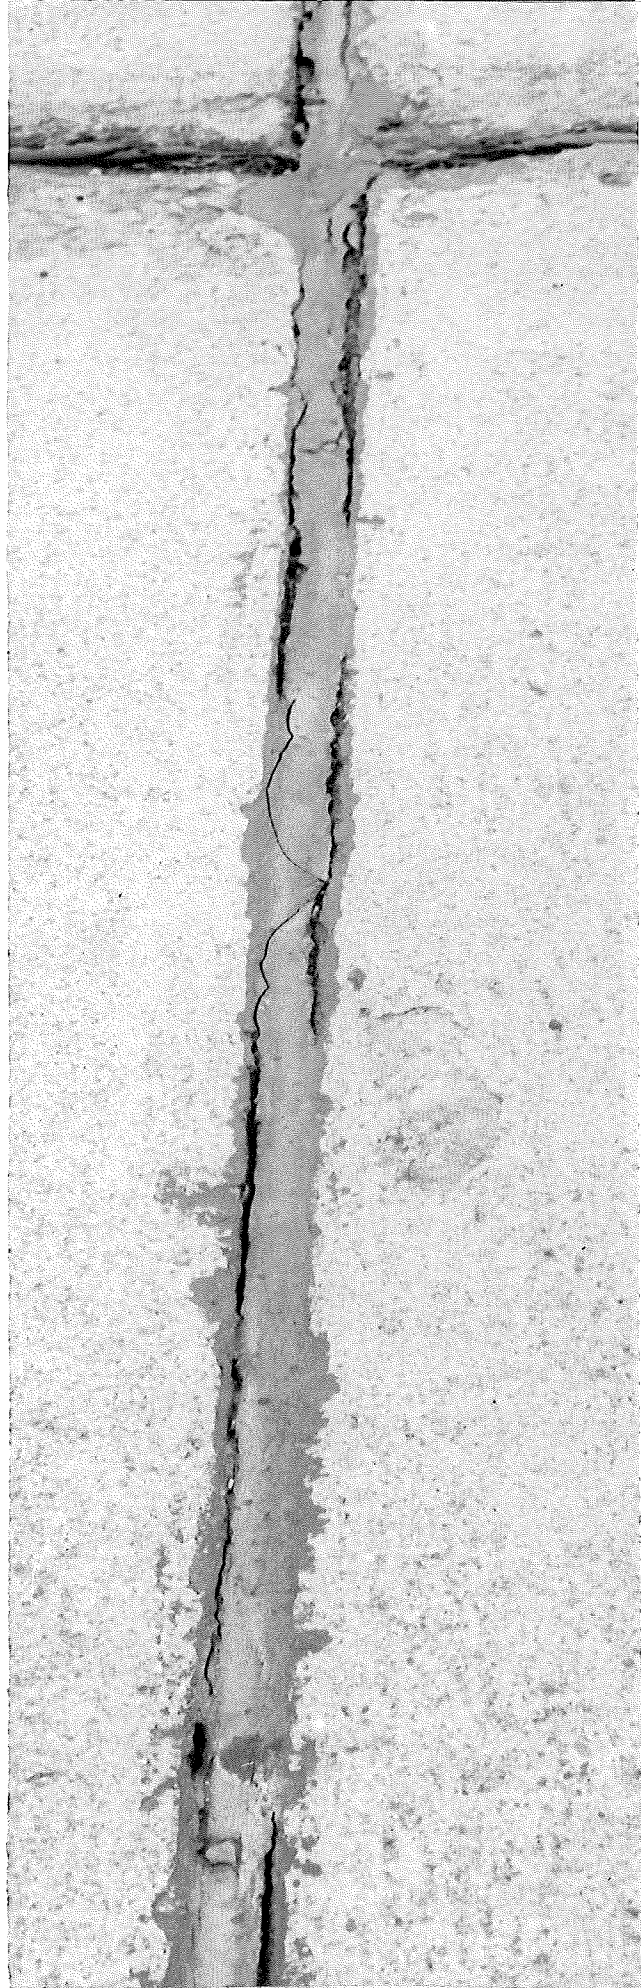
2339a

Material B, Station 160+90  
Failures in cohesion.

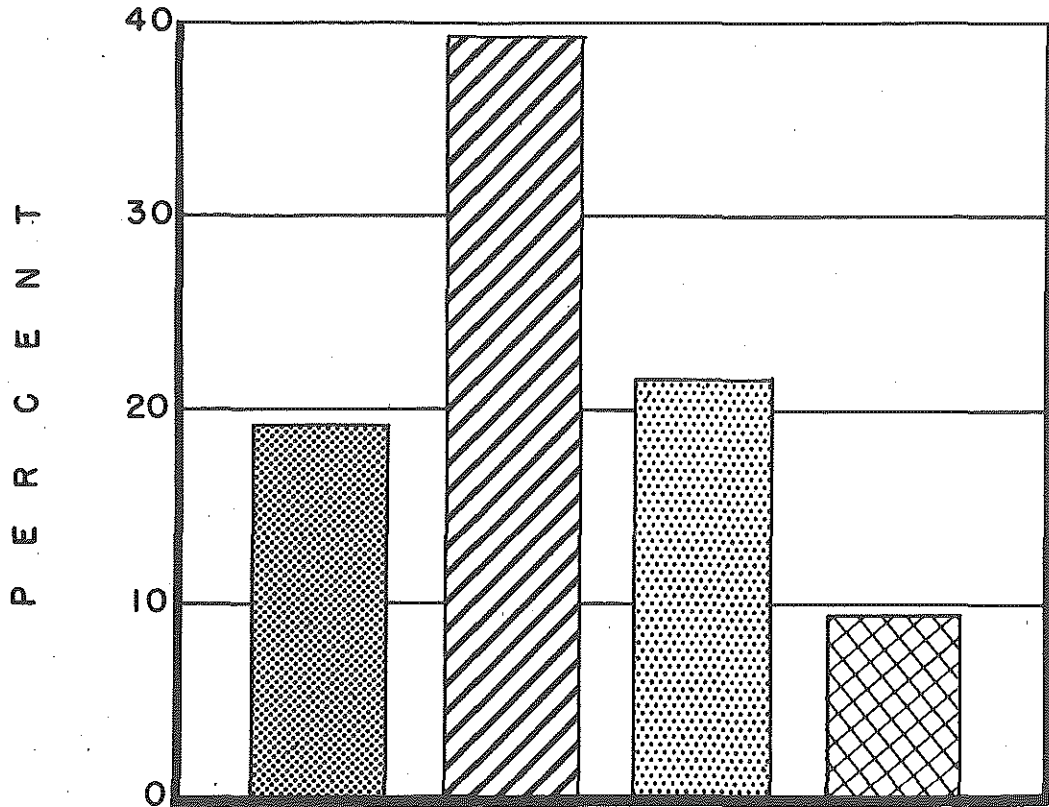
FIGURE XII

Reference to the chart, Figure 12, discloses that the various materials had the following total linear percentages of failure in adhesion on both sides of the joints, based on 40 feet of joint face for each joint:

Material C, 62 joints	9.38%
Material A, 61 joints	19.24%
Material B, 97 joints	21.46%
Material A*, 74 joints	39.14%

\* This comprised the group in section VI, which was not prepared or sealed under supervision by research laboratory personnel. (This means that, in the case of material C, for example, 62 x 40 x 9.38 gives 232.6 linear feet of adhesion failure out of a total of 2,480 feet of total joint face for all of the joints sealed with "C", considering both sides of the joints.)

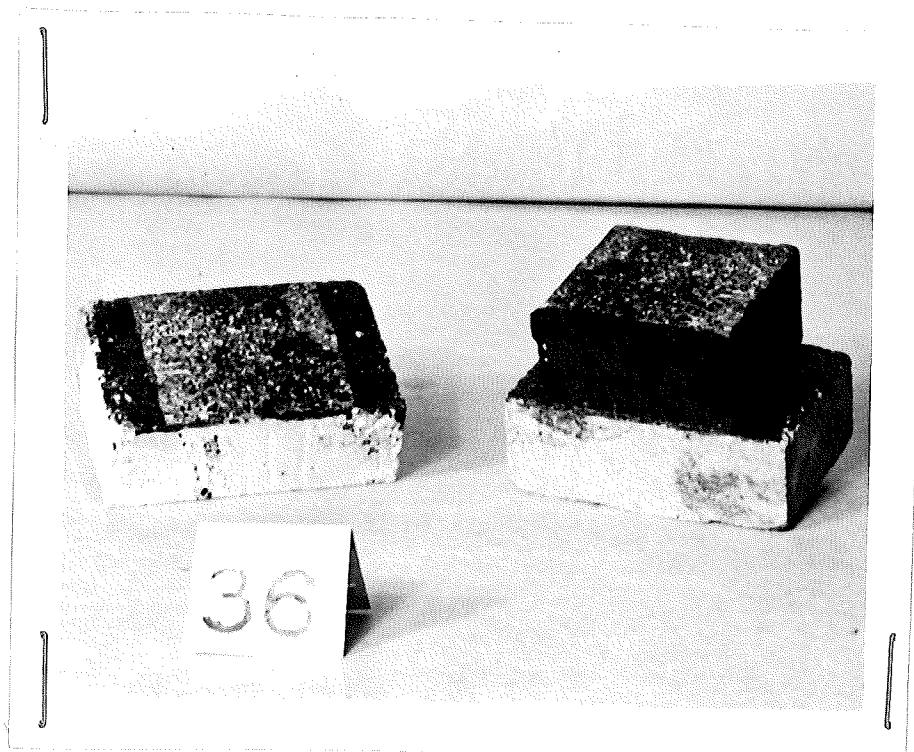
The results in Table III show that material A failed completely in adhesion during the first cycle as illustrated in Figure 14. It may be observed in Figure 14 that approximately 50 percent of the asphalt stain was pulled from the block. Materials B and C showed progressively increasing failure in adhesion during the 5 cycles, material B starting with the first cycle and material C the third. Typical failures of these materials are shown in Figures 15 and 16. Material D showed no failure in five cycles (see Figure 17). This particular material was submitted to the laboratory for examination and has not, to our knowledge, been used on any Highway work in Michigan. Material D, likewise, passes Federal Specification requirement SS-F-336.

Figure 14. Bond specimen material A, block stained with asphalt. Failed 100% during first cycle of extension at 0 degrees F. Note approximately half thickness of asphalt stain pulled off block.

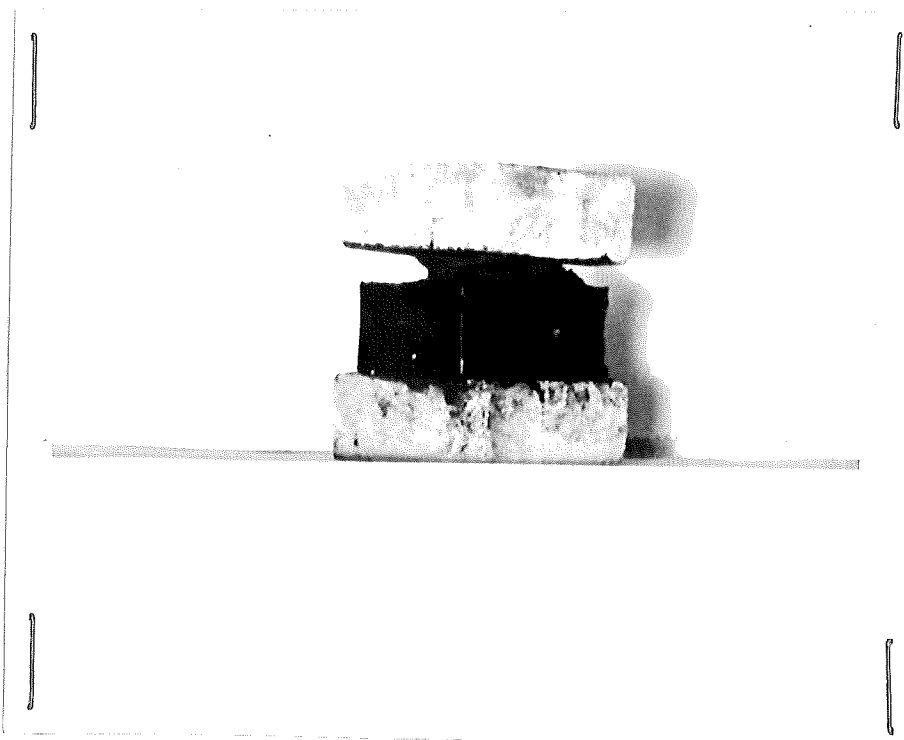
Figure 15. Bond specimen, material B, block stained with asphalt. Shows approximately 80% failure after 5 cycles of extension at 0 degrees F.

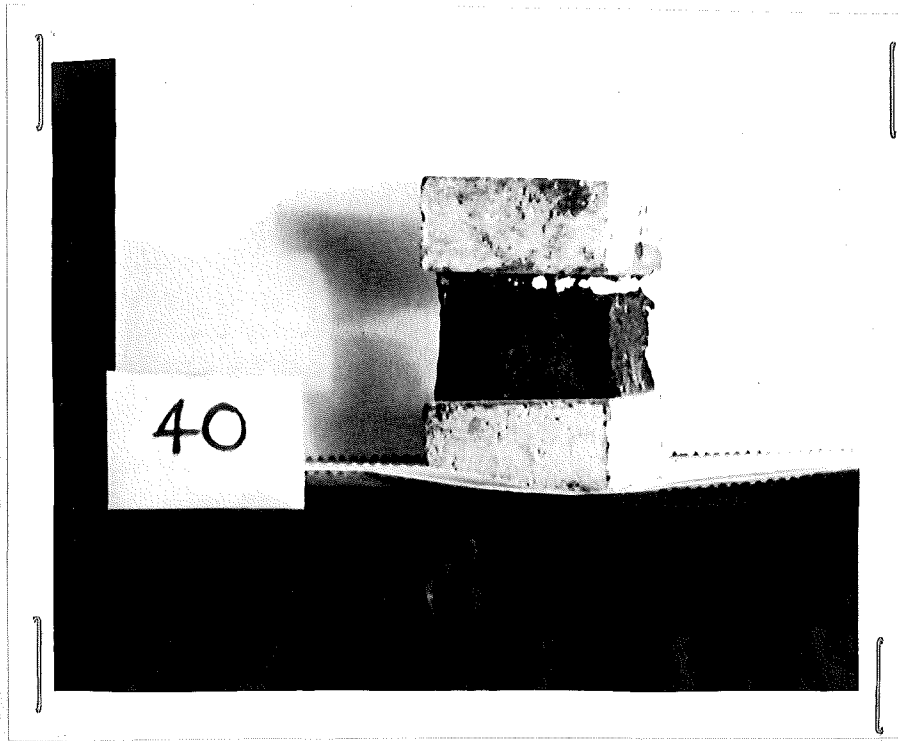
Figure 16. Material C during bond test at 0 degrees F. using asphalt-stained blocks. Shows 90% failure in adhesion after fourth cycle.

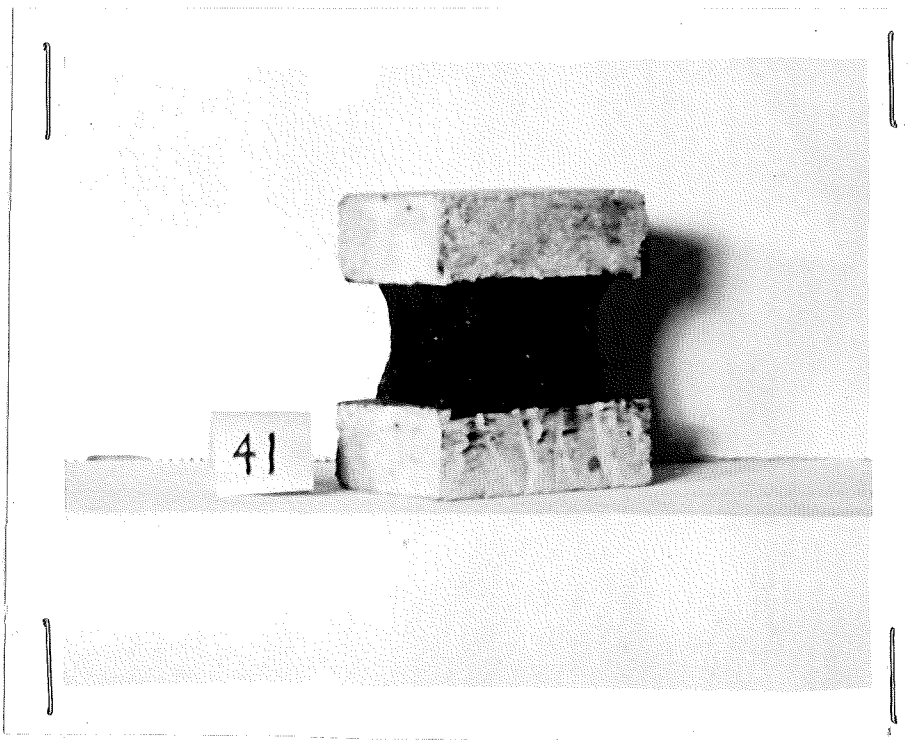
Figure 17. Material D showing condition at conclusion of bond test at 0 degrees F. using asphalt-stained blocks. Material passed 5 cycles of extension with no failure.
