R-319

1959 ROAD TEST ON 1,000 GALLONS OF  
3M CENTERLITE PREBEADED WHITE TRAFFIC PAINT

Research Laboratory Division  
Office of Testing and Research  
Report No. 319  
Research Project 47 G-36(12b)

Michigan State Highway Department  
John C. Mackie, Commissioner  
Lansing, December 1959

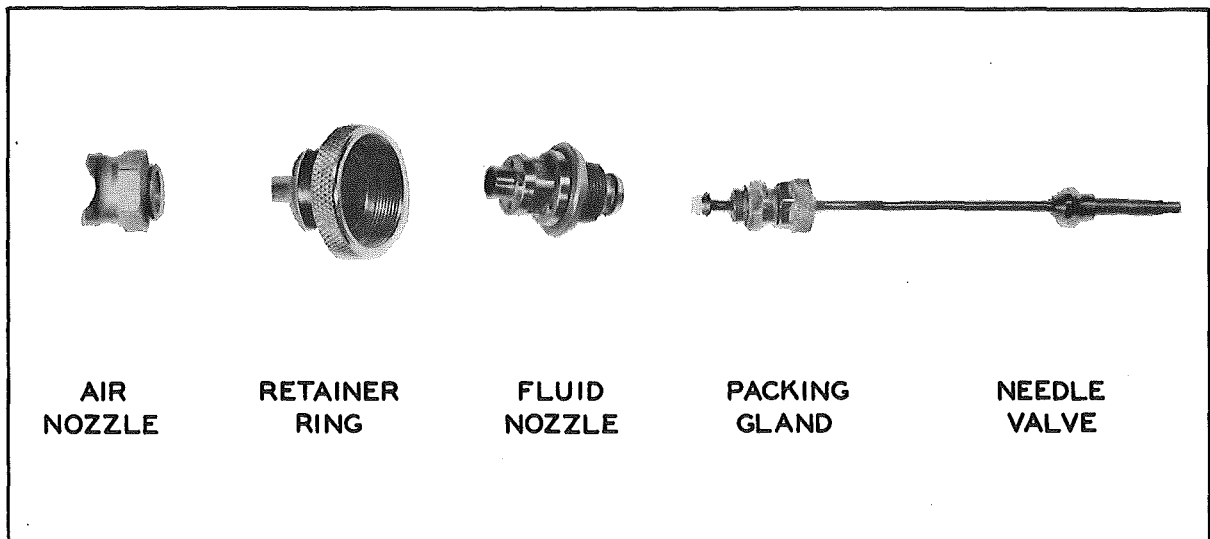
Figure 2. Gun parts subject to wear and replacement.

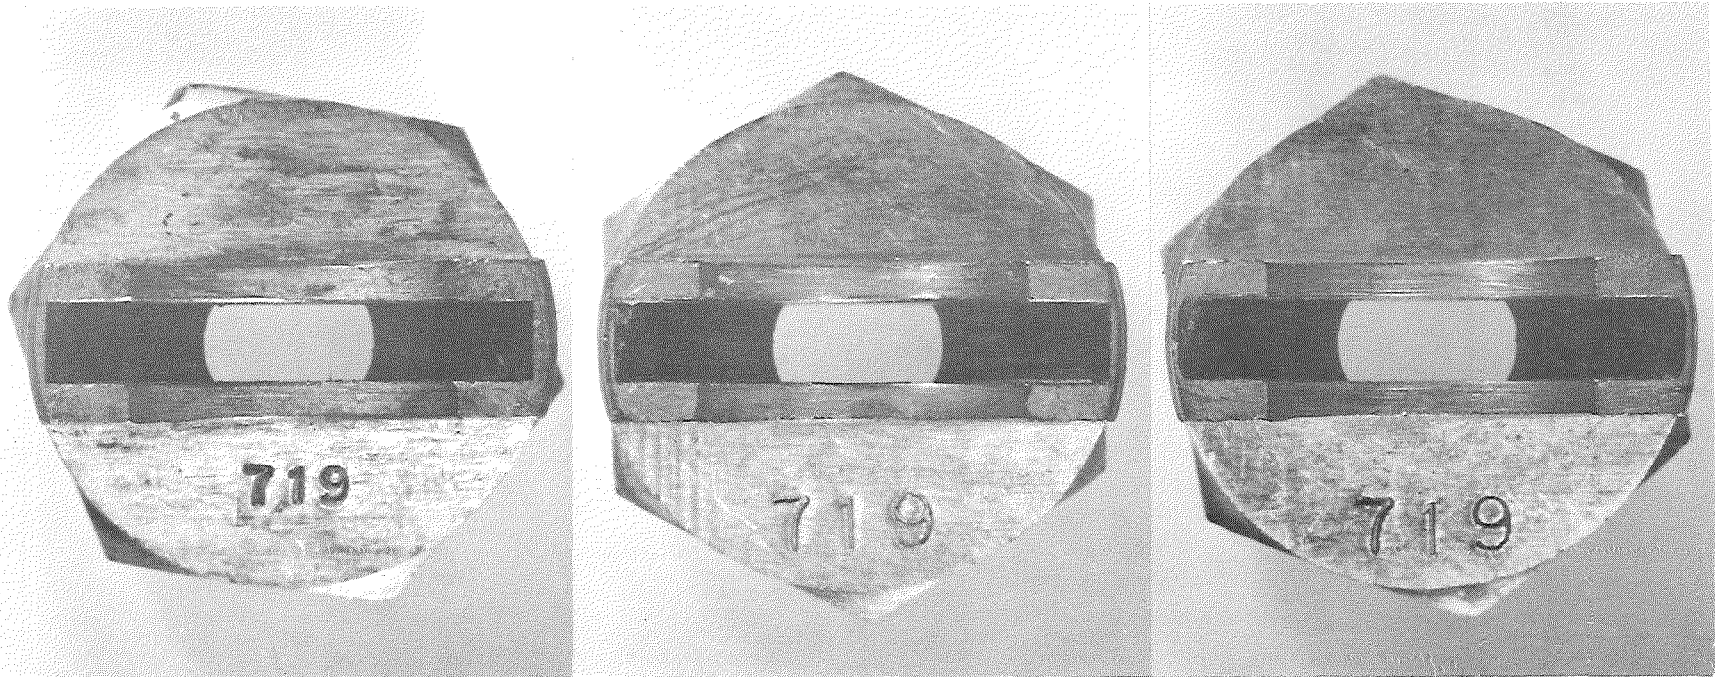
Fig. 3 provides a comparison of spray gun air nozzles when new, after spraying 1,000 gal of unbeaded specification paint, and after spraying 1,000 gal of beaded test paint. The nozzle used to spray the unbeaded paint shows no evidence of wear on the round center channel, and a 2-percent lengthening of fanned orifice. The nozzle used for spraying an equal amount of beaded test paint shows some wear on the round center channel

Figure 3. Spray gun air nozzles when new (left), after spraying 1,000 gal of unbeaded control paint (center), and after spraying 1,000 gal of beaded test paint (right).

(14percent enlargement of area by measurement), and a 5-percent lengthening of fanned orifice.

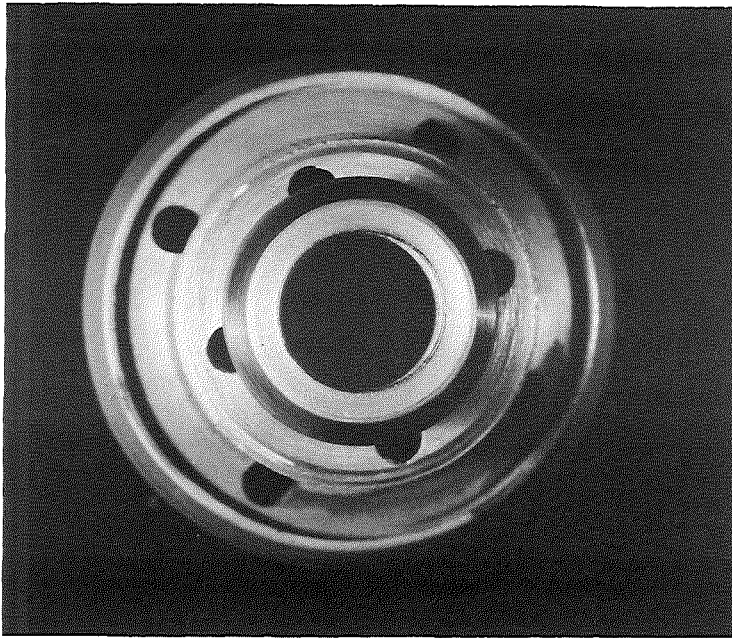
Fig. 4 shows the fluid nozzle after spraying 1,000 gal of the unbeaded control paint as standard skip centerline. The center round channel (paint channel) shows no significant wear at the shoulder, or valve seat, which contacts the needle valve when closing off the paint flow. The fluid nozzle used for beaded test paint was in similar condition, indicating that service life of a fluid nozzle is considerably greater than 1,000 gal of paint of either type.

▲ Figure 4. Spray gun fluid nozzle showing paint channel (center) with shoulders serving as valve seat, after spraying 1,000 gal of unbeaded control paint.

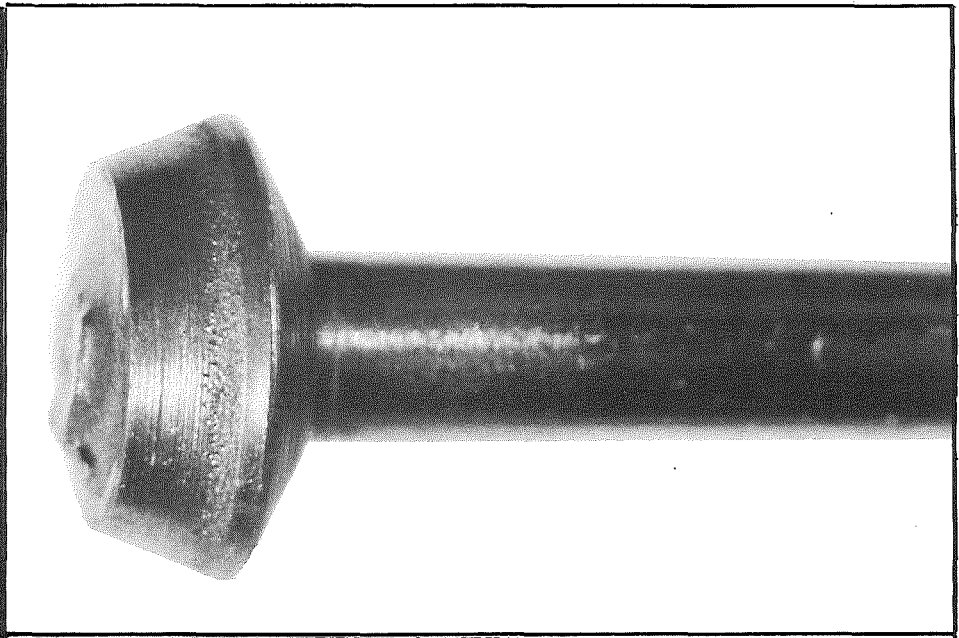
Fig. 5 shows the test gun needle valves after spraying 1,000 gal of each paint. Both valve tips show wear by pitting where valves made contact with the fluid nozzle during paint shutoff. Comparison indicates that the pitting is deeper and covers a larger area on the valve handling the prebeaded paint. In neither valve was the wear sufficient to allow dripping, and therefore need replacement during the 1,000-gal tests. A polished area may be noted on the stem of the needle valve used for beaded test paint, beginning about 1/2-in. above the tip; this area represents the portion passing through the packing gland which the 3M Co. in its report "Highway Spray Gun Wear Tests" admitted was the only area where wear was appreciably greater when spraying its prebeaded paint. However, in the Department's tests, the striping crew did not report having any trouble making adjustments on the packing gland surrounding the polished area of the stem.

▶ Figure 5. Needle valves after spraying control paint (top) and test paint (bottom), showing stem wear caused by the prebeaded test paint.
