EARLY CRACKING OF A
BITUMINOUS CONCRETE SECTION
OF US 2 LOCATED IN DISTRICT 2

E. C. Novak, Jr.

Research Laboratory Section
Testing and Research Division
Research Project 81 TI-776
Research Report No. R-1191

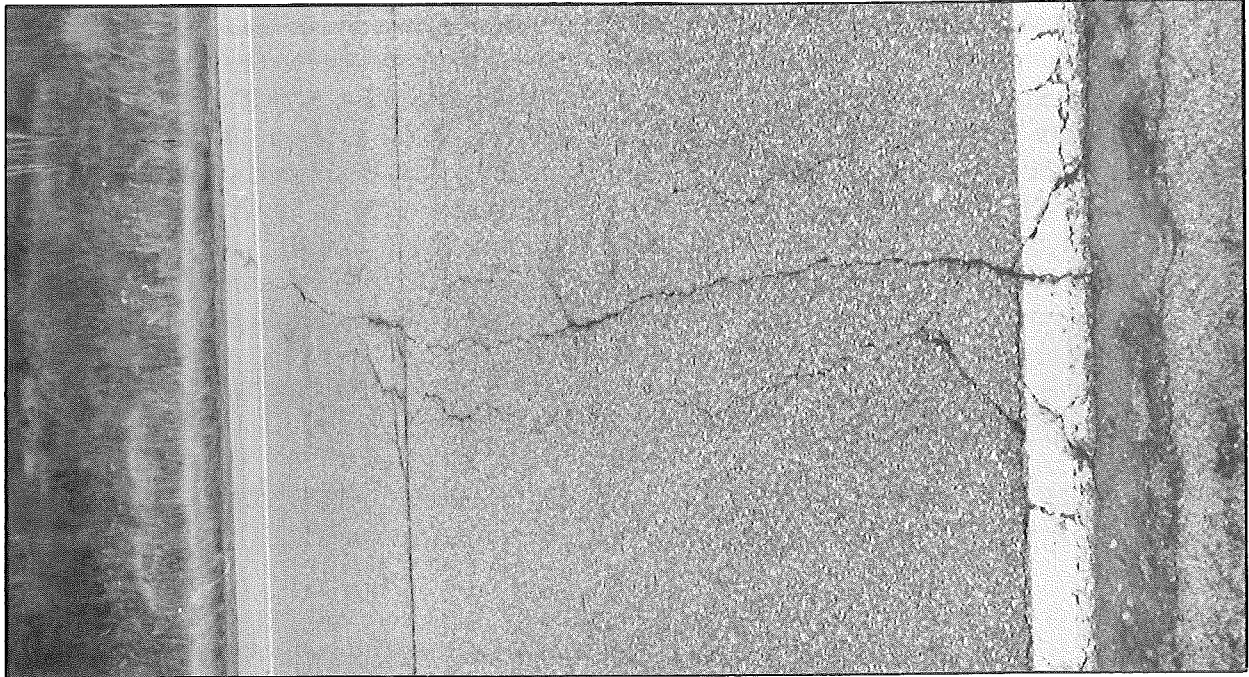
2) Alligator cracking in the vicinity of transverse and longitudinal cracks and at the pavement's edge (Figs. 2 through 4) - Much of the pavement is subject to this distress form, indicating the base layer is, for much of the roadway, subject to volume change and loss of strength as a result of frost action.

Figure 2. Alligator cracking and depressed pavement surface is associated with transverse cracks and is caused by frost action in the base and loss of base fines during periods of thaw.

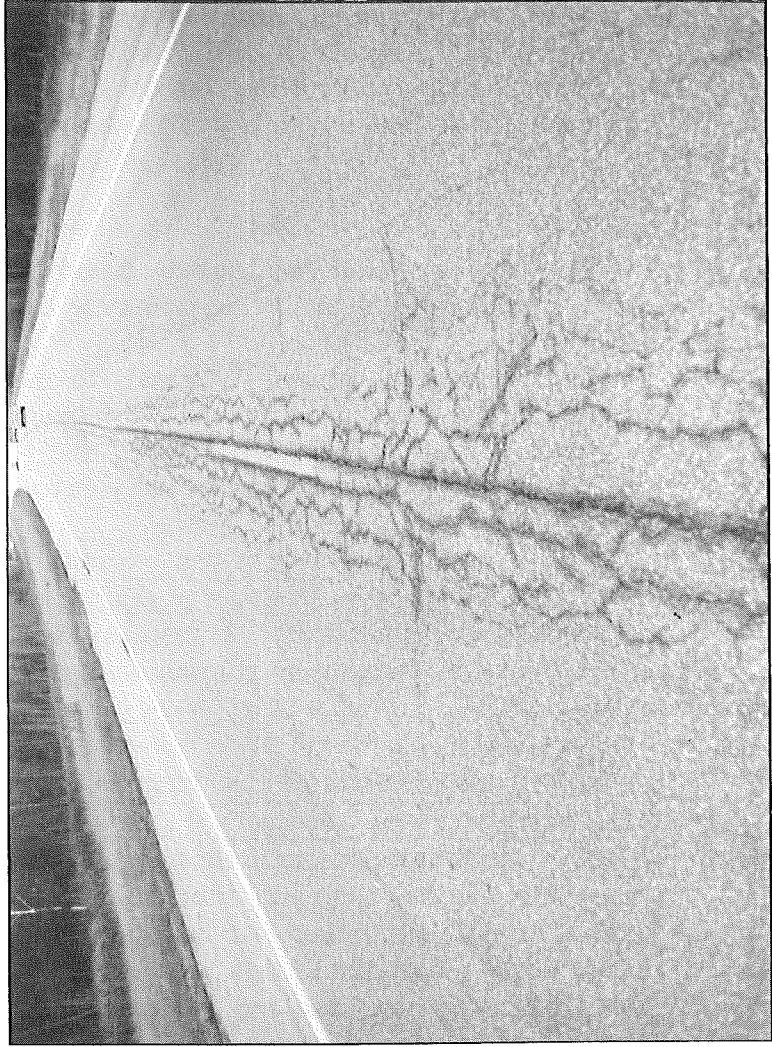
Figure 3. Alligator cracking along centerline construction joint caused by frost action in base.

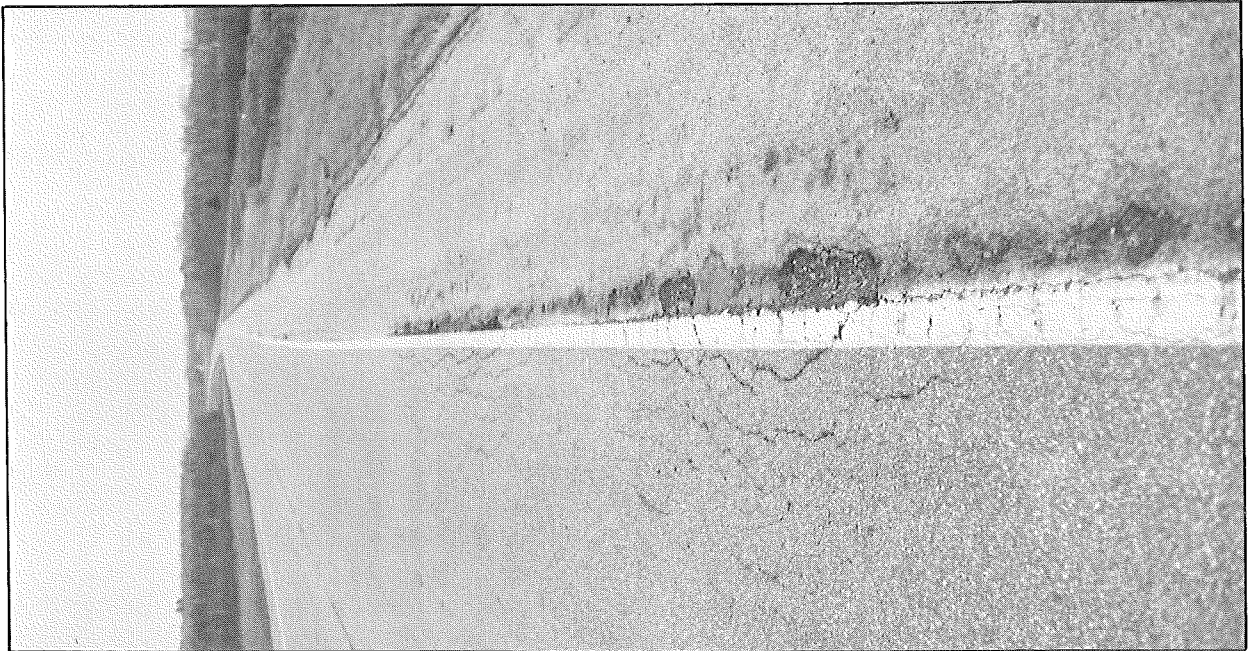
Figure 4. Alligator cracking at pavement edge caused by frost action in base, accompanied by loss of lateral support on thawing.

Another load capacity problem is that the base has inadequate lateral support during spring thaw periods due, principally, to infiltration of surface water at the pavement/shoulder joint. This results in alligator cracking of the pavement edge and, in more severe cases, short pothole-like depressions are formed.

6) Any rehabilitation scheme should consider full-depth shoulders to improve base confinement and to prevent surface water infiltration at the pavement/shoulder interface. In this respect, specifications should require there be no construction joints between the outside edge of shoulder and the pavement centerline. Other advantages of full-depth shoulders are that they reduce shoulder maintenance costs and facilitate future life cycle renewal.

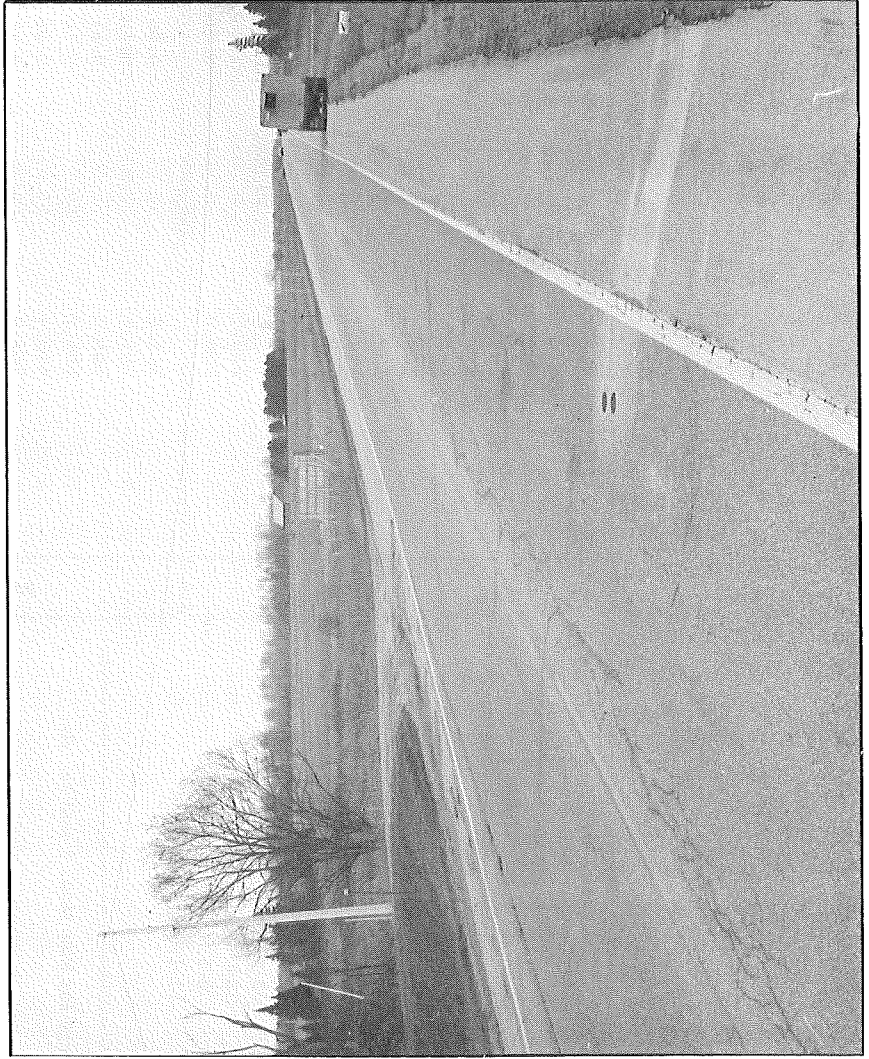
3) A band of alligator cracking occurring between the pavement centerline and the inner wheelpath - The exact cause of this form of cracking could not be definitely established, but it appears to be associated with the area where the two base and subbase layers abut. A scenario of how this form of cracking is believed to have occurred is as follows. Because traffic had to be maintained, this reconstruction was done one lane at a time. Thus, when the new base and subbase layers were placed for the second lane segment, complete consolidation of the longitudinal interface between the base and subbase sections of the first and second lanes was difficult to attain. This left a 'construction joint' area a foot or two to the side of the centerline of the pavement surface and it is an area that is difficult to adequately compact. Under traffic load, this area of the pavement was subject to a small amount of additional consolidation. The differential movement of the surface was enough to cause longitudinal cracks to form in areas of greatest movement. The presence of longitudinal cracks, which admit surface water, combined with the frost susceptible properties of the base, cause seasonal base weakening to occur and resulted in localized alligator cracking as shown in Figure 5.

Figure 5. Alligator cracking between pavement centerline and the inner wheelpath is associated with the foundation construction joint. This distress is believed to be associated with inadequate compaction in the joint area.

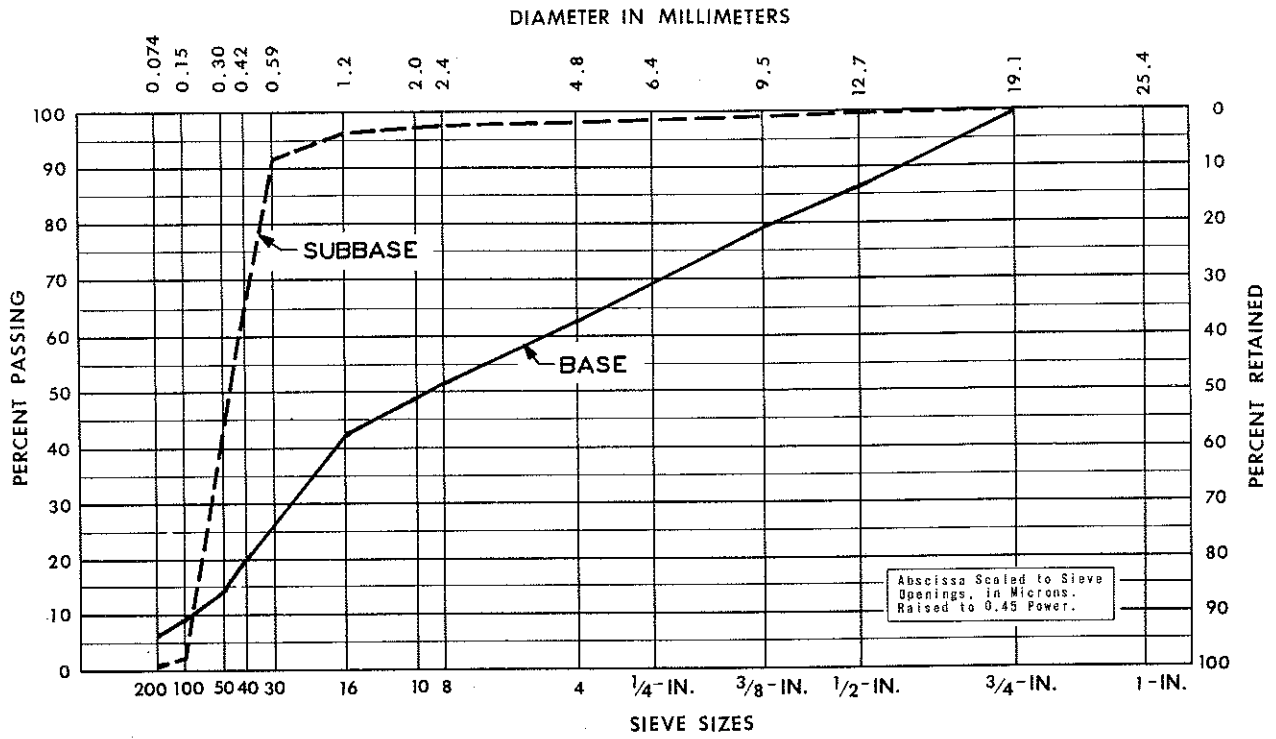
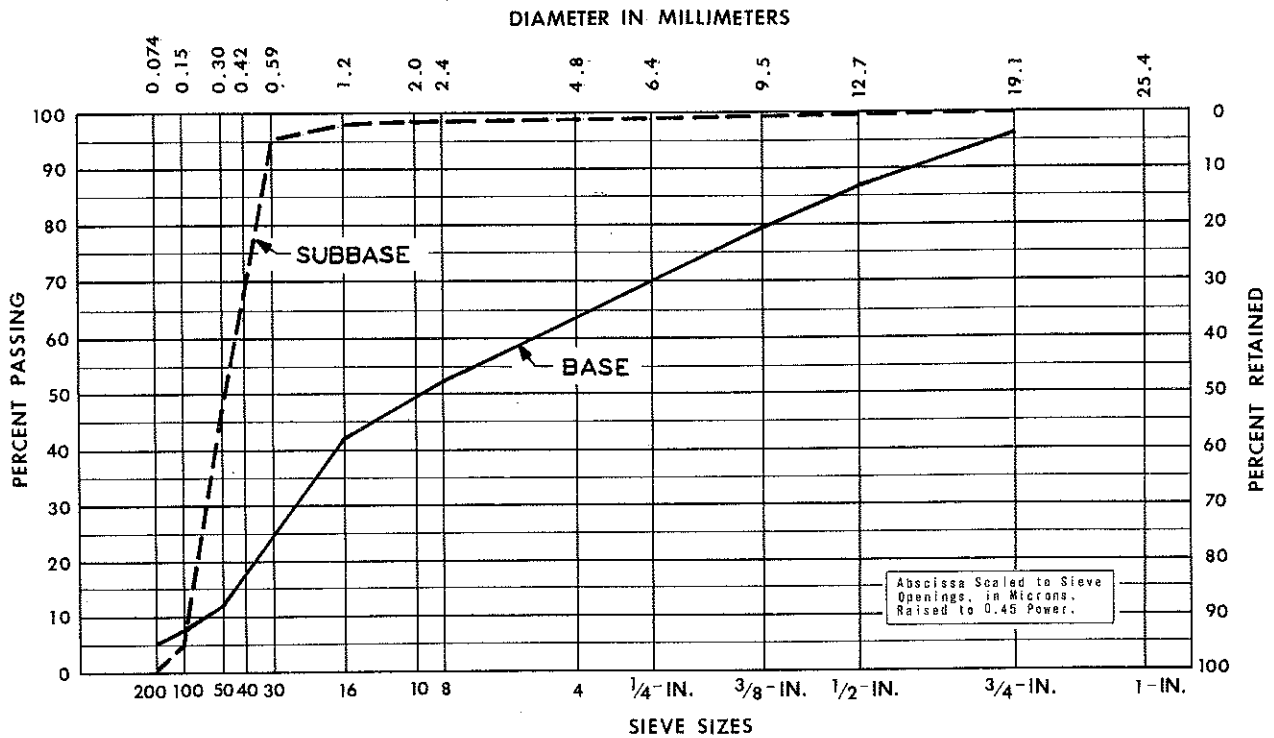
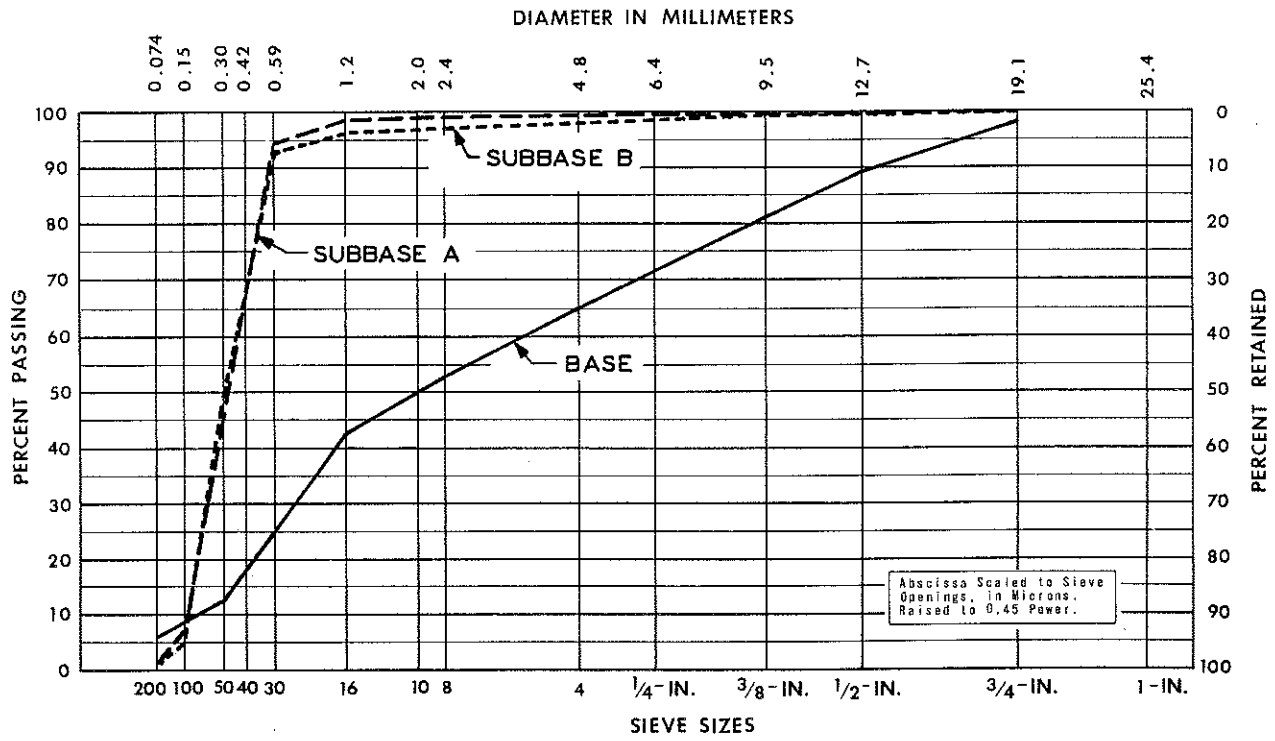
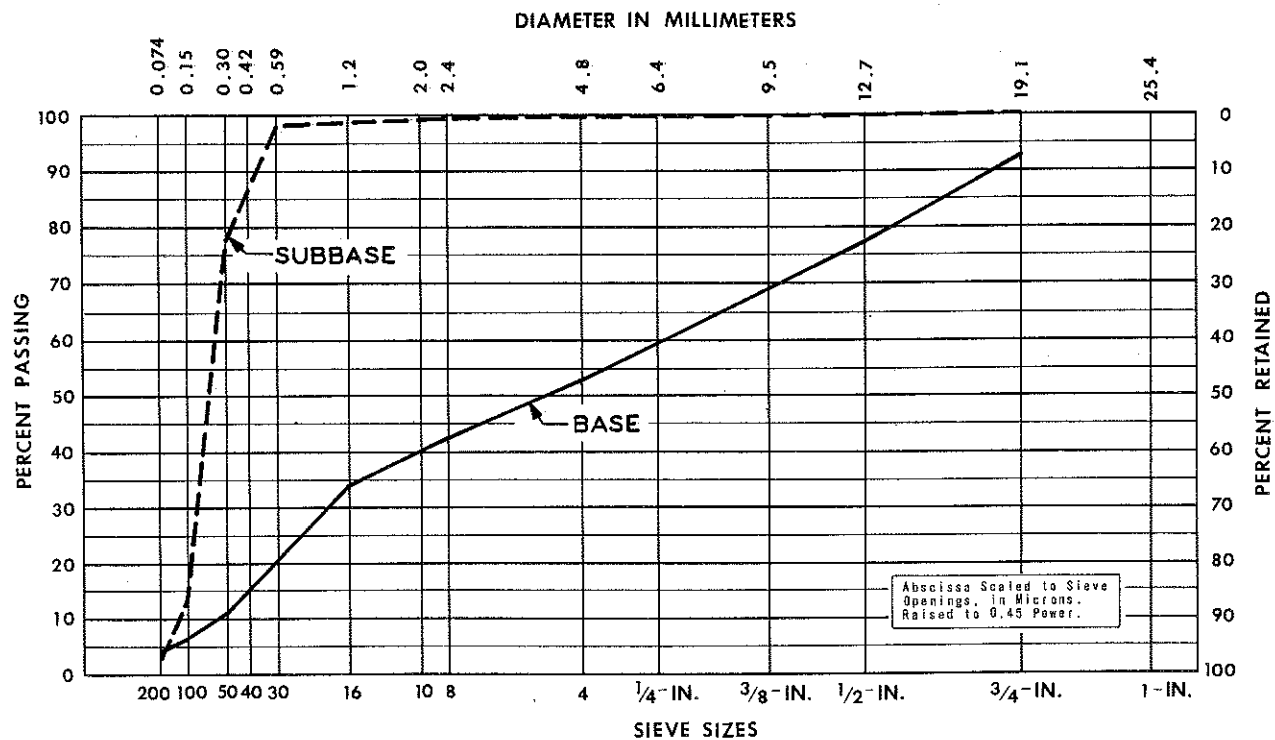
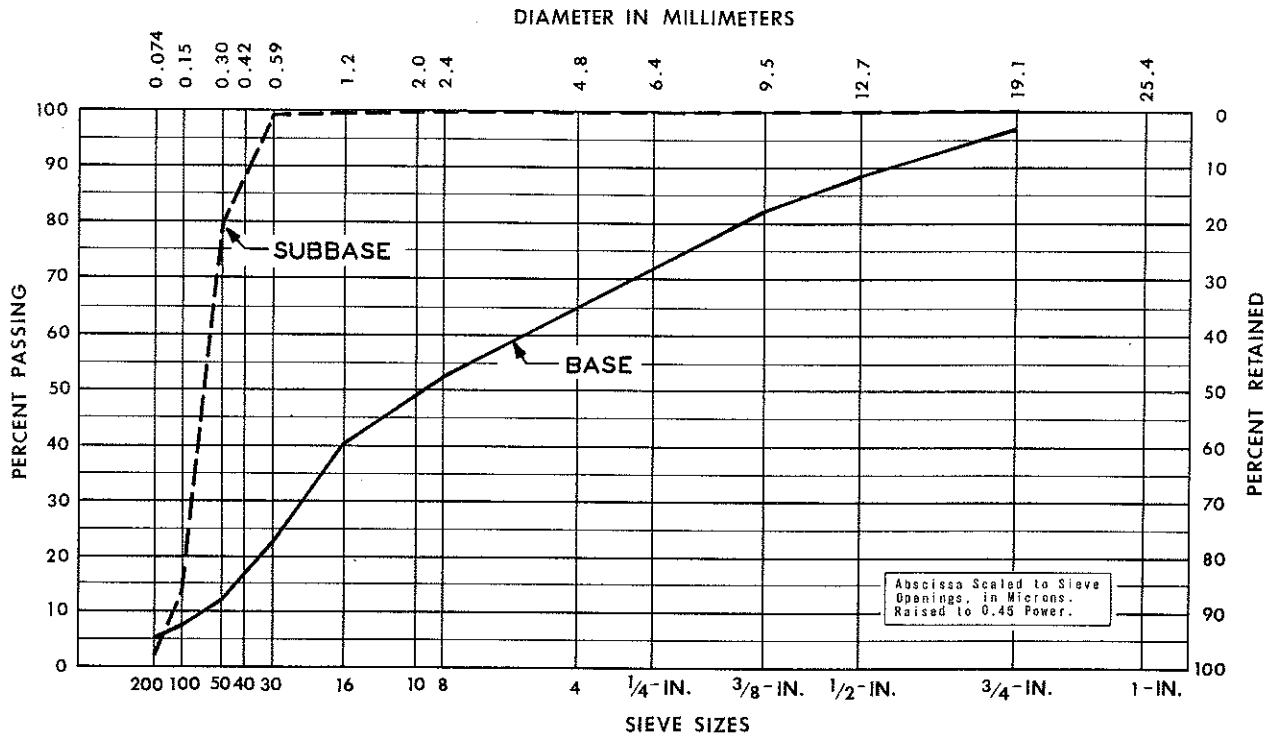
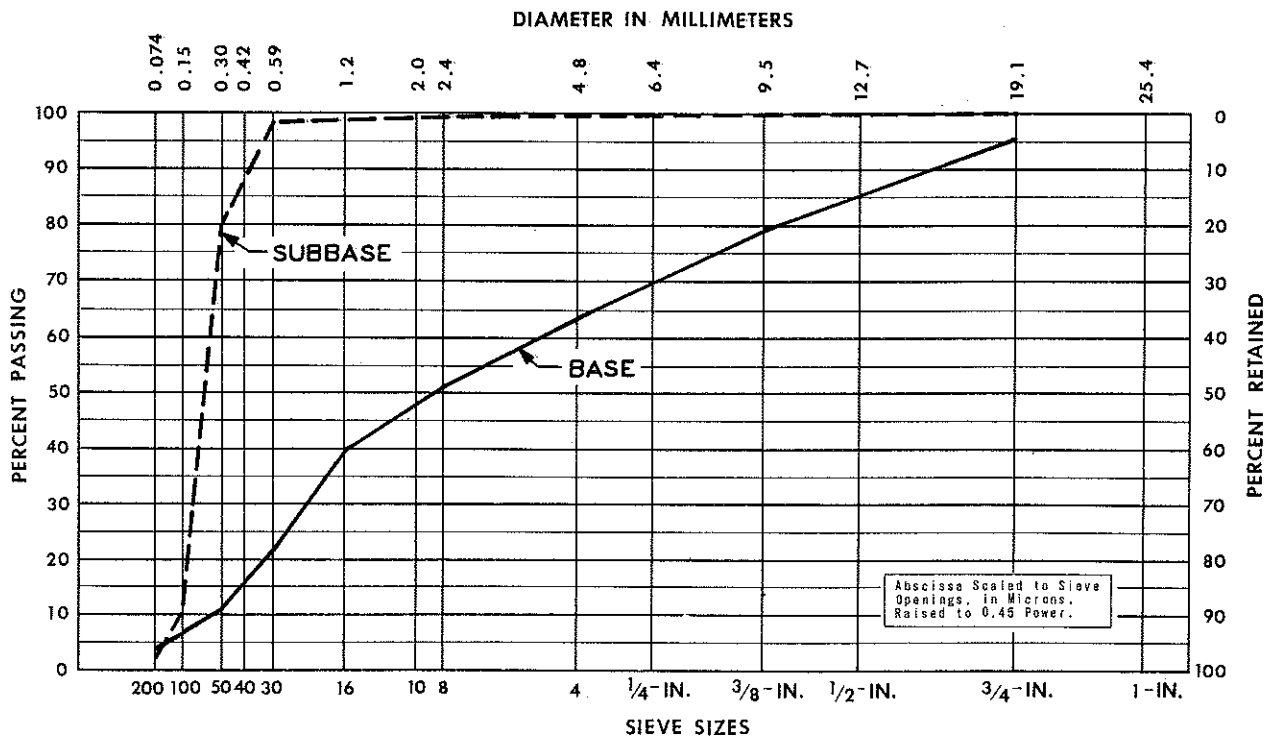
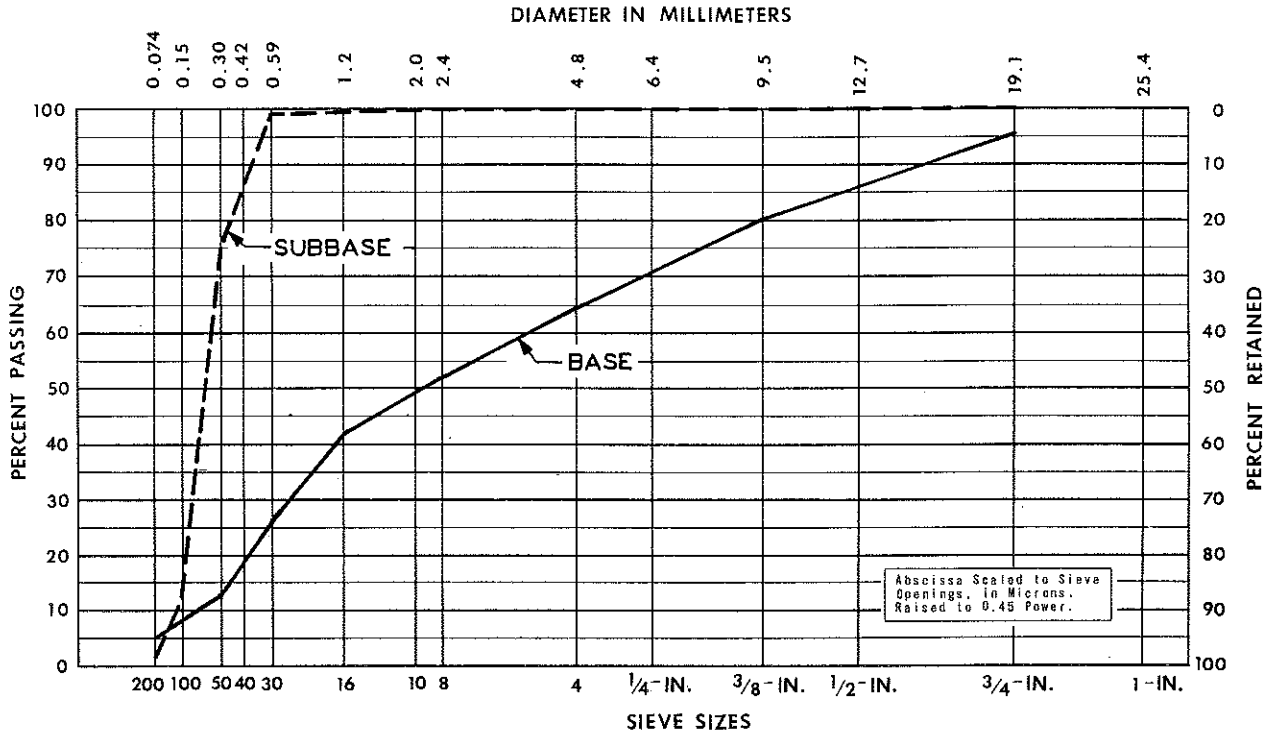
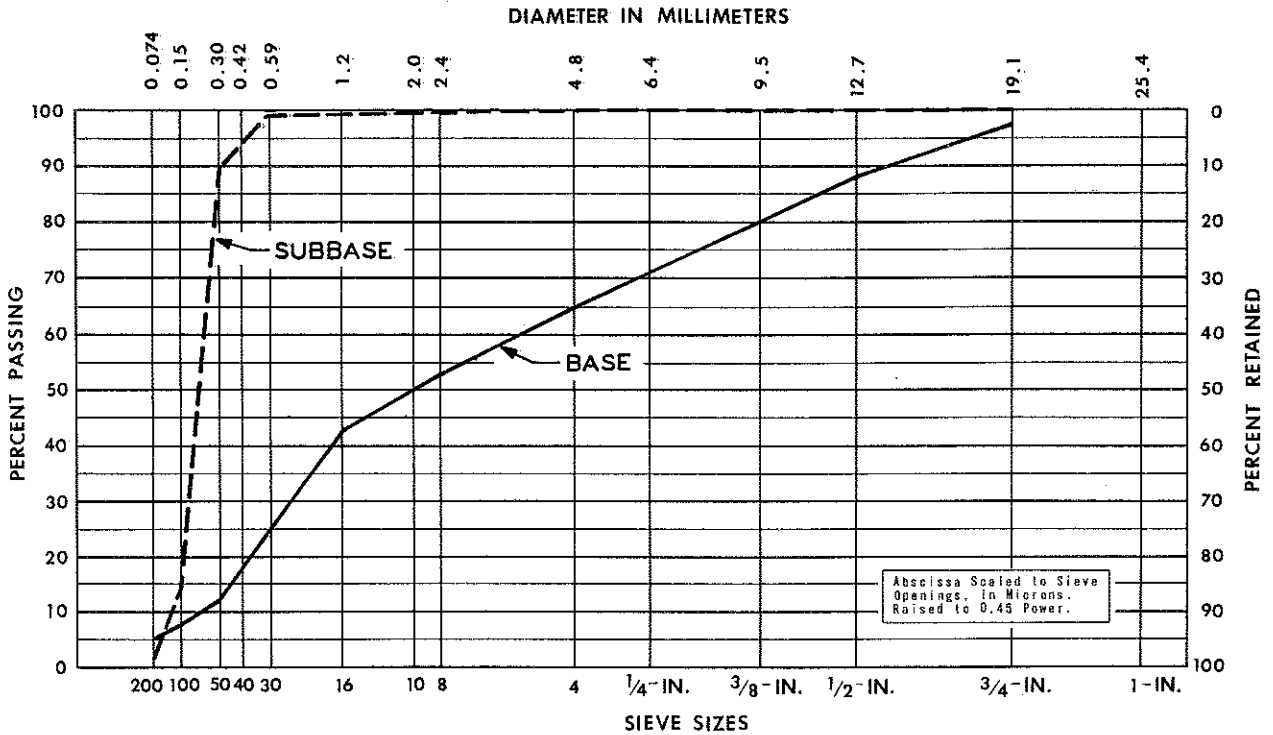
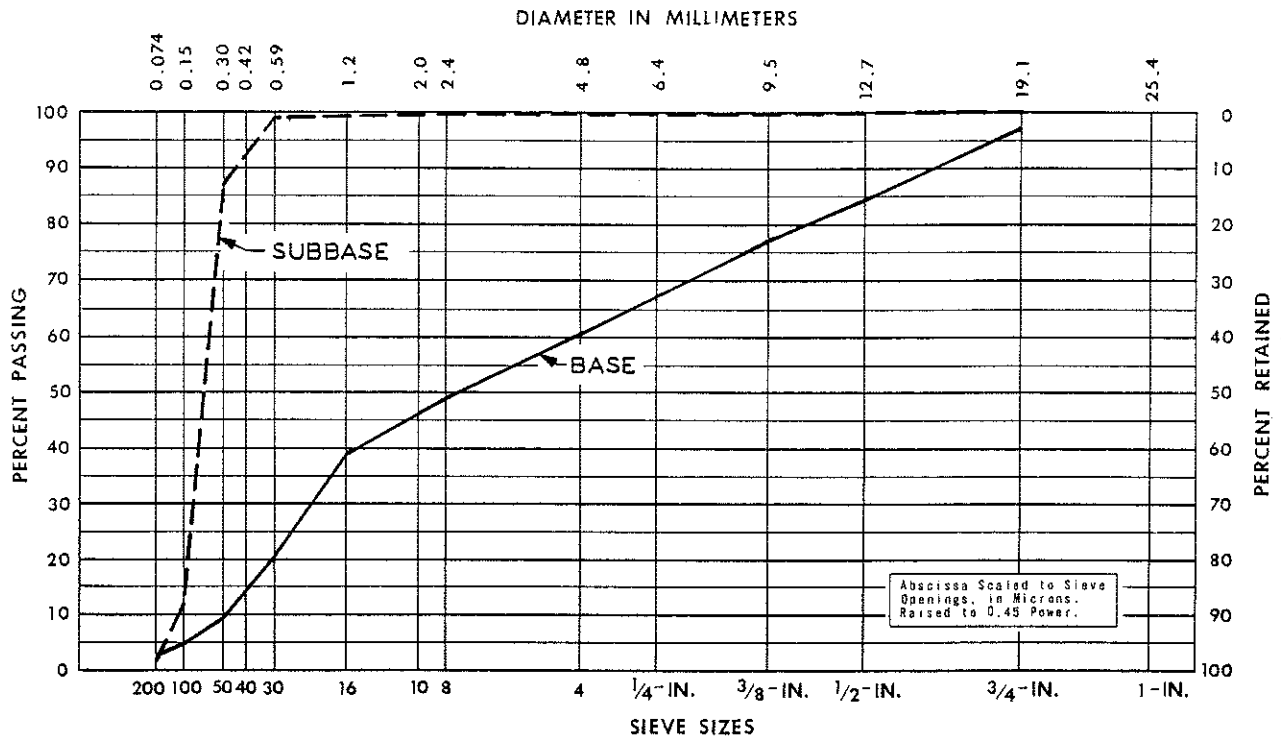
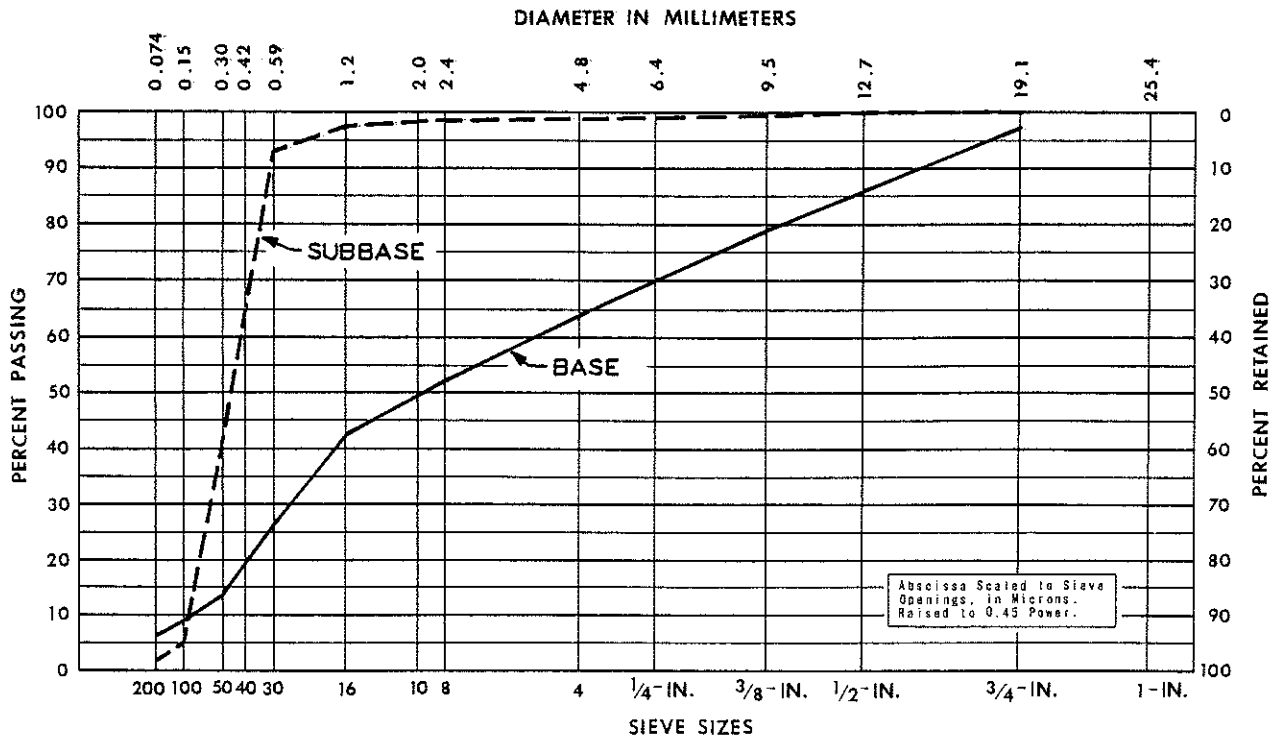
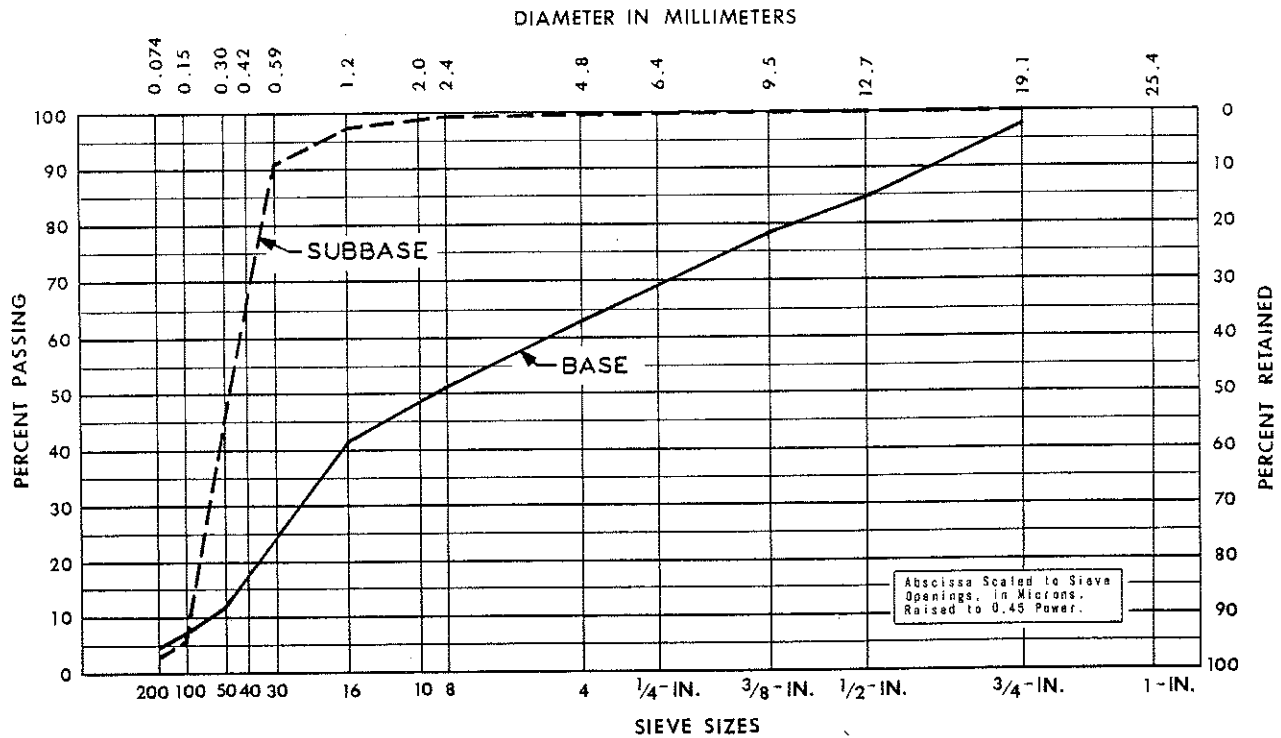
4) Base and subbase gradations are summarized in Figures 6 through 16. These results show that the base material generally does not meet 22A grading requirements but does meet all 20 series requirements. The subbase does meet all Class II grading requirements.

5) The in-place base material meets 20 series grading requirements. Therefore, in any scheme to recycle the existing bituminous concrete, the base could be used as the source of aggregate for virgin bituminous material.
