Concrete Median Barrier Study  
During Periods of Snow Accumulation

TSD-360-77

**MICHIGAN DEPARTMENT OF STATE HIGHWAYS  
AND TRANSPORTATION**

By  
William H. Opland  
Traffic Engineer

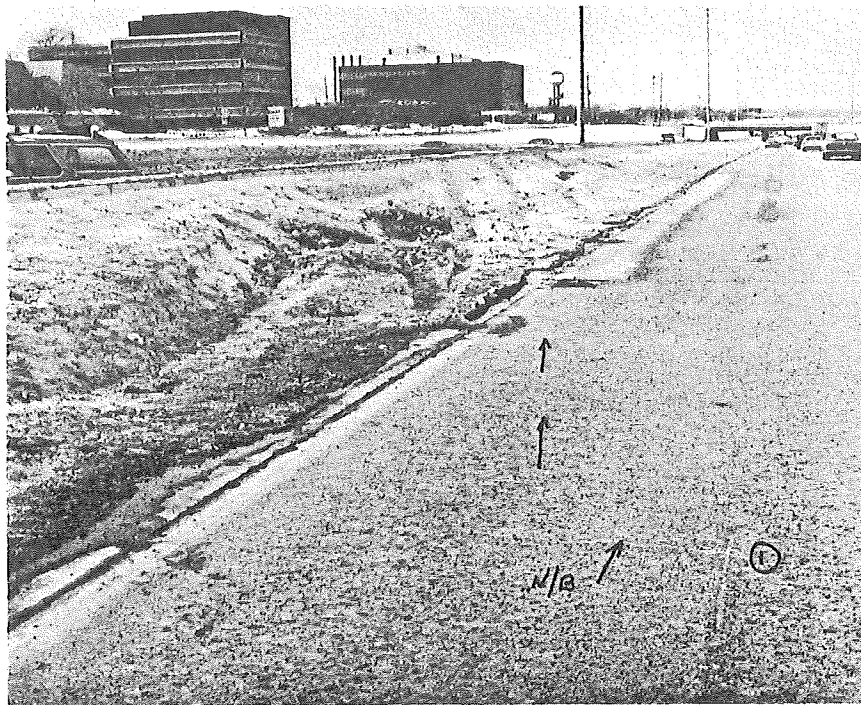
The situation can best be illustrated by examining the photographs that were taken at the scene of the accident. Figure 3 shows where the northbound vehicle lost control and mounted the snow wedged ramp. Figure 4 depicts the point of contact in the southbound shoulder median area. The top of the CMB is shown in Figure 5 where the vehicle scraped the wall. It can be noted how close the vehicle came to striking the light pole. It can also be noted that, at the time of the accident, concrete glare screen was not in place on the top of the wall. Concrete glare screen was installed on this freeway in the fall of 1976. Figure 5 also illustrates the relatively wide (10 feet) median shoulder areas at this location.

Figure 3. Photo shows where vehicle mounted snow wedged ramp.

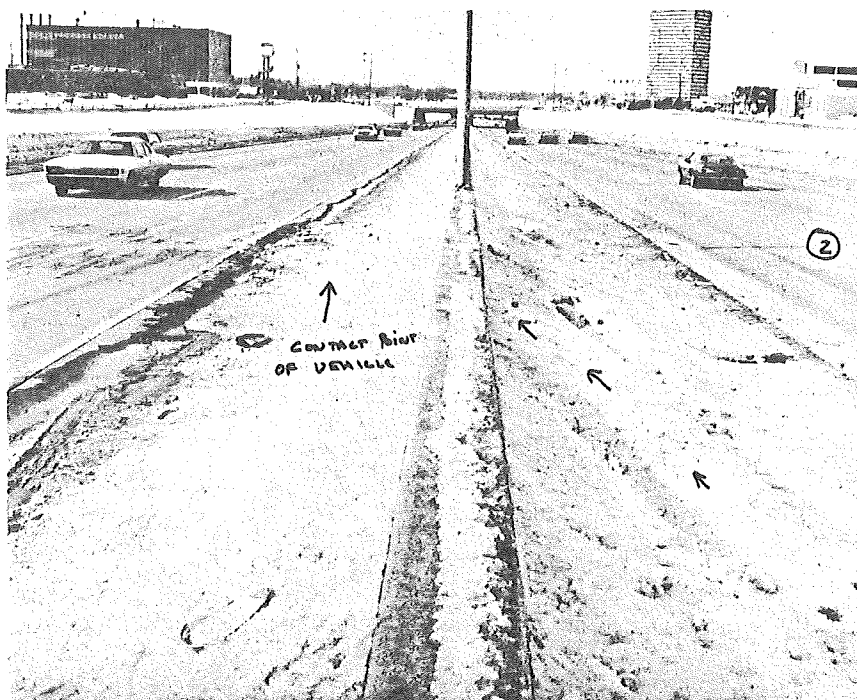
Figure 4. Photo shows contact point after vehicle hurdled barrier.

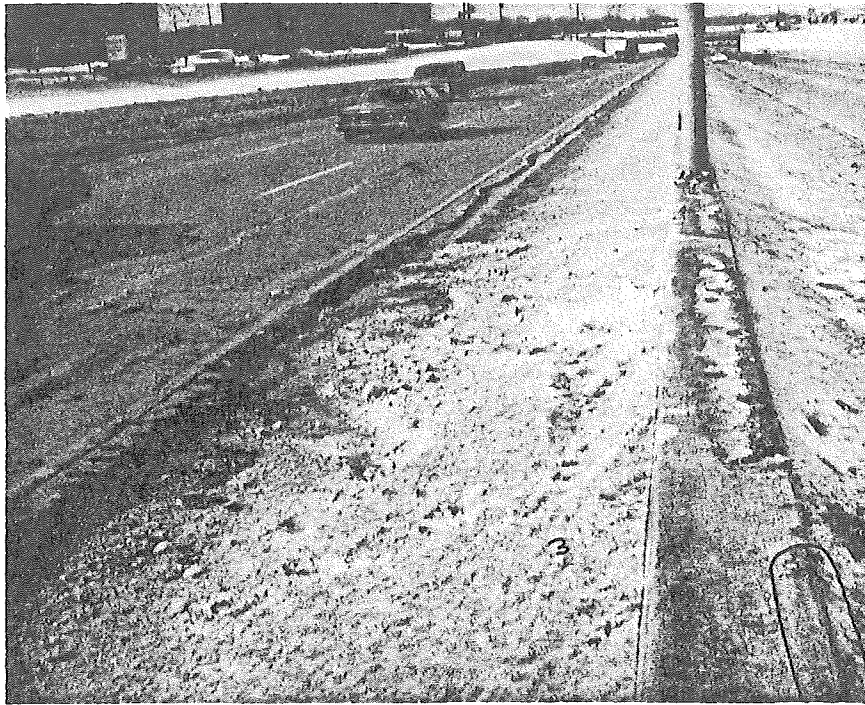
Figure 5. Photo shows where vehicle scraped the barrier (concrete glare screen was not present at time of accident).

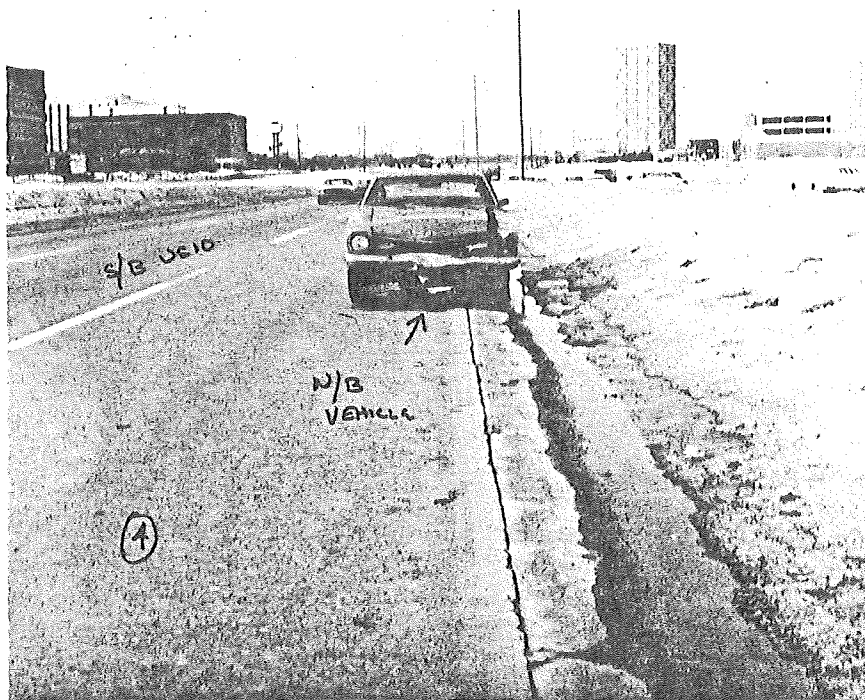
Figure 6 shows the northbound vehicle after it collided with a southbound vehicle and came to a halt in the inside lane of southbound US-10. The accident diagram in Figure 7 illustrates the path of the southbound vehicle after the collision. After making a 180 degree turn, the southbound vehicle mounted the median snow bank backwards and collided with a light pole atop the CMB. After hitting the pole, the vehicle flipped over (see Figure 8) and finally came to rest on the left edge of the inside lane of southbound US-10 (see Figure 9). Neither driver was injured in this 2-car collision.

Figure 6. Photo shows northbound vehicle in southbound lane.

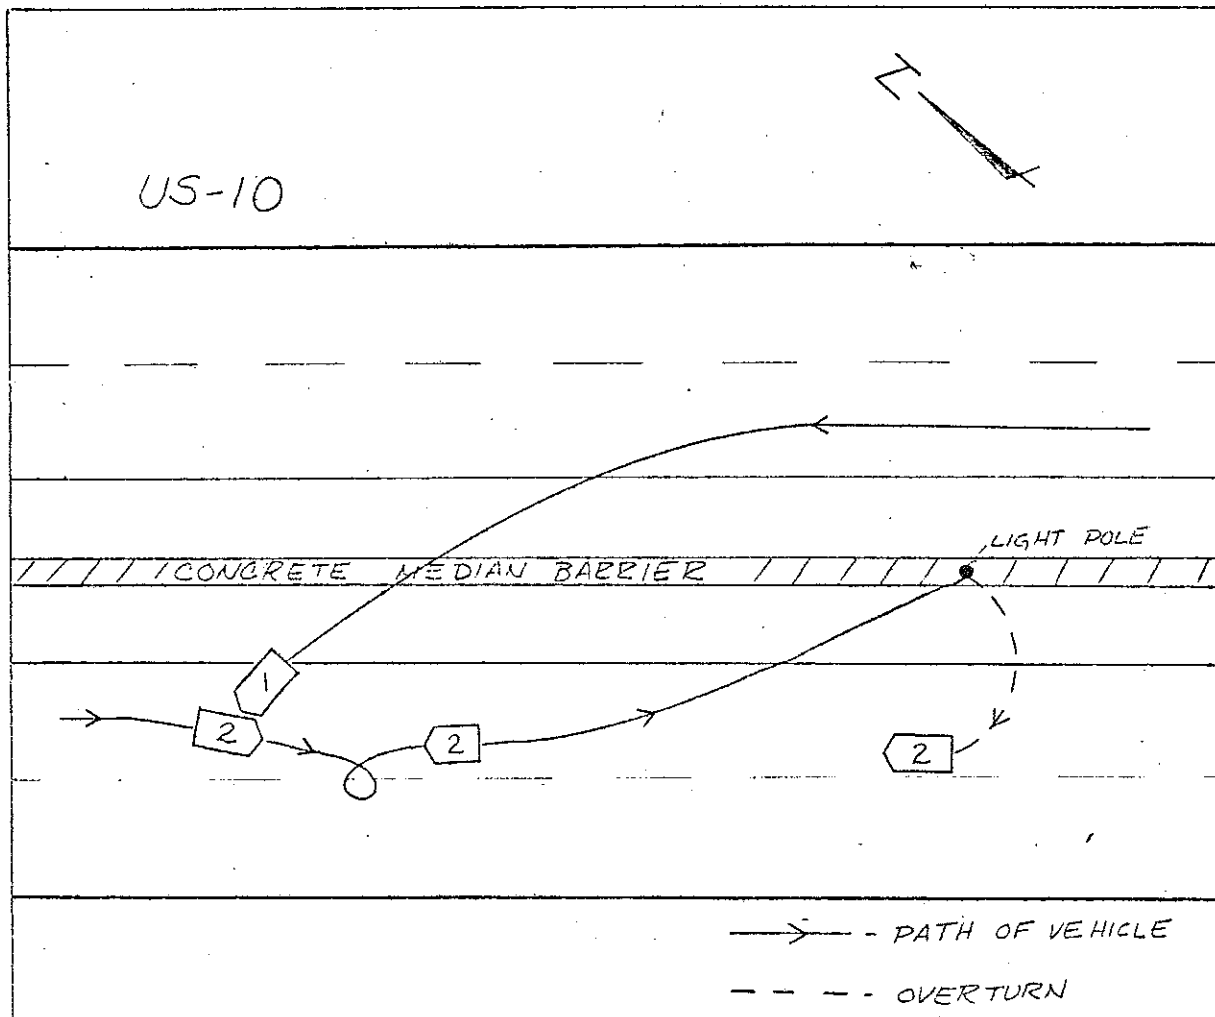
Figure 7. Accident diagram of a CMB hurdle accident.

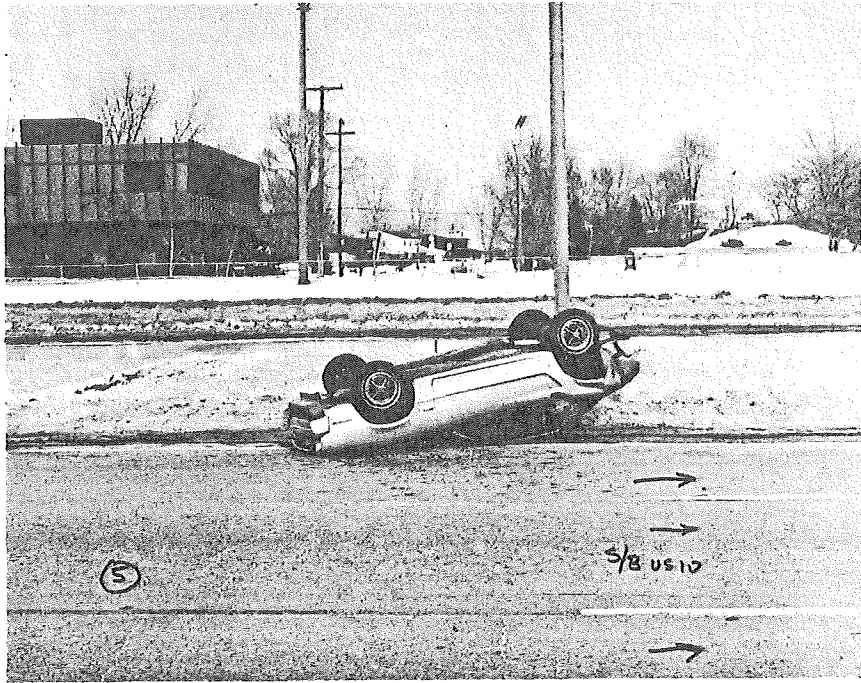
Figure 8. Southbound vehicle struck light pole and rolled over.

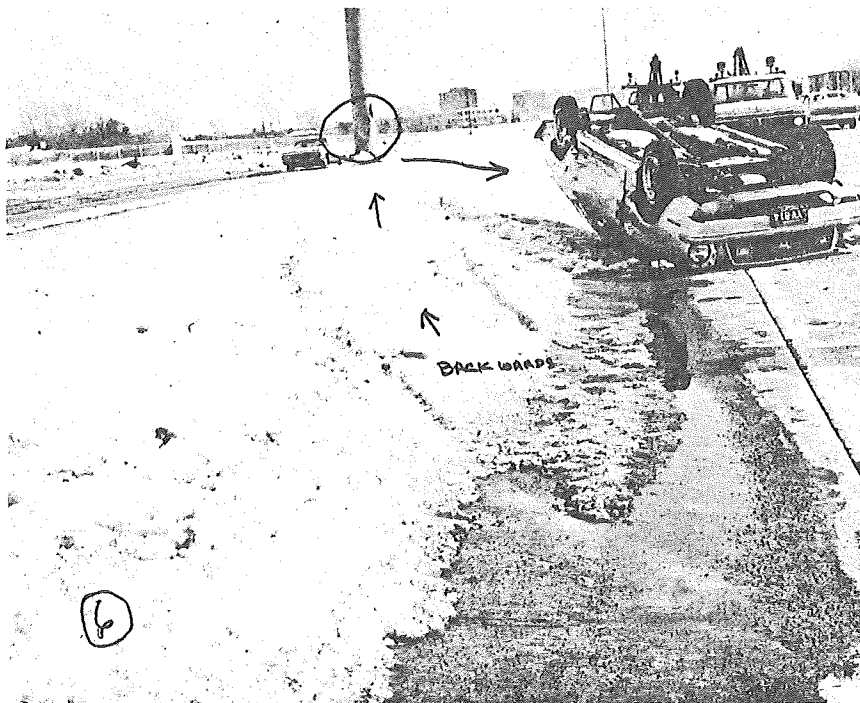
Figure 9. Photo shows path of southbound vehicle.

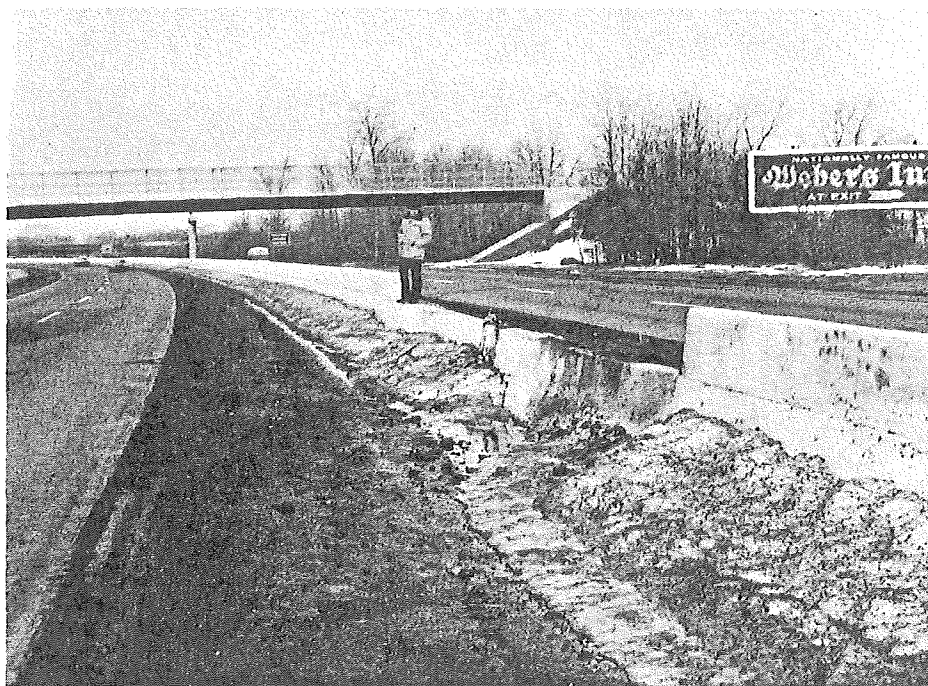
Figure 10 shows where a truck climbed a snowbank and knocked out several lineal feet of concrete glare screen atop the CMB. Although concrete glare screen is not designed to absorb heavy impacts, it is hypothesized that it does serve to increase the effective height of the barrier wall for most automobiles. Observations of tire marks on concrete glare screen seem to substantiate this hypothesis. The concrete glare screen in Figure 11, although fractured, may very well have prevented an errant vehicle from vaulting over the barrier and into the opposing traffic lanes.

Figure 10. Photo shows where truck climbed snowbank and knocked out concrete glare screen (I-94 near Ypsilanti).

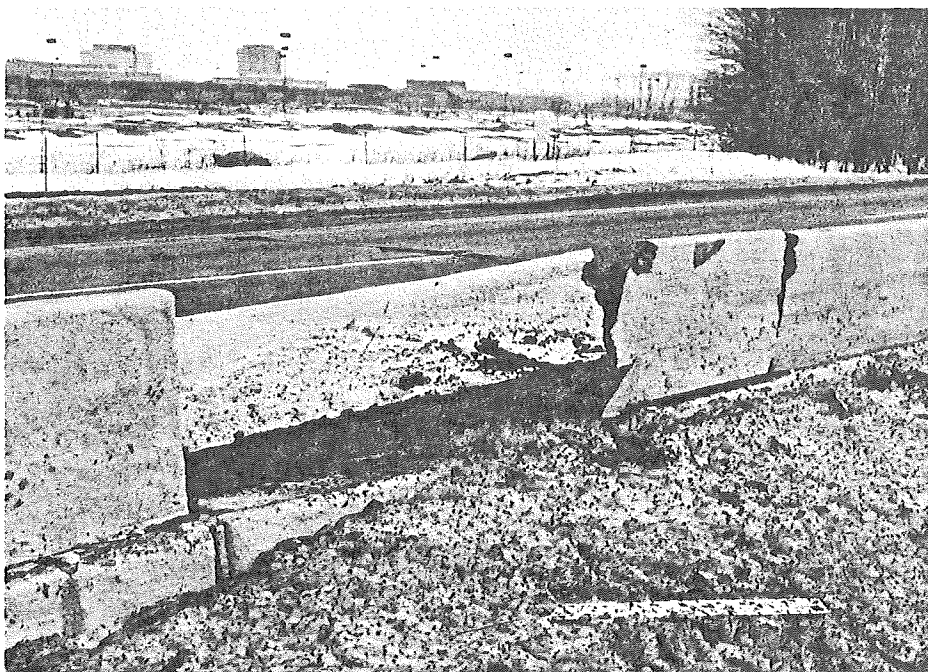
Figure 11. Concrete glare screen probably prevented vehicle from "ramping" over barrier (I-94 in Ann Arbor).

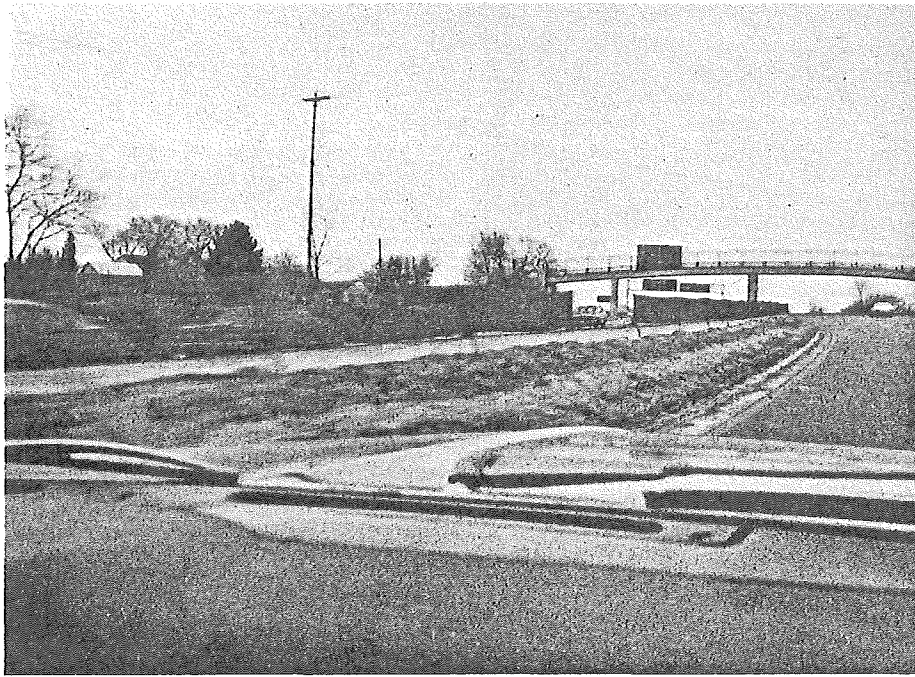
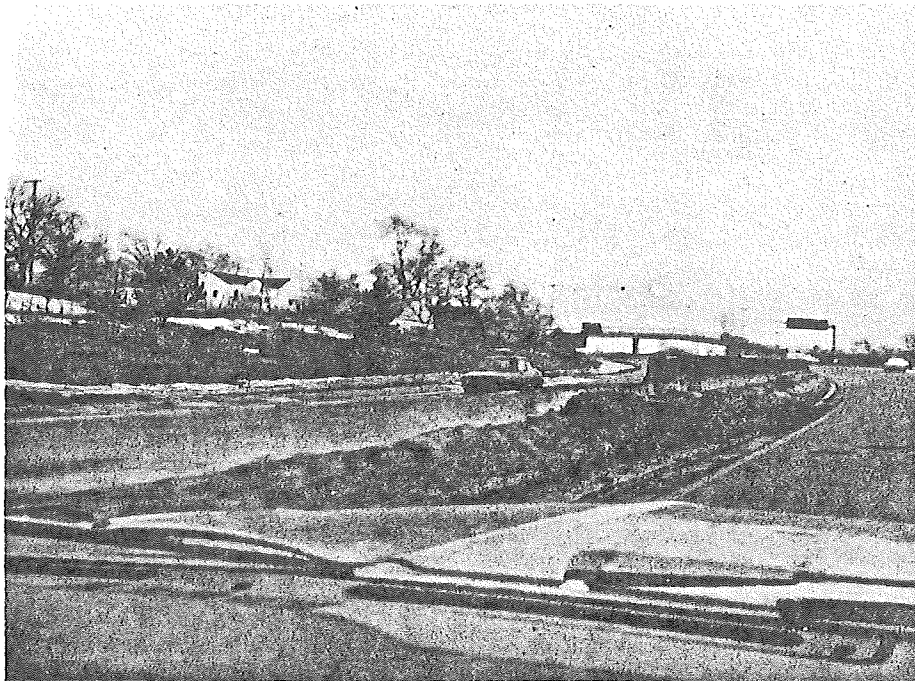
Woven wire glare screen is found atop CMB throughout numerous horizontal curves in the state. Figures 12 and 13 show where the woven wire glare screen has been damaged by errant vehicles. The woven wire screen does not have nearly the structural strength as that of the concrete glare screen and it is also harder to maintain.

Figure 12. Photo shows where short section of woven wire glare screen was knocked out (I-75 near Flint).

Figure 13. Photo shows where long section of woven wire glare screen was knocked out (I-75 near Flint).

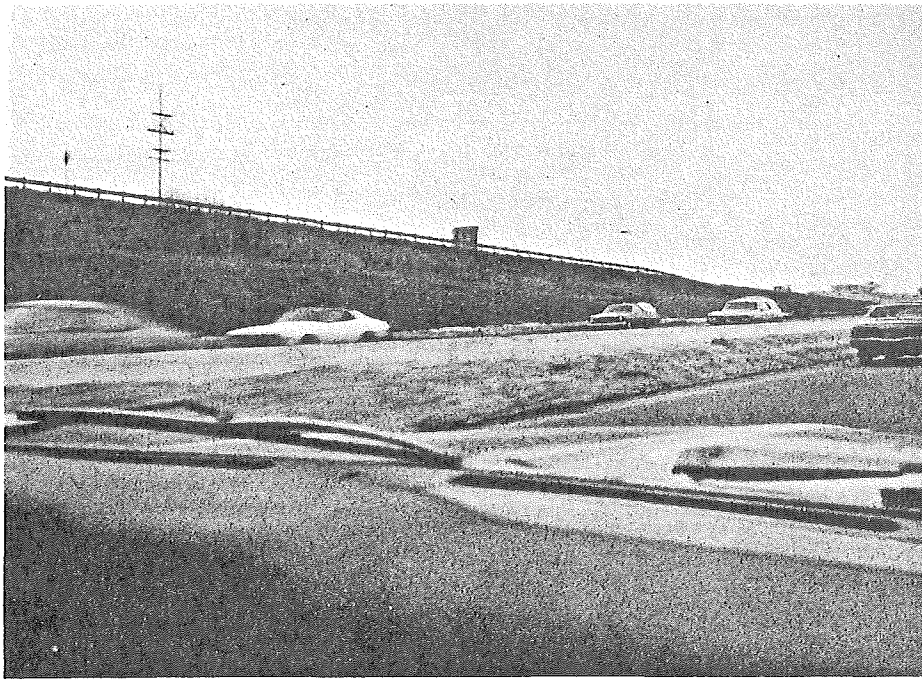
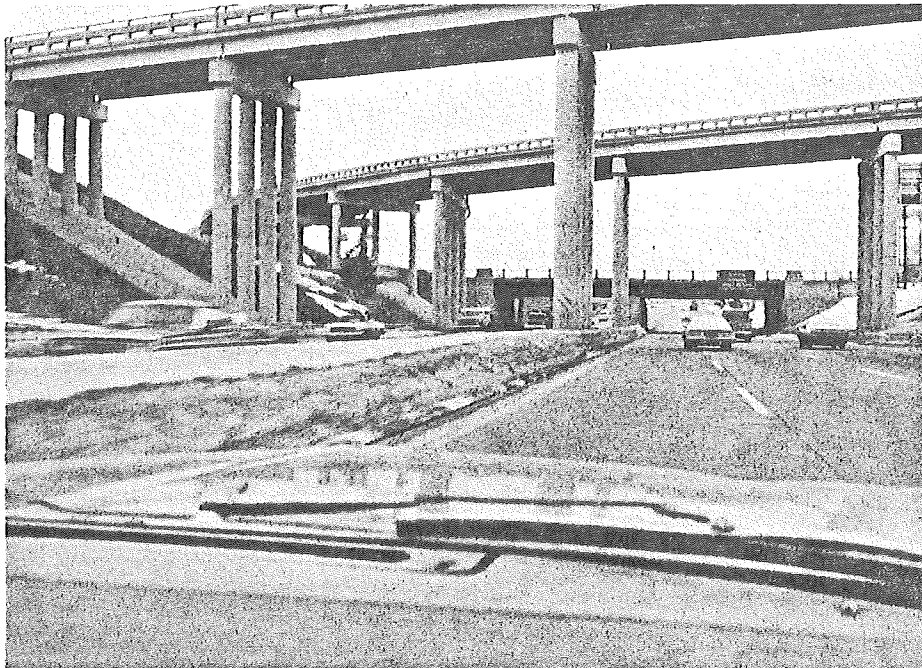
Figures 14 and 15 show some tangent segments of freeway that do not have the glare screen mounted atop the CMB. It can be observed in Figures 14 and 15 that less than 12 inches of the 32-inch high CMB is free of snow. Again, the triangular wedge of snow presents a potential problem for out of control vehicles.

Figure 14. Tangent section of CMB that has no glare screen mounted on top (I-75 near Flint).

Figure 15. Snow wedged in along 32 inch high CMB (I-75 near Flint).

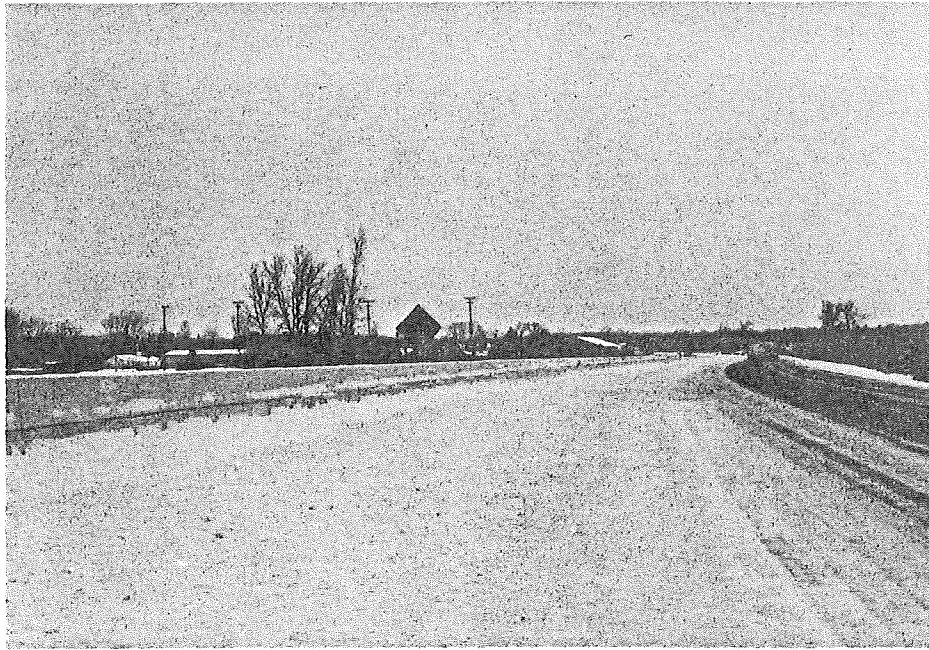
As can be seen in Figure 16, the concrete glare screen provides an effective wall height of 51 inches. It can be noted how much wall space is visible even with snow piled against the bottom portion of the CMB.

Figure 16. Concrete glare screen provides a 51 inch wall height (I-75 near Saginaw).

3. Since many of the district personnel strongly favor the use of concrete glare screen atop CMB in urbanized areas, strong consideration should be given to its installation along existing CMB sections currently without it. Although it would be rather difficult to determine the cost effectiveness of such projects, it is felt the added safety provided by concrete glare screen would warrant its use.

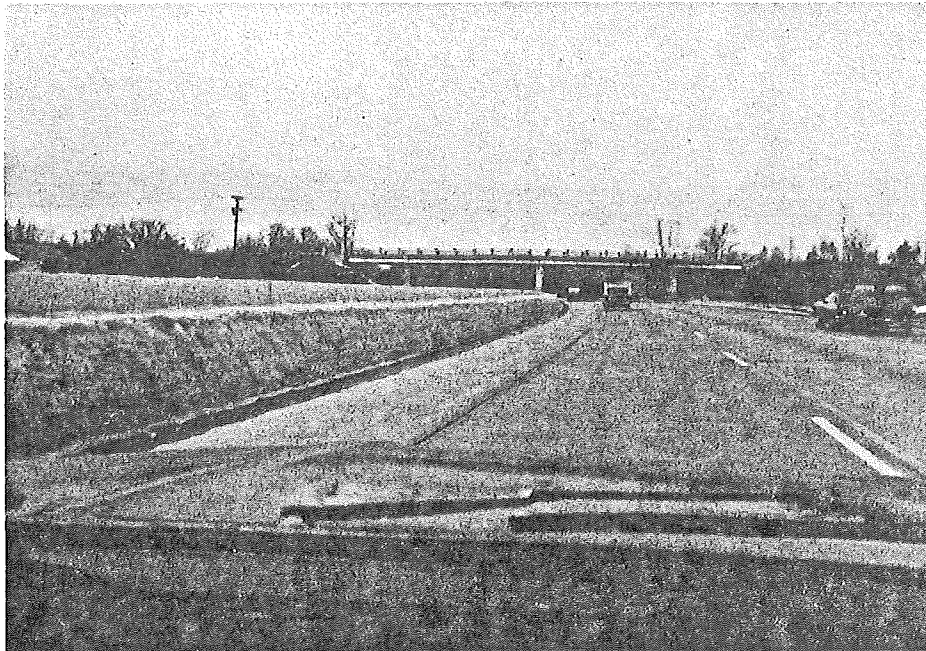
Figure 17 illustrates the same type of wall section as in Figure 16, but it also shows the results of a maintenance plowing procedure known as "verticalizing." It should be noted that a clear median shoulder is provided by the vertically cut snow face. In addition, the vertical face makes it difficult for a vehicle to scale the wall.

Figure 17. Results of snowplowing procedure known as "verticalizing" (I-75 near Saginaw).

1. Since the snowplowing process known as "verticalizing" has met with much success in District 6, this method should be considered for possible use on a statewide basis in concrete median barrier shoulder areas.
2. Snow removal procedures along concrete median barriers that create traffic backups for the motoring public should not be employed, i.e., "engineering judgment" should dictate the feasibility of when and where CMB shoulder areas should be addressed.
