**MDOT RC-1617B**

**Evaluation of Bridge Decks Using  
Non-Destructive Evaluation (NDE)  
at Near Highway Speeds  
for Effective Asset Management  
– Pilot Project**

**FINAL REPORT**

Michigan Department of Transportation

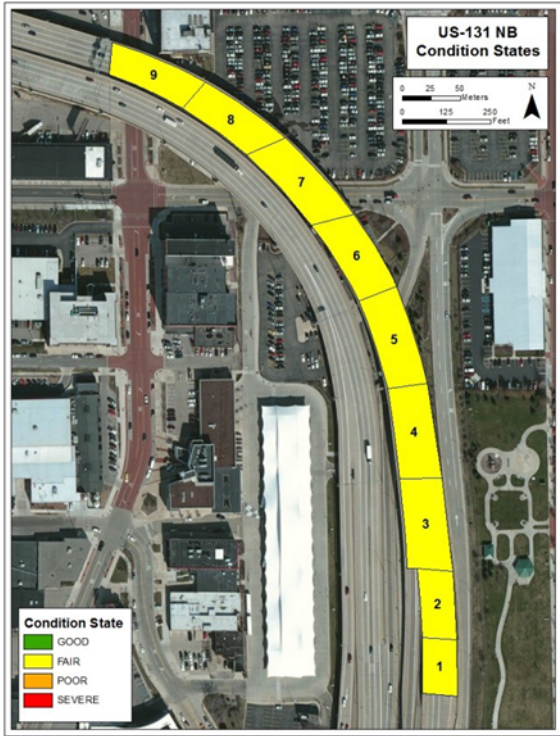
**Figure 1: Summary of condition state per span at US-131 northbound.**

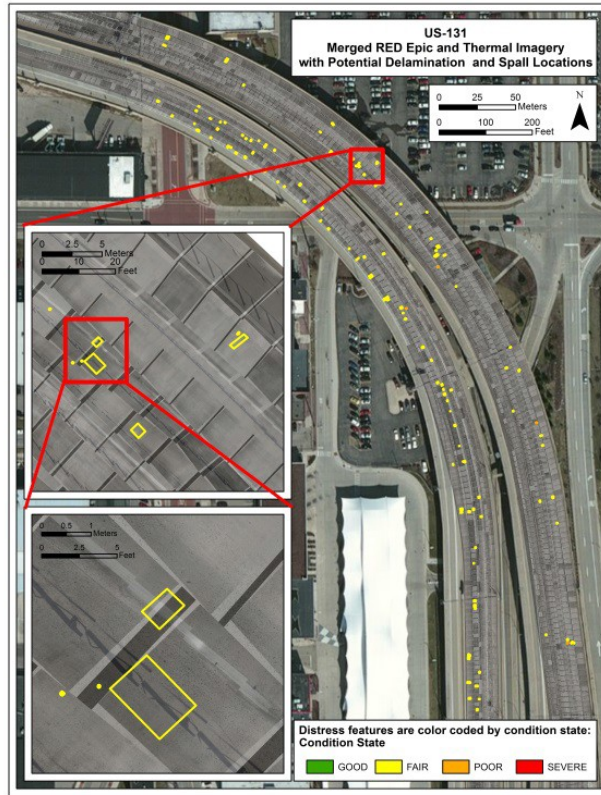
**Figure 2: Location of potential delaminations and spalls on US-131 northbound and southbound bridge decks.**

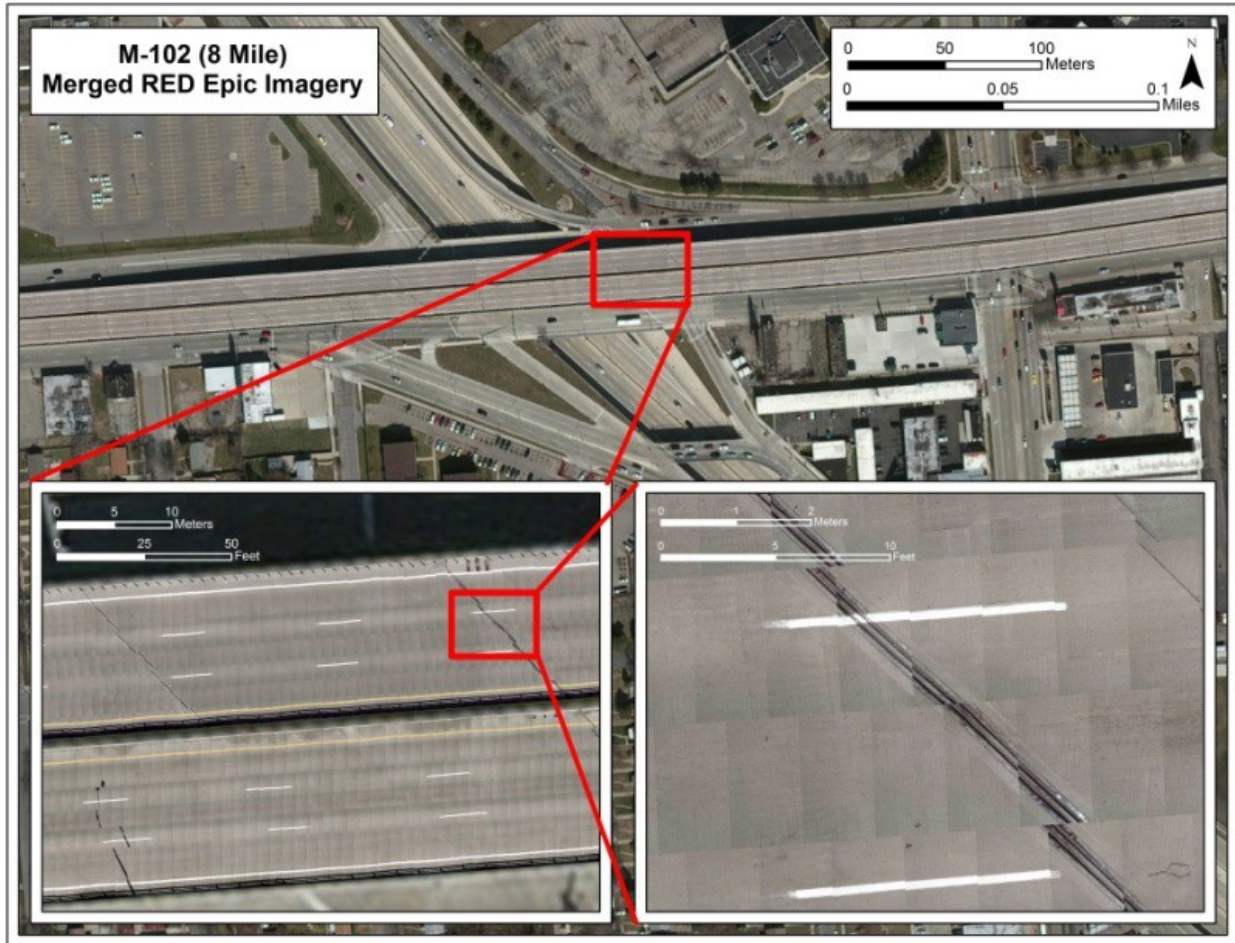
After processing, merging, and georeferencing both optical and thermal imagery data sets, the outputs were placed within GIS software to provide visualization of distress features. Through using an automated script created to correct the overlap in individual frames extracted from RED Epic video imagery, individual frames were cropped and placed end-to-end, resulting in a single image for subsets of the bridge deck. The subsets were then merged together and georeferenced to ESRI base maps to create a single image per pass over the bridge. For the optical imagery, this serves as the visual basis of the bridge deck. As seen in Figure 23, the separate passes over the bridge deck do not necessarily line up with one another, resulting in slight distortion of pavement markings and bridge joints. However, the merged optical imagery proved useful as it provided an overview of how the bridge deck appeared during data collection. This bridge deck contained no spalls outside of the bridge joint area.

**Figure 23: RED Epic imagery merged together to form spall locations on the bridge deck of M-102 (8 Mile) eastbound and westbound.**

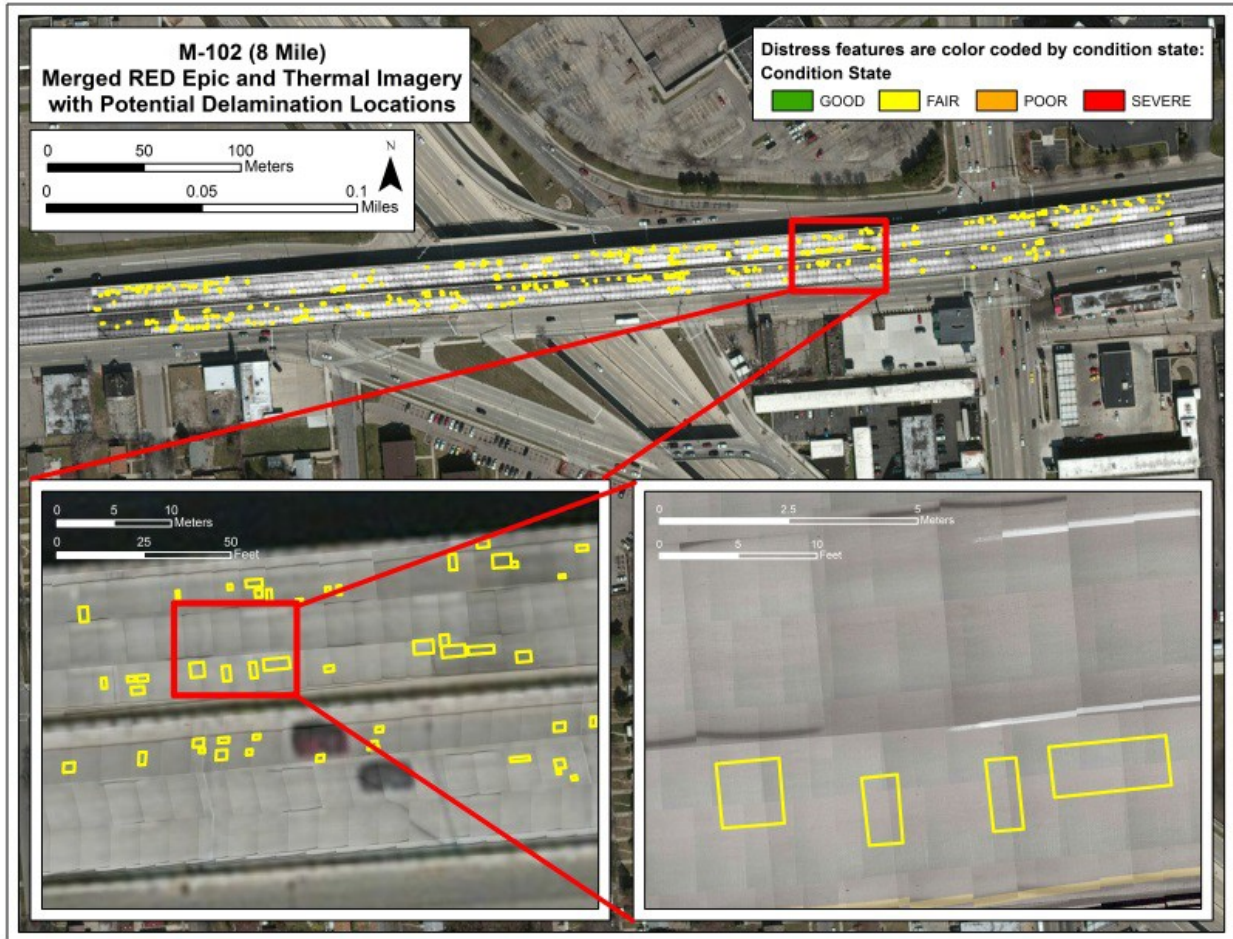
**Figure 25: Locations of potential delaminations for M-102 (8 Mile) eastbound and westbound bridge decks.**

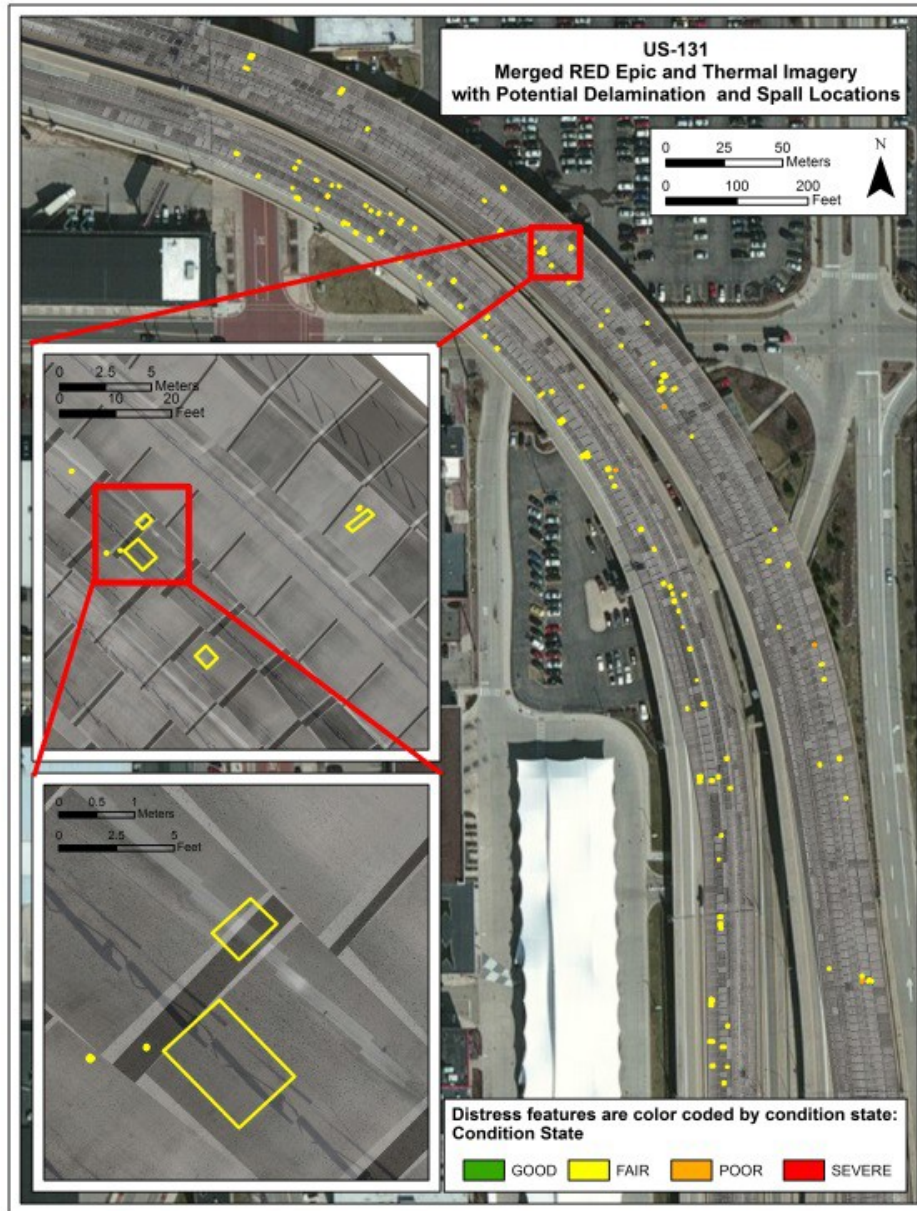
**Figure 28: Location of potential delaminations and spalls on US-131 northbound and southbound bridge decks.**

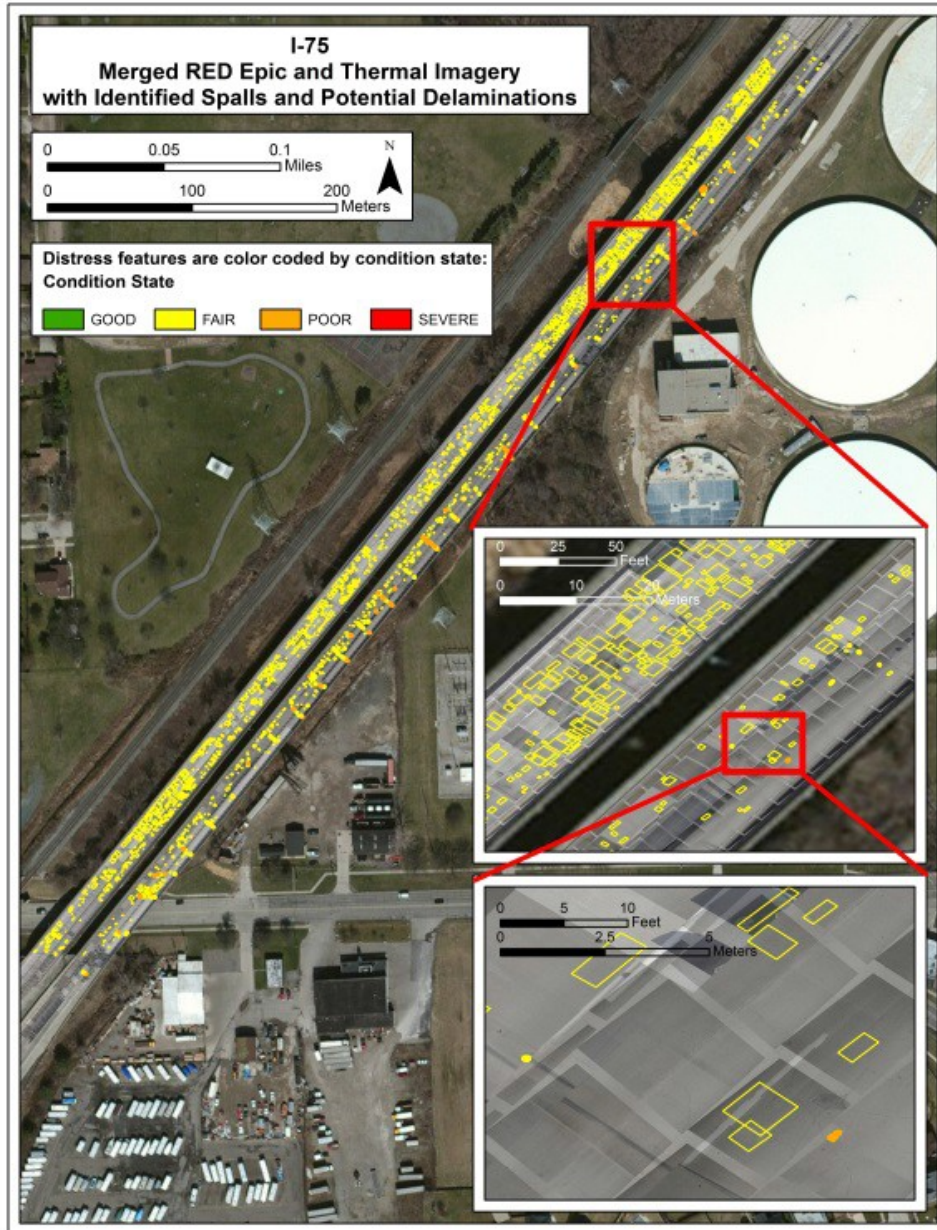
**Figure 31: Location of potential delaminations and spalls for I-75 northbound and southbound decks.**

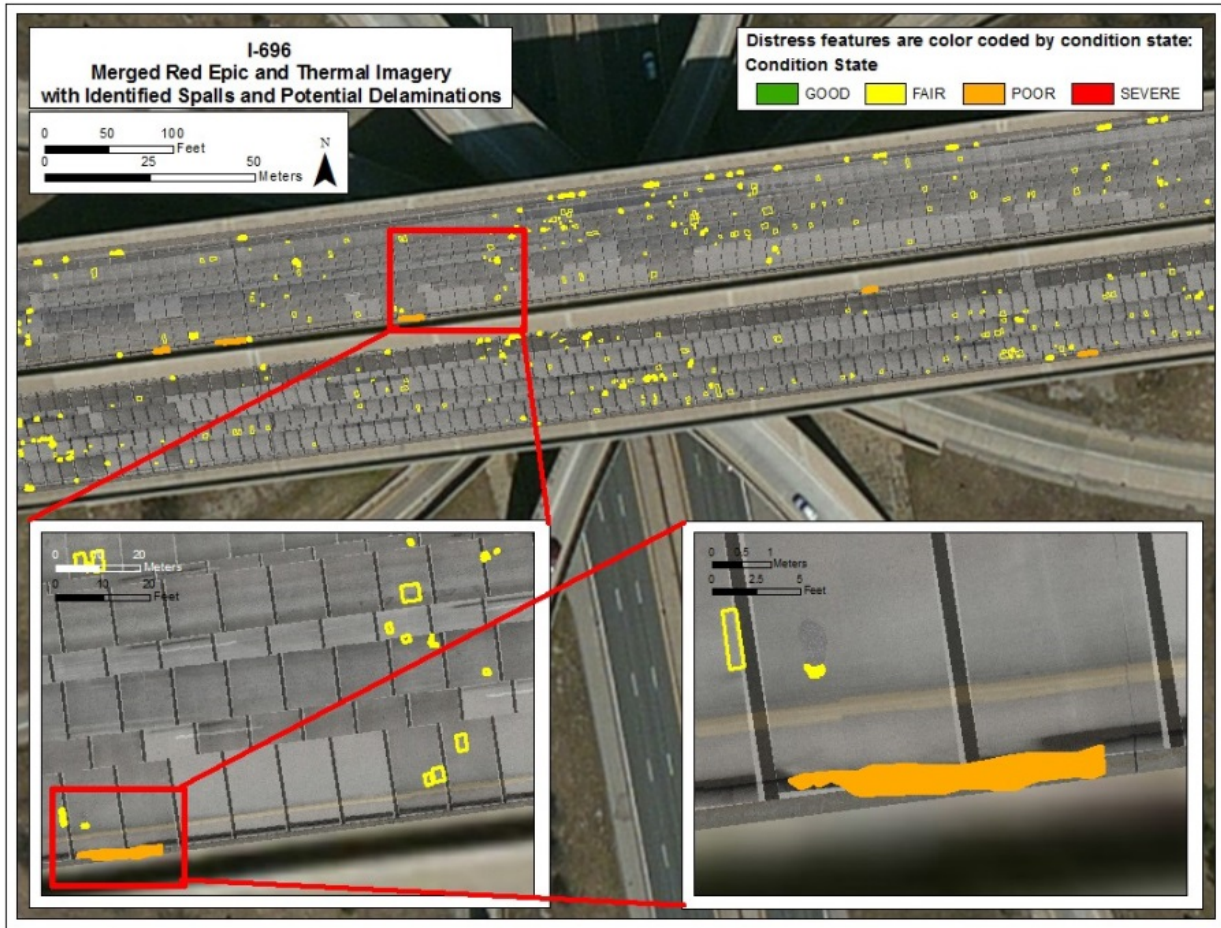
Figure 34: Location of potential delaminations and spalls on the I-696 bridge deck.

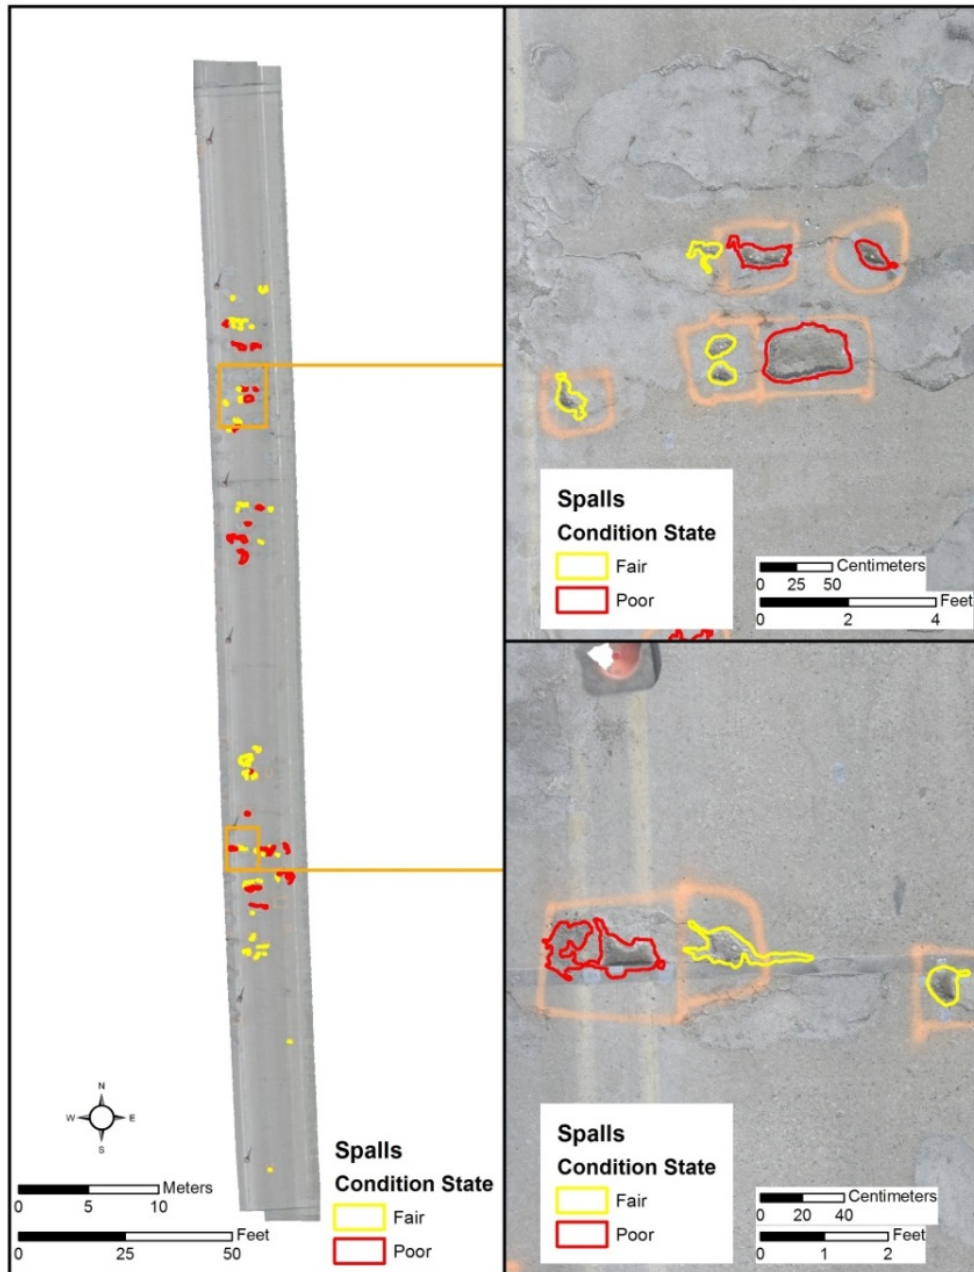
A spall detection algorithm developed under the USDOT/RITA Bridge Condition Assessment Using Remote Sensors project (Ahlborn et al., 2013) was used on the resulting DEMs to create a spalls shapefile for the Lake Nepessing Rd. bridge deck. Figure 39 is an example of the northbound lane of Lake Nepessing Rd with the detected spalls layer. The spalls layer also contains area and volume of the detected spalls. Lake Nepessing Rd bridge deck is estimated to be 80.4 ft<sup>2</sup> or about 1% of the bridge deck is spalled based on the detected spalls layer. Of the spalls detected 68% were in Condition State 2 and 32% were in Condition State 3.

**Figure 39: Northbound Lake Nepessing Rd bridge deck orthoimage with the detected spalls layer showing the location of spalls.**

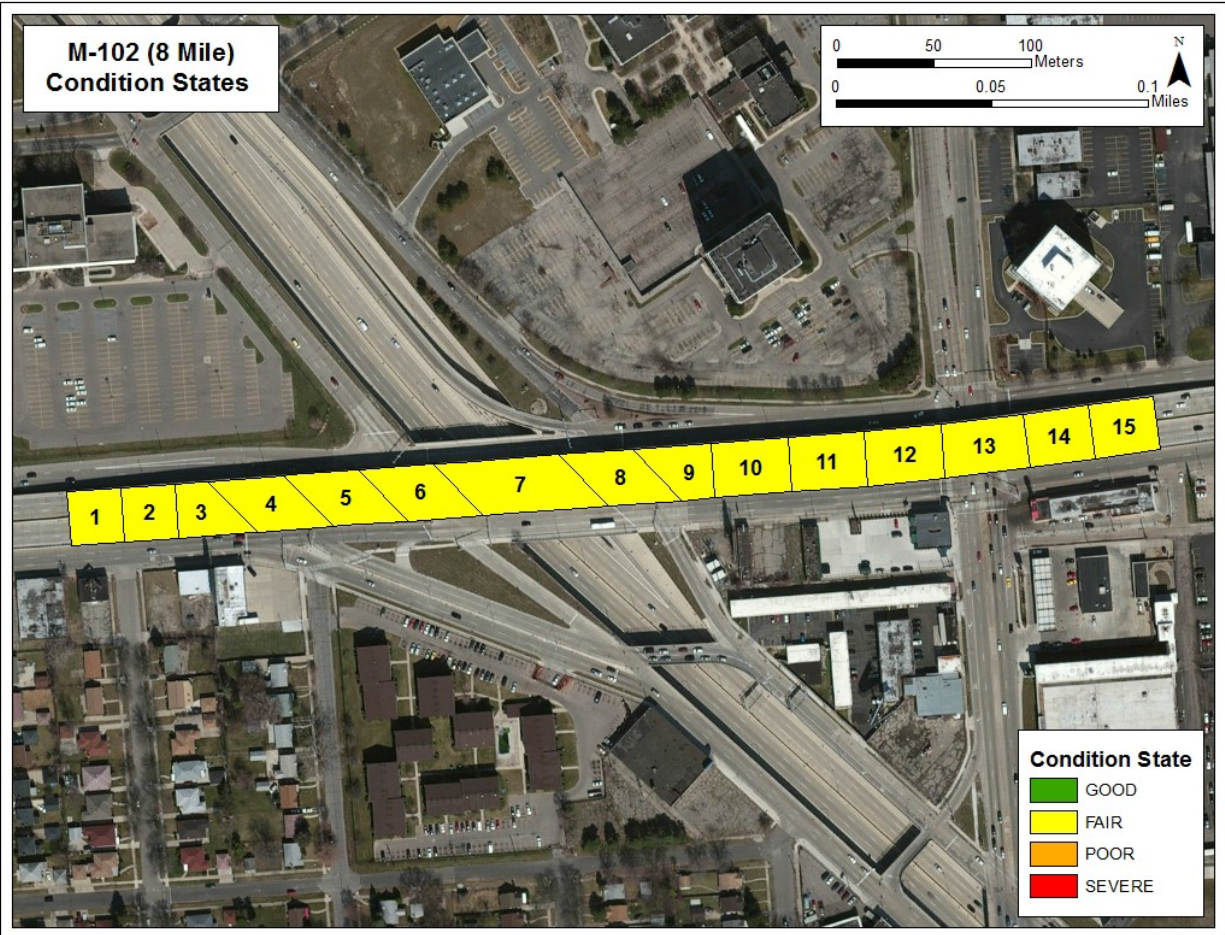
**Figure 40: Summary of Condition state per span at M-102 (8 Mile).**

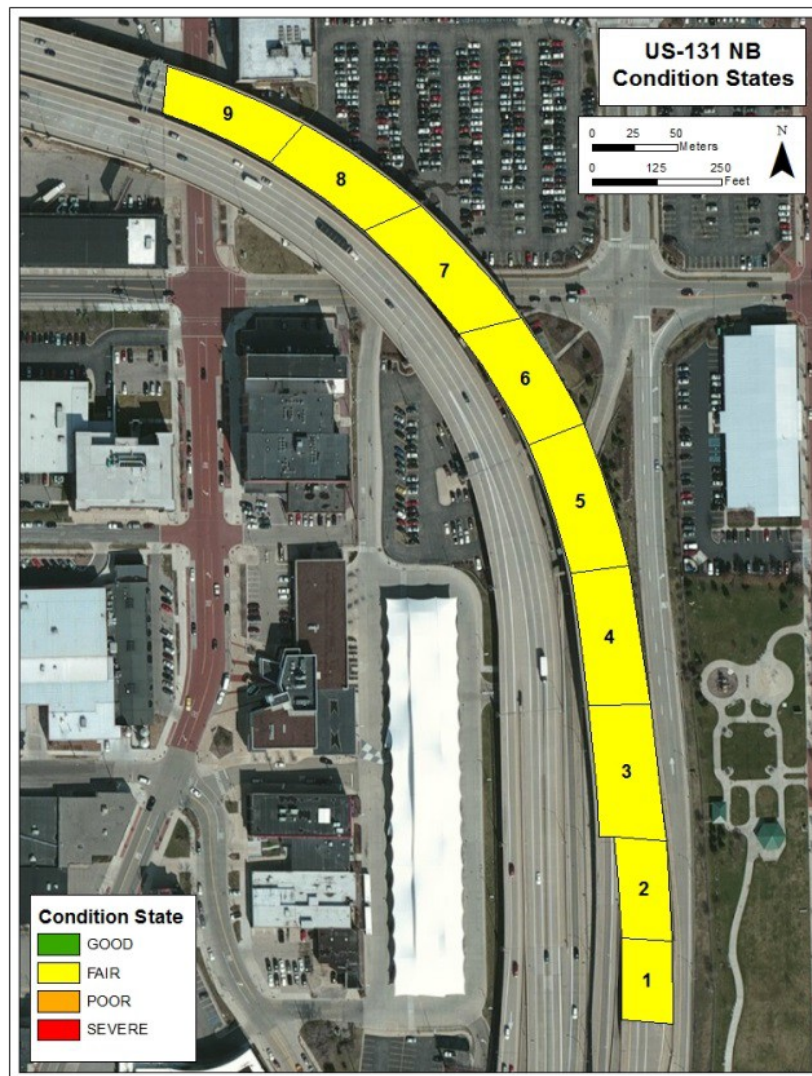
**Figure 41: Summary of condition state per span at US-131 northbound.**

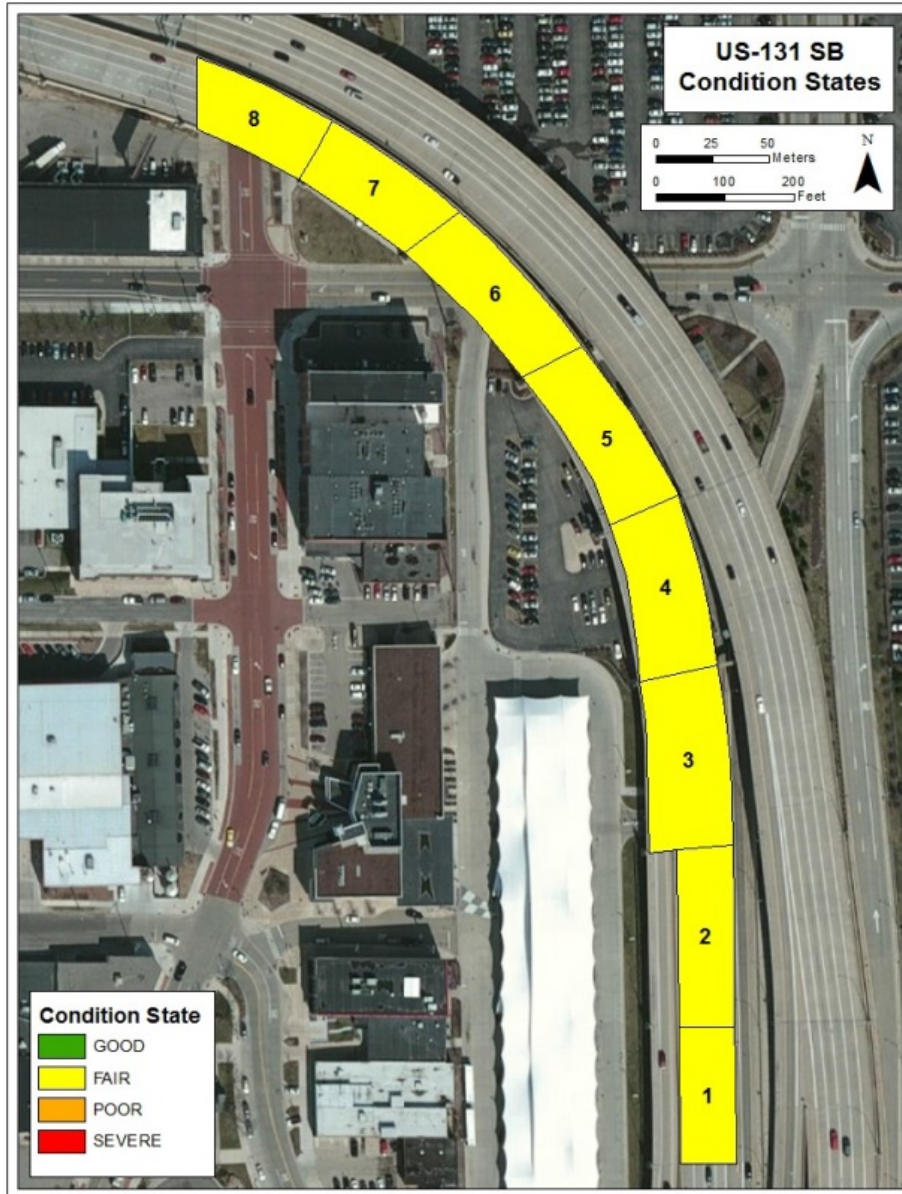
**Figure 42: Summary of condition state per span at US-131 southbound.**

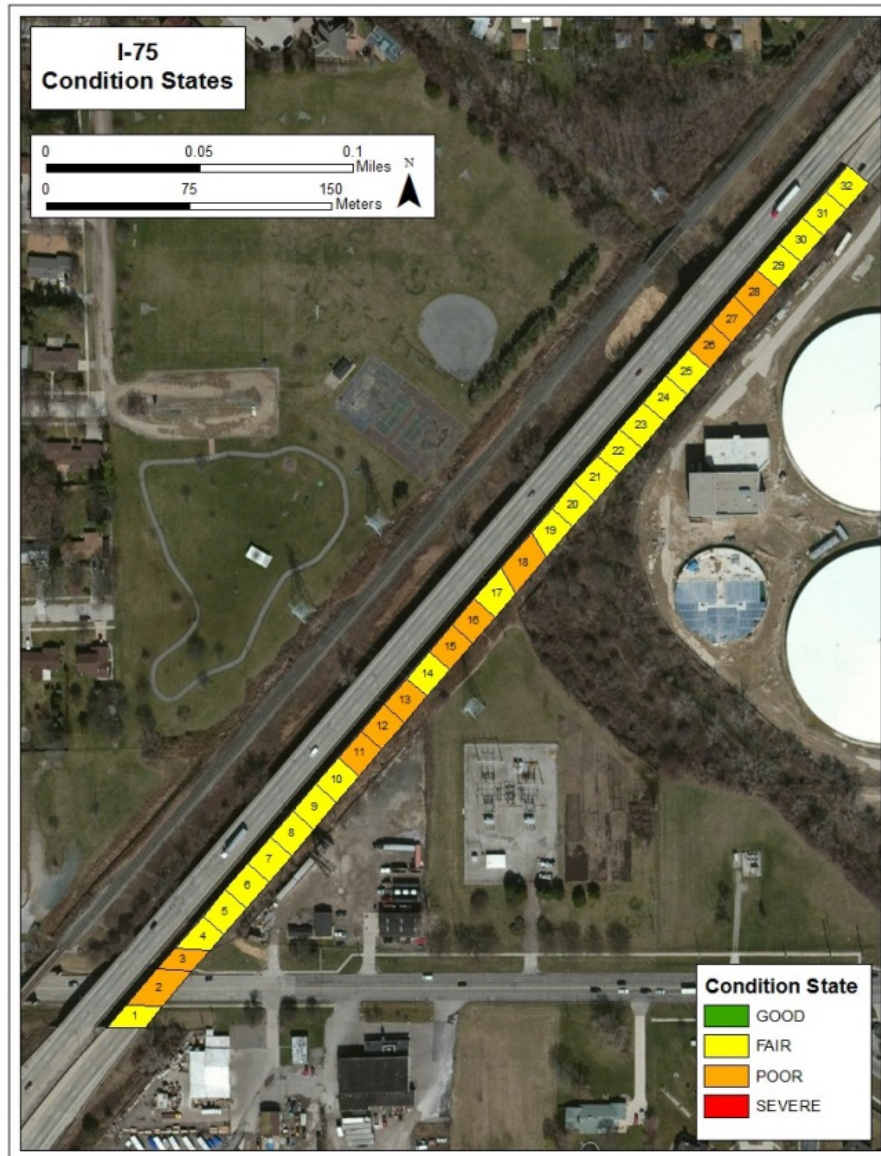
**Figure 43: Summary of condition state per deck span at I-75 northbound.**

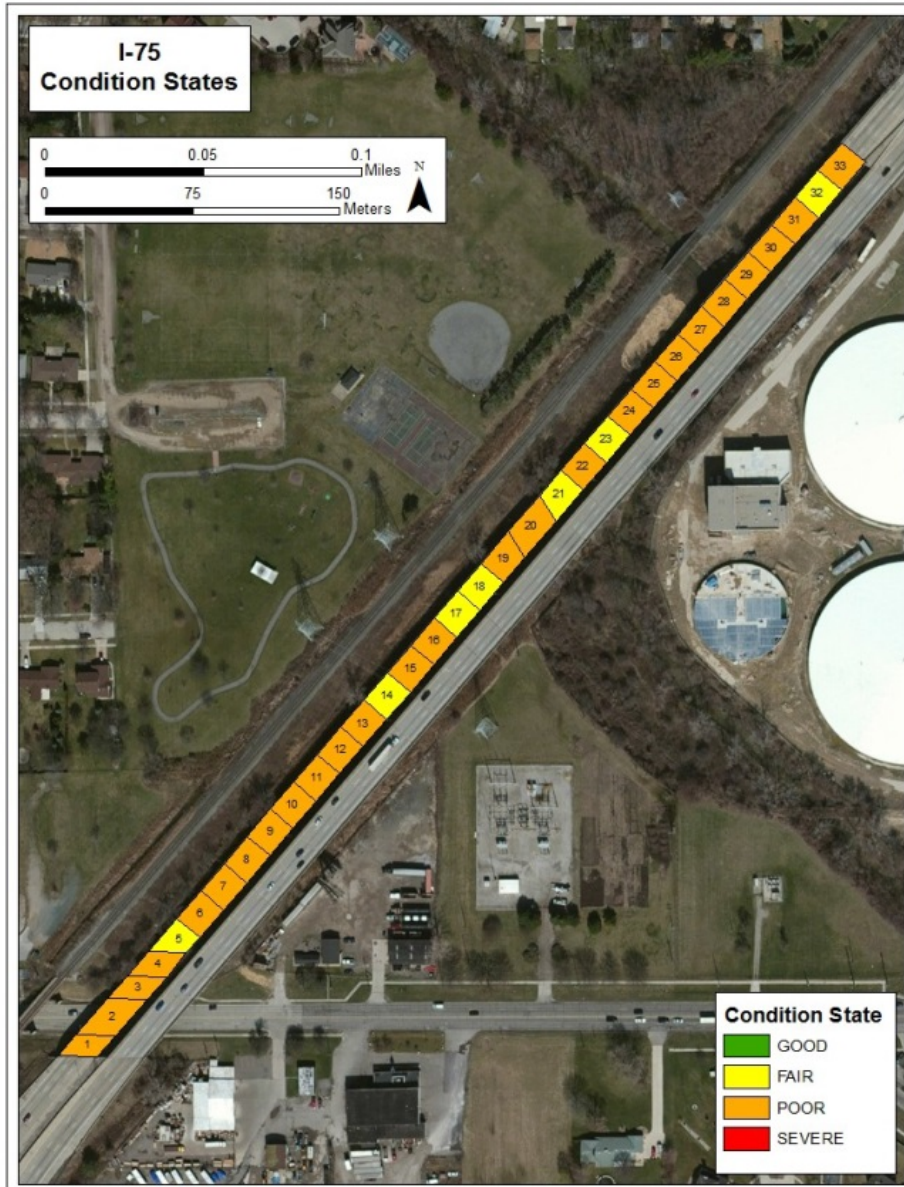
**Figure 44: Summary of condition state per deck span at I-75 southbound.**

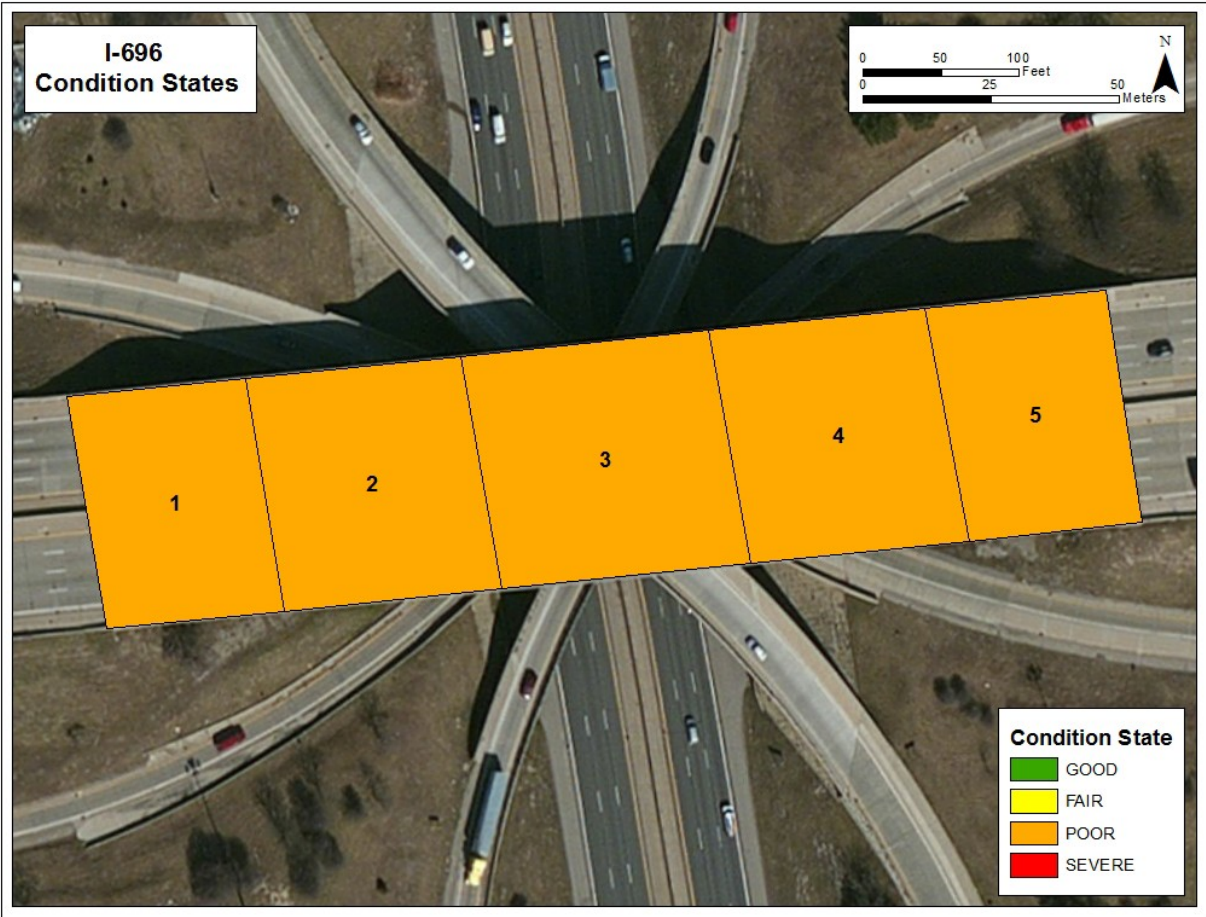
**Figure 45: Summary of condition state per deck span at I-696.**

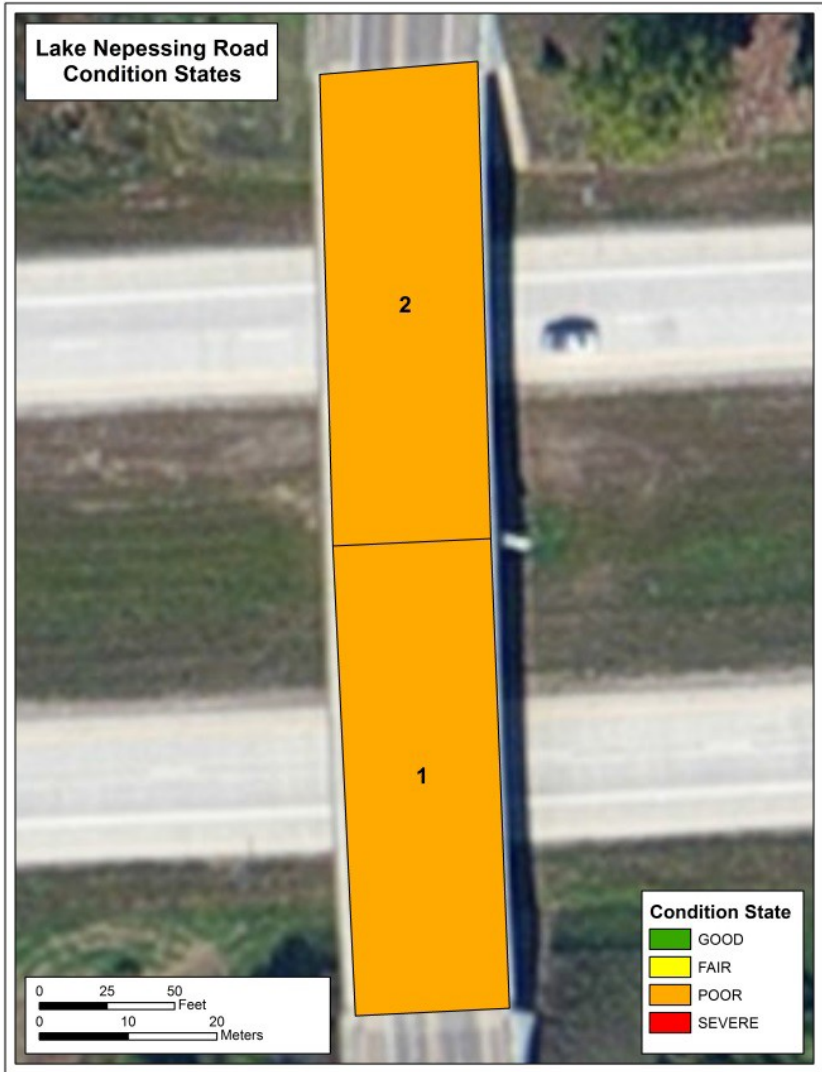
**Figure 46: Summary of condition state per deck span at Lake Nepessing Rd.**
