OFFICE MEMORANDUM

MICHIGAN
STATE HIGHWAY DEPARTMENT

Subject: Inspection of Pavement Joint Blowup on US 131 North of Grand Rapids
(Construction Project 41-90, C4). Research Project 39 F-7(14).
Research Report No. R-533.

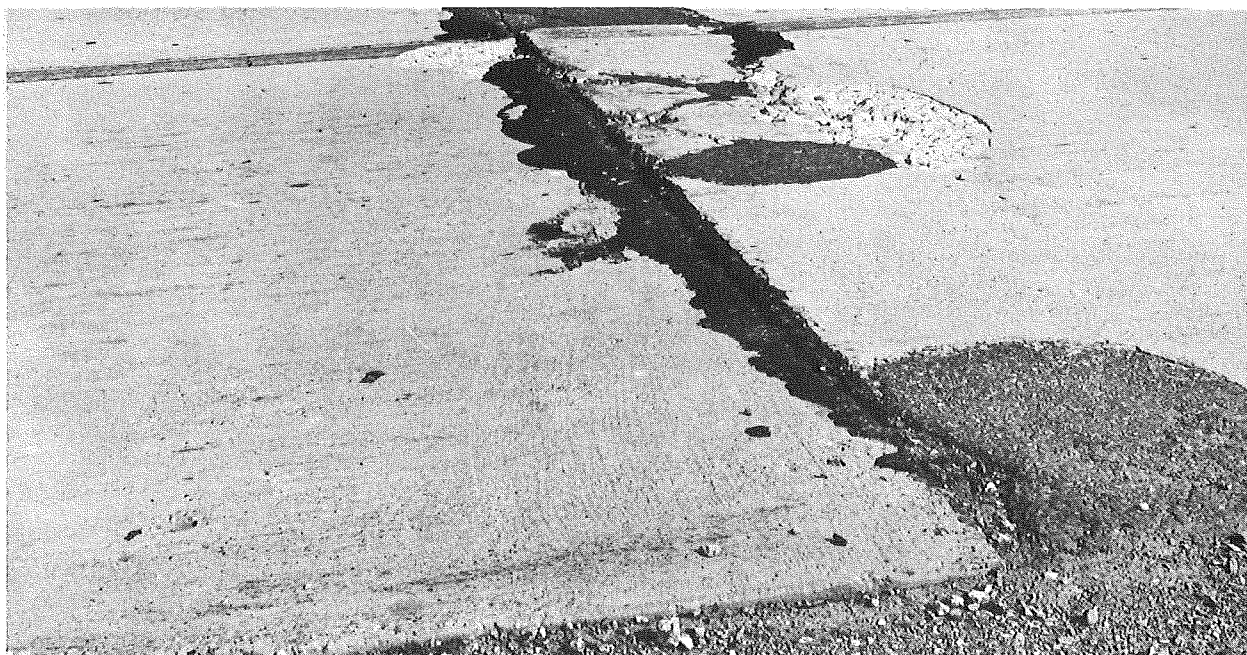
The blowup extended across both lanes at this night joint on the southbound roadway (Fig. 1). Measurements showed that this construction joint was formed by a 150-ft slab at the south (50 percent over maximum length) which was the final pour of June 19, 1956, and a conventional 99-ft slab to the north. The joints immediately north and south of the blowup both were open and full of debris. Because no basket was found during repair of the joint it is assumed that dowel bars were placed through holes in the bulkhead at the end of the slab during construction. Coarse aggregate used in the concrete was taken from the Pickett Pit (No. 41-38), located in Kent County.

Figure 1. Transverse joint blowup (Sta. 58+36).

The repair work consisted of breaking out the damaged concrete and replacing it with cold mix asphalt. Fig. 3 shows dowel bars removed from the damaged joint. Some were rusted over their entire length, and almost no lubricant remained on the dowel surfaces. Corrosion had reduced the diameter of some dowels by 1/8 in. or about 10 percent. Concrete beneath the dowels was disintegrated (Fig. 4).

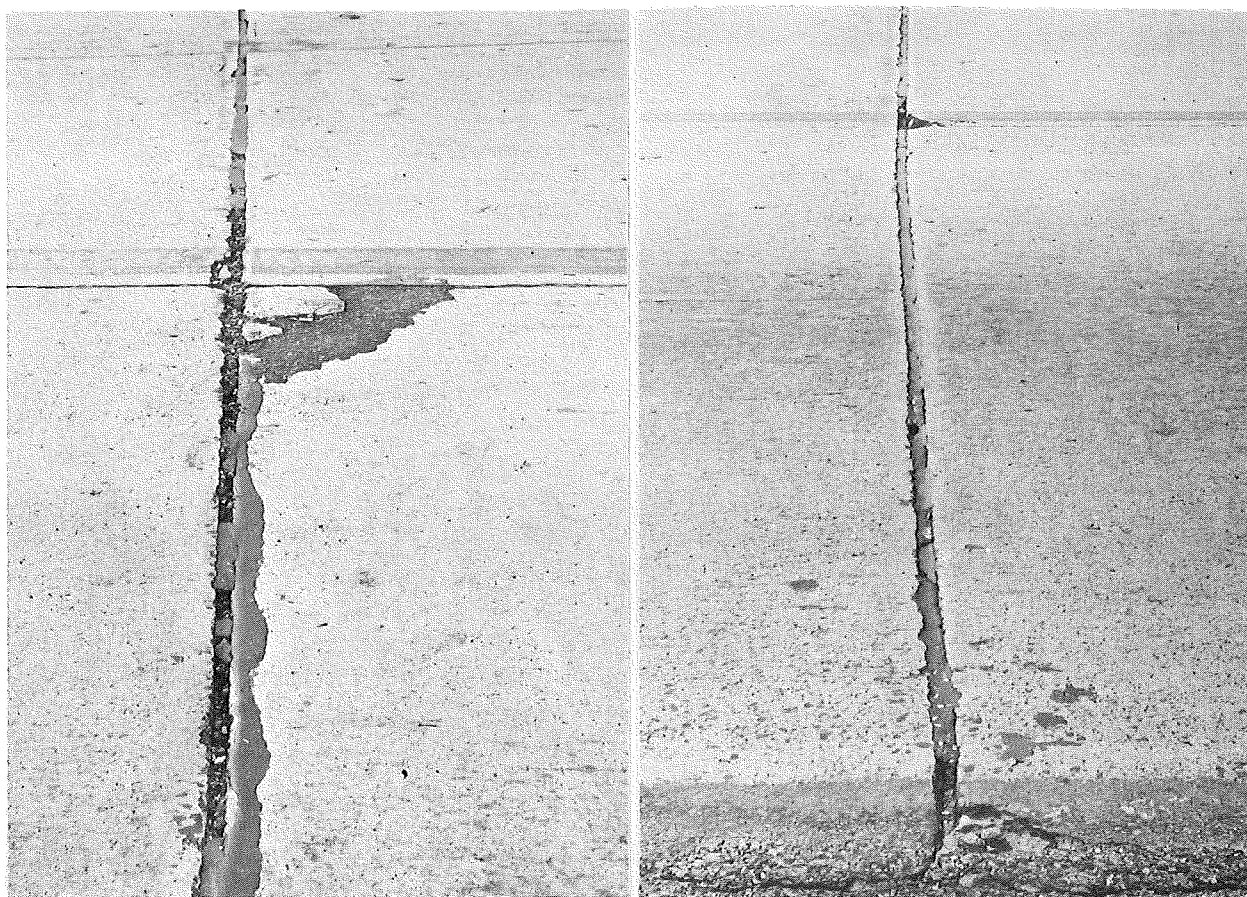
Figure 2. Transverse joints adjacent to blowup, at end of 150-ft slab south of blowup (left: Sta. 56+85), and north of blowup (right: Sta. 59+34).

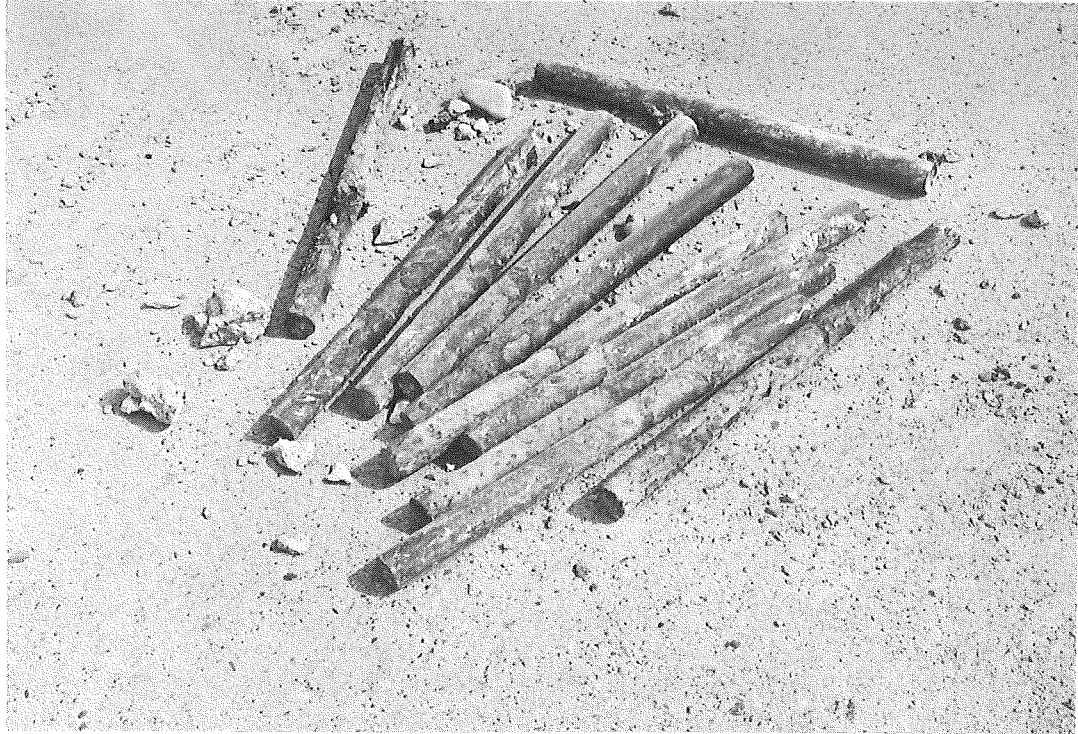
Figure 3. Dowel bars as removed from blown up joint.

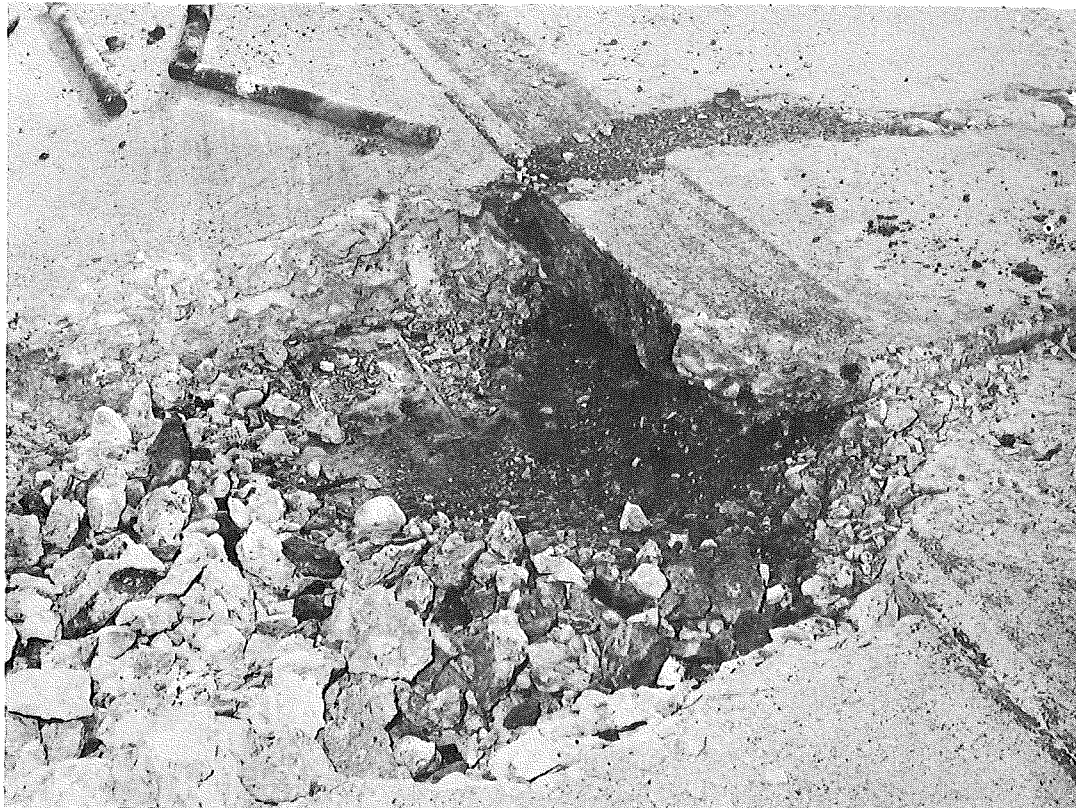
Since the base plate under the joint might impound this salty water, the lower part of the slab would resist longitudinal movement, and the disintegrated joint edge would provide a smaller bearing area to support large, thermally caused compressive stresses.

Figure 4. Intersection of transverse and longitudinal joint exposed during repair. Note decomposed concrete in lower portion of slab.

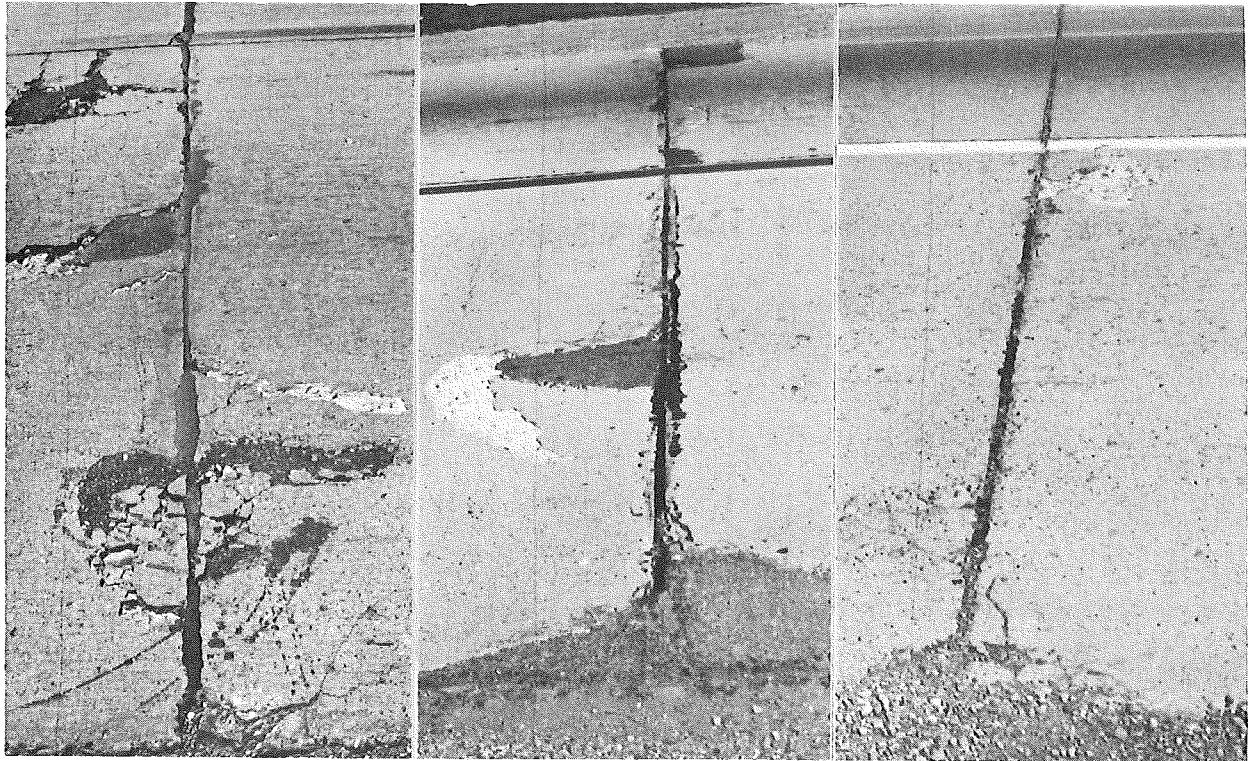
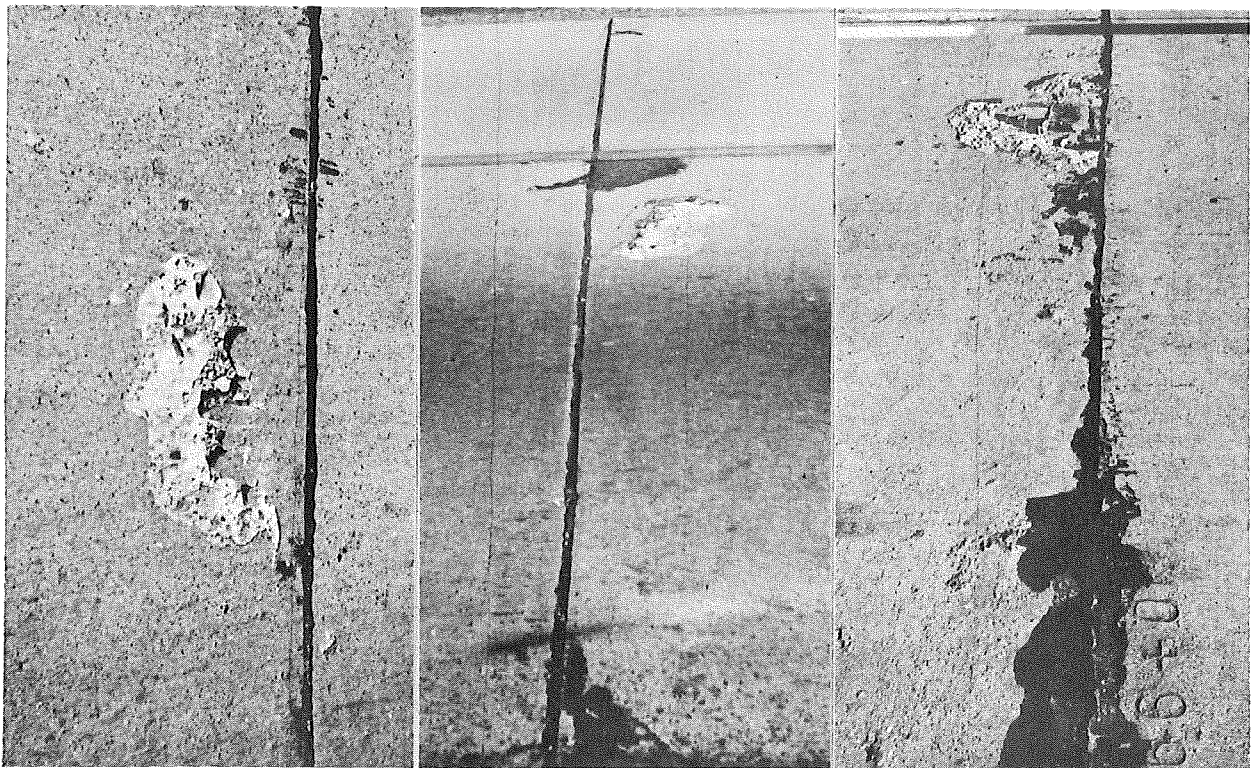
Numerous other joints in the area also appeared to be on the verge of blowup failure (Fig. 5).

Figure 5. Varying degrees of failure were apparent for other joints in this project; joint at upper left is a construction joint, and all others shown are contraction joints.
