R-726

OFFICE MEMORANDUM

MICHIGAN
DEPARTMENT OF STATE HIGHWAYS

Subject: Performance of Latex-Modified Mortar on Concrete Bridge Decks.
Research Project 57 B-39. Research Report No. R-726.

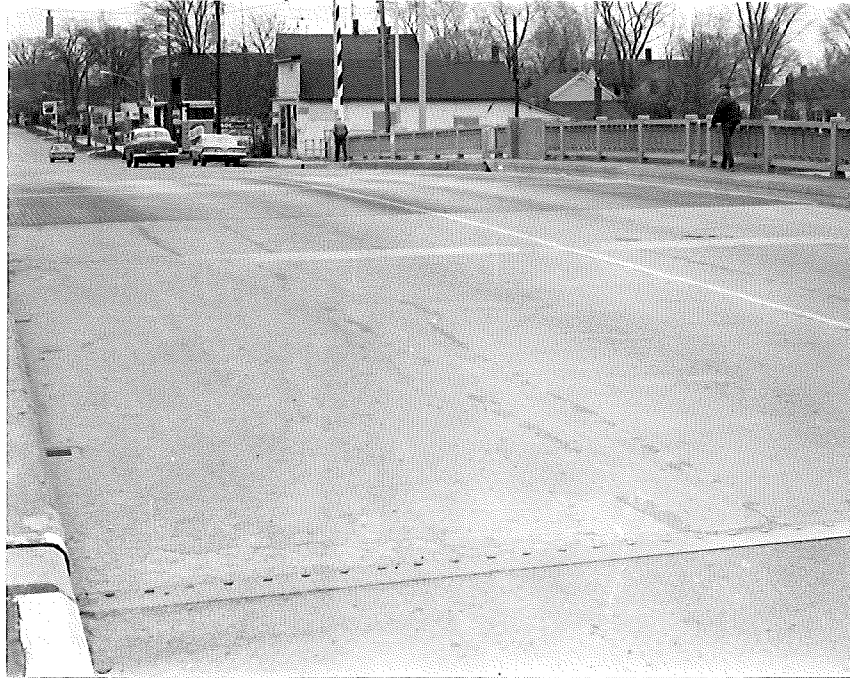
This early test structure has been inspected a number of times; most recently in the summer of 1967 and 1968. Figures 1 through 4 show the current condition of the 5/8- to 3/4-in. latex mortar surfacing which was originally applied in 1957 or replaced in 1958. In general, the latex mortar has maintained its bond to the old substrate for over 11 or 12 years. The end spans, Figures 1 and 4, appear in sound condition as they did in the inspection of 1959. However, Figures 2 and 3 show several areas in the counterweight pours which have lost bond and developed cracks. These areas can be attributed to partial opening of the bascule span and vibration effects during the initial placements in 1957 and 1958.

Figure 1. Latex mortar surfacing on west end span, looking east on US 23.

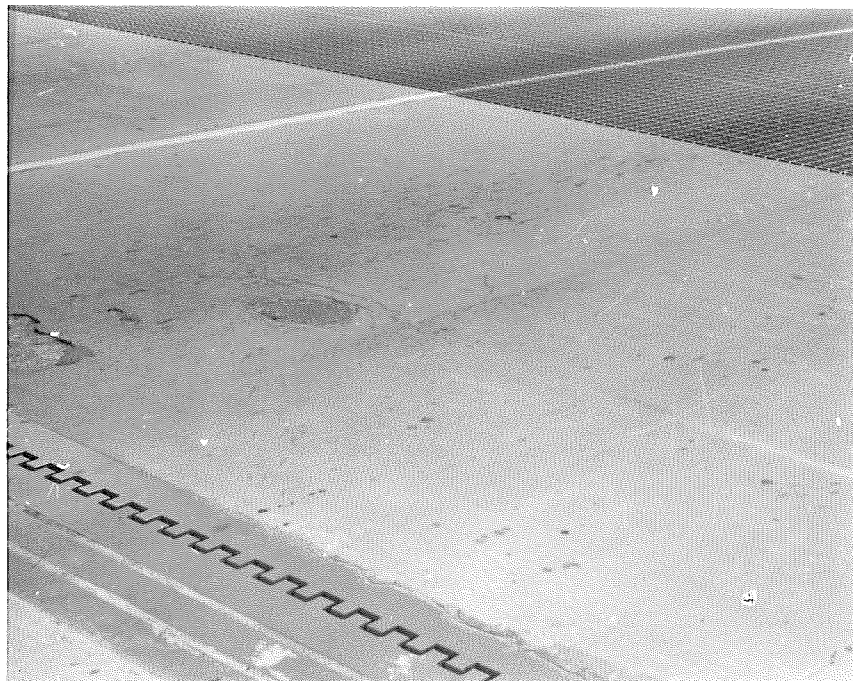
Figure 2. Area in west counterweight span with some loss of bond and cracking of latex mortar surface.

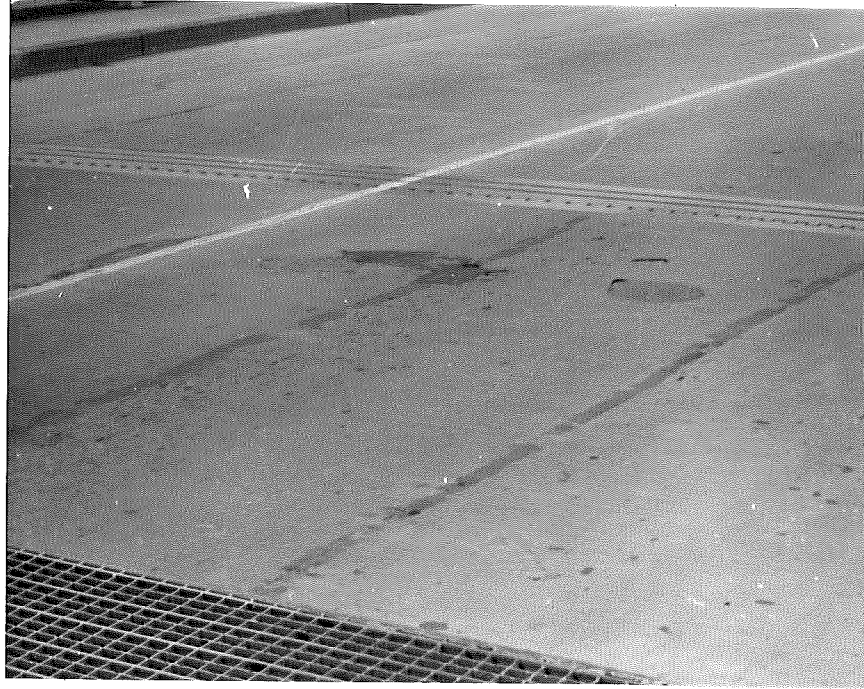
Figure 3. Small area in east counterweight surface with bond loss of latex mortar.

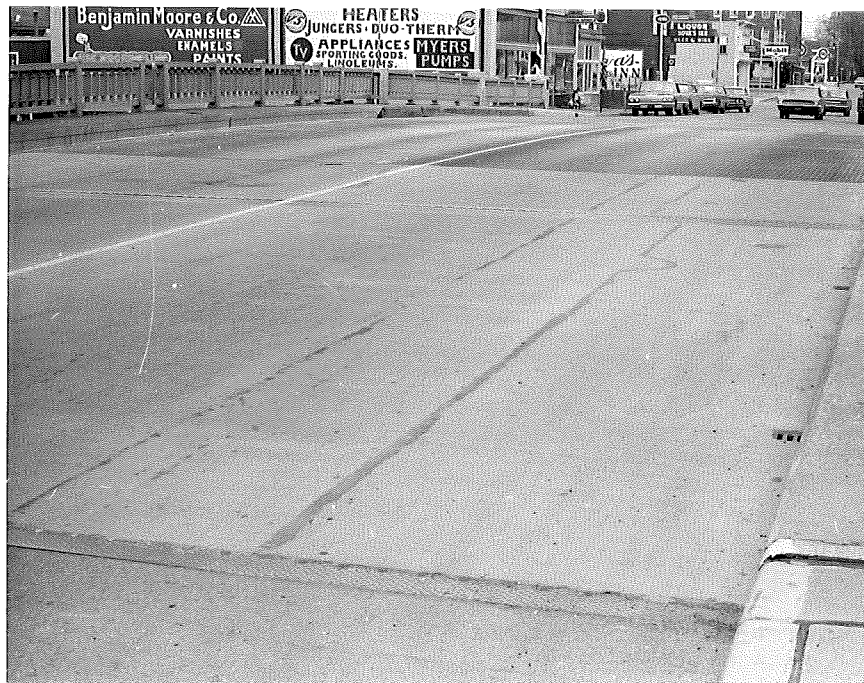
Figure 4. View of east end span and counterweight pour looking west on US 23.

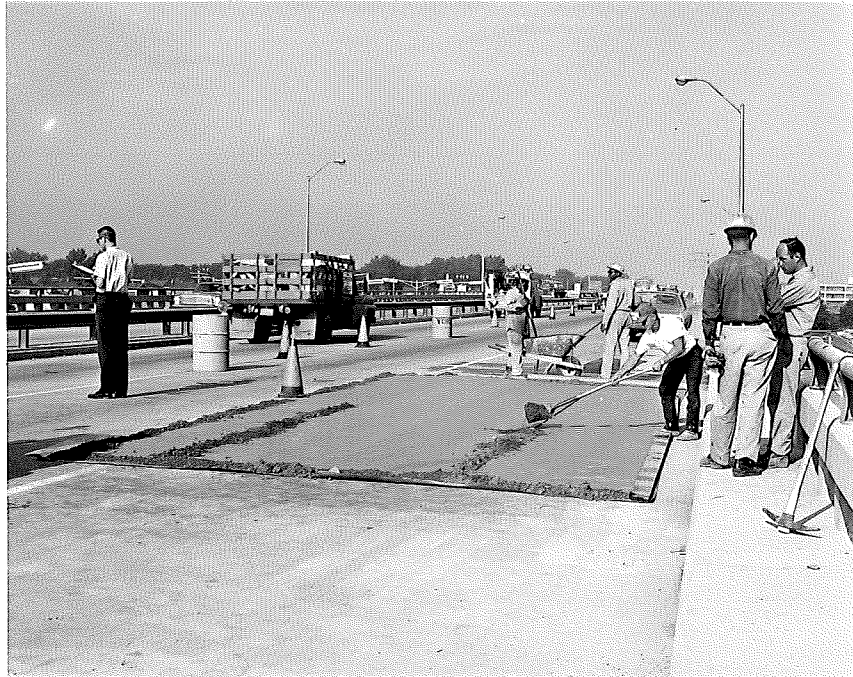
Figure 5 shows a completed 13- by 30-ft patch placed August 14, 1968, in the north lane of span 8 on S34 of 82112 which carries westbound M 102 over I696 in Detroit. This patch repaired a badly spalled area and was saw-cut at the perimeter and chipped out about 2 in. deep by Wayne County personnel. A latex-modified concrete was used containing 1/2-in. gravel, 7 sacks per cu yd of

Wyandotte type 3 cement, 3.5 gal of SM-100 per sack of cement, and 6 to 7 percent entrained air. Thus far, this patch looks very good although some other spalled areas are developing in spans 6 and 8. Figure 6 shows one of these areas in span 8 which has been progressively getting larger. These spalls appear to be developing from shrinkage cracks which were observed to have formed during the initial deck placement on October 11, 1964.

Figure 5. Curing of latex concrete patch in north lane of westbound M 102 (span 8).

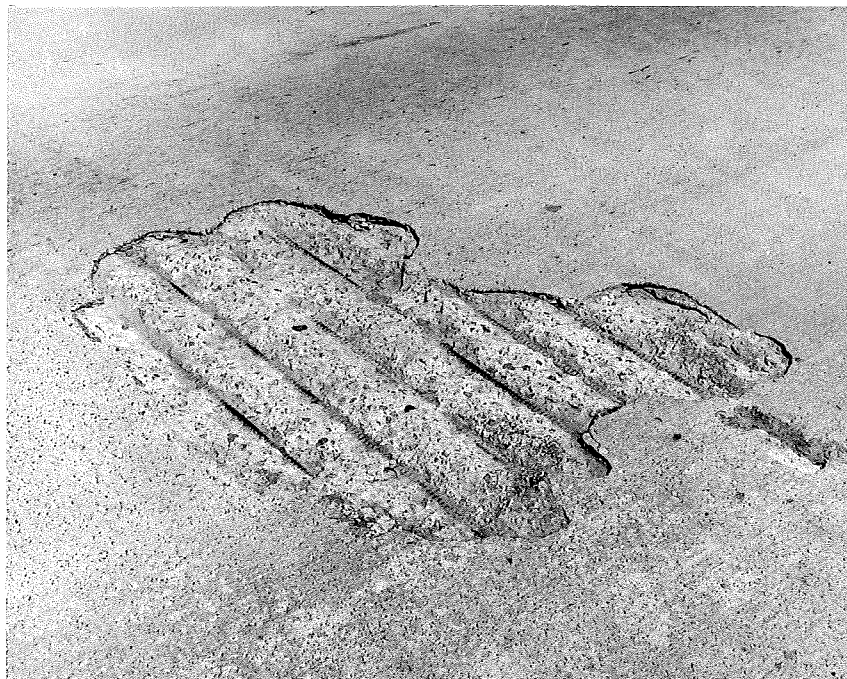
Figure 6. Typical spall development in westbound lane along median adjacent to latex concrete patch (5-1-69).

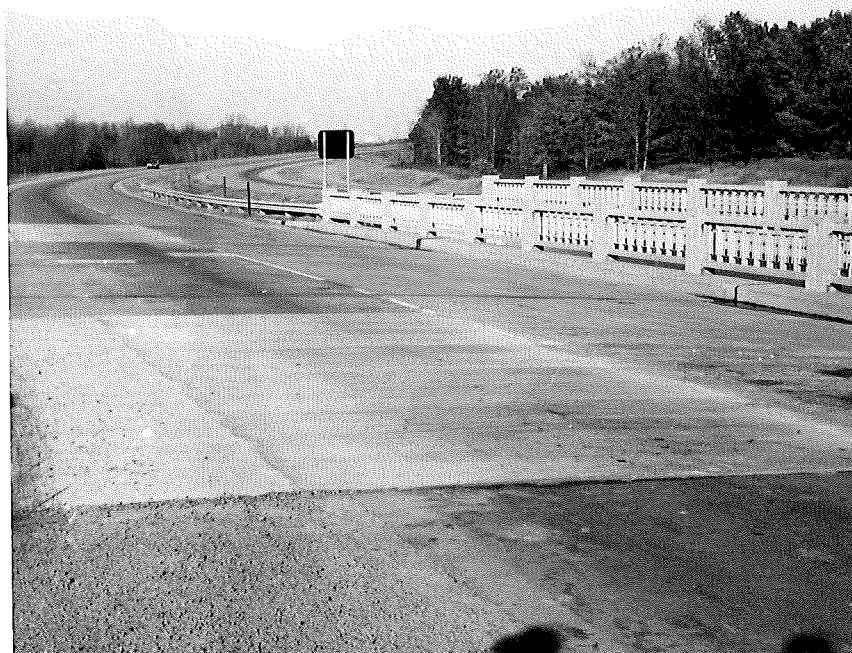
Figure 7 shows three patched areas in the west half of B04 of 38111 which carries southbound US 127 over the Grand River on the east side of Jackson. These areas were prepared by District 8 Maintenance personnel and finished with latex-modified concrete of the same design as used on the M 102 structure. The large patches in spans 1 and 3 were placed on August 23, 1968, and the remainder on August 26, with the deck being opened to traffic on August 30. The patches are currently in sound condition as they are being exposed to their second winter.

Figure 7. Latex concrete patches placed 8-23-68 in southbound US 127 over the Grand River (11-13-68).

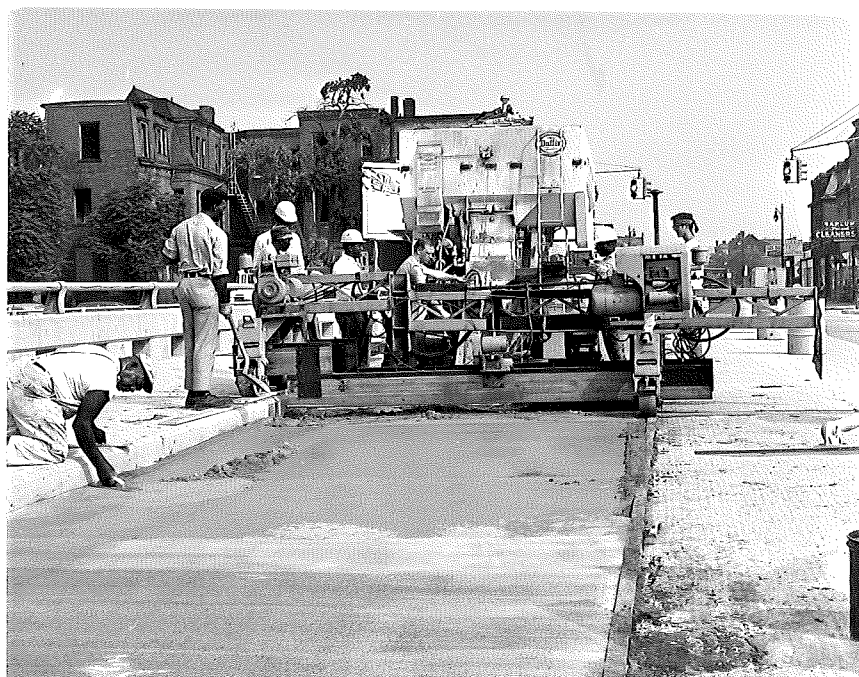
More recently, in 1968 and 1969, about four bridge deck repair projects were done using SM-100 latex-modified mortar or concrete mixed and applied with mobile equipment owned by the Dow Chemical Co. This equipment is shown in Figure 8 and consists of a vehicle which can batch and mix up to 6 cu yds of mortar or concrete and is used in conjunction with a Maginniss self-propelled vibratory screed. The SM-100 liquid latex admixture, as now designated, is essentially the same as the Dow 560 used at Cheboygan, with the addition of a defoamer so the SM-100 can now be used with air-entrained cement.

The most recent latex-modified placements which we have followed, were applied in the summer of 1969 on John R and Brush Streets over I 75 in Detroit. These two structures S 26 and S 27 of 82195, were scarified 1/4 in. deep with a Tennant model G-12 machine, sandblasted, and then surfaced with 1 in. of an SM-100 latex mortar using the Dow mixing-finishing equipment previously described. An MDSH Supplemental Specification, dated 3-28-69, was prepared and used for these two projects. The latex mortar was applied to these structures to add about 3/4 in. of cover to the top steel which was too shallow in some areas. Figure 8 shows the Dow batching and mixing truck ahead of the self-propelled vibratory screed placing the first 11-ft wide pass along the west curb of the Brush Street structure on July 16, 1969. The rest of the surfacing was placed on July 17, August 7, 8, 19, and 21. The John R Structure was similarly surfaced on July 25, 30, and August 13, 14, and 21. About 15.8 square yards of the latex mortar had to be re-done on the two structures where loss of bond was discovered. These small areas were primarily at the ends of the structures where the latex mortar was carried 2 feet beyond the end joints without providing for early movement under the new mortar.

Figure 8. Latex mortar surfacing being placed with vibratory screed and batching and mixing truck. West lane of Brush Street over I 75 (7-16-69).
