# OFFICE MEMORANDUM

MICHIGAN  
STATE HIGHWAY DEPARTMENT

Subject: Curb and Median Joint Sealing to Correct Deck Leakage: Houghton-Hancock Lift Bridge (B01 of 31012). Research Project R-62 B-66. Report No. R-402.

SUMMARY OF JOINT SEALING OPERATIONS  
Houghton-Hancock Bridge, Span 6

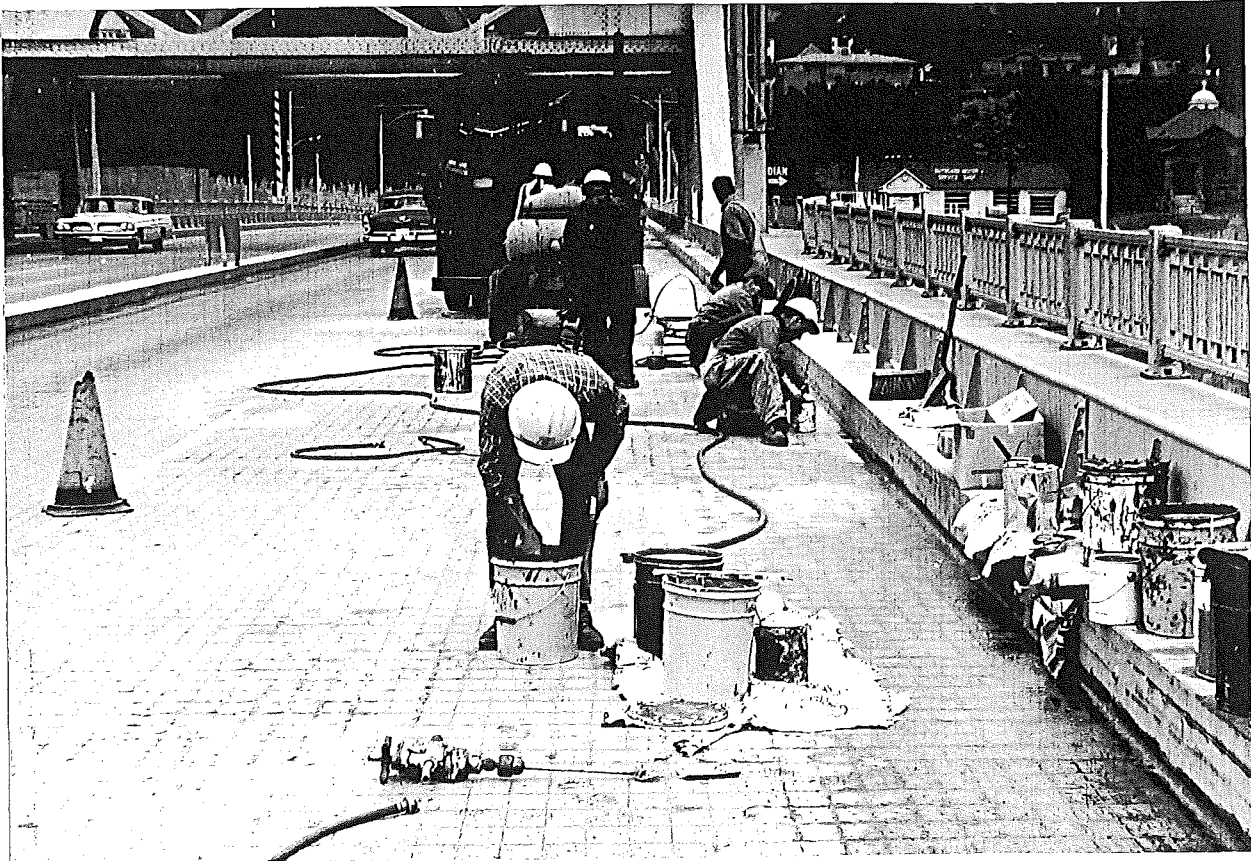
Figure 1. Sandblasting, priming, and mixing operations during joint sealing on the east curb, northbound lanes.

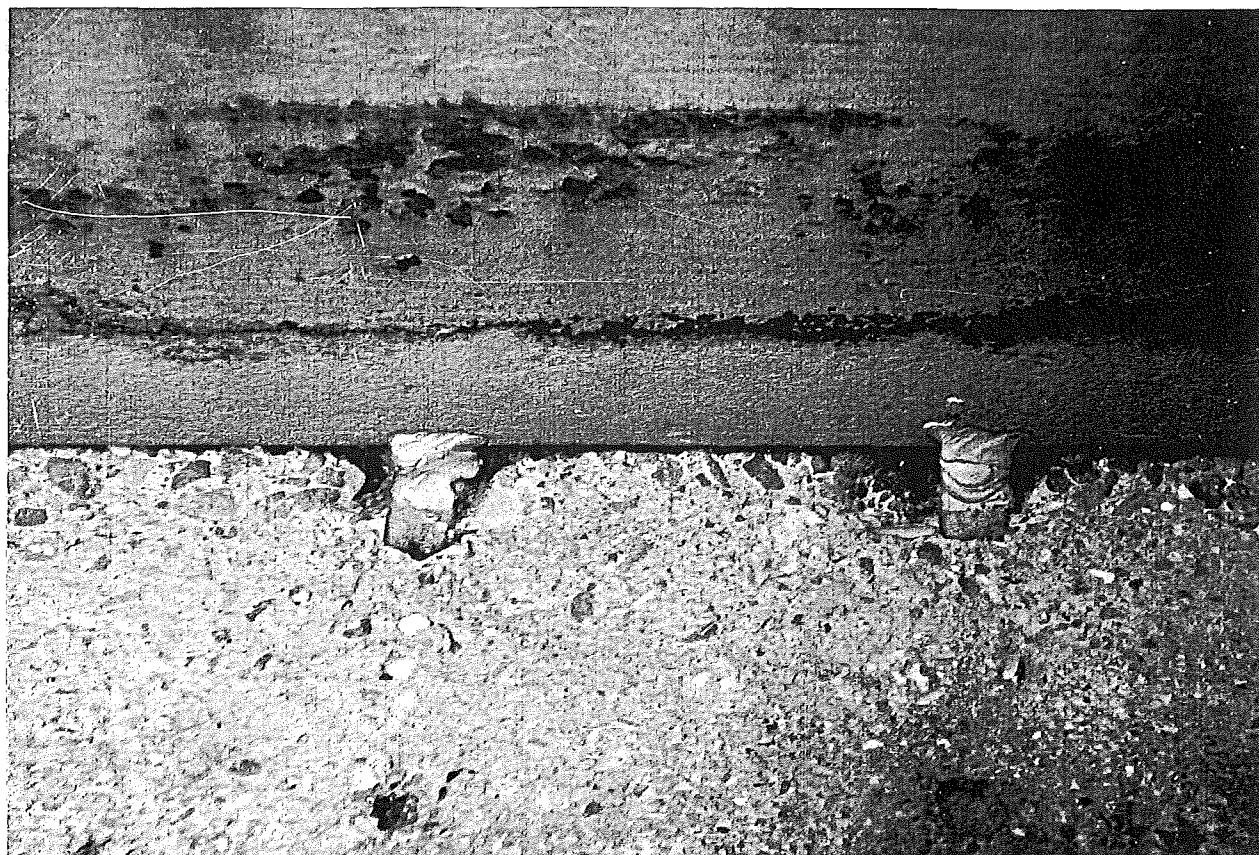
Figure 2. East curb joint after sandblasting, showing transverse steel welds made previously by maintenance crew.

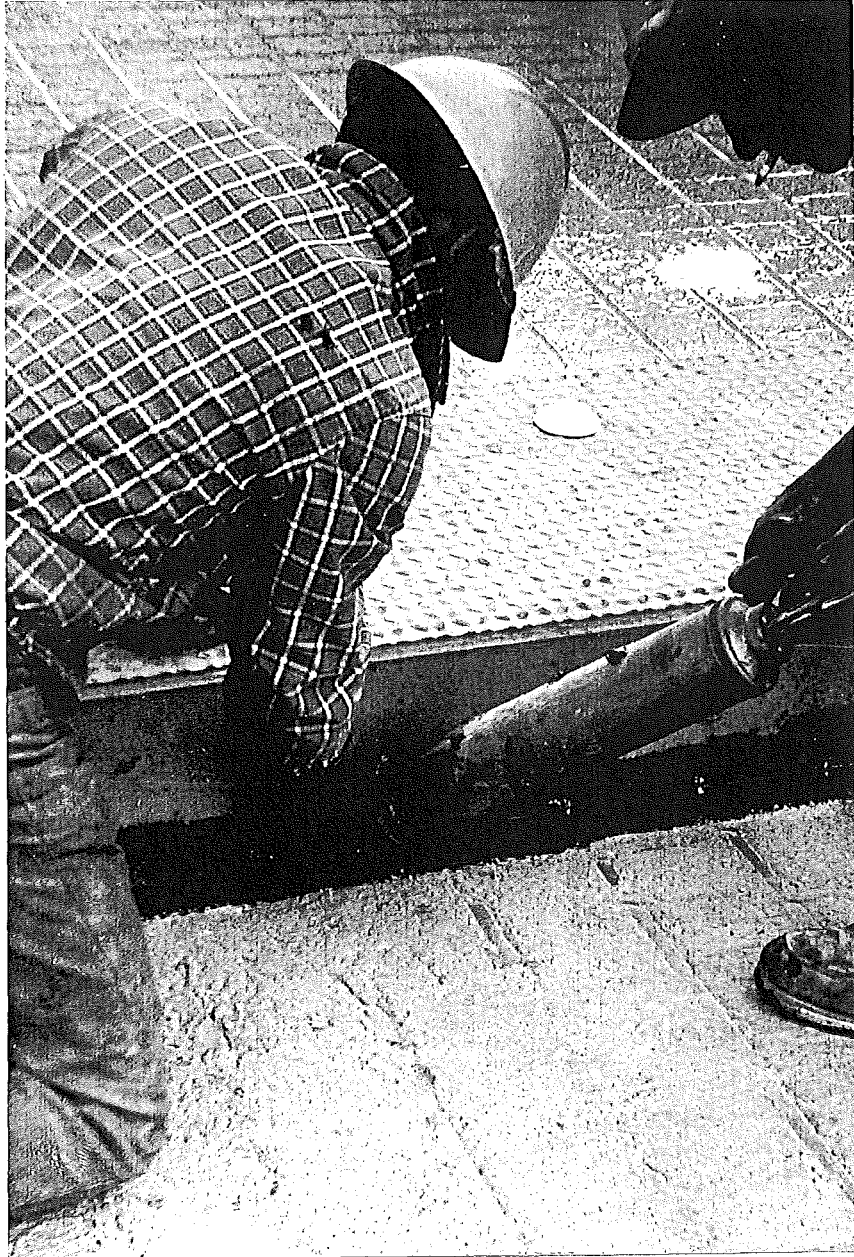
Figure 3. Sealing median curb joint with 2.5-quart caulking gun.

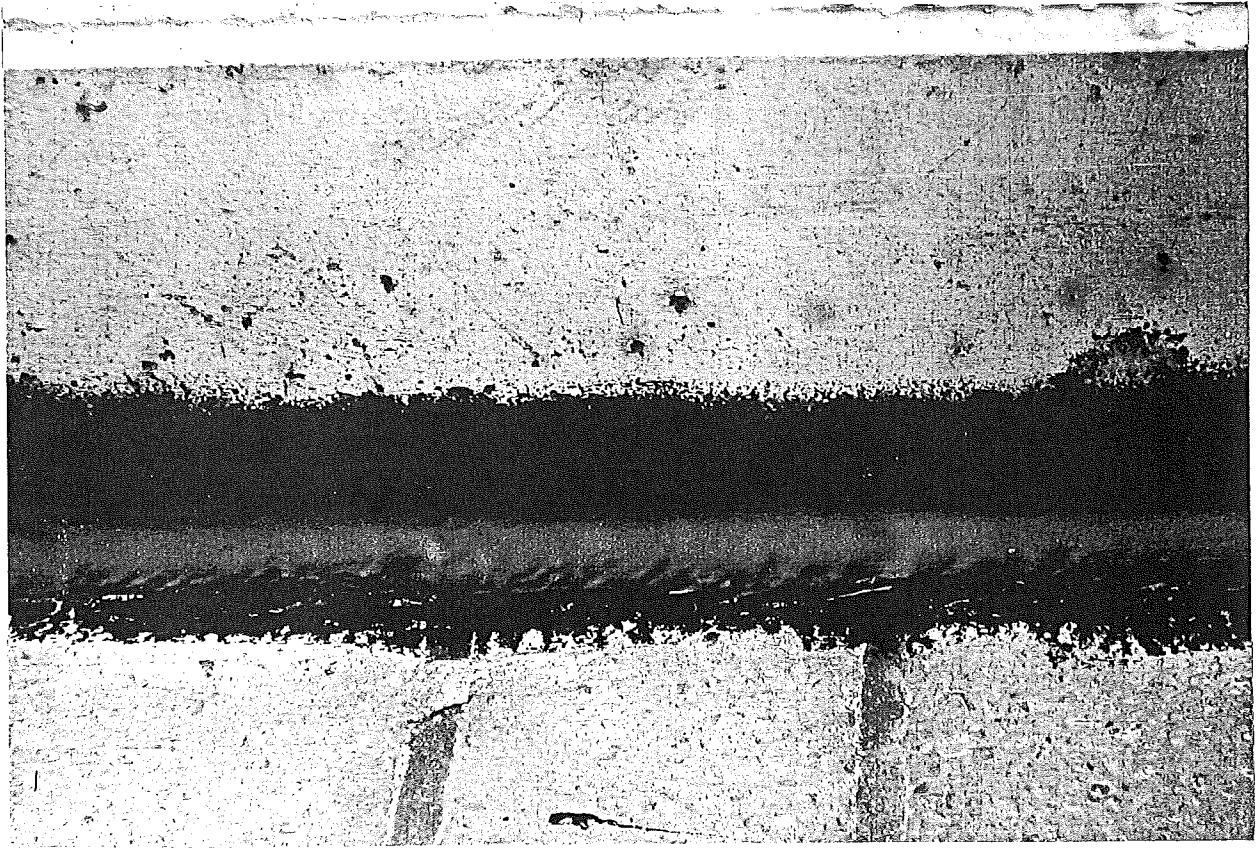
Figure 4. Finished curb joint after priming and sealing.
