PARA-PLASTIC JOINT SEALING COMPOUNDS

Research Project 36 G-4 (3)

Research Laboratory
Testing and Research Laboratory
Report No. 53
June 2, 1944

SUBJECT: Report on Para-Plastic Joint Seal Material
Expansion Joint Seal Study 36-G-4

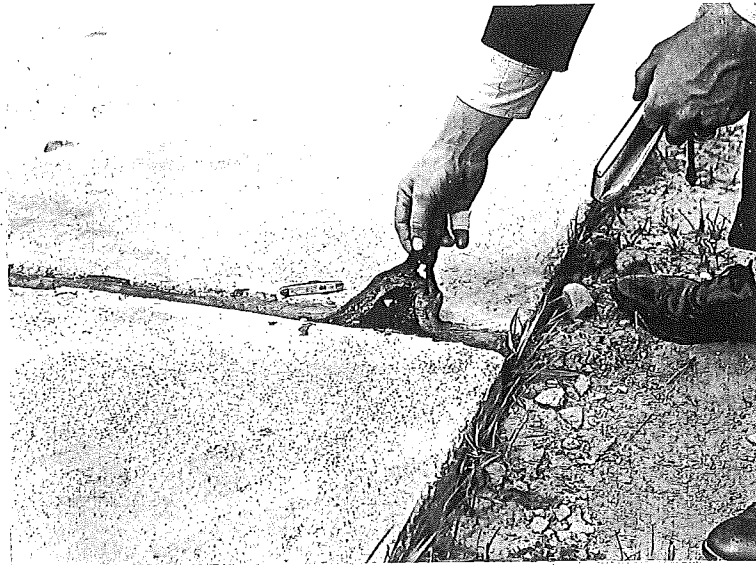
After two years of service the para-plastic material appeared live, plastic, and displayed considerable cohesion as illustrated in Figure 1 and 2. However, its bonding characteristics with the concrete were unusually poor and dirt penetrated into the joint as illustrated in Figures 3 and 4. Why such a condition developed is difficult to state. Although the pavement was 2 years old at the time of application of the Para-Plastic compound, the joints were free of bituminous material since a premolded rubber joint seal was used previously. Also the joints were carefully cleaned and dried before the material was installed. The compound showed a tendency to adhere to the joint filler underneath.

1. 36 G-4(G) Michigan Test Road. Paraplasic joint seal. 5-11-44. Station 166+10. View showing plasticity of material which was installed summer 1942. Material in itself is in a fair state of preservation. Material has high degree of cohesion.

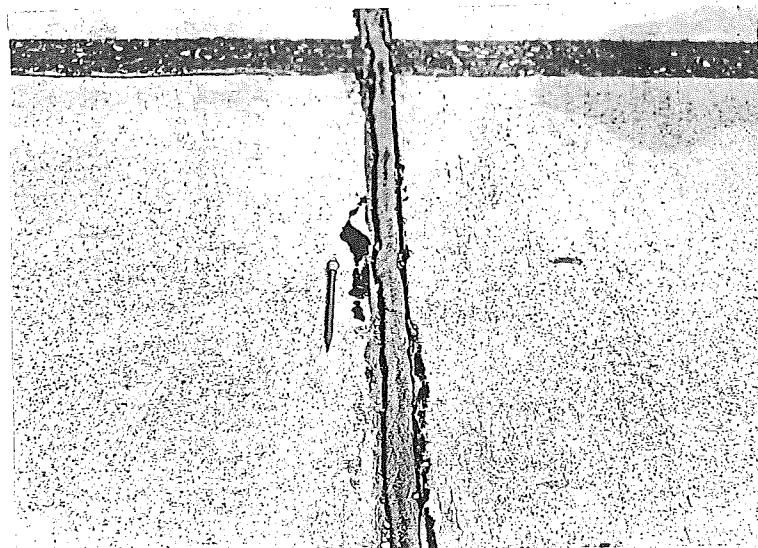
2. 36 G-4(G) Michigan Test Road. Paraplasic joint seal. 5-11-44. Station 166+10. Note lack of bond between cement and material. Note unusual tendency for material to curl away from the cement allowing sand and dirt to enter joint. There is a certain amount of adhesion between joint sealer and joint filler underneath.

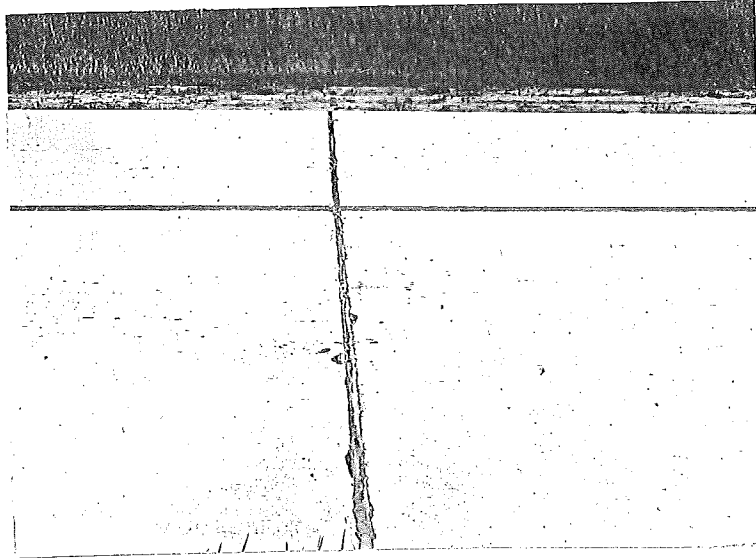
3. 36 G-4(G) Michigan Test Road. 5-11-44. Station 167+10. General view of joint with para-plastic joint seal. E.A.F.

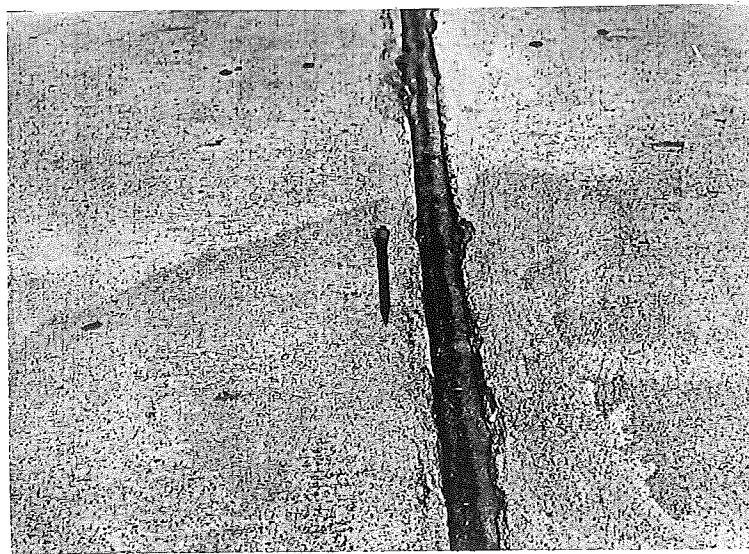
4. 36 G-4(G) Michigan Test Road. 5-11-44. Station 168+10. Typical view of para-plastic joint seal under best conditions. Note lack of bond between material and cement.

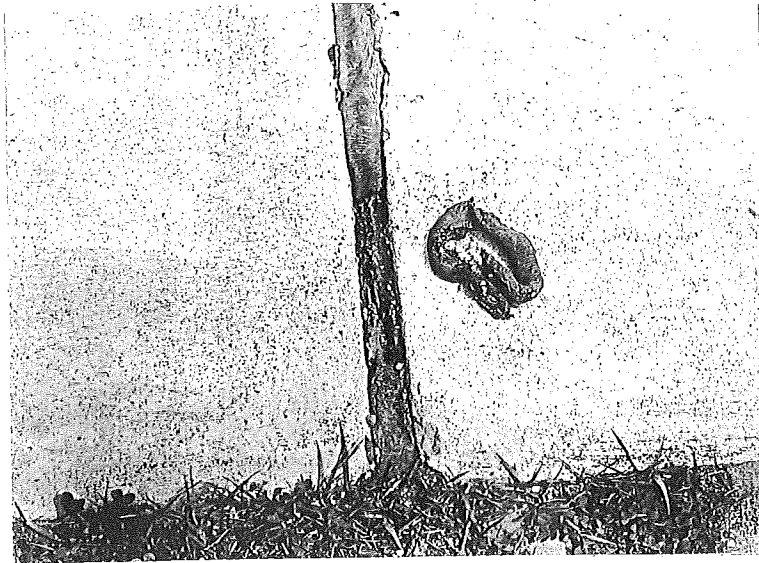
5. 36 G-4(G) Michigan Test Road. 5-11-44. Station 169+10. View showing condition of joint underneath the seal. Note sealing material is live and resilient but lack bonding properties.

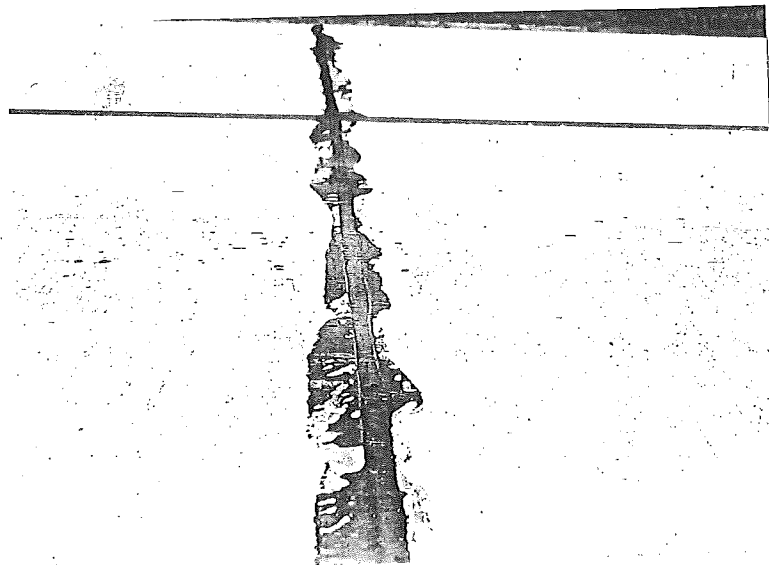
6. 36 G-4(G) Michigan Test Road. Thermoplastic seal. 5-11-44. Station 185+50. General view of thermoplastic seal material after 4 years. 100% perfect bond. No subsequent maintenance after installation. Material had considerable plasticity.

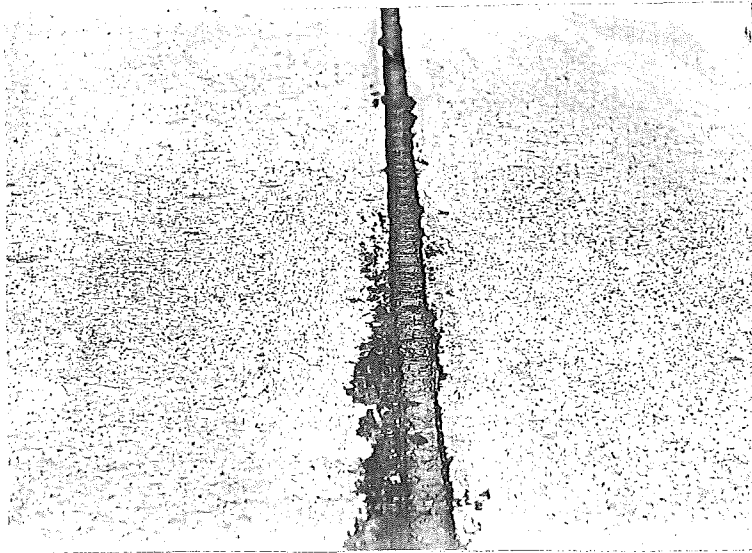
The Asphaltic Oil-Vultex was installed in series 4-6-7-8 and parts B1 and B2 of Series 10 during construction of Michigan Test Road. After 4 years in service the Asphaltic Oil-Vultex material was found to be extremely live and adhered perfectly to the concrete throughout the entire length of the joints as illustrated in Figures 5 and 6. This material has received no subsequent maintenance of any kind since installation.

7. 36 G-4(G) Michigan Test Road. Oil-Vultex Seal
5-11-44. Station 199+90. After 4 years material is
in excellent condition, 100% bonding, very plastic
and adheres somewhat to finger upon penetration. No
subsequent maintenance after installation.

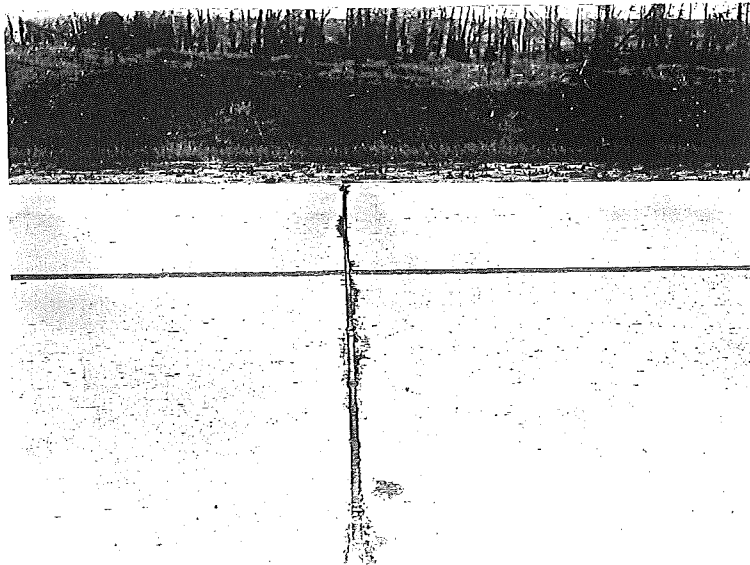
8. 36 G-4(G) Michigan Test Road. 5-11-44, Sta-
tion 199+90. General view of oil-vultex joint
seal installation.
