SPUN-CONCRETE LIGHT POLES,
I 96 AND I 296 KENT COUNTY

Research Laboratory Section
Testing and Research Division
Research Project 70 TI-7
Research Report No. R-732

State of Michigan
Department of State Highways
Lansing, March 1970

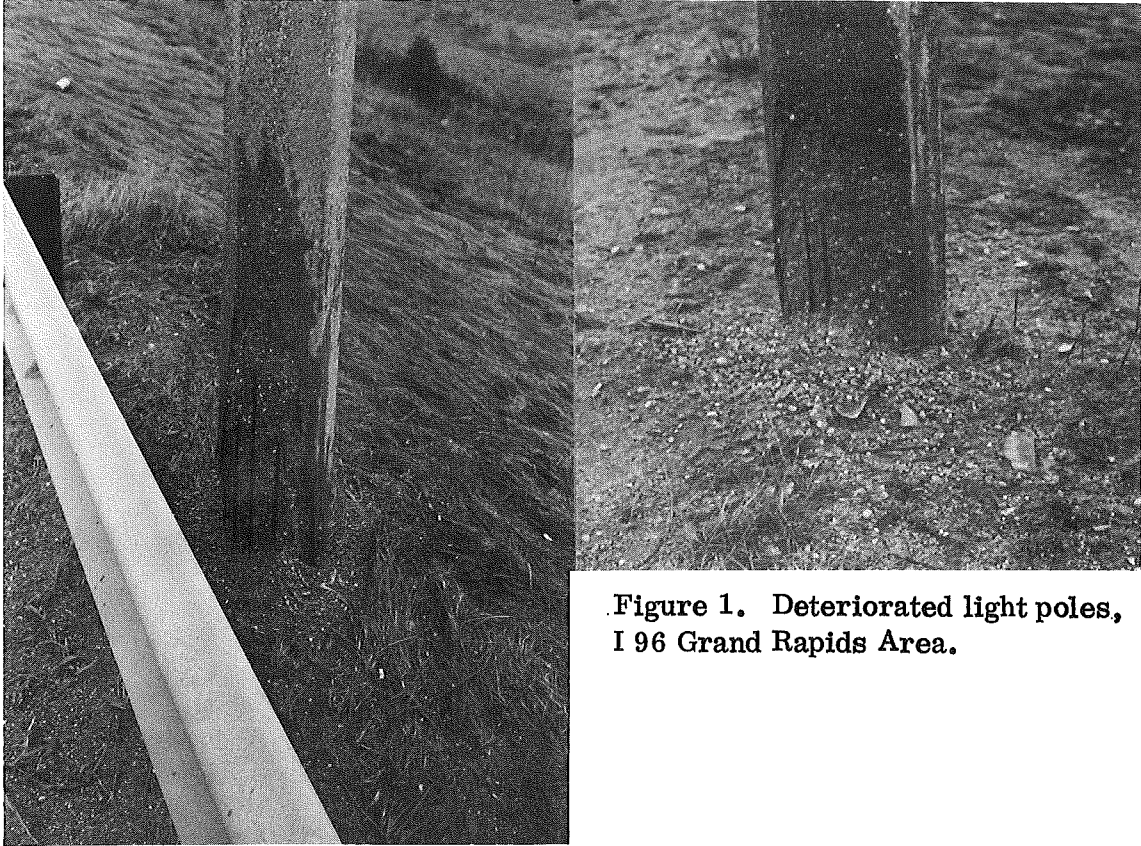
Several spun-concrete light poles were found to be in a seriously deteriorated condition, apparently as a result of exposure to ice-control chemicals (Fig. 1). Two of the poles are known to have fallen during the past few weeks. Figure 2 shows a fallen pole located near the I 96 and US 131 intersection.

**Figure 1. Deteriorated light poles,
I 96 Grand Rapids Area.**

It is recommended that an inspection of all concrete lightpoles be made immediately and any that are badly deteriorated be taken down immediately or, at the very least, their light brackets removed immediately to reduce the compressive stress in the pole. Further, an annual or biannual inspection of all concrete poles should be made to detect those which deteriorate in the future.

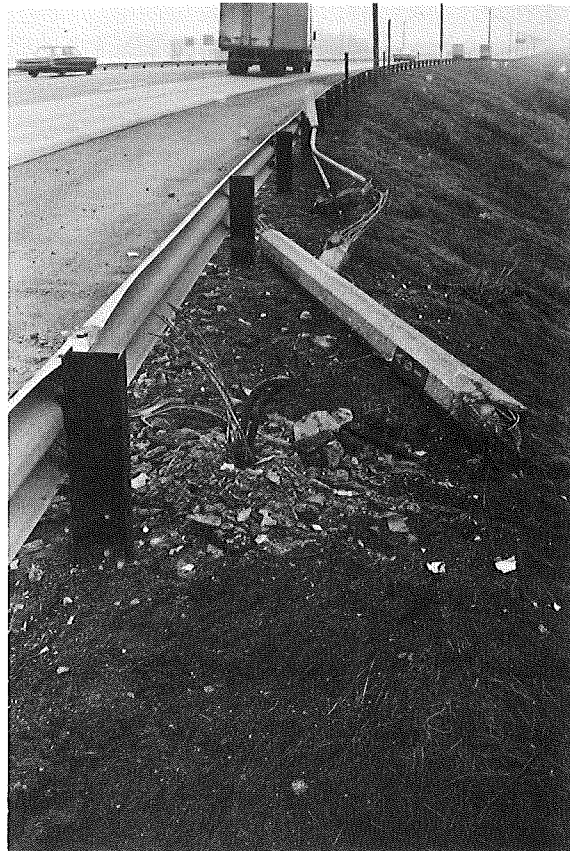
**Figure 2. Fallen light pole I 96 near
Intersection with US 131. Note dent
in top of guardrail where pole fell
onto pavement.**

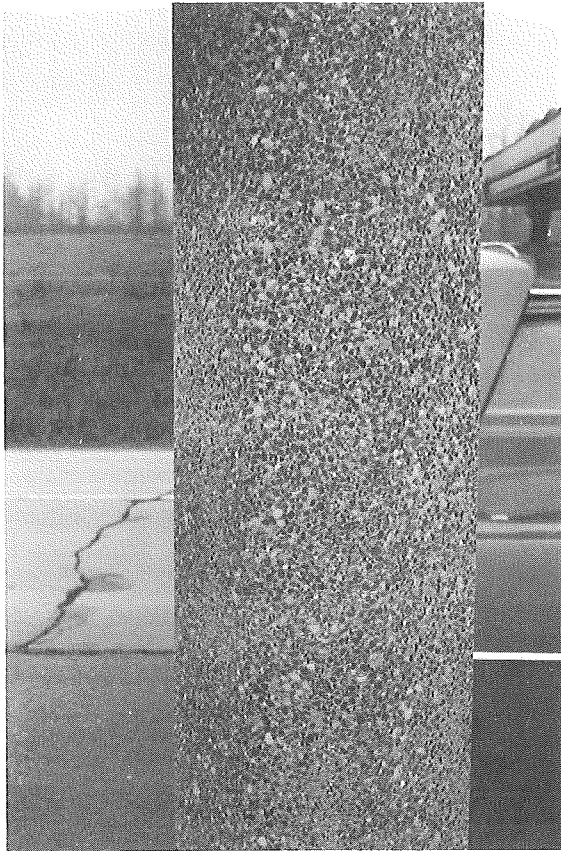
Laboratory examination of concrete samples from the pole showed several particles of deleterious aggregate which contributed to accelerated deterioration. The surface of the poles had been polished or etched; a process which removes the protective "skin" from the concrete and makes it more susceptible to deterioration by environmental action (Fig. 3). Also, there appeared to be no air entrainment in the concrete to resist freeze-thaw action. To make the situation even worse, the mortar appeared to be of poor quality (probably high water-cement ratio) as evidenced by the large number of aggregate particles that pulled out of the mass when it was being sawed and polished for observation under the microscope.

Figure 3. Typical ground polished or etched finish on light pole.

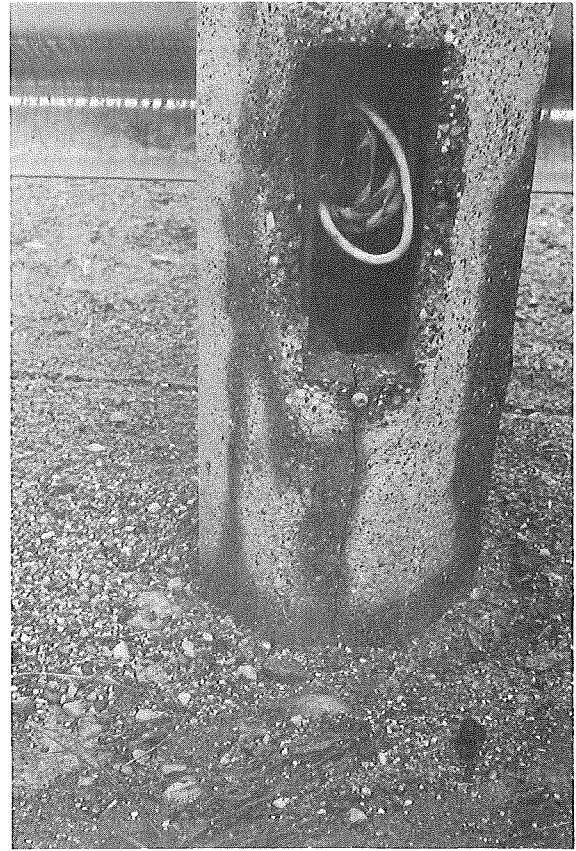
A different type of hazard was noted on several poles where missing cover plates permitted easy access into the wiring hand hole where the danger of electrical shock exists (Fig. 4).

Figure 4. Wiring hand hole with missing cover plate. Note vertical cracks in pole typical of those where side facing street has deteriorated.
