EXPERIMENTAL SHORING TO REDUCE  
VIBRATION DURING BRIDGE DECK WIDENING  
Progress Report: 9-year performance

Research Laboratory Section  
Testing and Research Division  
Research Project 65 F-84  
Research Report No. R-951

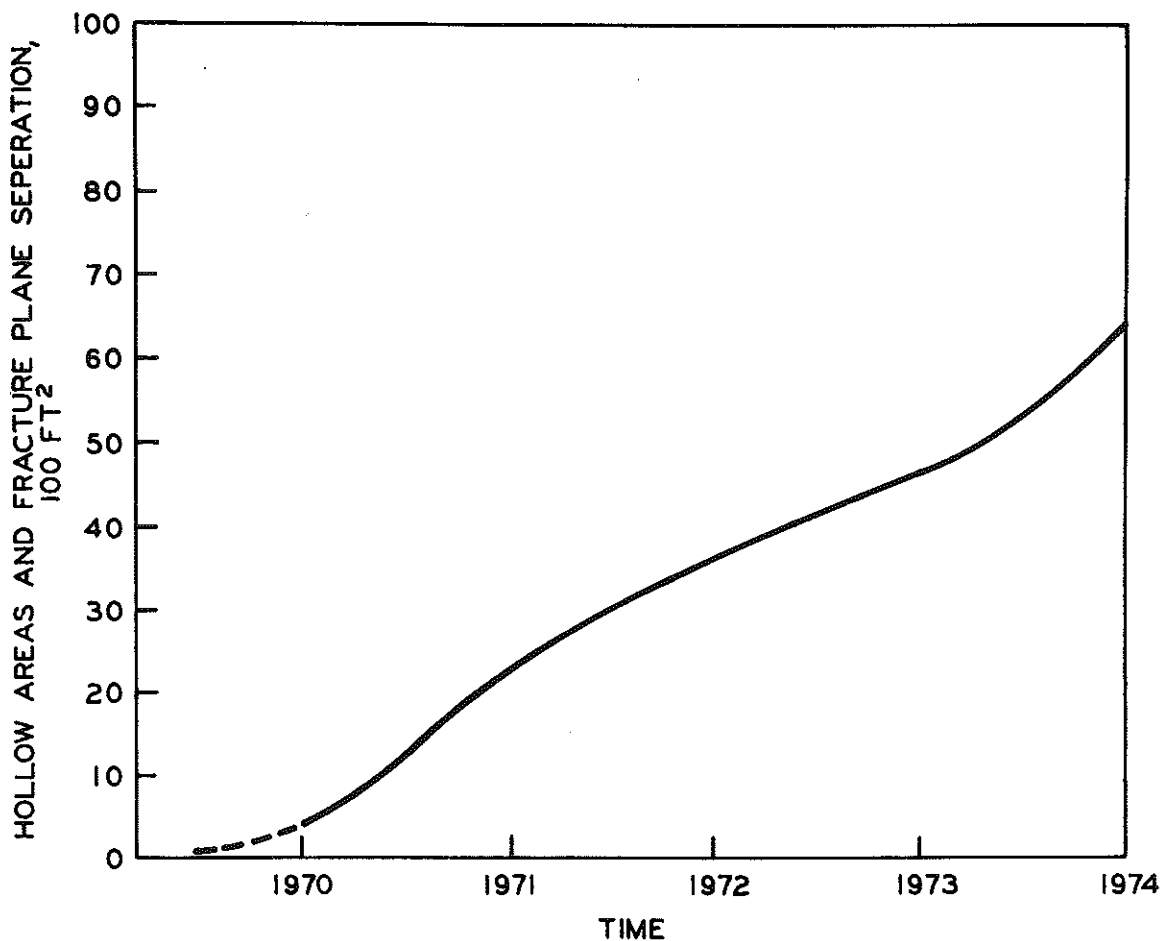
Figure 1. Deterioration vs. time. Summation for 30 structures from Table 2.

Generally, the 1974 survey showed an increase in deterioration on 17 of the 34 structures with the increase in hollow areas being the most dominant. Figure 1 shows the progression of hollow areas and fracture plane deterioration with time. Structures S01 of 11016 WB and EB decks have been resurfaced with a latex concrete overlay since the 1973 inspection. This was due to extensive deterioration of the original deck, which was not included in our surveys of the widened portion.
