***INSPECTION AND PERFORMANCE  
EVALUATION OF PREFABRICATED  
DRAINAGE SYSTEM (PDS)***

**INSPECTION AND PERFORMANCE EVALUATION OF  
PREFABRICATED DRAINAGE SYSTEM (PDS)  
IN COOPERATION WITH MONSANTO COMPANY**

Final Report

Testing and Research Section  
Construction and Technology Division  
Research Project 92 TI-1616  
Research Report R-1341

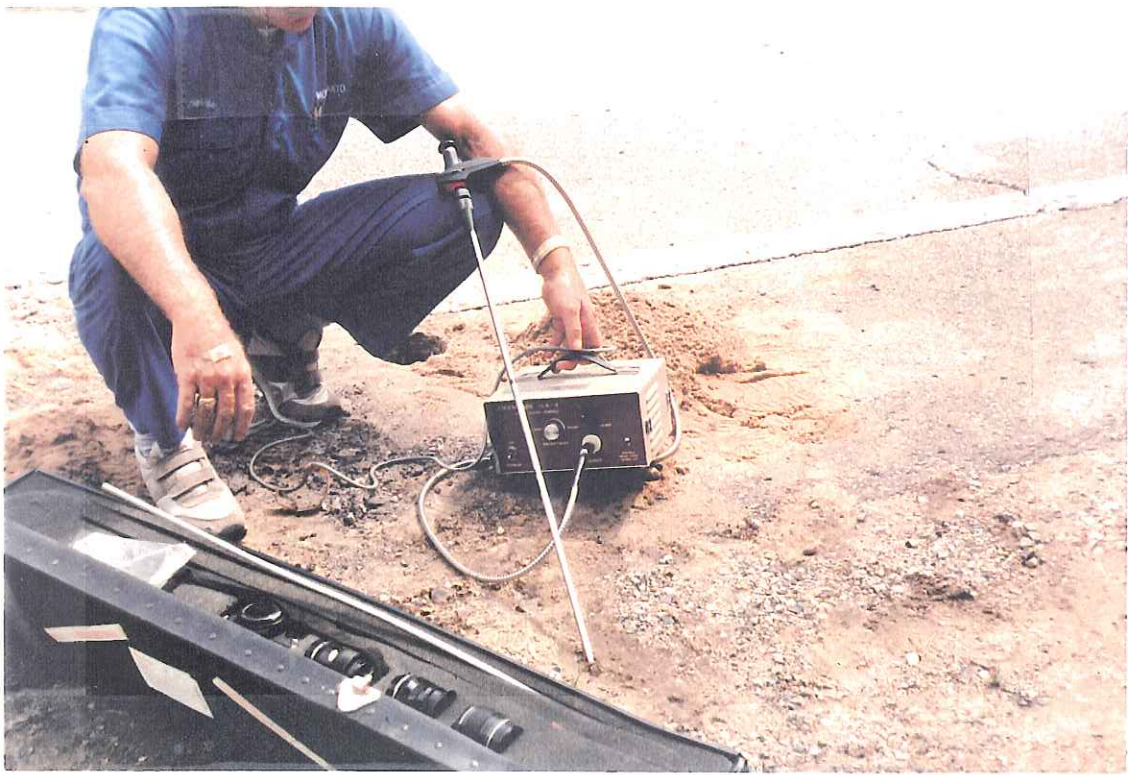
FIGURE 1

Borescope and power source used in the inspection of the Prefabricated Drainage Systems (PDS)

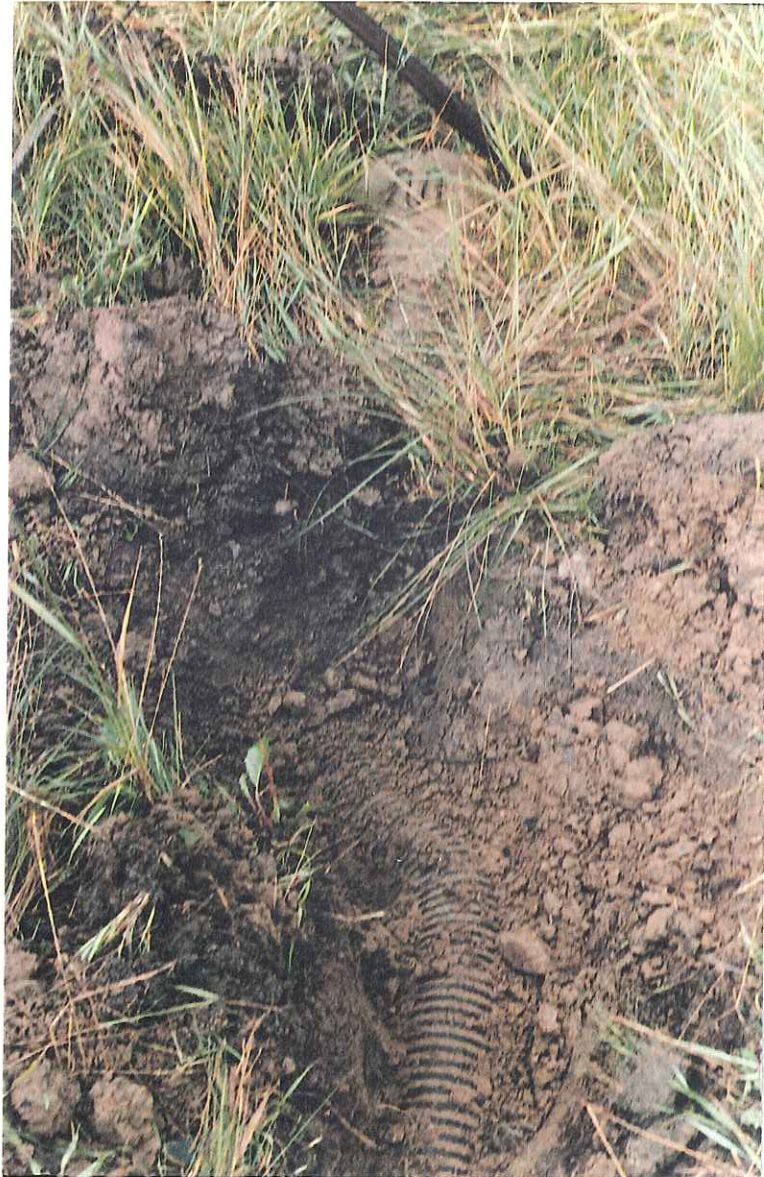
FIGURE 3

1. The PDS was placed at an improper grade and position in the trench that prevented drain water from flowing continuously through the PDS to the outlet pipe.
2. The outlet pipe and headwall/endsection were improperly aligned and not set to grade to provide a positive outlet for the water.
3. Most of the outlet pipes and/or endsections were not kept cleaned out during and after construction to provide an unobstructed outlet for the PDS water.
4. There was no marker locating the outlet pipe or the headwall to perform maintenance inspections and cleanout.
5. The outlet ditch and the mainline ditch were not maintained to provide an unobstructed outlet for the discharge water.

The flexible outlet pipe for PDS was improperly installed. There is a in S curve in the pipe.

The outlet pipe for the underdrains (trench type or PDS) should be changed to allow only rigid PVC or corrugated steel pipe. Also, the section of pipe in the headwall/endsection must be the same type of pipe as used for the outlet pipe. This will help assure a good connection between the outlet pipe and the headwall/endsection.

The outlet pipe grade should be increased from a minimum of 2% to 4% to better ensure a positive discharge.

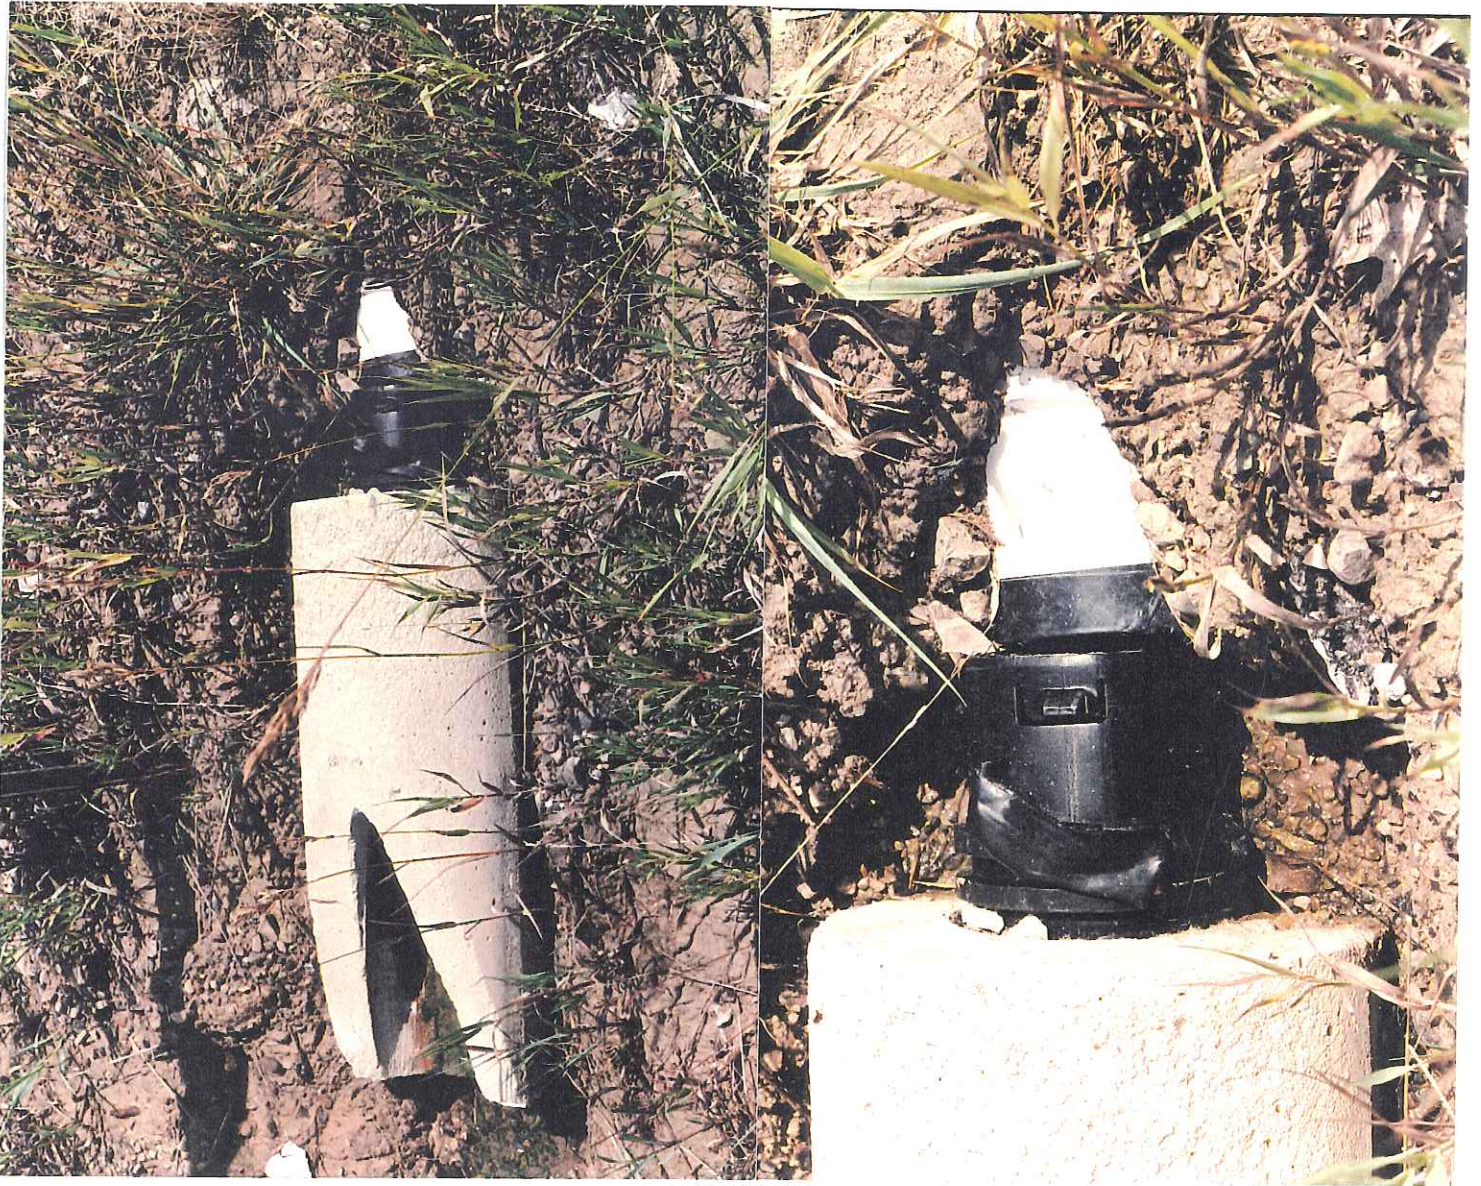
FIGURE 4

At most of the project sites, the headwalls/endsections for the outlet pipes for the PDS were partially covered with topsoil or overgrown with grass. The headwalls/endsections were almost impossible to find if a drainage marker post was not next to the headwall/endsection. One outlet (M-68 Project #3 Site #2) had no drainage marker post and the headwall/endsection was covered with 0.6 m (2 ft) of embankment. At another site (I-75 Project #9 Site #1), the outlet pipe and headwall/endsection was plugged with dirt, but after cleanout there was no water flow. The I-75 outlet pipe was then excavated to check on the installation of the outlet pipe and it was found that it had been improperly installed (Figure 3). Also, there was a site (I-75 Project #11 Site #1) where the headwall/endsection had been separated from the outlet pipe (Figure 4).

Endsection of the outlet pipe for the PDS has become separated from outlet pipe.

Close-up of the endsection of the outlet pipe for the PDS separated from the outlet pipe.

The area around the headwall/endsection should have stone riprap placed on a geotextile blanket to keep the grass away from the headwall/endsection and to provide for a clear discharge path to the ditch.
