MICHIGAN
DEPARTMENT OF STATE HIGHWAYS

August 2, 1971

Subject: Determination of Extent of Fire Damage to Span 7 of X03 of 25042.
(Ramp B over GT&W RR and I 75 at the I 75 - M 78 Interchange, southwest of Flint.) Research Project 71 TI-28. Research Report No. R-774.

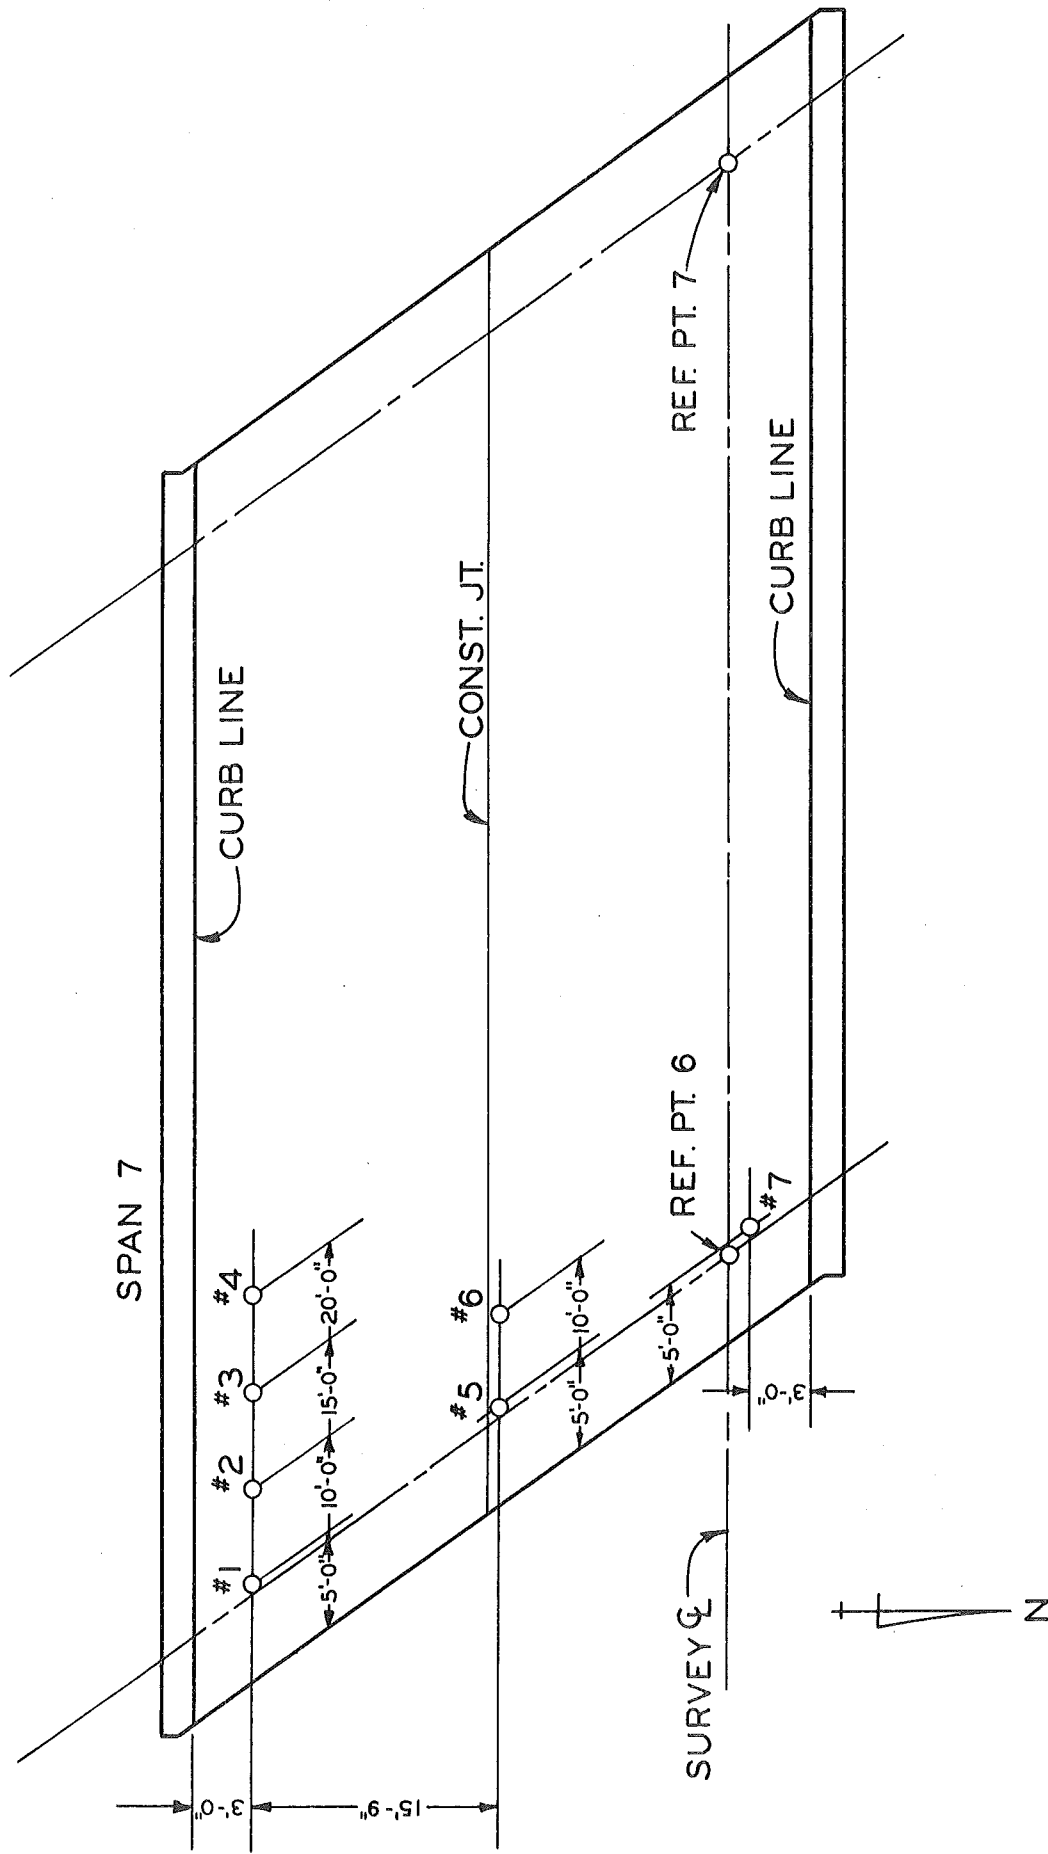
Spans 5 and 6 of the subject bridge were destroyed by a gasoline tanker truck fire on January 14, 1971. In a letter of March 30, 1971 to Max N. Clyde, M. Rothstein requested that cores be drilled from the east end of span 7 to determine the extent of fire damage to the concrete. On April 5 and 6, seven cores were cut at the locations shown in Figure 1, and delivered to the Research Laboratory for examination and testing.

Figure 1. Core location plan X03 of 25042D (Ramp B over GTWRR and I 75).

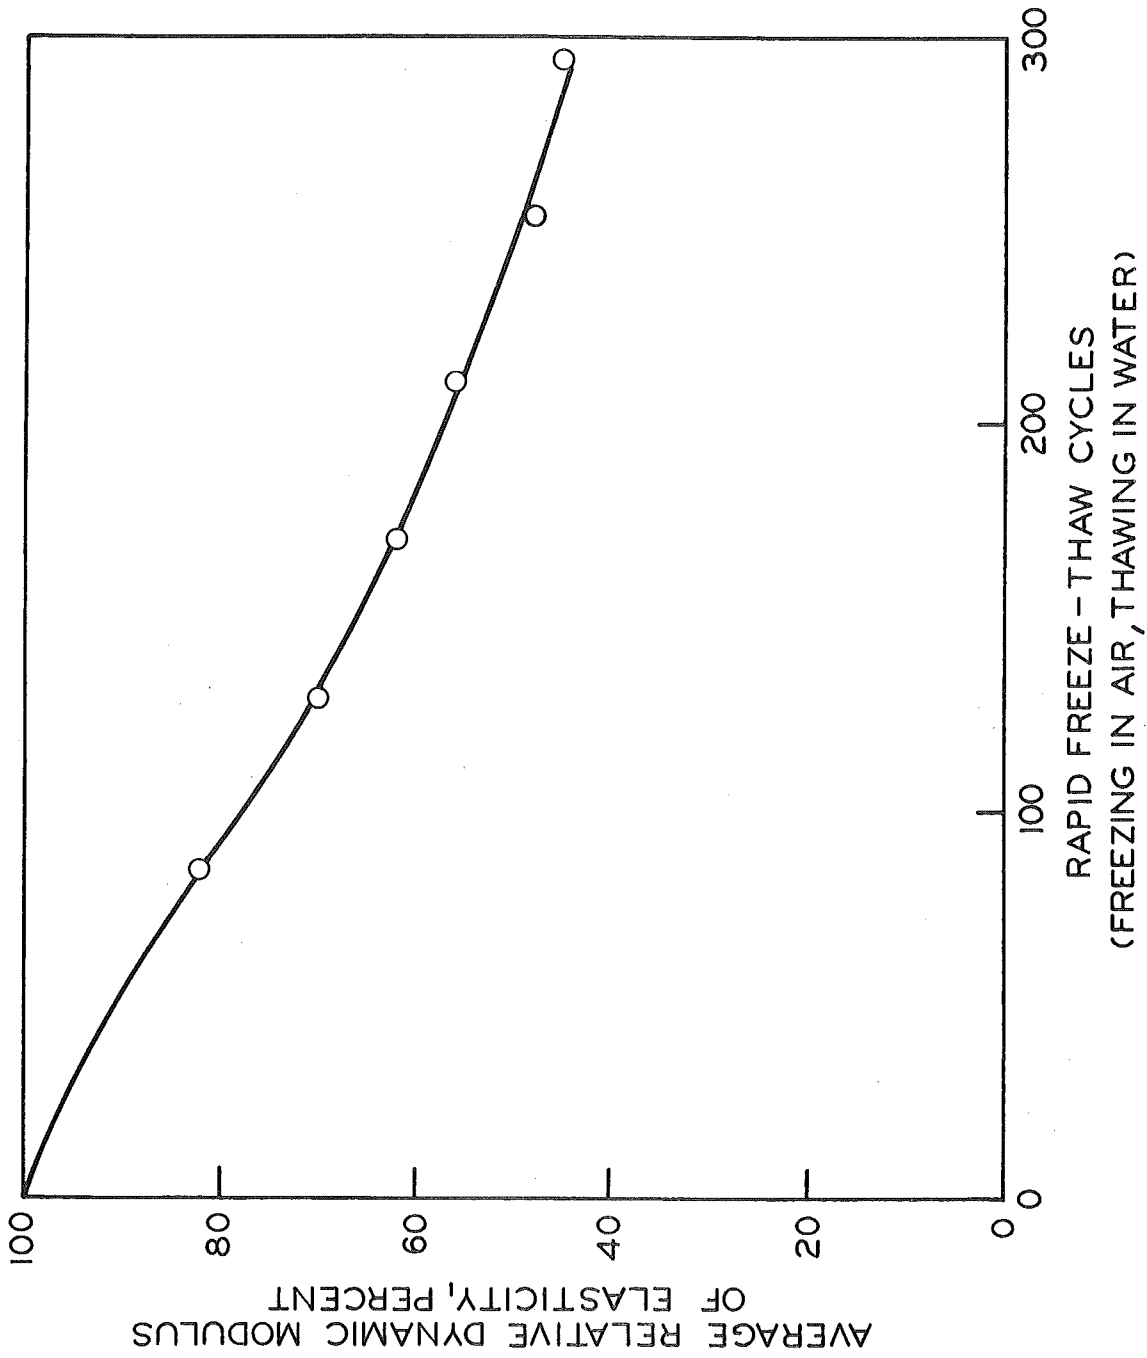
For each of the resonant frequency measurements that were taken throughout the freeze-thaw testing interval, the dynamic modulus of elasticity was calculated and the average values are shown in graphical form in Figure 2. The figure shows a rate of decrease which is slightly greater than that which is considered normal for good air-entrained structural

concrete. However, since the freeze-thaw deterioration was apparently uniform throughout the cores, there is no visual evidence to suggest that fire-weakened concrete significantly contributed to the decrease in the dynamic modulus.

Figure 2. Average dynamic modulus of elasticity vs. freeze-thaw cycles. (Does not include Cores No. 1 and 6 which were cut over full-depth cracks).
