OFFICE MEMORANDUM

STATE HIGHWAY DEPARTMENT

February 22, 1963

Subject: Air Pollutants from Gypsum Plants at the I 96 Grand River Bridge
(B03 of 41029E, C1). Research Project R-62 G-112(1).
Report No. R-413.

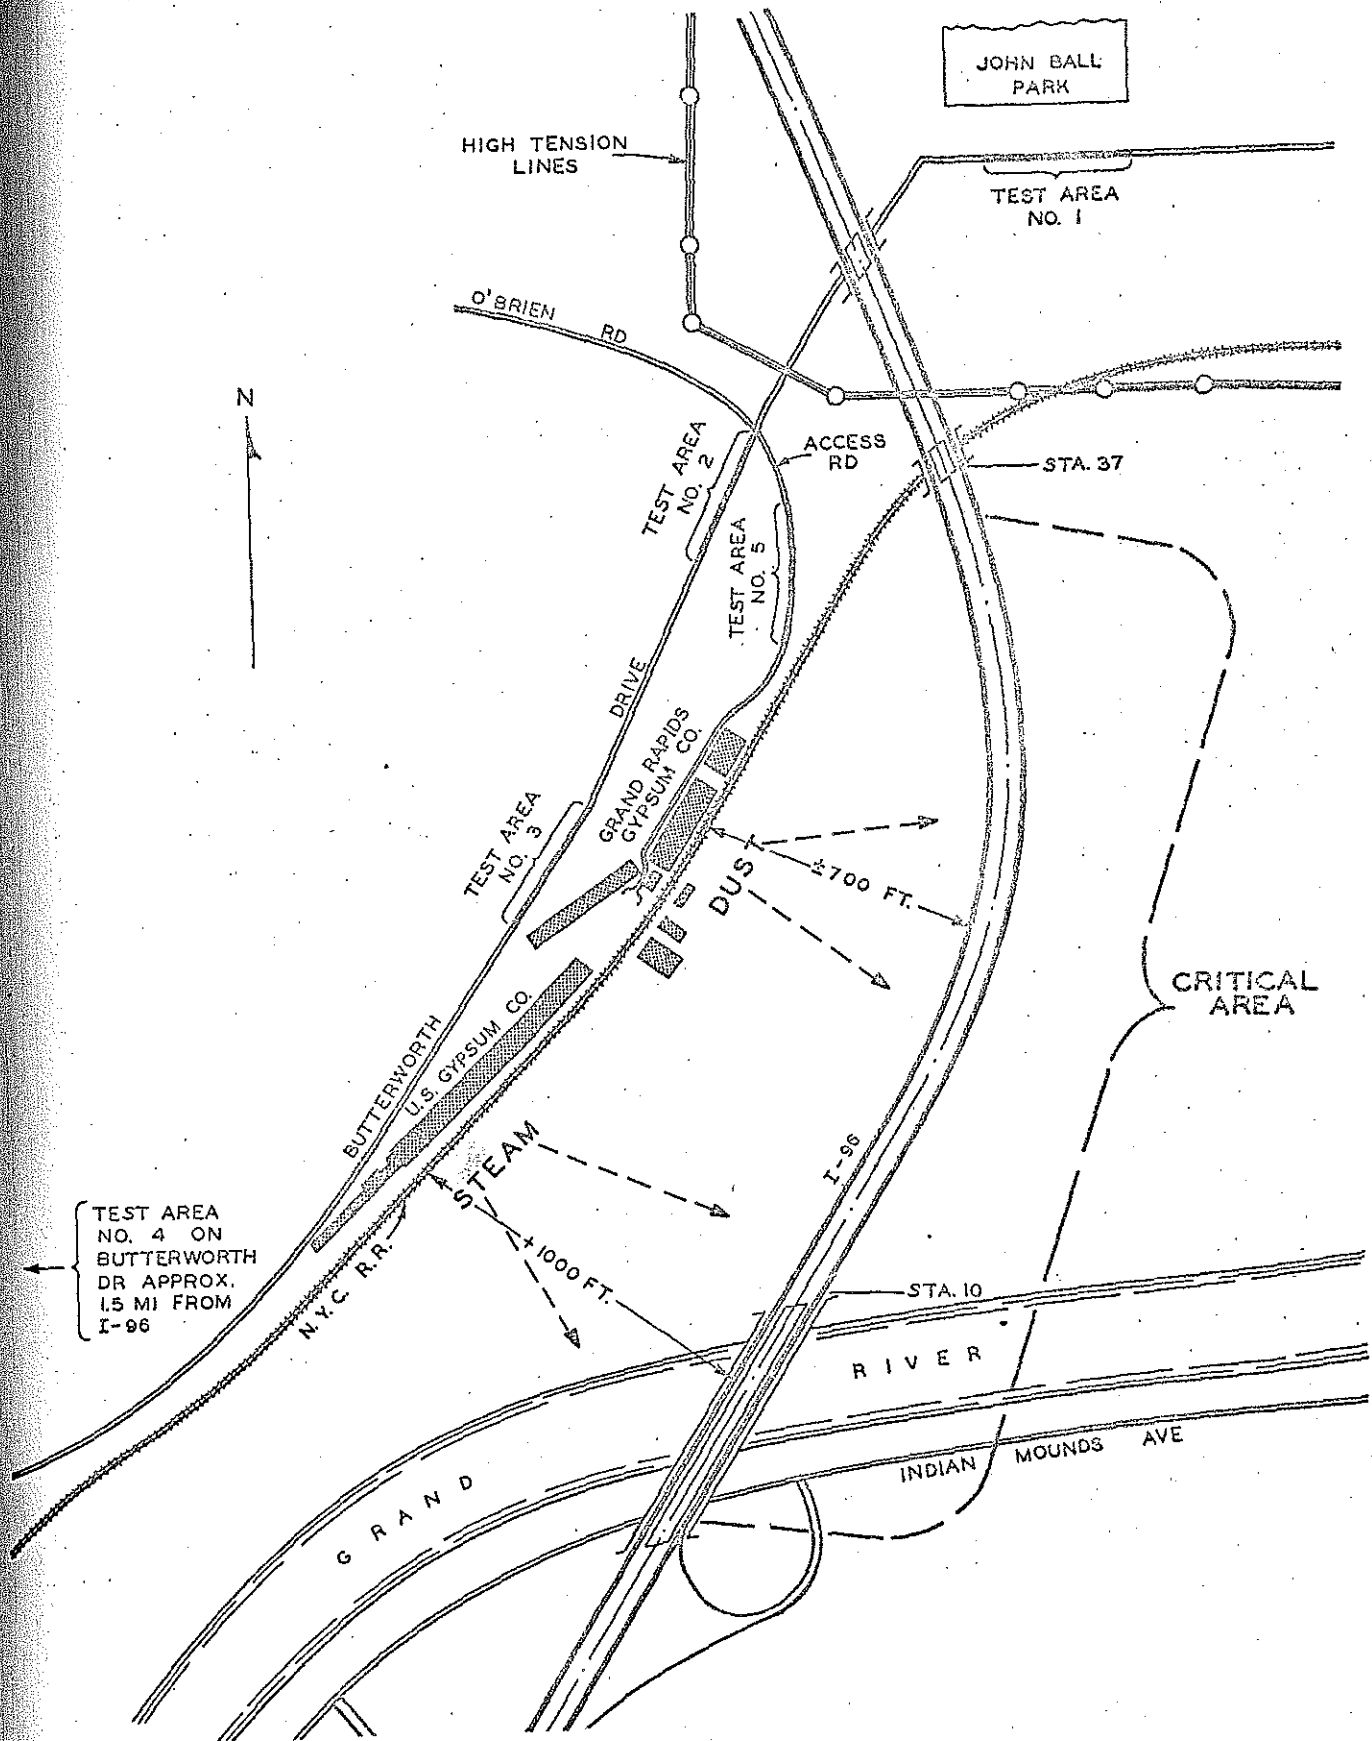
(mostly of brick) were about 50 years old. The access road to plant from Butterworth Dr. was of bituminous surface over a concrete base, with the latter protruding at a curve. The visible concrete appeared worn, but not disintegrated; its age was not determined. The apron in front of the building in Fig. 1 was also of concrete. This also appeared worn, through a covering of dust and snow slush, but otherwise apparently sound; its age was not known. There was a slight accumulation of dust, greatest near the plant, but no significant amount of dust on the I 96 roadbed about 500 ft away. Steam from drying and de-hydrating operations at the plants was being exhausted in varying amounts, which at greatest discharge formed clouds that billowed toward the I 96 roadbed.

Figure 1. Schematic diagram showing I 96 bridge site, gypsum plants, skid test sites, and critical area.

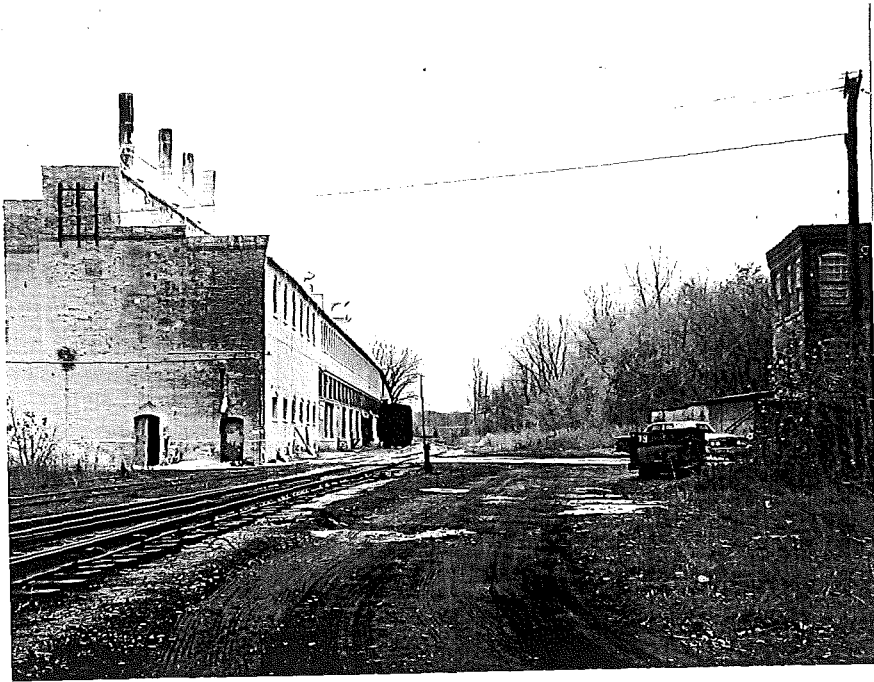
1. On November 23, 1962, W. L. Frederick and M. H. Janson visited the area and found grading operations in progress on the I 96 roadbed, with some bridge piers in place. The bridge appeared about equidistant from the plants of the U. S. Gypsum and the Grand Rapids Gypsum Co., both north of the river and west of I 96. Neither plant was operating, but it appeared that most of dust had exhausted from four stacks of calcining building of Grand Rapids Gypsum Co. (Fig. 2). A sample of dust collected from a ledge of this building indicated by infrared analysis a composition of calcium sulfate with some calcium carbonate. Away from the building a small accumulation of white dust was evident, but insufficient dust had accumulated on nearby trees (at right in Fig. 2) to permit sampling. Dust was not readily noticeable across the I 96 right-of-way to the east and south of the plant, or on the trees west of the four stacks (Fig. 3).

Figure 2. Four stacks on calcining building of Grand Rapids Gypsum Co.

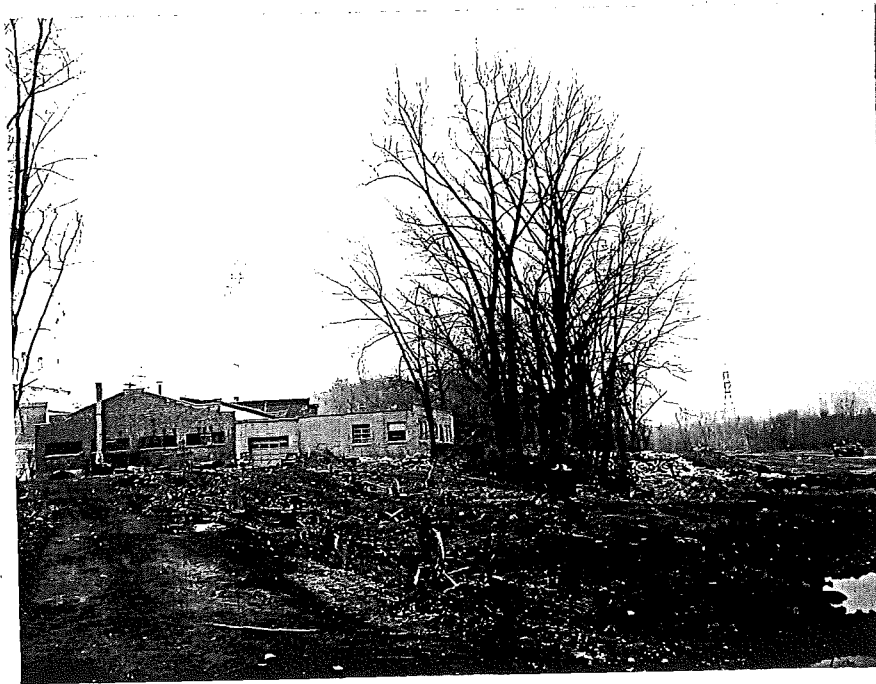
Figure 3. Area southwest of calcining building near I 96 grading operations.
