PERFORMANCE OF HOT-POURED RUBBER-ASPHALT JOINT SEALING COMPOUNDS

Highway Research Project 53 G-71

Research Laboratory
Testing and Research Division
Report No. 220
May 19, 1955

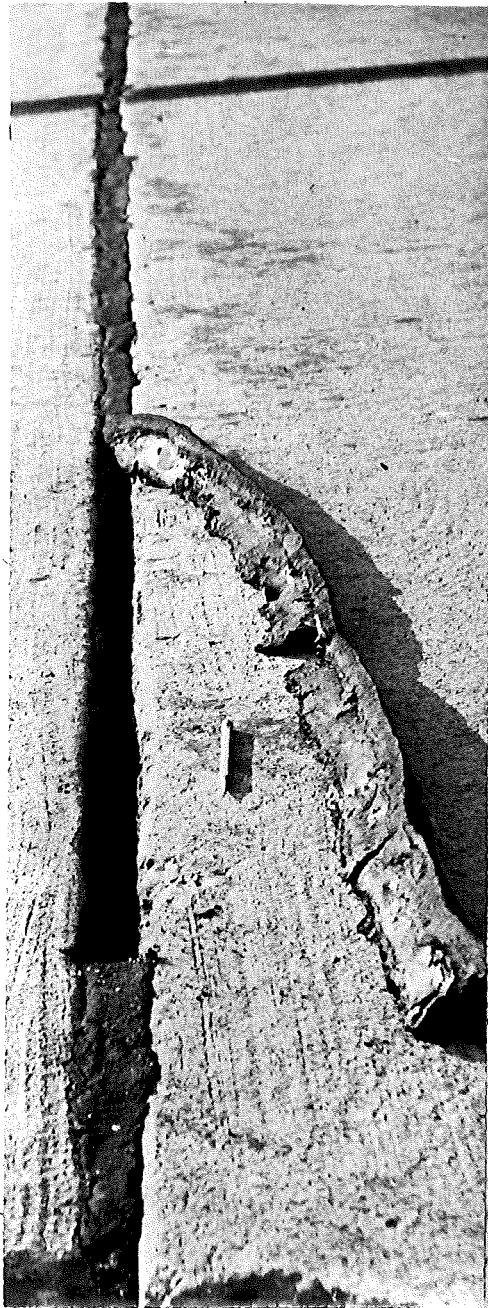
A typical adhesion failure is shown in Figure 1. This is one of the most common types of failure. The sealer in this type of failure is usually in fairly good condition, but can be pulled intact from the joint with various degrees of ease. In these adhesion failures, close examination of the joint faces gives no evidence that true adhesion of the sealer to the joint faces had ever occurred. This might indicate insufficient cleaning of joints, improper pouring temperatures at the time the joints were sealed, or lack of adhesive properties in the sealing material. Dirt and moisture were found deposited below the sealer and between the sealer and joint faces in such cases.

▲ FIGURE 1. TYPICAL JOINT SEAL FAILURE WITH COMPLETE LACK OF ADHESION TO BOTH JOINT FACES. PAVEMENT 7 YRS. OLD. CONSTR. PROJ. F 17-7, C 6. STA. 1171 + 00.

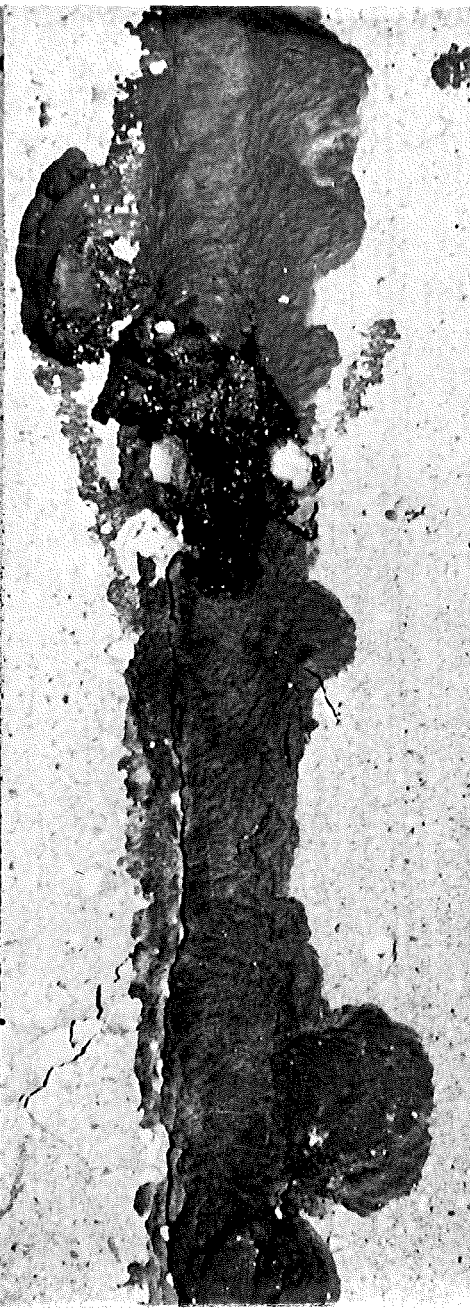
In some of the projects, the sealer had adhered fairly well to one joint face but was completely separated from the other. This is a modification of the complete loss in adhesion type of failure. Figure 2 shows a joint with such partial loss in adhesion.

▲ FIGURE 2. PARTIAL ADHESION FAILURE OF JOINT SEAL. NOTE LACK OF ADHESION TO LEFT FACE OF JOINT. PAVEMENT SEALED ONE WEEK. CONSTR. PROJ. 39-45, C 2 AND 3.

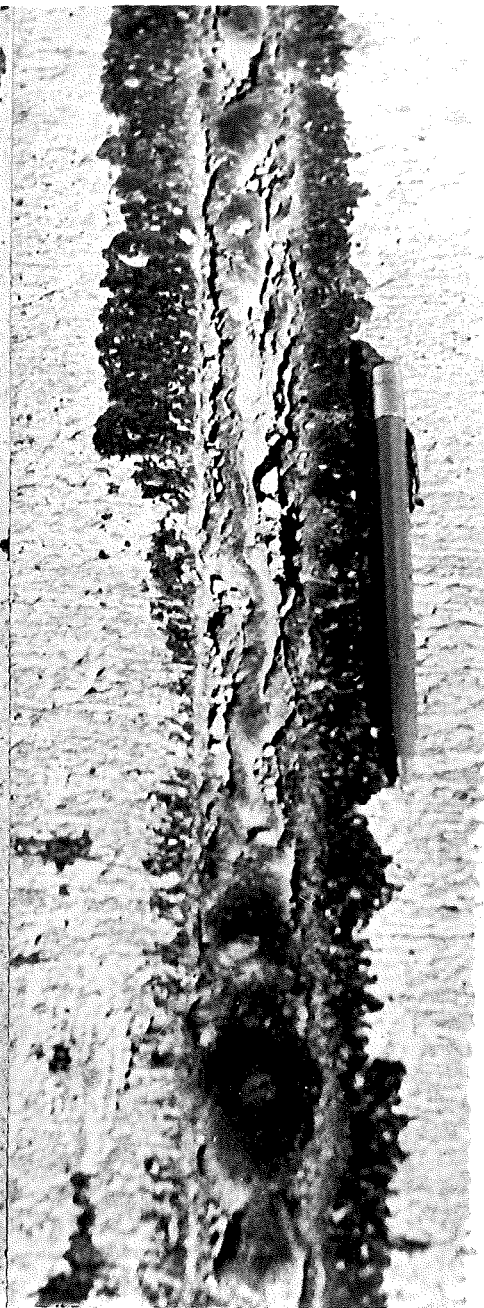
Another type of failure is shown in Figures 3 and 4. In these cases, there is not only partial or total loss in adhesion, but the sealer itself is

cracked or wrinkled and admixed with sand and dirt. This type of failure is not as common as the other types and may be due to an inherent property of some of the sealing materials themselves.

▲ FIGURE 3. JOINT SEAL FAILURE WHERE CRACKS AND DIRT ARE FOUND IN SEALER MATERIAL. ADHESION USUALLY POOR. MIDDLEBELT ROAD, DETROIT. CONSTR. PROJ. 82-176, C 2.

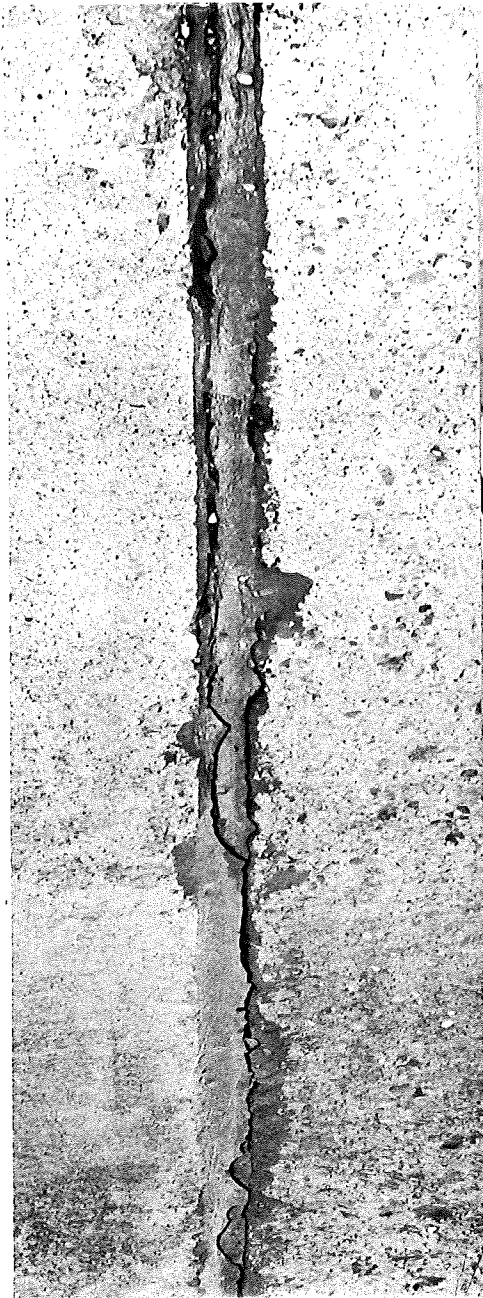
▲ FIGURE 4. FAILURE IN BOTH ADHESION AND COHESION OF JOINT SEAL, US-12.

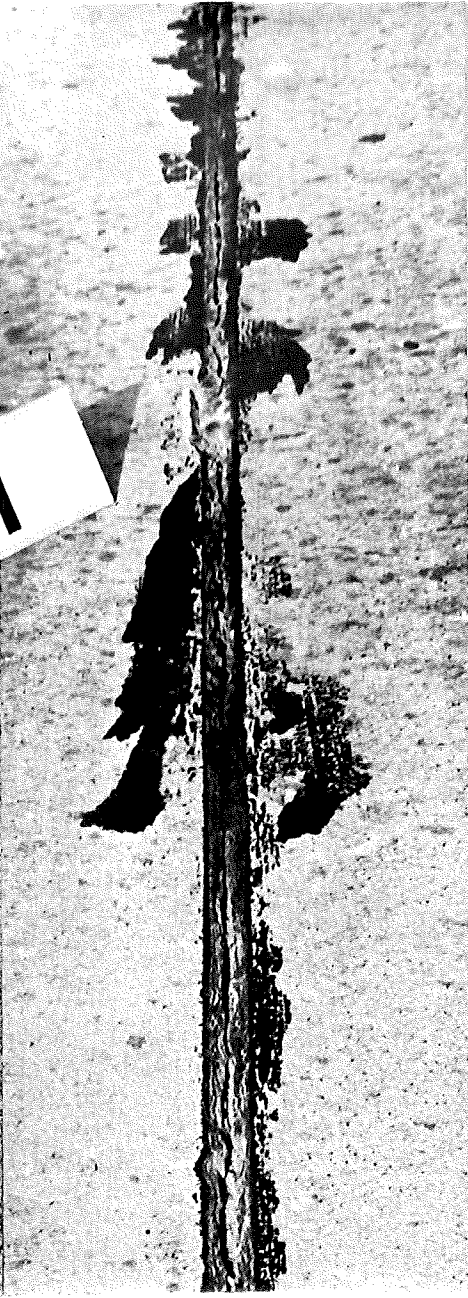
Figure 5 shows a condition met occasionally in which lack of resilience causes a fold to occur in the sealer when the joint closes. This fold is usually filled with foreign material which eventually becomes thoroughly mixed with the sealer.

▲ FIGURE 5. LONGITUDINAL FOLD IN JOINT SEAL CONTAINING INFILTRATED FOREIGN MATERIAL. SEALER STILL IN CONTACT BELOW FOLD. CONSTR. PROJ. F19-41, C6. STA. 435+25.

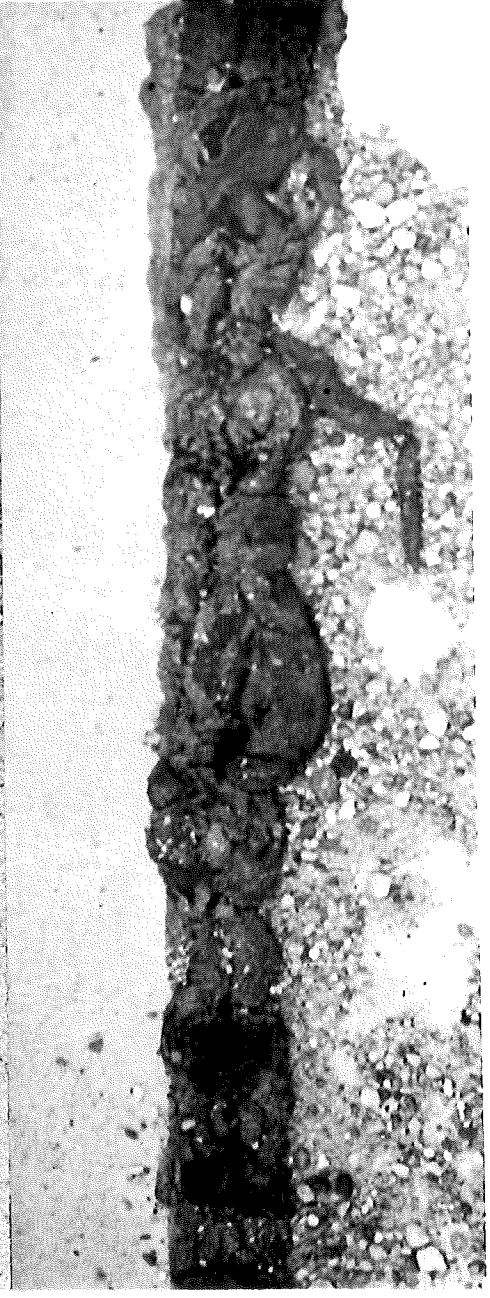
An unusual type of failure which occurred on a new pavement which had not been open to traffic is shown in Figure 6. The material became tough, wrinkled and crevassed.

▲ FIGURE 6. NEW CONSTRUCTION NOT YET OPENED TO TRAFFIC IN WHICH SEALER HAS BECOME TOUGH AND FISSURED. CONSTR. PROJ. 39-40, C 4. STA. 981+60.

39-40, C4	1953	US-12	Sealer extremely tough and dry; partially adhered to concrete but a lot of separation in sealer itself.
13-51, C2 & 3	1948	M-89	Sealer fresh and sticky but not adhered to concrete at all. Dirt and moisture between sealer and concrete.

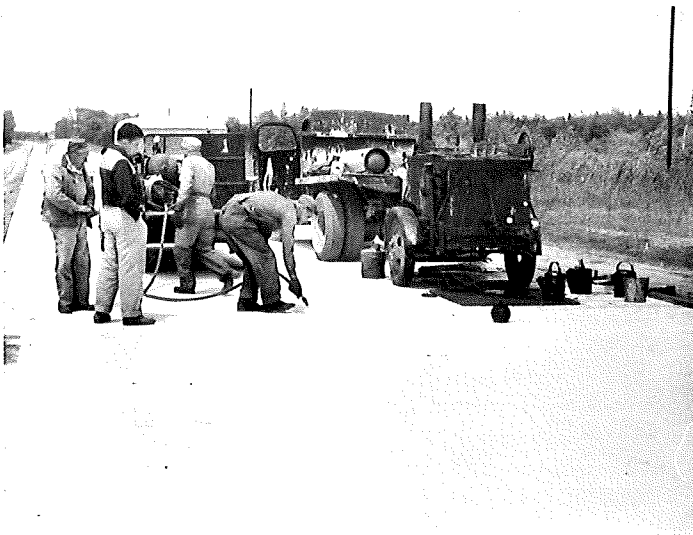
Prior to sealing the joints, they were partially blown out with compressed air, as seen in Figure 7, and then poured with a hand pouring pot,

▲ FIGURE 7. JOINT SEAL MELTER, RIGHT, AND AIR BLOWING OPERATION, LEFT, OF CARL GOODWIN AND SONS, CONTRACTORS.

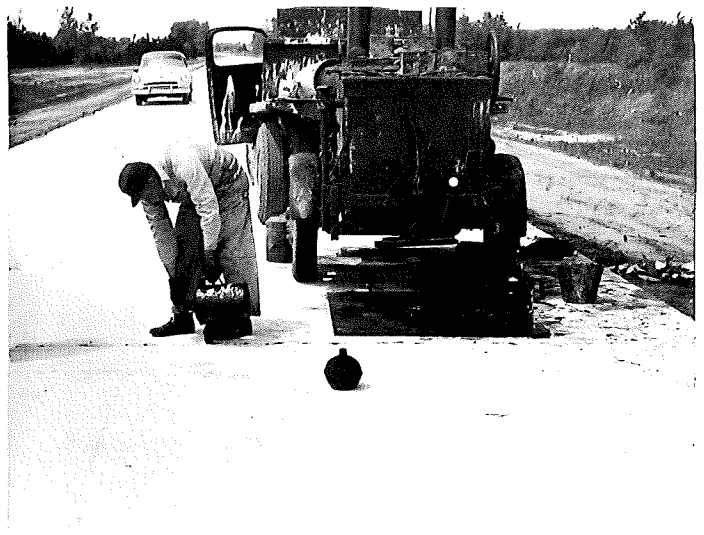
▲ FIGURE 8. JOINT SEAL POURING OPERATION OF CARL GOODWIN AND SONS .

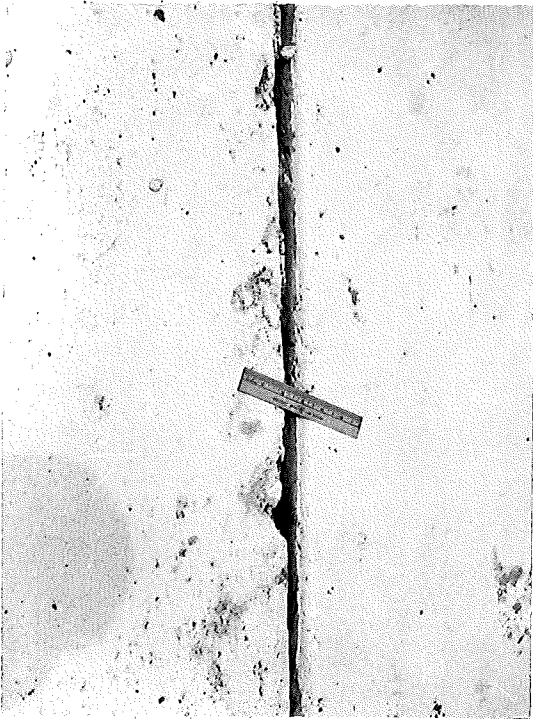
Figure 8. The faces of many of the joints were coated with membrane curing compound, Figure 9, prior to sealing and nothing was done to remove it. Examination of a joint poured 5 days previously indicated that it was not blown out at all previous to sealing. In this joint the sealer was not adhered at all; sand and dirt were found between the sealer and joint face and a 1-inch layer of sand and dirt below the sealer, Figure 10. In addition, white membrane curing compound from the joint faces was adhered to sealer pulled from the joint, Figure 11.

▲ FIGURE 9. MEMBRANE CURING COM- POUND ON JOINT FACE PRIOR TO SEALING BY CARL GOODWIN AND SONS .

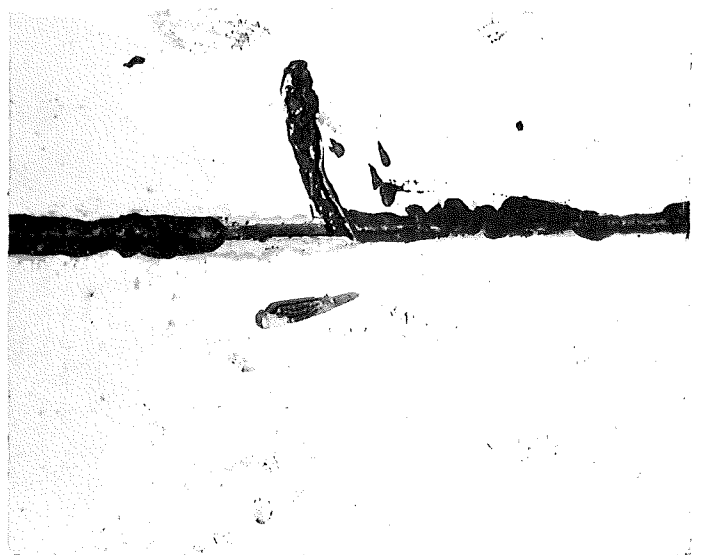
▲ FIGURE 10. JOINT SEALED BY CARL GOODWIN AND SONS . NOTE LACK OF ADHESION AND LAYER OF DIRT IN BOTTOM OF JOINT .

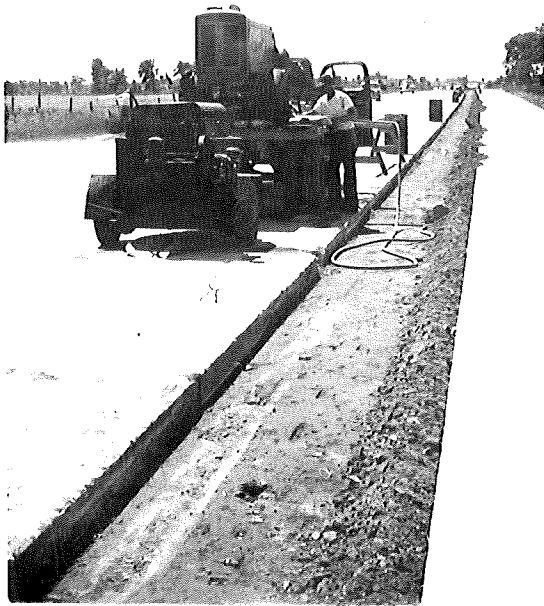
FIGURE 12.
JOINT SEAL MELTER AND AIR COMPRESSOR OF SARGENT
CONSTRUCTION COMPANY.

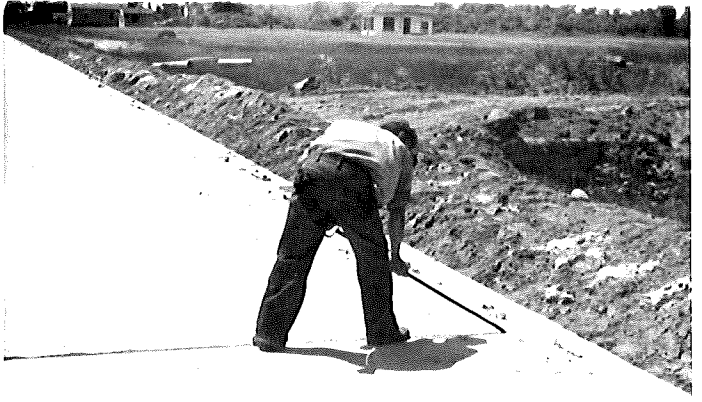
FIGURE 13. RAKING OUT OF JOINT PRIOR TO SEALING, SARGENT CONSTRUCTION COMPANY.

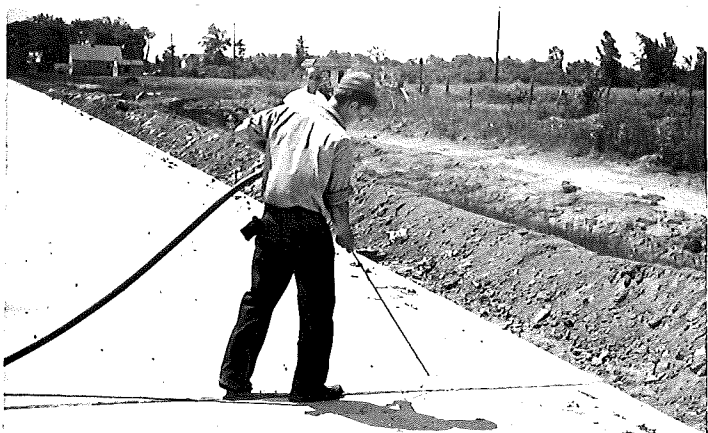
FIGURE 15.
SEALING OPERATION BY SARGENT CONSTRUCTION COMPANY. NOTE AREA EACH SIDE OF JOINT FREE OF MEMBRANE CURING COMPOUND.

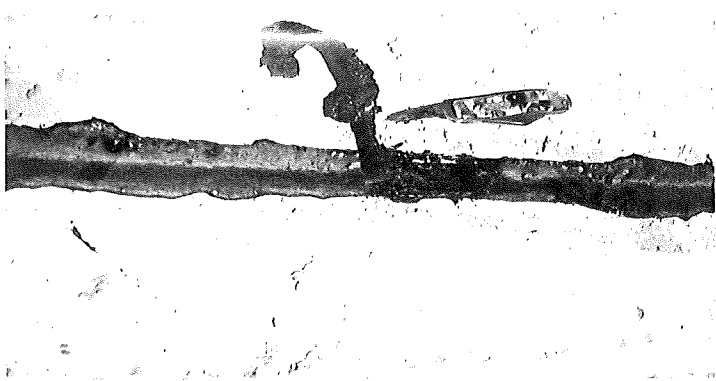
Examination of the joints just prior to sealing showed them to be free of all extraneous matter except for a very fine dust on the joint faces. This dust, observable only by wiping the finger tips across the joint faces, apparently results from cement laitance. Examination of a joint sealed the previous day indicated that adhesion was fair but not perfect. This lack of perfect adhesion, as seen in Figure 16, appeared to result from the fine laitance dust just described.

FIGURE 16. JOINT SEALED BY SARGENT CONSTRUCTION COMPANY. ADHESION GOOD BUT NOT PERFECT.
