**MICHIGAN DEPARTMENT OF TRANSPORTATION
MDOT**

THREE YEAR EVALUATION OF WHITETOPPING PROJECT ON M-46

Testing and Research Section
Construction and Technology Support Area
Research Project 98 G-0322
Research Report R-1417

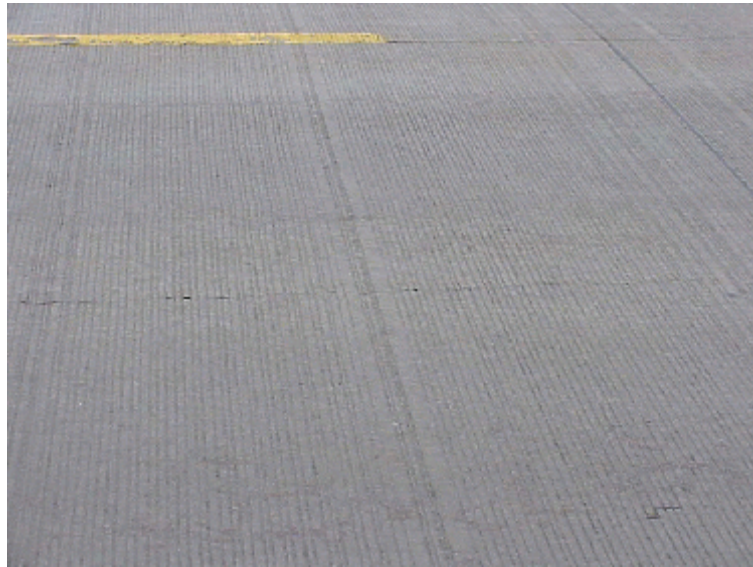
Test sections 4, 5, and 6 have exhibited a few distresses; the primary one being longitudinal cracking. The first sign of longitudinal cracking came during the summer of 2000; about one year after project completion. A long longitudinal crack down the center of the eastbound lane near the west end of the project was reported. It was a hairline crack and 21 panels long.

Figure 2 shows what it looked like initially. Inspection of the remainder of the project turned up several cracks in the westbound lane totaling 18 panels. These were also right down the center of the lane, and in all cases the crack began and ended at a transverse joint.

Figure 2. Initial Condition of Longitudinal Crack.

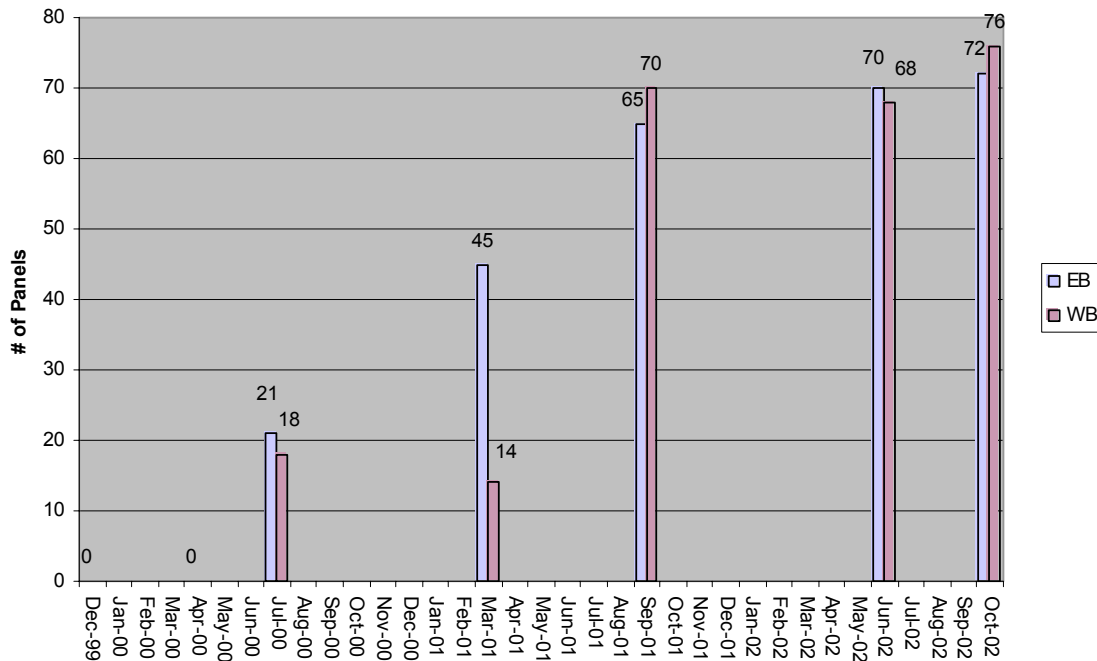
In the Spring of 2001, the total number of panels with a longitudinal crack increased to 59. By the fall of that year the total had increased to 135, with only minor increases during each inspection since then. Figures 3 and 4 show the number and percentage, respectively, of

Figure 3. Number of Longitudinally Cracked Panels in the Five and Six Inch Whitetopping Sections.

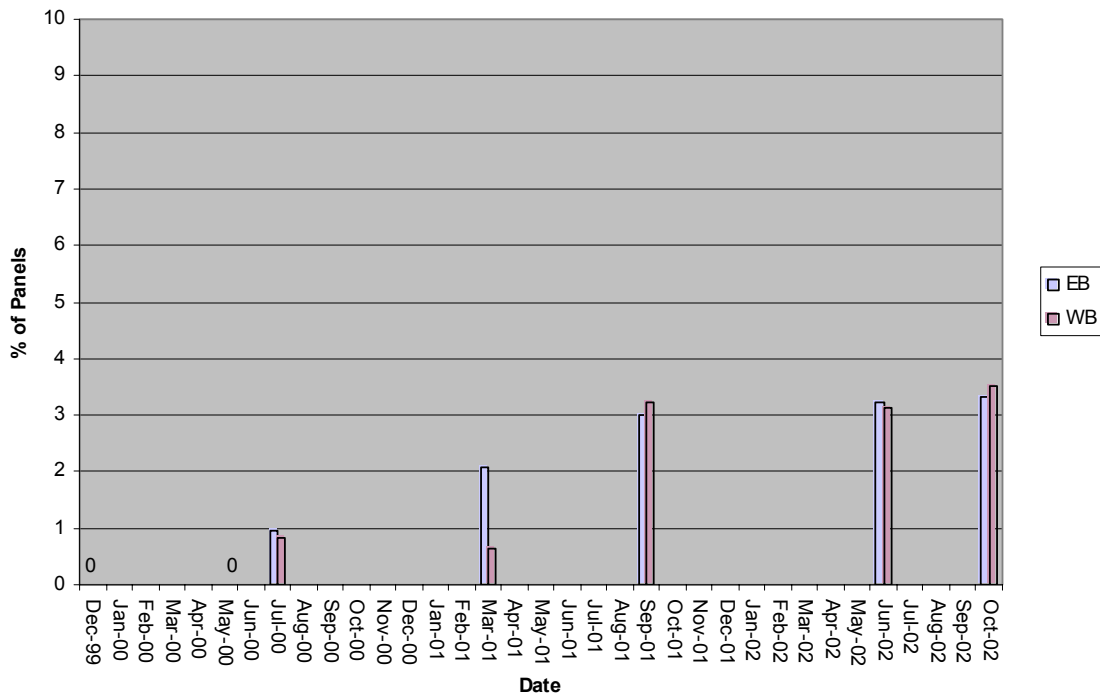
Figure 4. Percentage of Longitudinally Cracked Panels in the Five and Sixinch Whitetopping Sections.

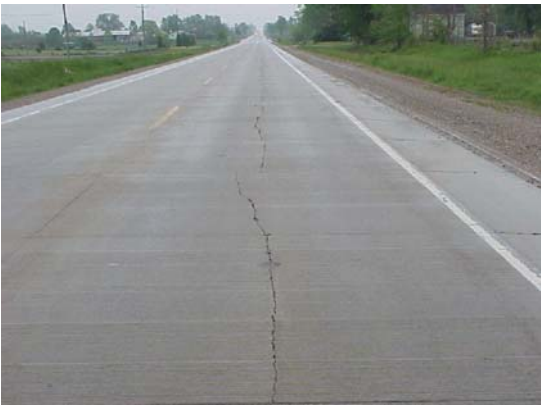
longitudinally cracked panels at each of the inspections. One transverse crack, the full-width of the pavement, and three large spalls were also noted during this inspection. Most of the longitudinal cracks were 5 panels or less, with a few reaching 9 panels, and the long one, which was now up to 22 panels. The 22 panel-long crack was starting to show signs of opening up slightly and had very minor spalling in some spots, as can be seen in Figures 5 and 6.

Figure 5. Looking Down the Pavement at the Long Longitudinal Crack.

Since this was a job warranted by the contractor, the contractor cored the long longitudinal crack as well as the centerline joint. They found that the centerline joint did have a relief crack, which was full-depth. This ruled out late sawing of the centerline joint as a possible cause.

At this point, MDOT needed to determine the cause of the longitudinal cracking. FWD testing was conducted at several randomly selected cracks to check load transfer efficiencies (LTE) across the cracks. Tests were also conducted at the mid-point of non-cracked panels in the vicinity of the crack, and at the corner of cracked panels near the shoulder. LTE's across the four cracks selected were in the 71 to 82 percent range, which is fair. The actual deflections under the load plate at the 22 panel-long crack were 8.1 to 9.7 mils. This is slightly higher than mid-panel deflections (away from joints and cracks) in the vicinity, which were 7.0 and 7.9 mils. Deflections at the corners, however, were 13.0 to 15.2 mils, which may indicate poor support at the edge. Deflections at the other three cracks were 5.1 to 8.8 mils, which again is higher than mid-panel deflections of 4.3 to 5.6 mils. However, corner deflections for these cracks were 5.6 to 7.8 mils. This may explain why these three cracks are still in hairline condition, while the 22 panel-long crack with its higher corner deflections is starting to open and spall. The 22 panel-long crack is likely experiencing bending from less support under the right wheel path, resulting in a faster deterioration of the crack. In fact, this bending could be the cause of the longitudinal cracks to begin with.

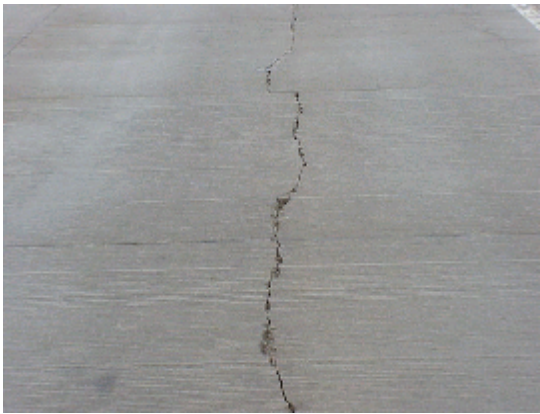
Figure 6. Closer Look at the Spalling

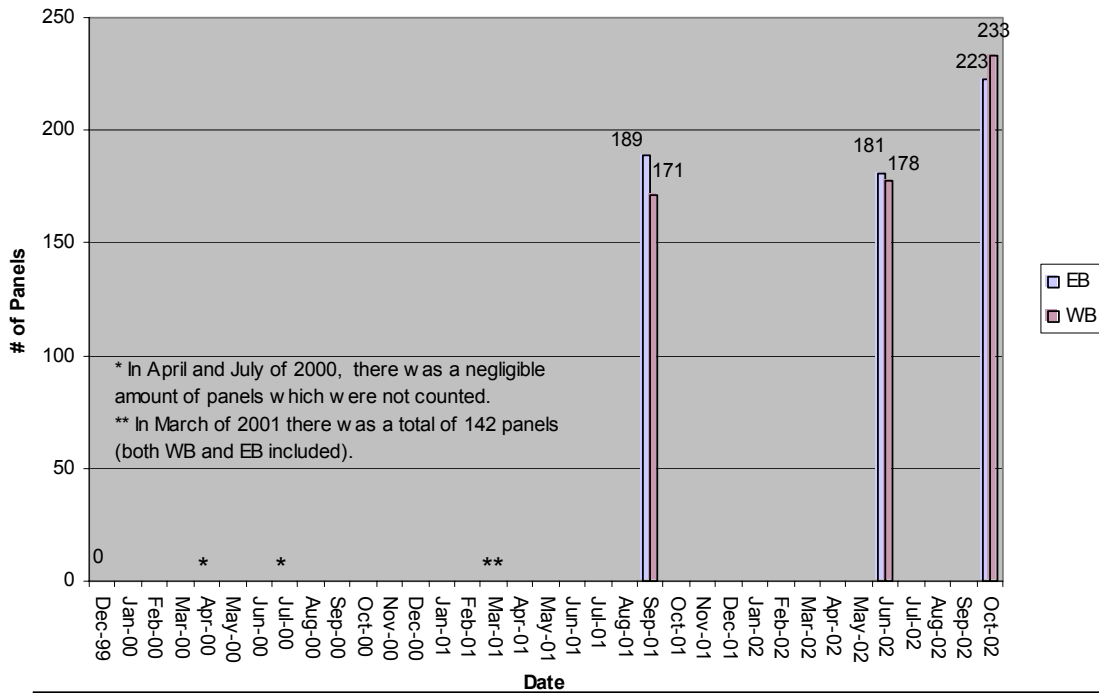
This section has many of its 3.3 foot by 3.3 foot (1 m by 1 m) panels showing distress. In the latest visual survey, 223 panels in eastbound and 233 panels in westbound have some form of distress. Figures 7 and 8 show the number and percentage, respectively, of distressed panels at each of the inspections. Most of the distress (90%) is cracking, with a few panels (10%) showing just spalling. Figures 9 through 14 show typical distresses.

Figure 7. Number of Distressed Panels in the Ultra-Thin Whitetopping Section.

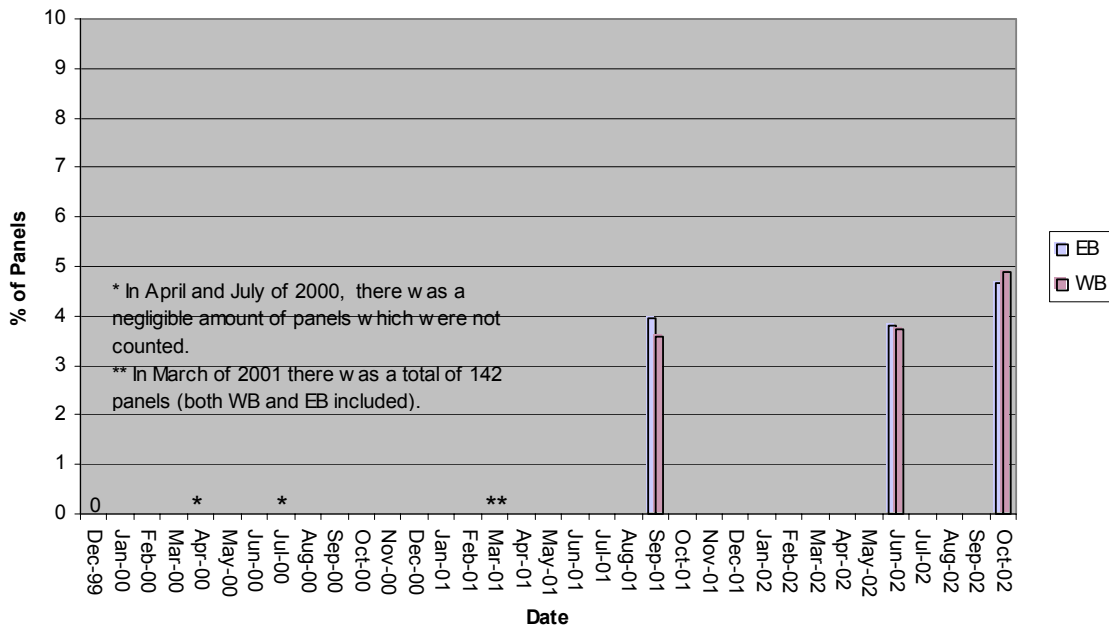
Figure 8. Percentage of Distressed Panels in the Ultra-Thin Whitetopping Section

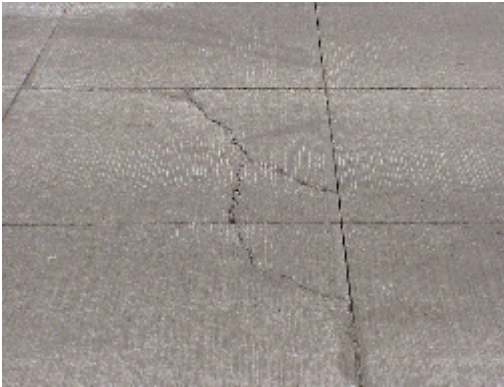
Figure 9. Example of Transverse Cracking.

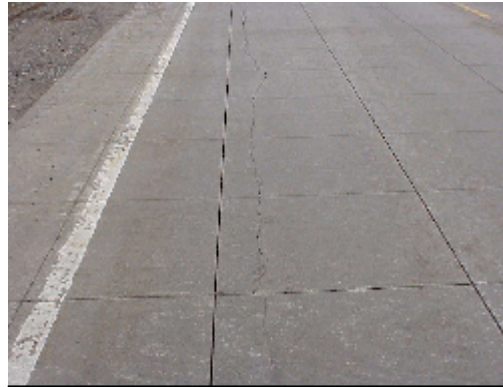
Figure 10. Example of Long Longitudinal Crack.

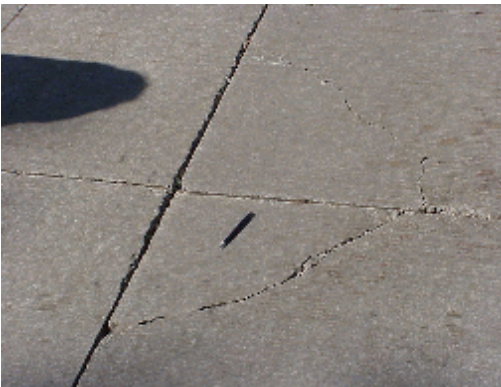
Figure 11. Example of Cracking Around the Joint Intersection.

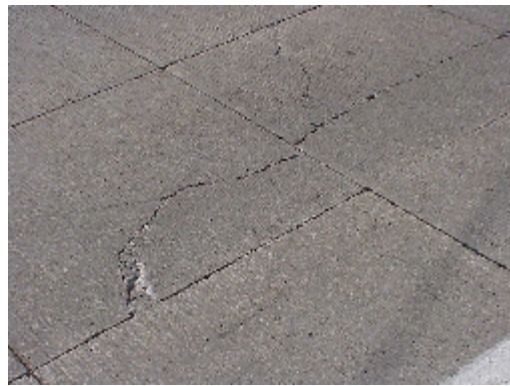
Figure 12. Example of Multiple Cracks in a Panel.

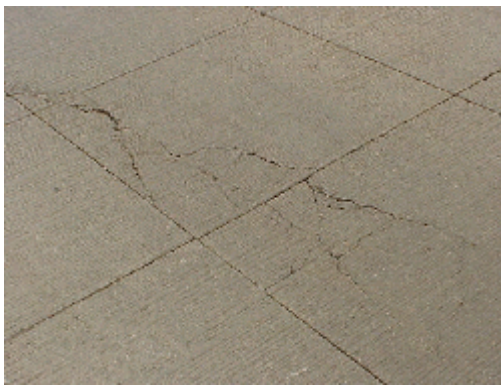
Figure 13. Another Example of Multiple Cracks.

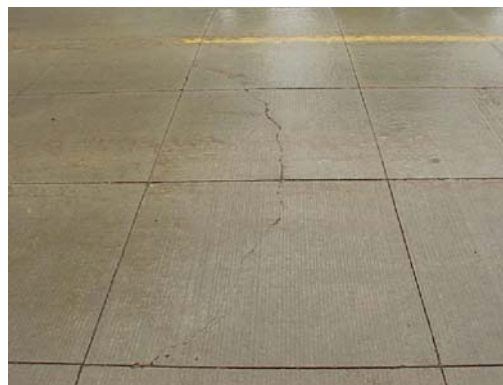
Figure 14. Another Example of Transverse Cracking.

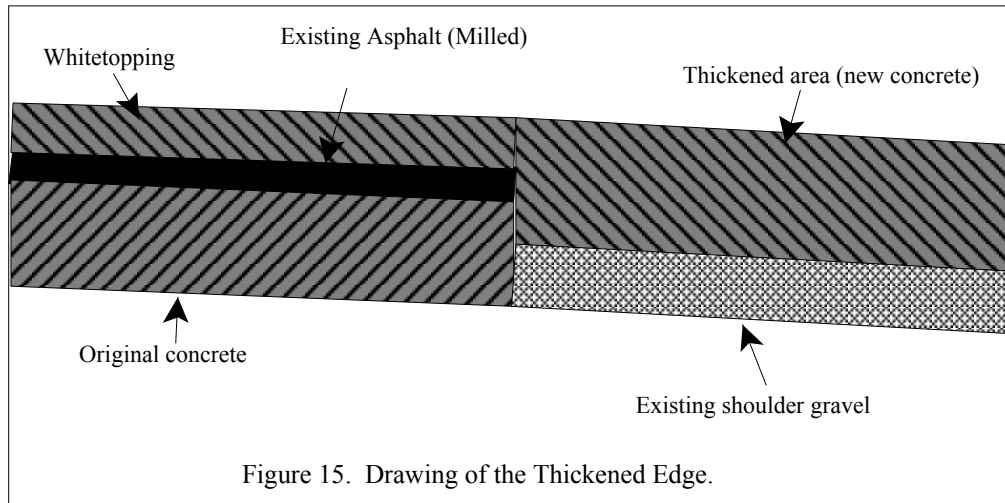
Approximately 80 percent of the distressed panels are over the area of the thickened edge. The thickened edge is shown in Figure 15 (full cross-section can be found in the Appendix). Several inches of shoulder gravel were removed for the thickened area.

- The majority of the cracking in the ultra-thin whitetopping section is due to lack of (or differential) support at the edge of the underlying pavement.

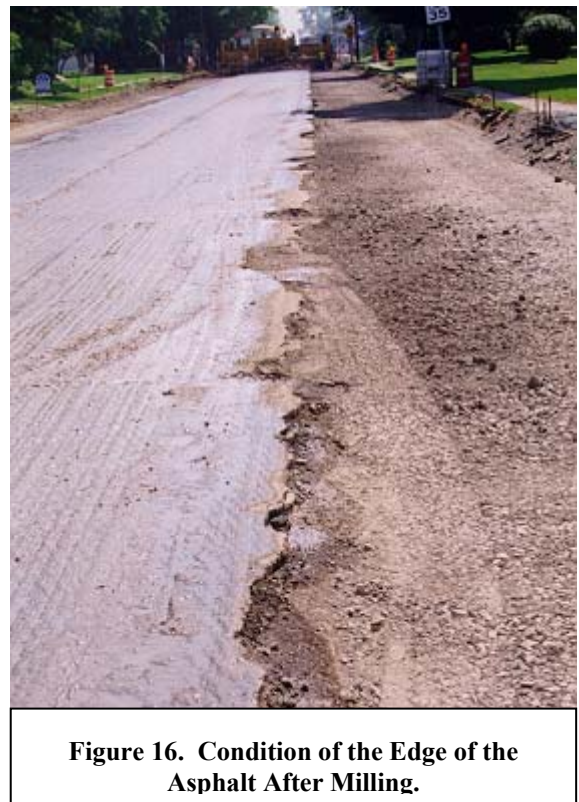
During construction, the asphalt in this section was milled down to about 1-1/2 to 2 inches thick. Figure 16 shows what the edge of the asphalt looked like after milling. This edge is providing poor support for the new concrete surface, resulting in heavy cracking and shattering of panels above it. Secondary distresses such as spalling of the cracks and faulting, are also beginning to show up.

- The thickened shoulder portion of the ultra-thin whitetopping section can be repaired full-depth successfully as evidenced by the water main work.
- Care should be taken to ensure good and even support under whitetopping pavement, especially at the edge of the existing pavement.

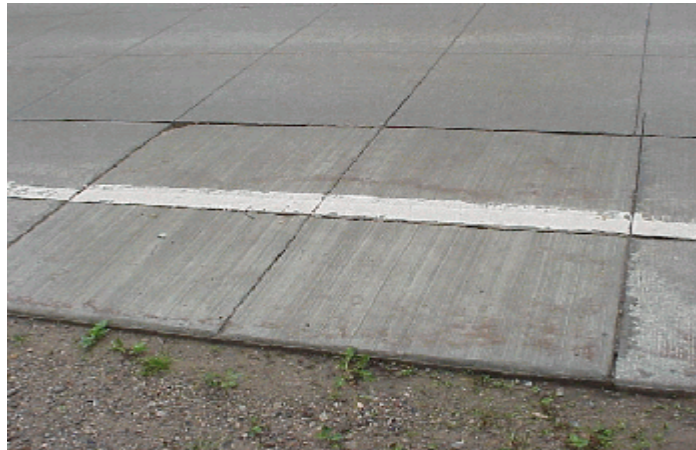
In 2000, a water main break necessitated the removal of four panels for repair work. These panels were in the eastbound direction at the very outside edge of the pavement (in the thickened edge area). They were replaced full-depth with concrete. It is not known if the village work crew made an attempt to tie the repairs to the surrounding concrete. To date, the new panels look very good except for a spall in one corner. Figure 17 shows what they looked like at the last inspection.

Figure 17. Replaced Panels from a Water Main Break.

(Four panels in the foreground)
