CONSTRUCTION REPORT ON  
CONCRETE PAVEMENT JOINT REPAIR  
WITH PRE-CAST SLABS

J. E. Simonsen

Research Laboratory Section  
Testing and Research Division  
Research Project 68 F-102  
Research Report No. R-804

Michigan State Highway Commission  
Charles H. Hewitt, Chairman; Louis A. Fisher, Vice-Chairman  
Claude J. Tobin; E. V. Erickson; Henrik E. Stafseth, Director  
Lansing, February 1972

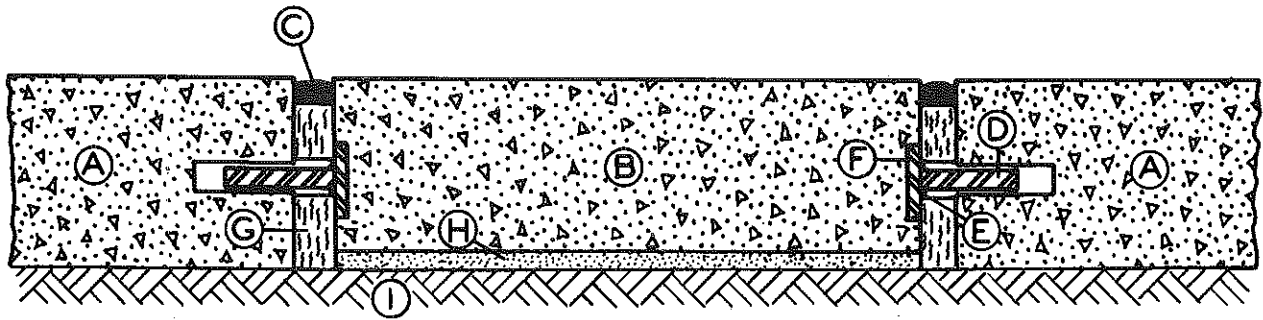
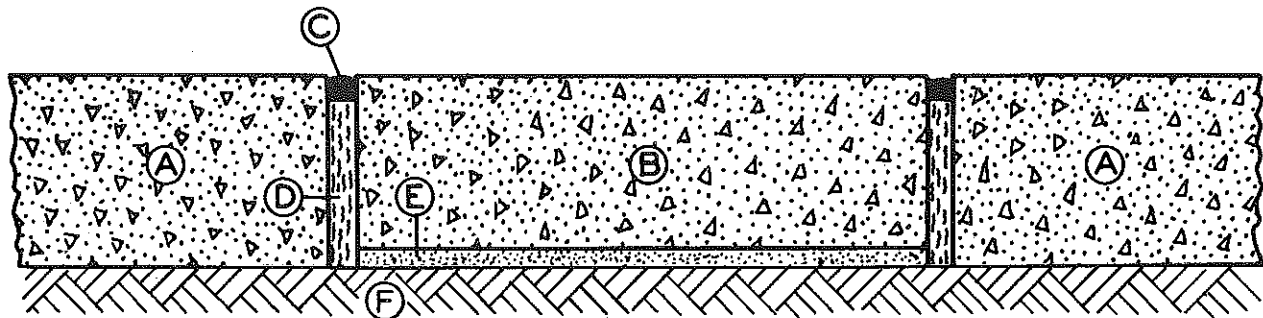
Figure 1. Transverse joint details.

All joints, except the ethafoam joints, were sealed with hot-poured rubber-asphalt sealant. Figure 1 shows the details concerning pre-cast slab support and joint construction; further information is given in Table 1.

The four slabs designed for load transfer installation were cast with a 3/8- by 4-in. steel plate in each 12-ft side (see Joint detail in Figure 1).
