WATER LEAKAGE ON A PRESTRESSED CONCRETE BRIDGE
B9 of 38-1-14, Dettman Road over US 12, Jackson

Research Laboratory Division
Office of Testing and Research
Research Project 58 F-49(2)
Report No. 346

Michigan State Highway Department
John C. Mackie, Commissioner
Lansing, November 1960

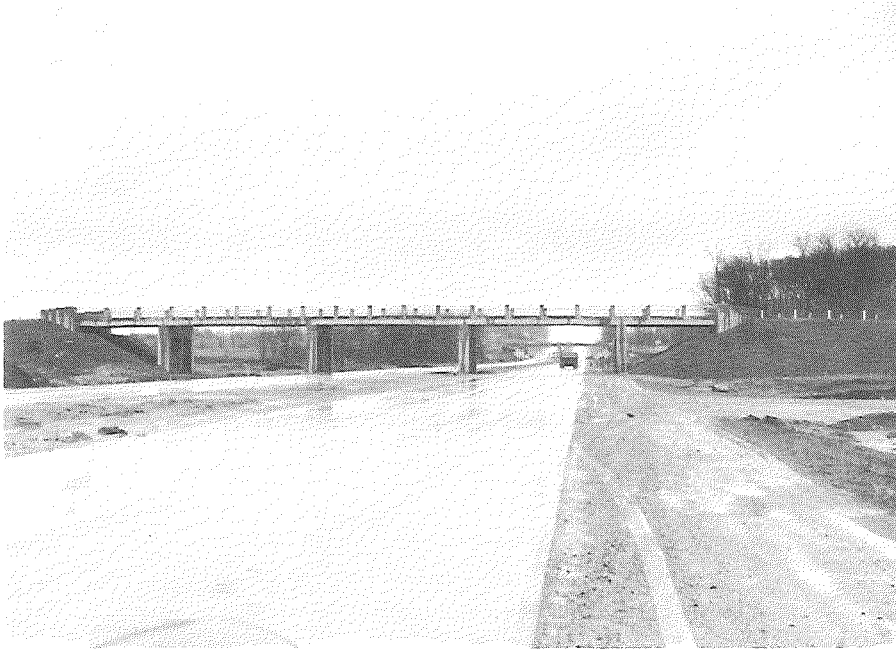
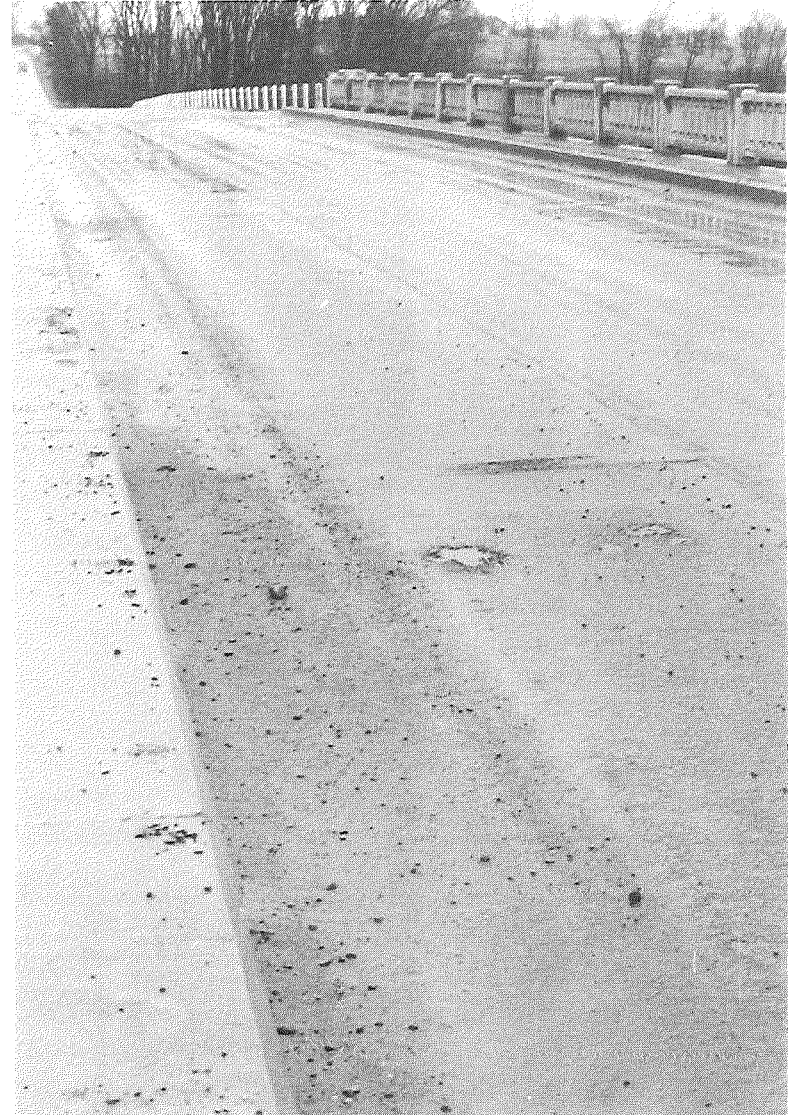
Figure 1. Dettman Road overpass, US 12 near Jackson (B9 of 38-1-14), with view of deterioration of original light wearing-surface covering (4-11-58).

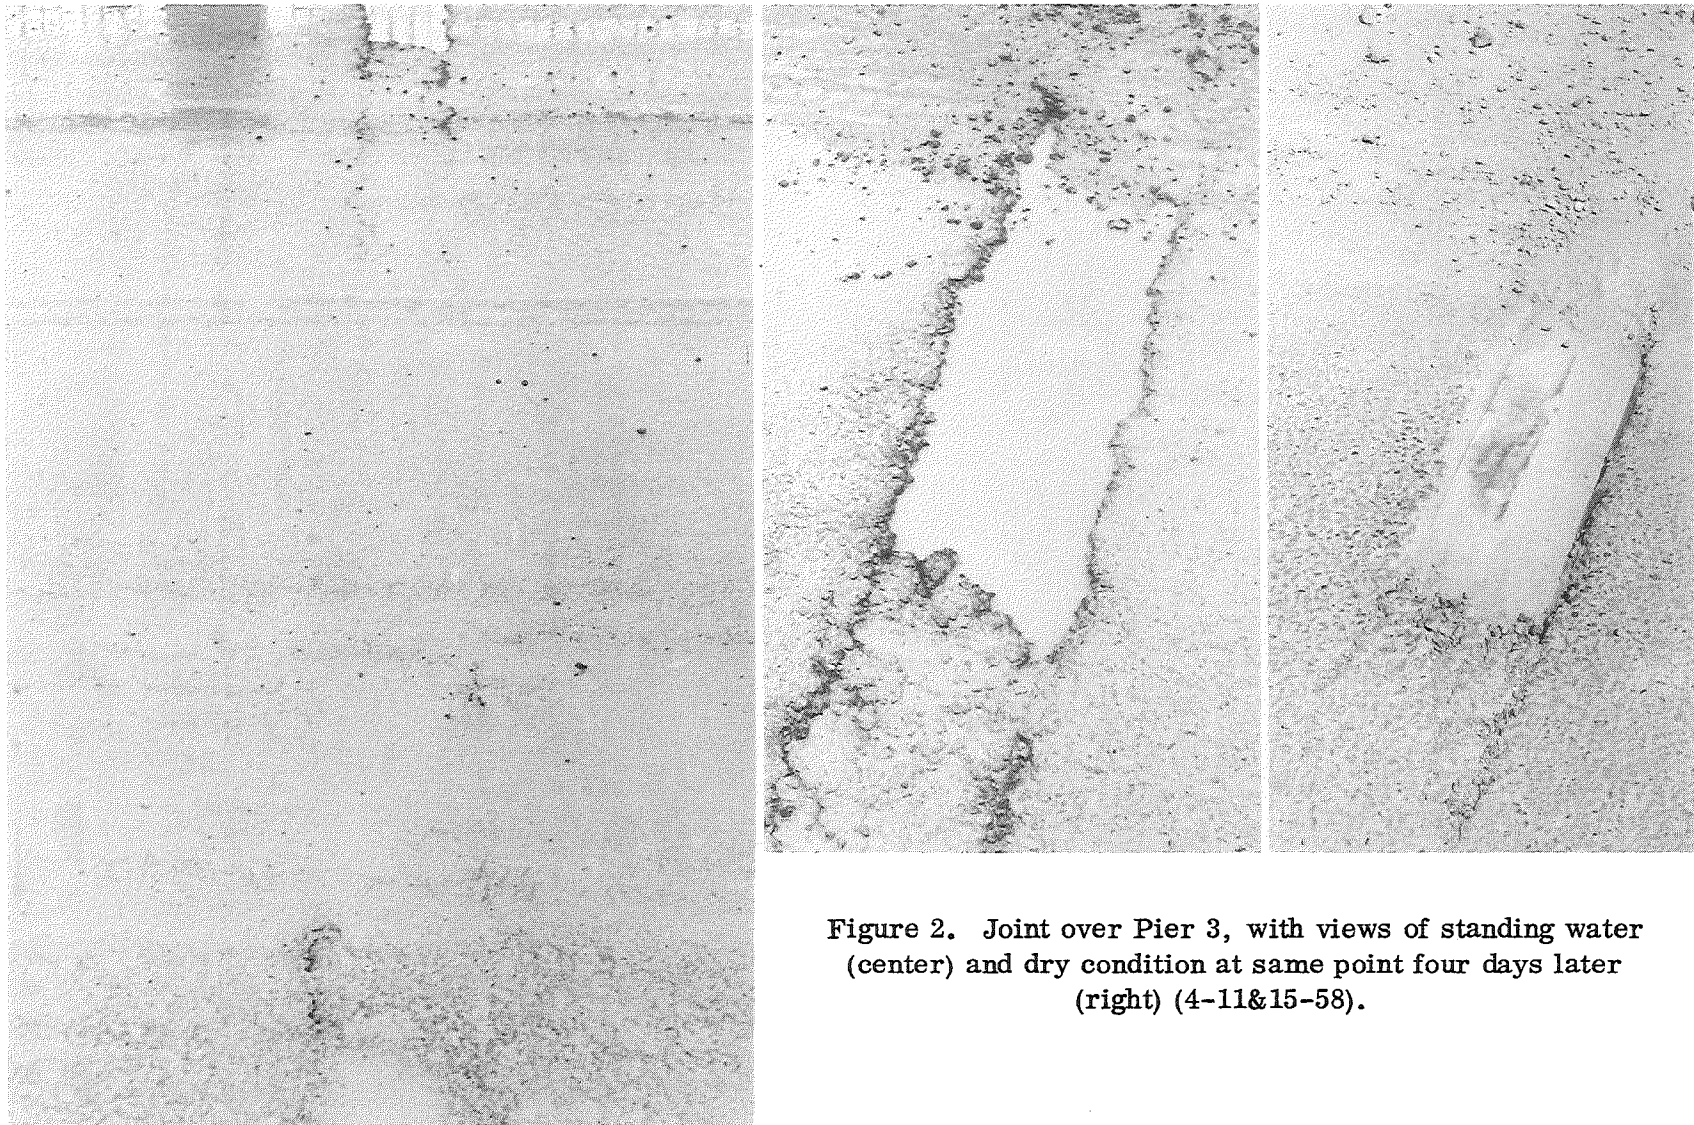
Figure 2. Joint over Pier 3, with views of standing water (center) and dry condition at same point four days later (right) (4-11&15-58).

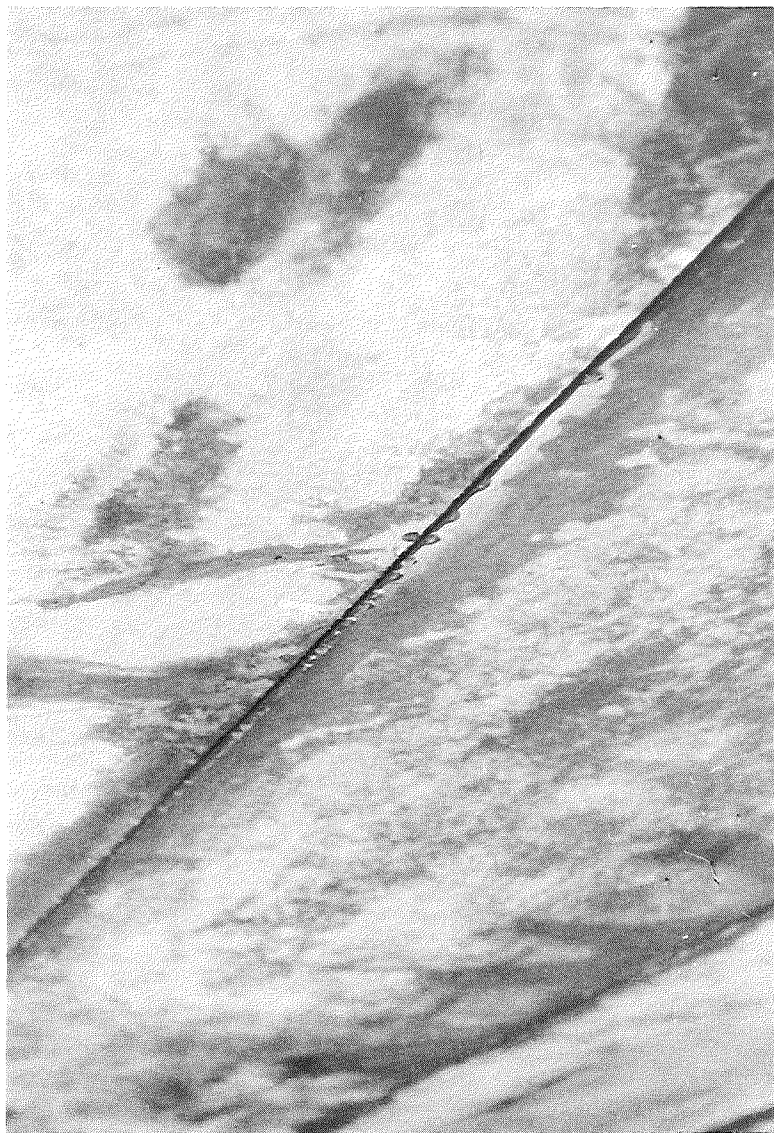
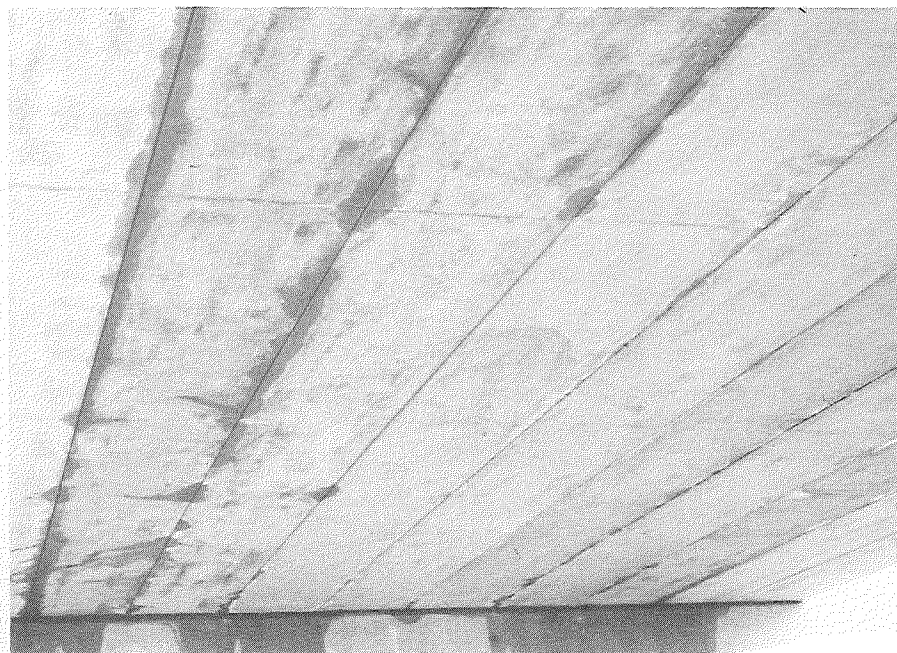
Figure 3. Undersurfaces of Span 1 (left) and Span 2 (right) with seepage in progress, showing stains from previous moisture (4-11-58).

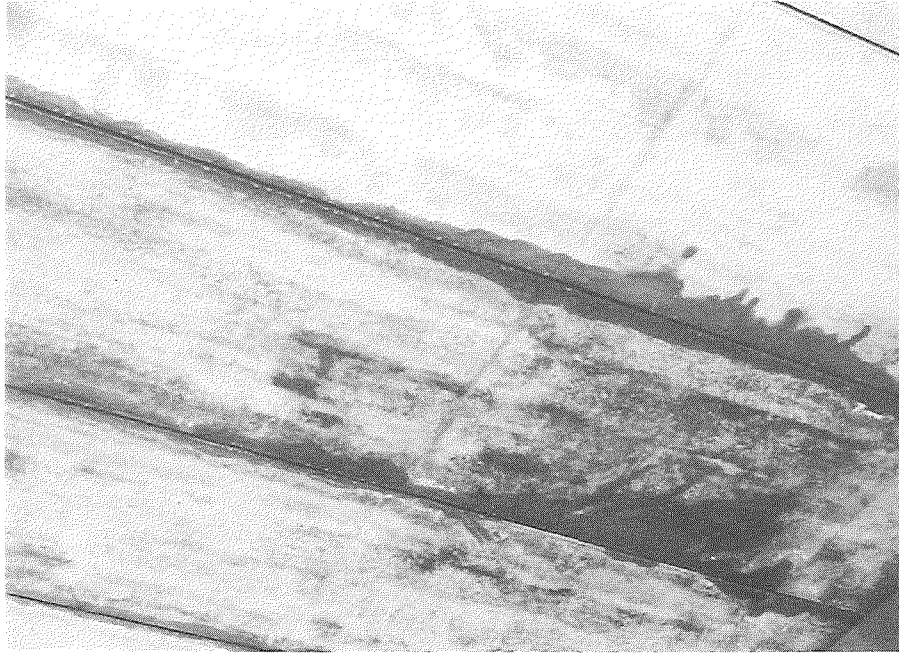
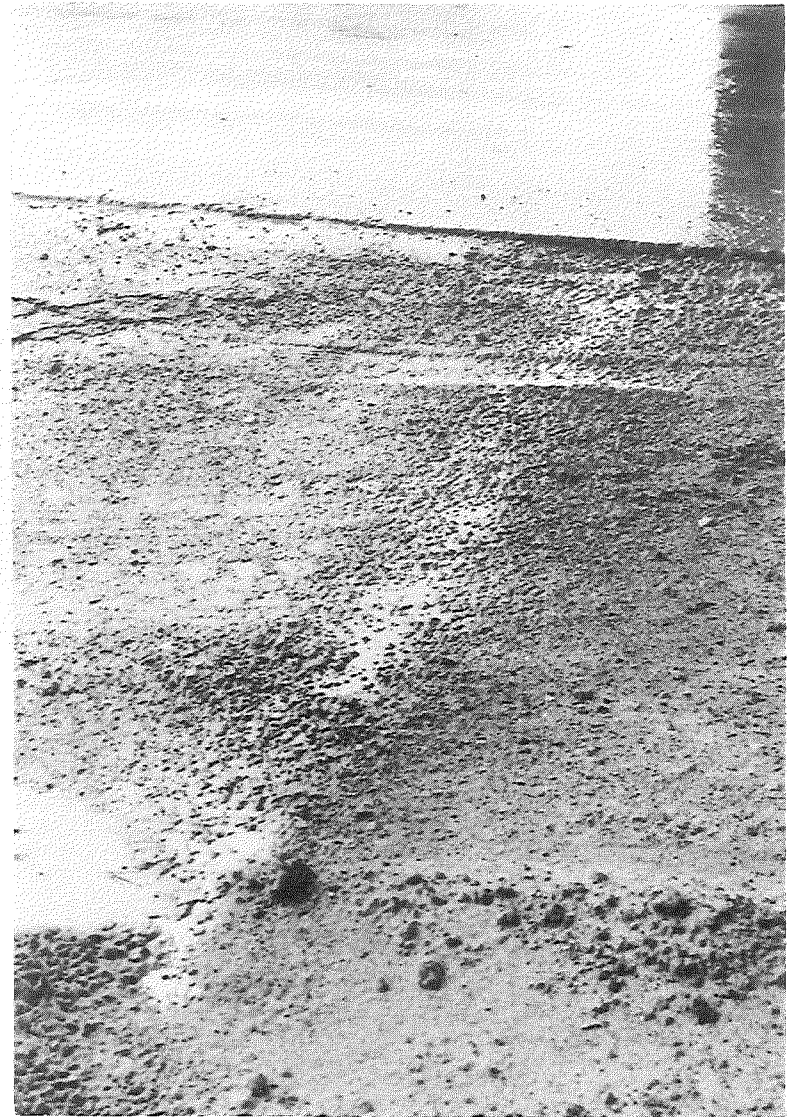
Figure 4. Undersurface seepage on Span 3 (left), with view of drip pattern on the US 12 shoulder directly beneath a longitudinal joint (right) (4-11-58).

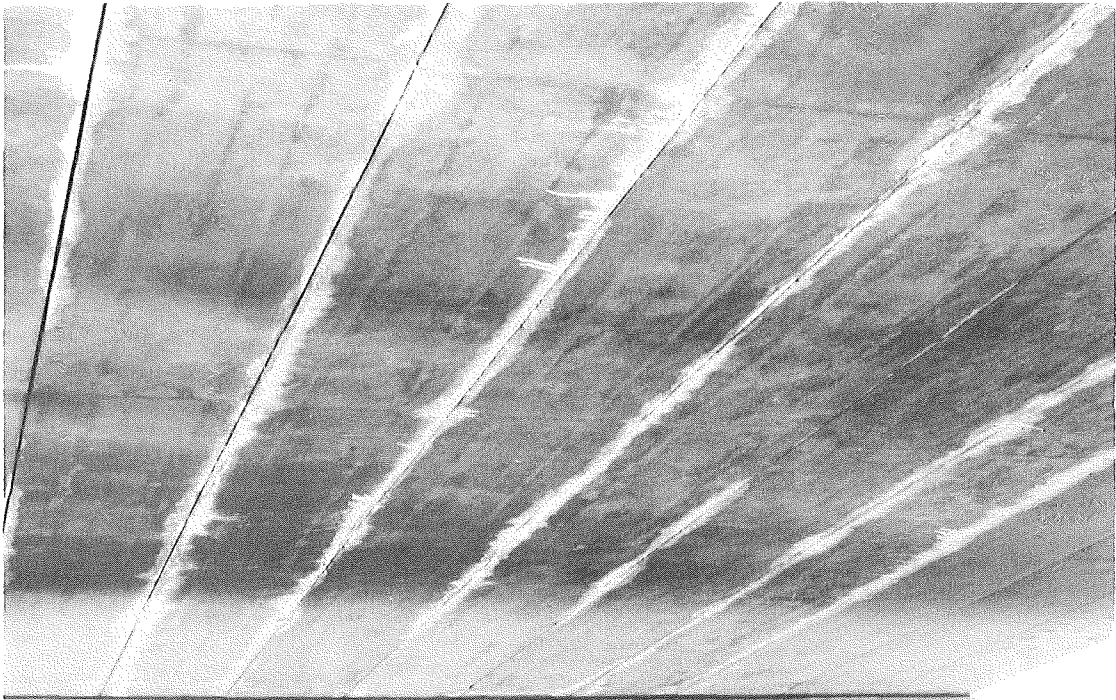
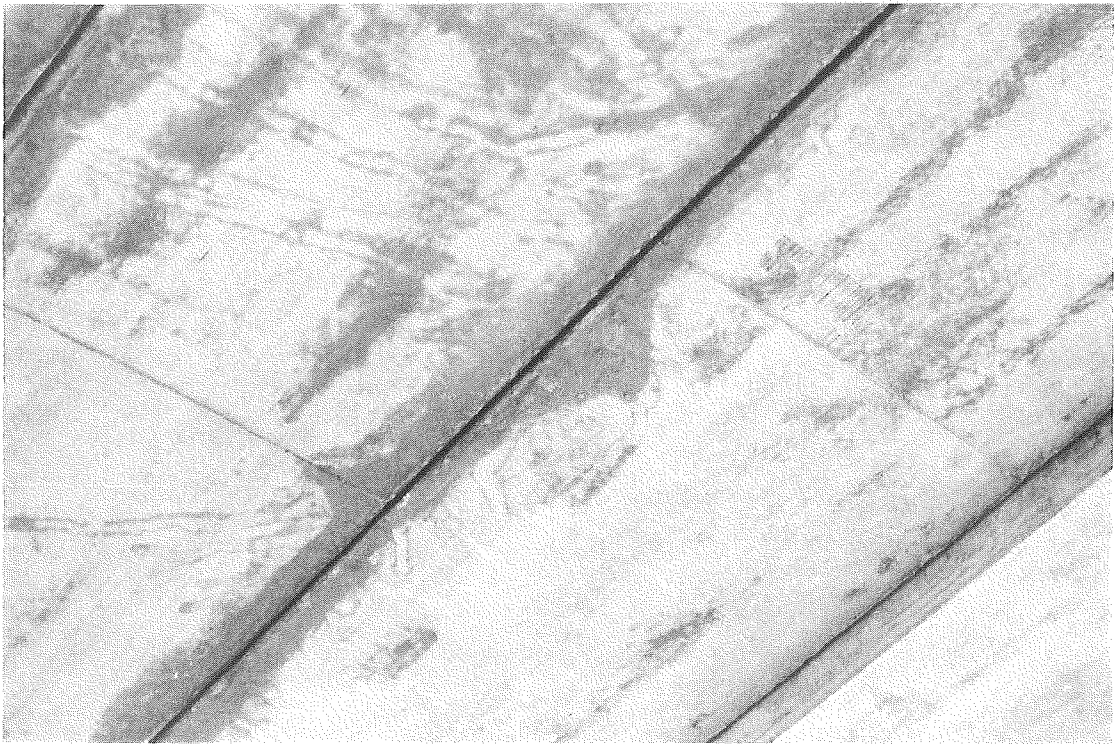
Figure 5. Water markings on undersurfaces of Span 4 (top) and Span 5 (bottom). Span 4 undersurface blackened by contractor's fires required for equipment maintenance (4-11-58).

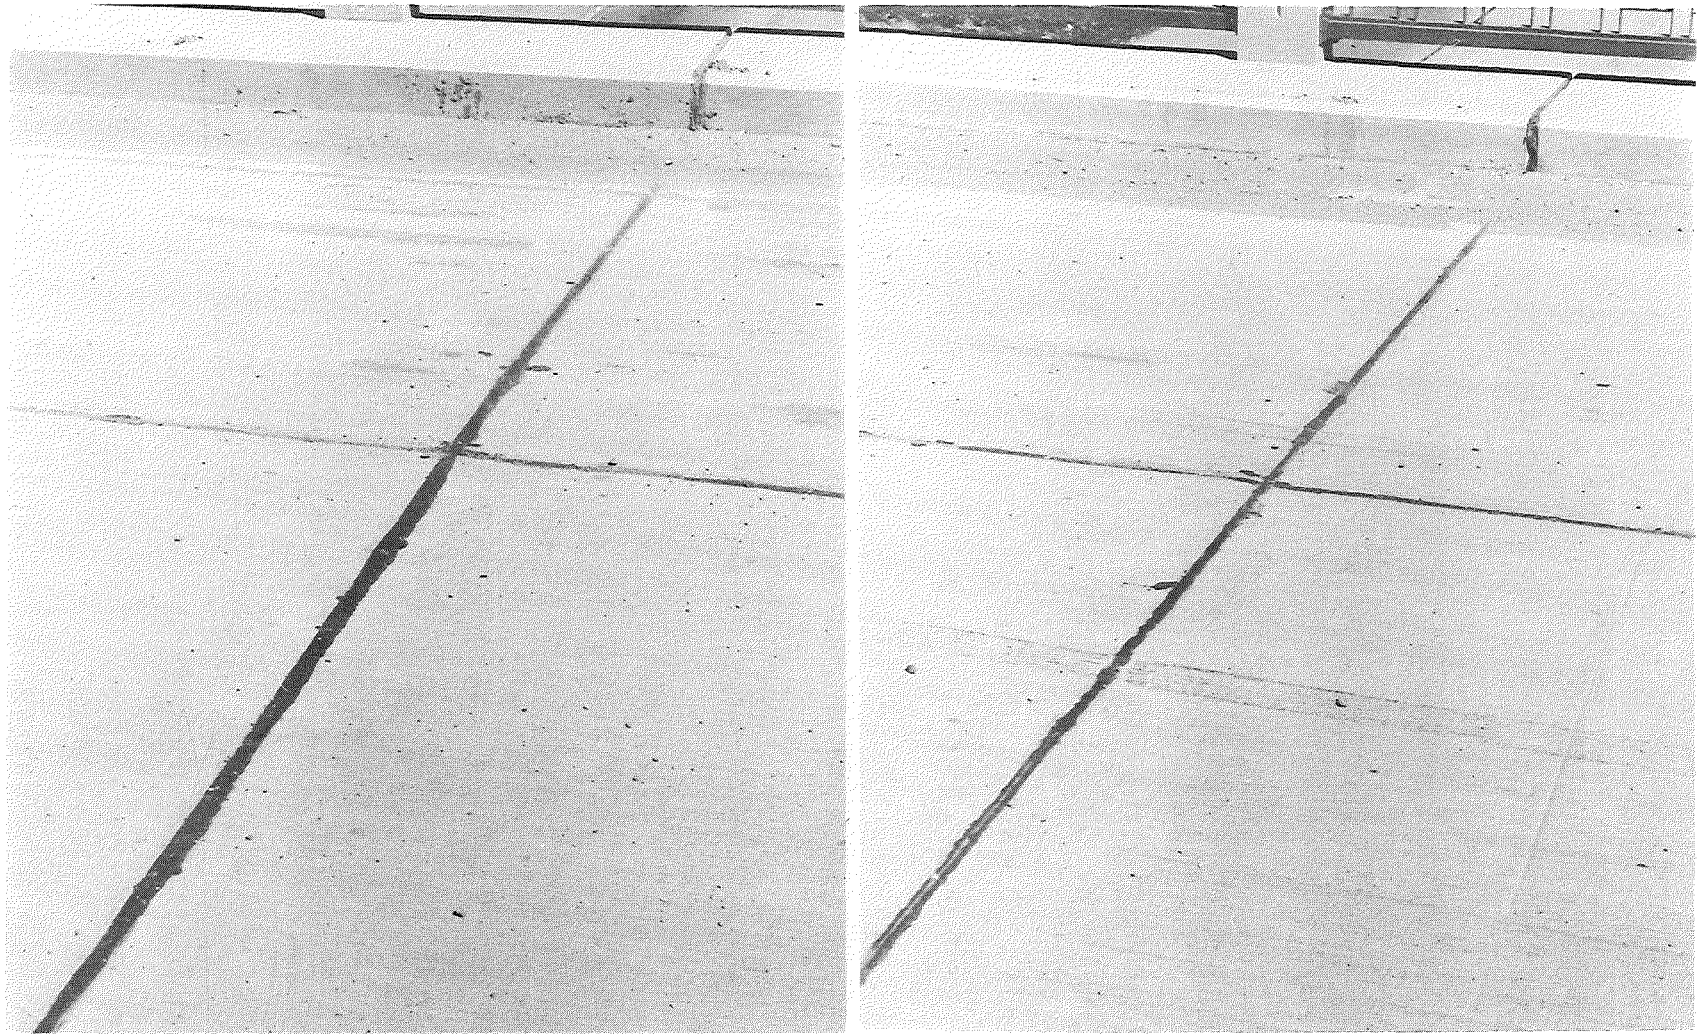
Figure 6. Sutton Road overpass on US 12 (B2 of 38-7-14), built at same time as nearby Dettman Road overpass, but with conventional concrete deck. Good joint sealing prevented leakage (4-15-58).

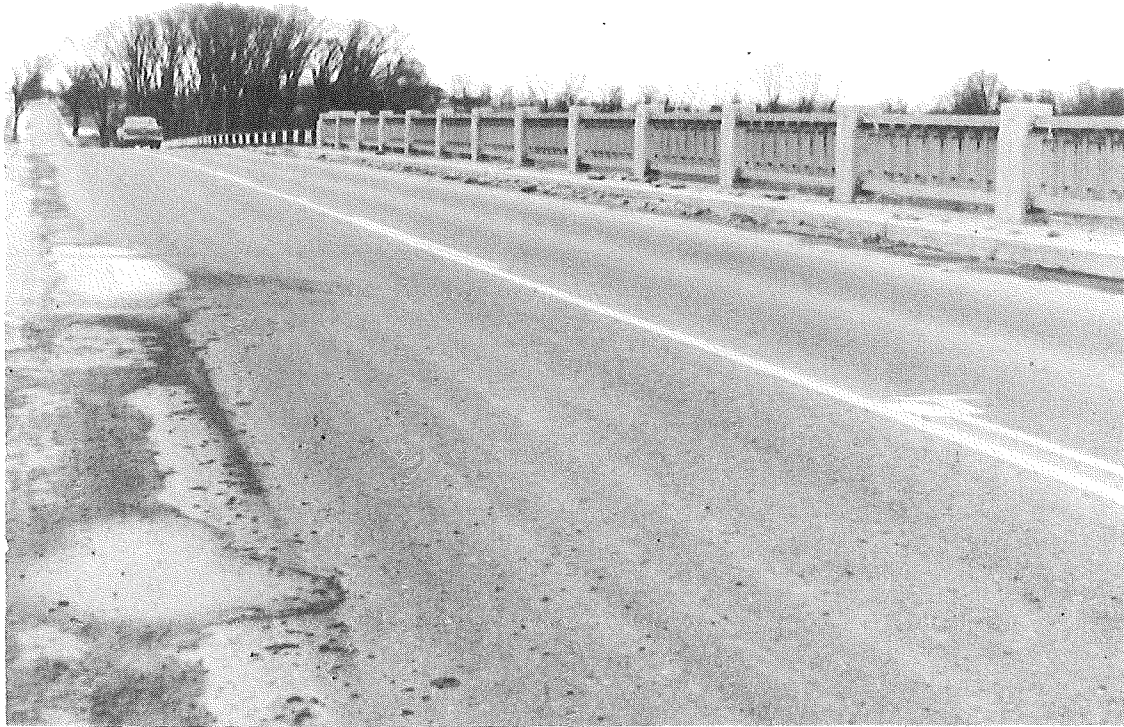
During the summer of 1958, Dettman Road, including this overpass, was resurfaced with bituminous aggregate. This surface treatment only partially and temporarily alleviated the leakage situation. As reflection cracks over the joints developed and enlarged, the situation again became serious.

Figure 7. Dettman Road overpass with bituminous aggregate resurfacing (2-60).

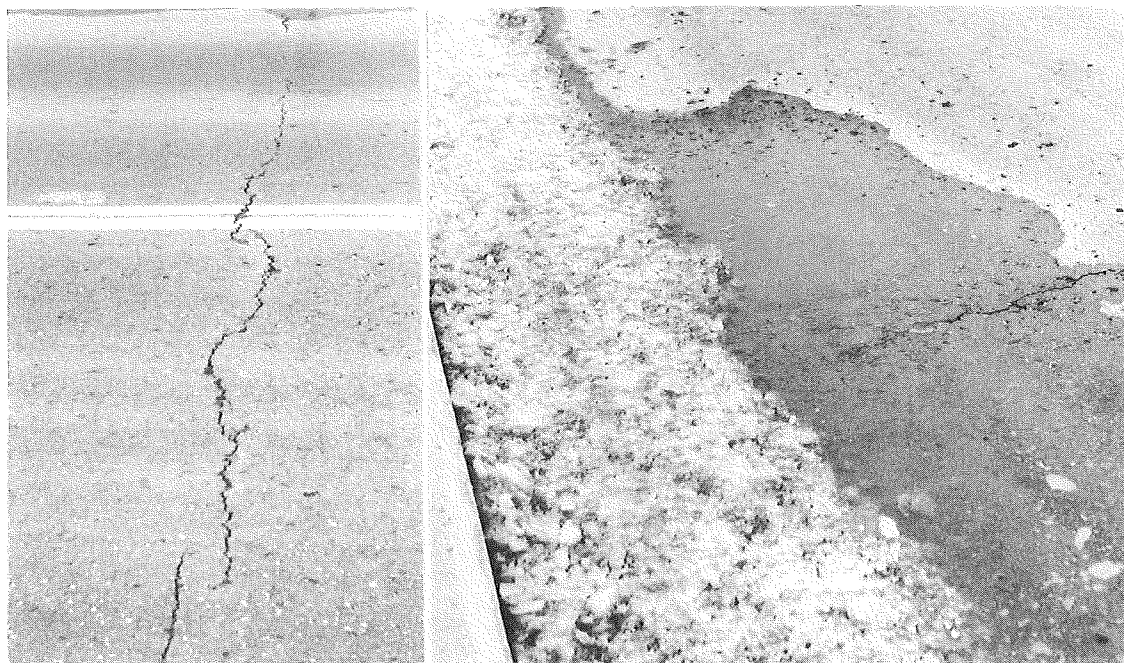
(Figs. 7-9). While the reflection cracks on the deck surface are average in size for bituminous aggregate resurfacing projects, they are of sufficient magnitude to allow passage of water into the superstructure. Even though the wearing surface appeared dry during the survey of February 1960, enough water had leaked through the joints between the girders and was still being released to cause the undersurface dampness and icing condition shown in the photographs.

Figure 8. Reflection crack over joint (left), with view of moisture conditions at curb adjacent to same crack (2-60).

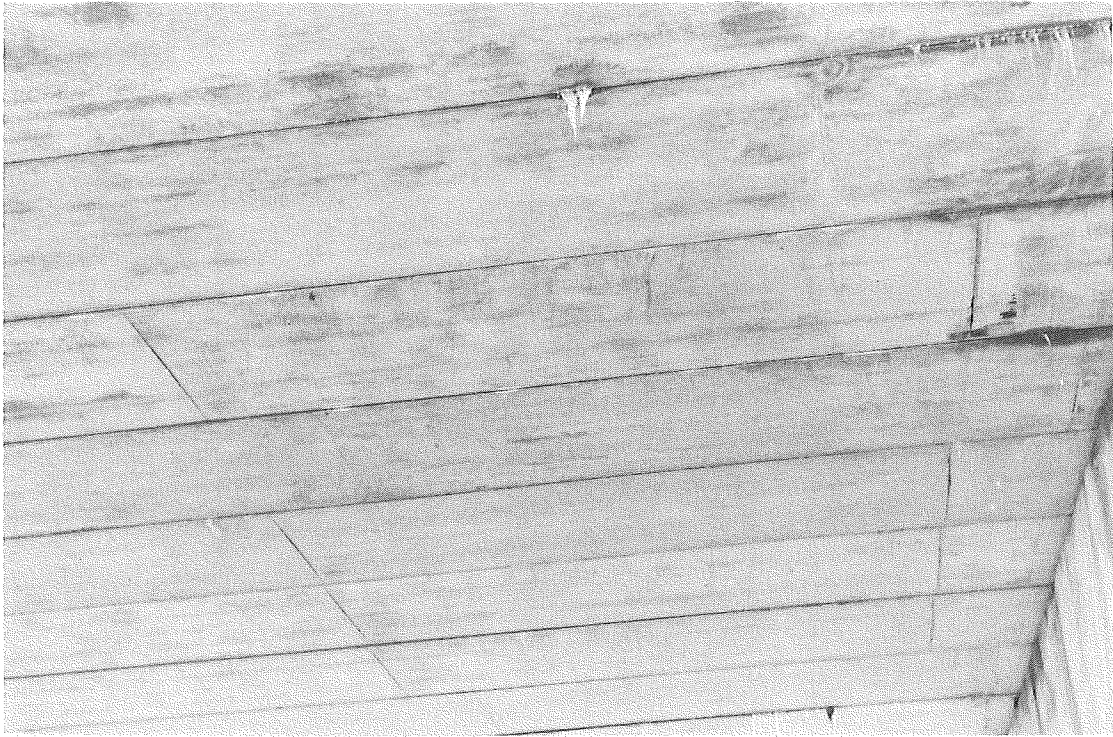
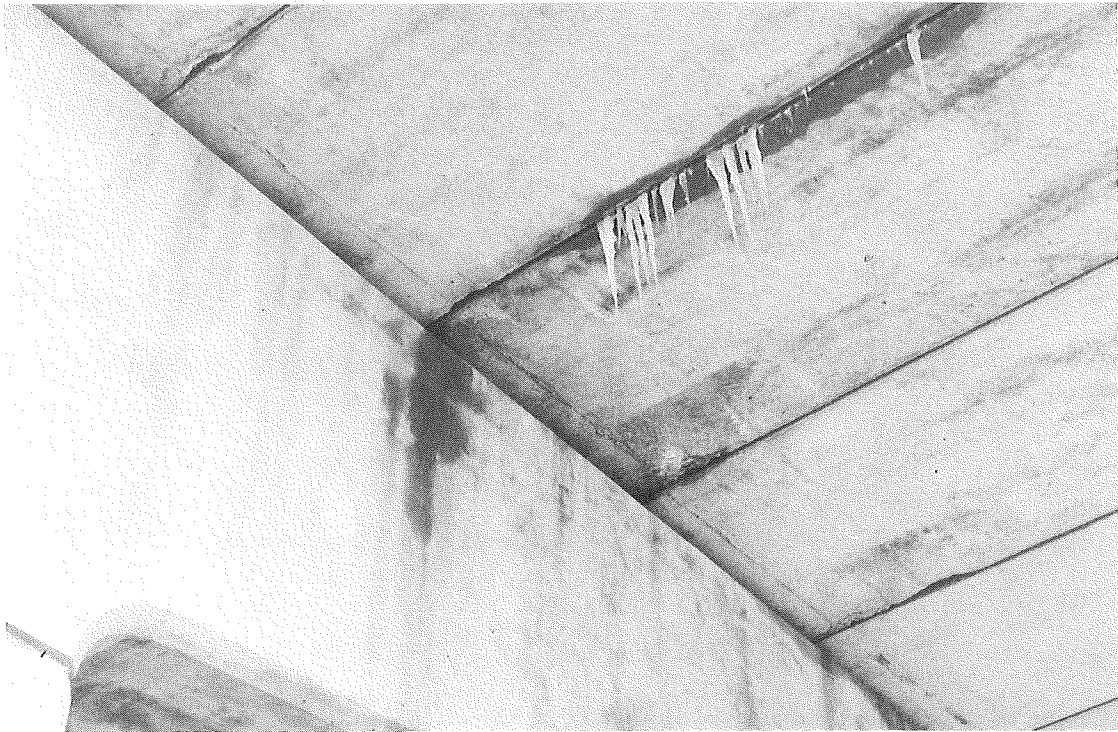
Figure 9. Undersurface conditions on Dettman Road overpass (2-60).

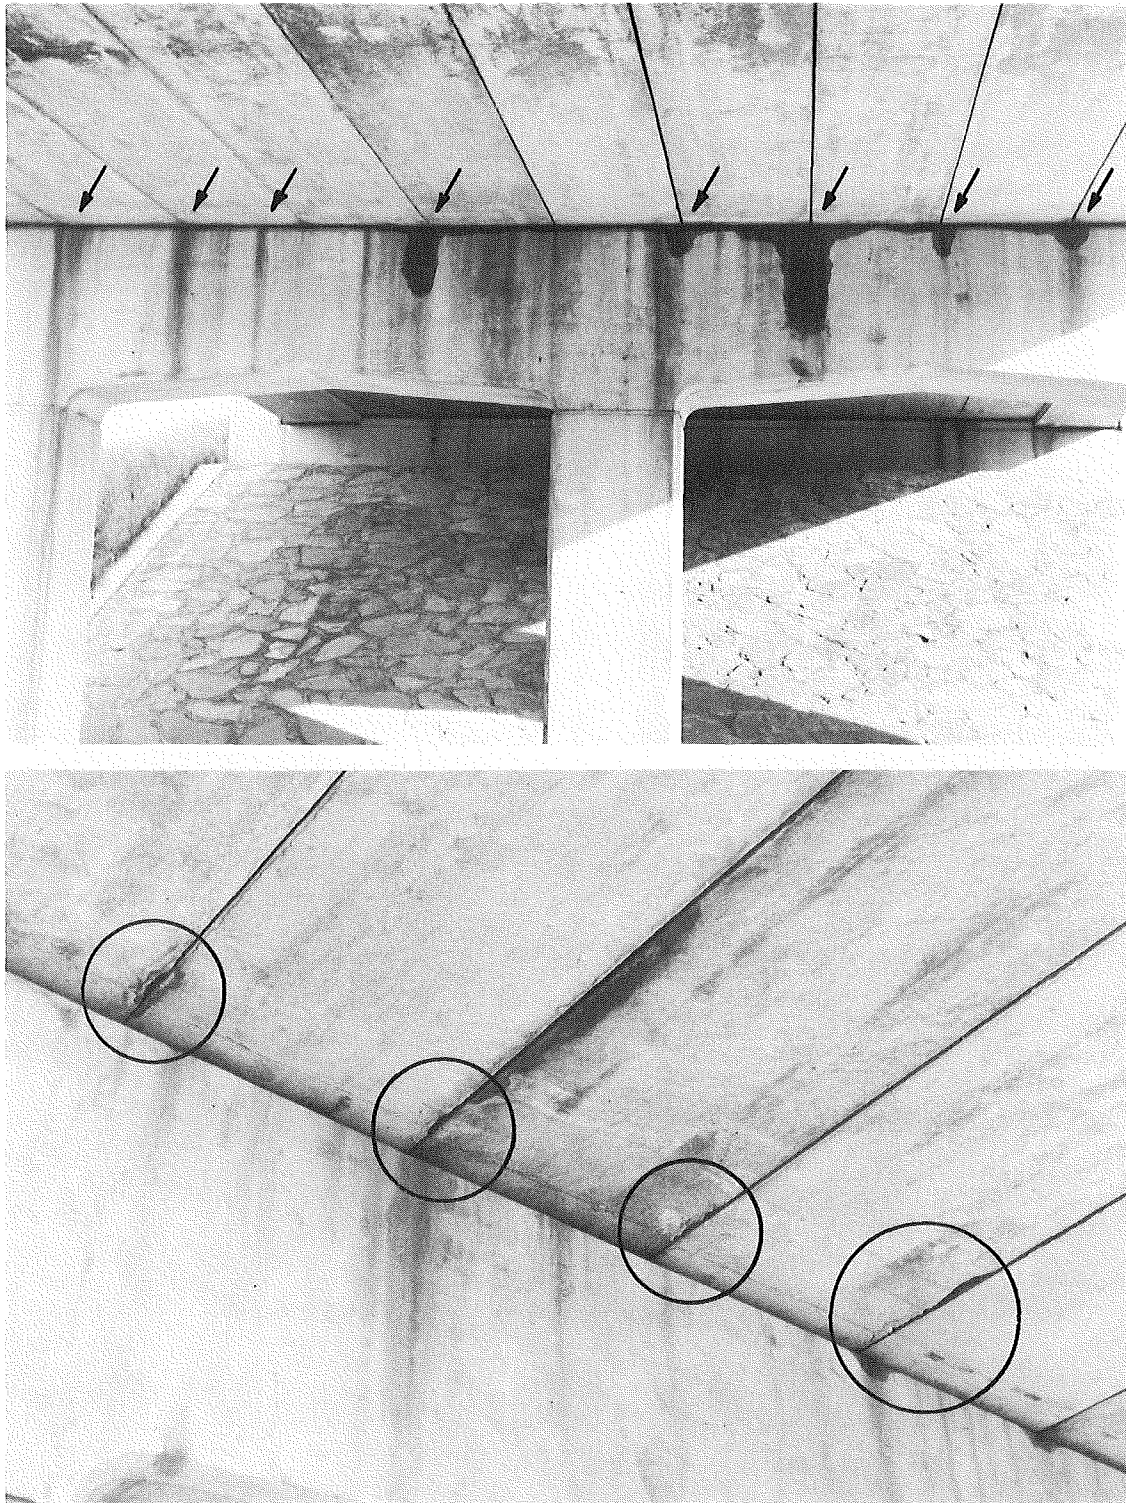
A second 1960 inspection, on September 27, showed that even several days after a rainfall, moisture was draining from within the beam structure and that distinct spall-like deterioration was taking place at beam corners (Fig. 10).

In summary, the evidence indicates the start of deterioration of concrete in the prestressed beams. Further, this deterioration may be taking place not only at the undersurface, but also between the beams where it is impossible to determine its extent or seriousness.

Figure 10. Condition of underside of beams after several days without rain, showing water draining from within the beam structure (top) and deterioration at beam corners (bottom) (9-27-60).

Consequently, it appears that some appropriate maintenance treatment should be undertaken at an early date to prevent further leakage.
