CONDITION OF THE STOCKBRIDGE SOIL-CEMENT PROJECT
AFTER 21 YEARS OF SERVICE
Construction Project M 33-50, C1

Research Laboratory Division
Office of Testing and Research
Research Project R-36 E-5(2)
Report No. R-408R

Michigan State Highway Department
John C. Mackie, Commissioner
Lansing, January 1963

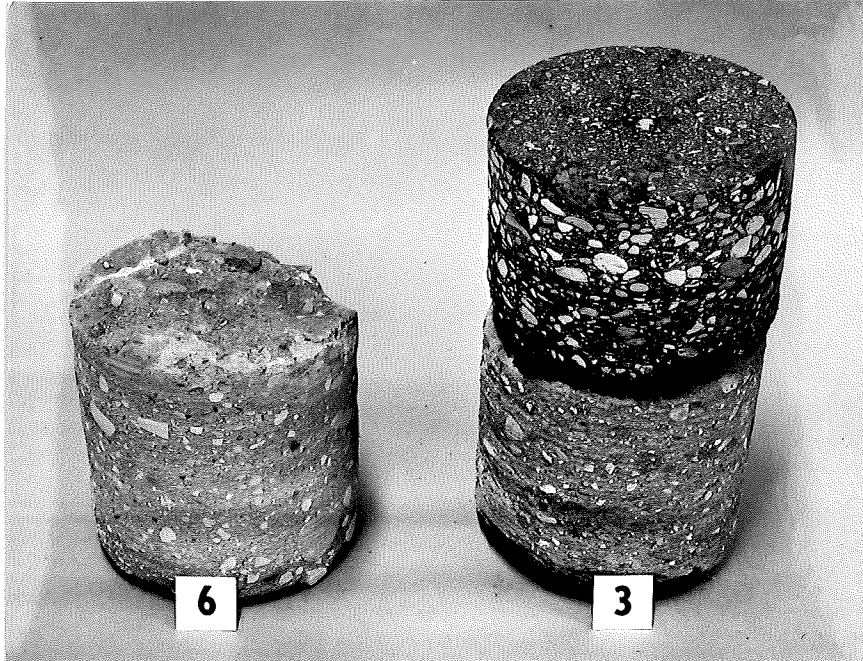
In October 1962, the project was inspected and nine samples were cored from the surfacing and base. In all cases, the samples were quite firm and offered no problems during the coring operations. Fig. 2 shows representative cores as obtained throughout the length of the project. Fig. 2-A shows typical full length cores obtained and includes a section of the present $3-1/2$ to 4-in. thick surfacing course. Fig. 2-B shows cores obtained from an area where a longitudinal crack was encountered, resulting in broken cores. All the portions were very firm, however.

The depth of the soil-cement portion of the cores varied from $4-1/2$ to $6-1/4$ in. The diameter was 6 in. The average compressive strength of four selected cores, corrected to a 2 to 1 height-to-diameter ratio, was 1310 psi. These compressive strengths were slightly higher than those obtained by similar operations in 1945. Average dry density of the cores was approximately 135 pcf, somewhat higher than obtained during construction.

A. Cores obtained from soil-cement base; No. 3 includes sample of 4-in. thick surface course.

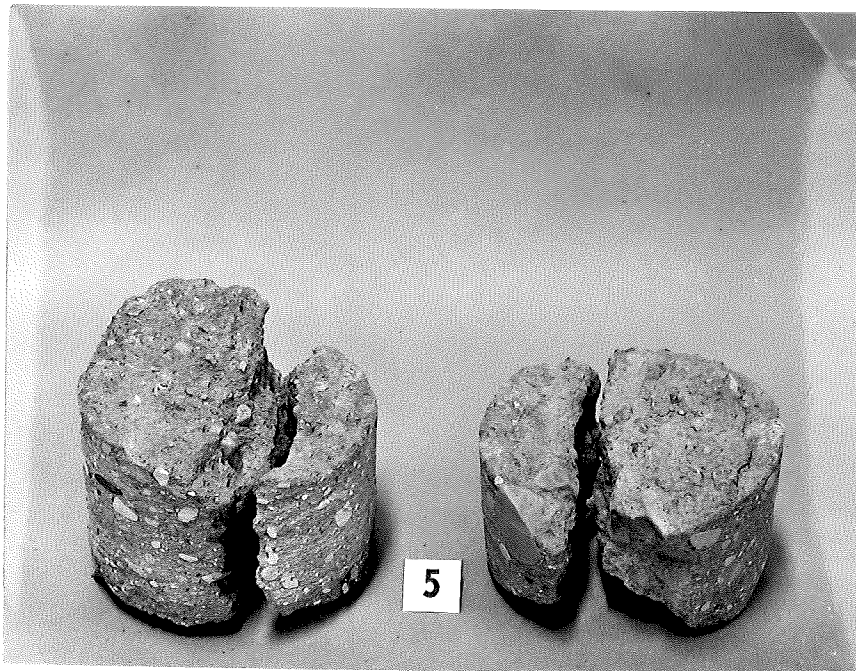
B. Split cores obtained at longitudinal crack; individual sections were very hard.

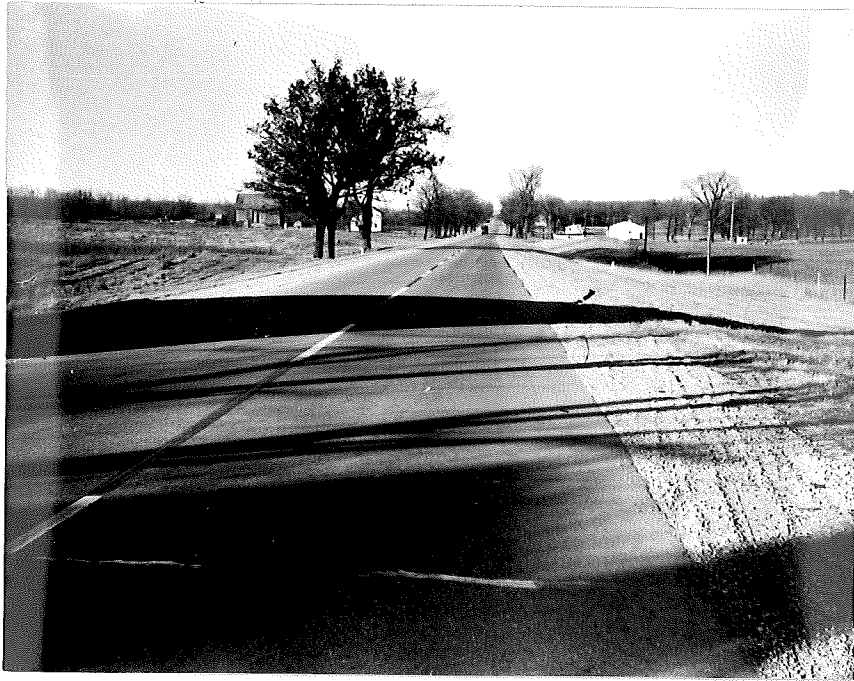
effects of traffic and weather well during the past 21 years, and that the roadway as a whole is in excellent condition. Typical surface condition throughout the length of the project is shown in Fig. 3.

A. North from POB (near Dexter Trail).

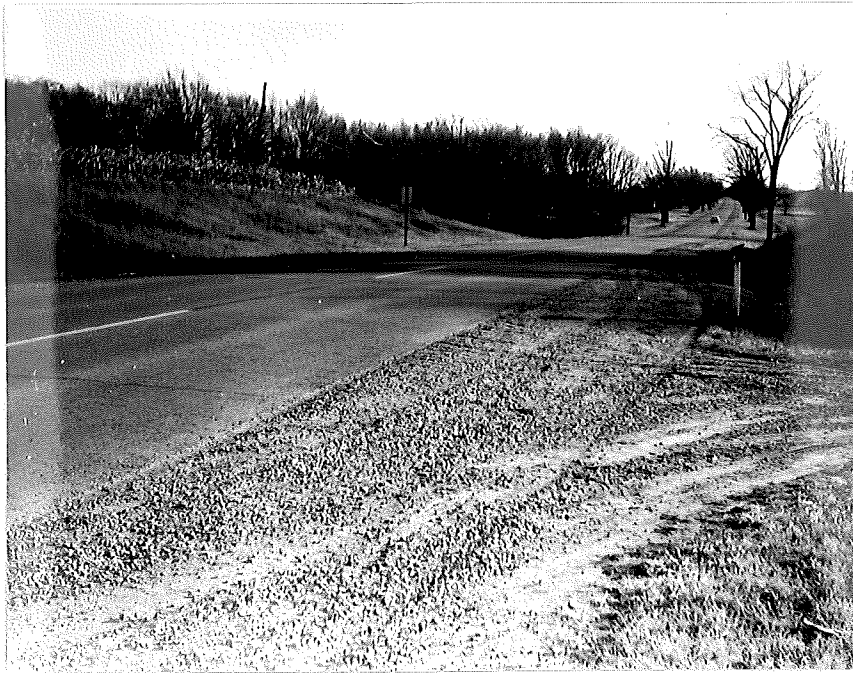
B. South through cut section.

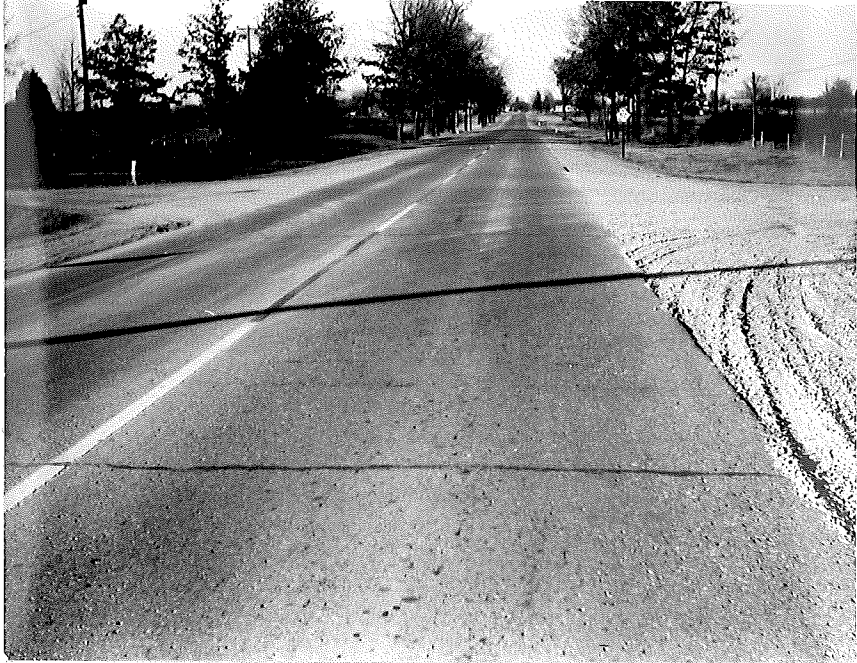
C. North at intersection with Milner Road.

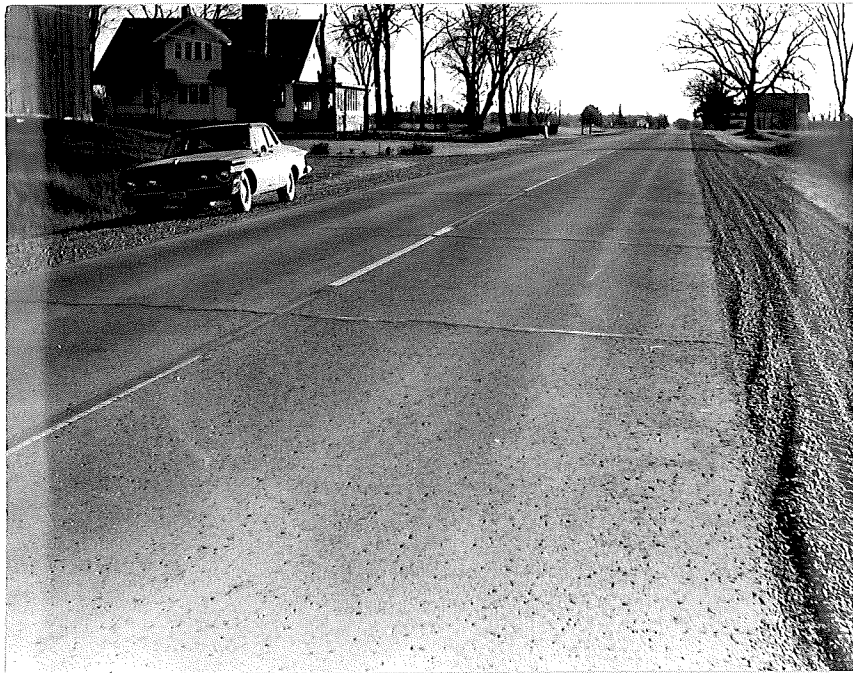
D. South from end of project (near M 36 junction).
