FIRST CONDITION SURVEY OF HOT-POURED
BITUMINOUS-RUBBER JOINT SEAL INVESTIGATION
ON US 16, WEST OF LANSING

Research Project 36 G-4 (3) E

Research Laboratory
Testing and Research Division
Report F-83
May 15, 1946

Installation on US 16, West of Lansing

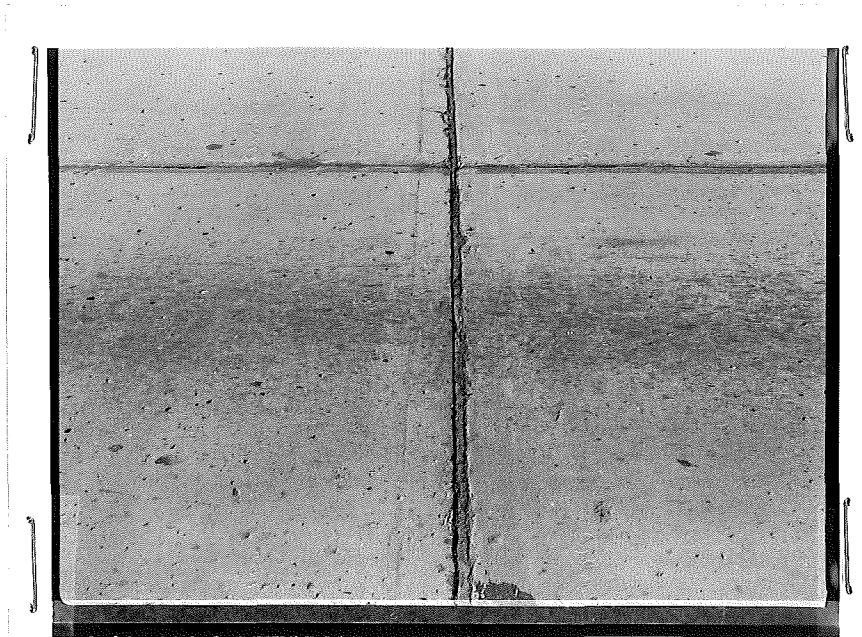
In general, all joints sealed with Paraplastic material were in very good condition. However, the joints on the south half of the pavement appeared to be better sealed than those on the north half. The joints on the north half of the pavement evidently, for some unknown reason, were not flush with the pavement as compared with those on the south half. No apparent difference could be noticed in the bonding characteristics of the joints which were primed as compared with the joints which were not primed. In other words, the value of priming expansion joints prior to sealing is questionable. The air temperature at the time of inspection was approximately 70°F. The material could be readily dented with the finger. Figure No. 1 is a view showing typical expansion joint sealed with a tar joint seal material. Figures 2, 3 and 4 show typical condition of paraplastic joint seal material.

Figure 1. View of joint sealed with tar material. North half Station 188+95.

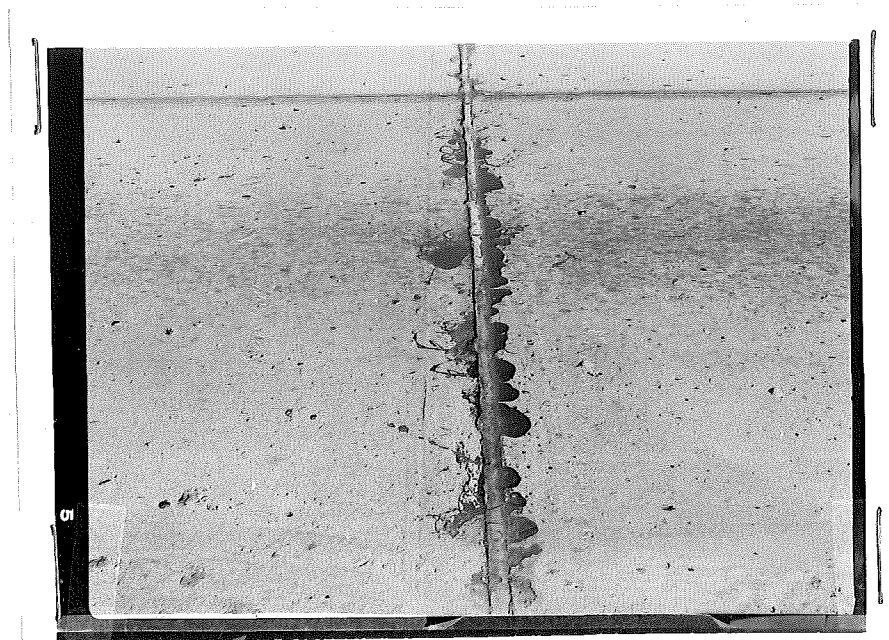
Figure 2. Paraplastic. North half looking south. Station 187+78. Not enough seal material in joint.

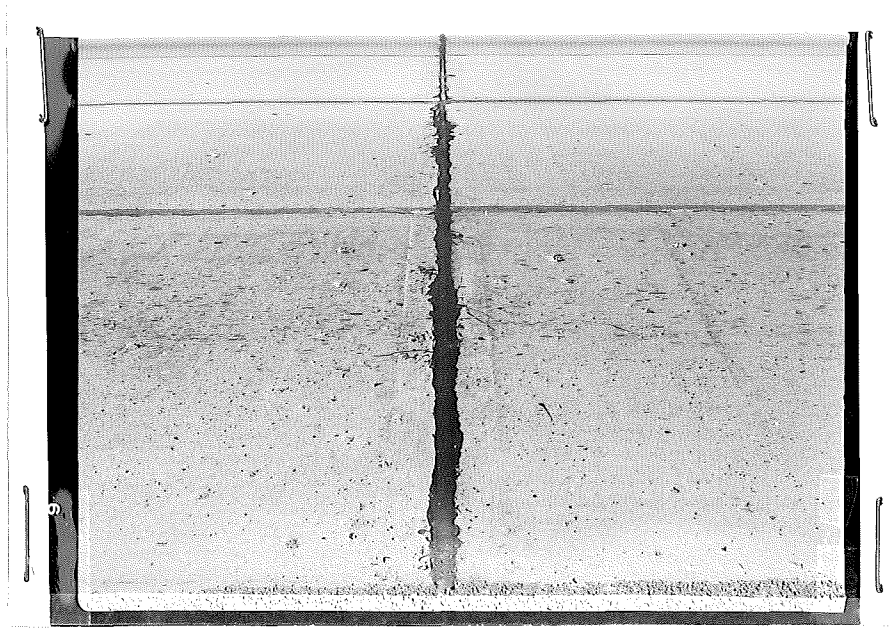
Figure 3. Paraplastic. South half looking north. Station 186+55. Joint properly filled.

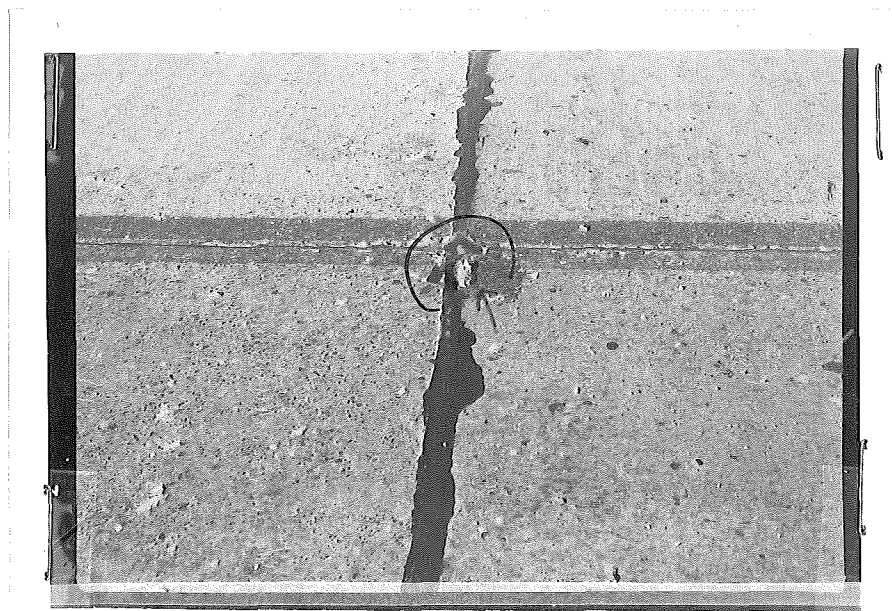
Figure 4. Paraplastic. Station 185+95. Note lack of bond where joint was not cleaned properly.

carefully as those on the south half. In other words, the joints had the appearance of not being completely filled at the time of pouring and they seemed to have weathered more than the south half. Another thing that was quite obvious during the survey was that the joints must be cleaned completely of all loose material and dirt adhering to the concrete in order that the seal will become 100 percent effective. This is a very important requirement.

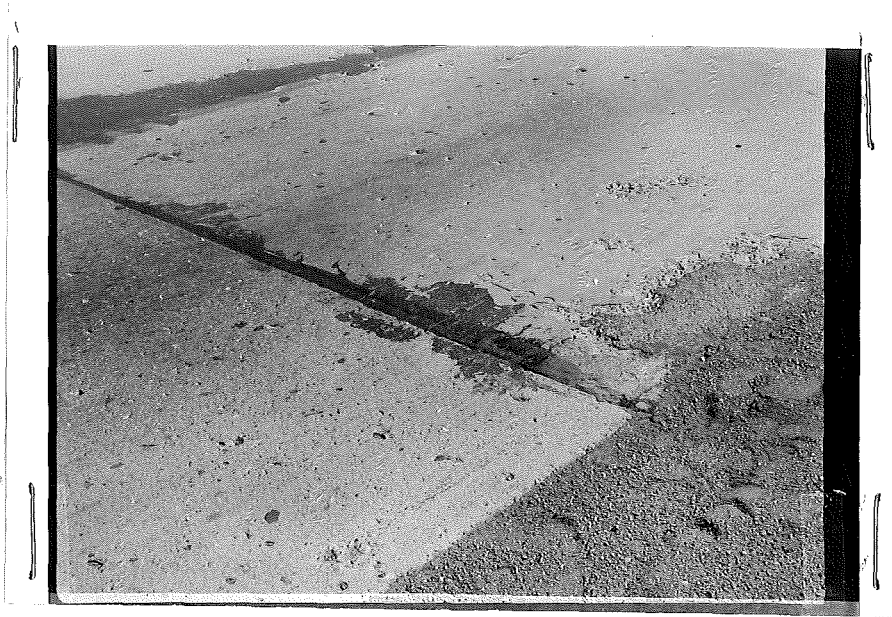
This material apparently sealed the joints perfectly except that the material was too soft, having a tendency to run out on the shoulder at the end of the joint. See Figure 5.

Figure 5. Oil-Revertex. South half looking north.
Station 185+30. Bleeding was noticeable at
edge of slab. Material too soft.

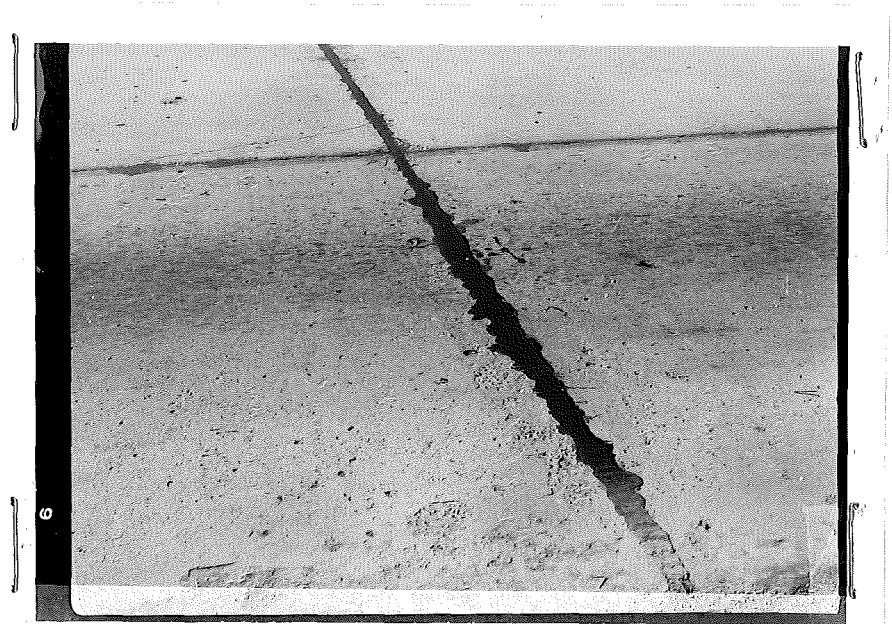
This material appeared harder than the Asphaltic Oil - Revertex, but was too soft for satisfactory joint seal material. The joint at Station 185+30 was in poor condition due apparently to improper pouring operations. However, the material adheres well to the concrete and provides excellent sealing. See Figure 6.

Figure 6. Oil-Anode GRS. North half looking south.
Station 184+80. Provides excellent seal,
but too soft.

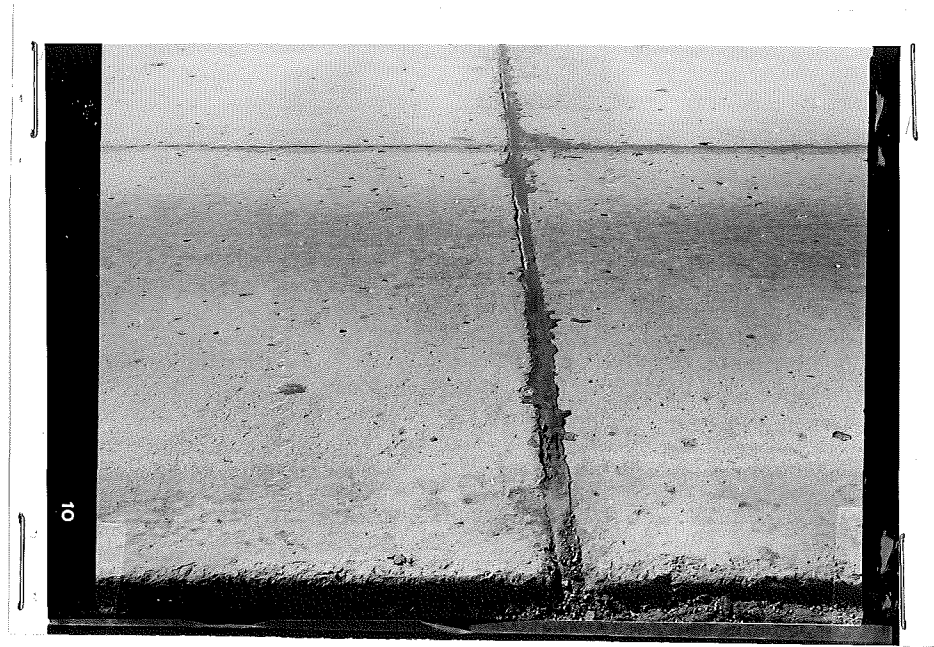
This material apparently had about the same consistency as the Paraplastic, but had very low wetting properties and did not bond satisfactorily to the concrete. See Figure 7.

Figure 7. SOA-GRS. North half looking south. Station 183+48. Material does not bond satisfactorily. About same consistency as Hot Poured type.

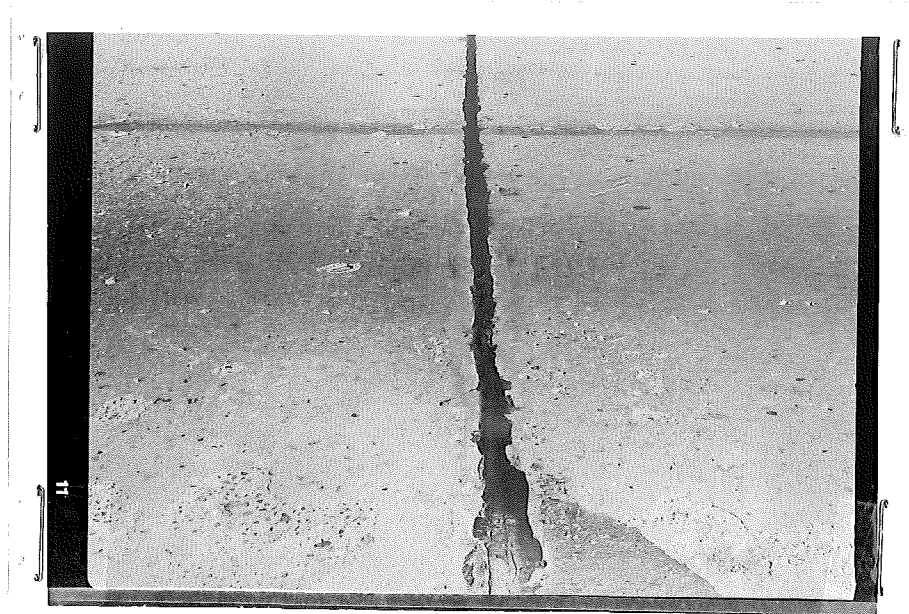
This material was very similar in every respect to that of SOA - Anode GRS both in wetting properties and in general consistency. The general appearance of all the joints was excellent, yet the material does not seem to bond properly to the concrete. See Figure 8.

Figure 8. SOA, Revertex. South half looking north. Station 182+91. Good consistency, but poor bond, same as SOA-GRS. General appearance excellent.

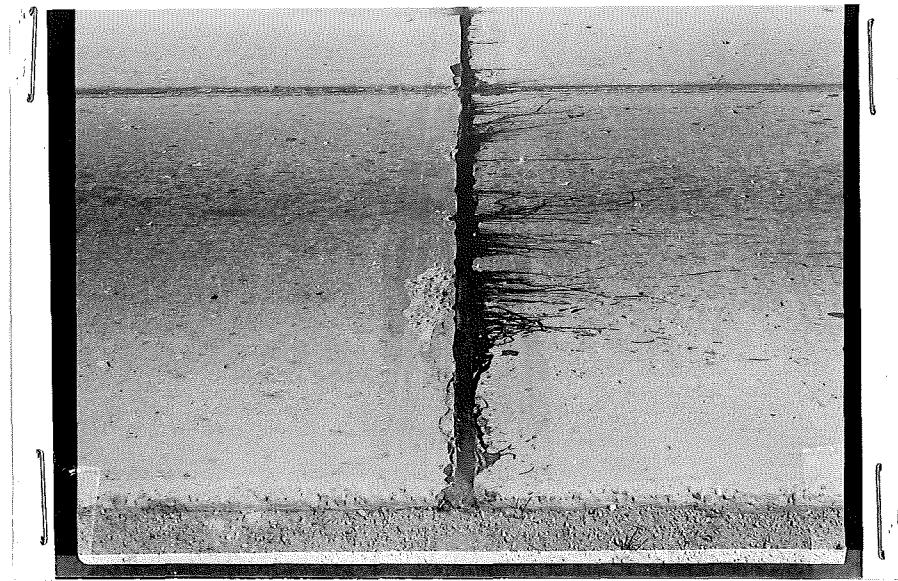
This material sealed the joint in a very excellent manner and the joints appeared to be in very good condition on both sides of the pavement. Careylastic seemed to have the proper consistency and adhered very well to the concrete where the latter was clean when the joint was poured. From the inspection it would appear that Careylastic was giving the best performance to date. See Figure 9.

Immediately after pouring the joints on the north half of the pavement, Portland Cement was dusted lightly over the hot seal material to prevent pick up by traffic. A portion of the cement dust has evidently combined with the seal material at the surface to form a very thin crust. This crust has cracked to the extent that the joint seal material has the appearance of having undergone accelerated weathering. The joints on the south half of the test section were not dusted with a Portland Cement. Traffic was detoured until the seal material had hardened sufficiently to resist pick up by the wheels. Results indicate that this method should be used.

Figure 9. Careylastic. South half looking north.
Station 181+13. All joints in good condition.
View showing pick up by traffic.
