## OFFICE MEMORANDUM

MICHIGAN  
STATE HIGHWAY DEPARTMENT

December 14, 1964

Subject: Repair of Rubber Pad Railroad Crossing (NYC RR Crossing US 23 South of Dundee). Research Project R-64 G-134. Research Report No. R-486.

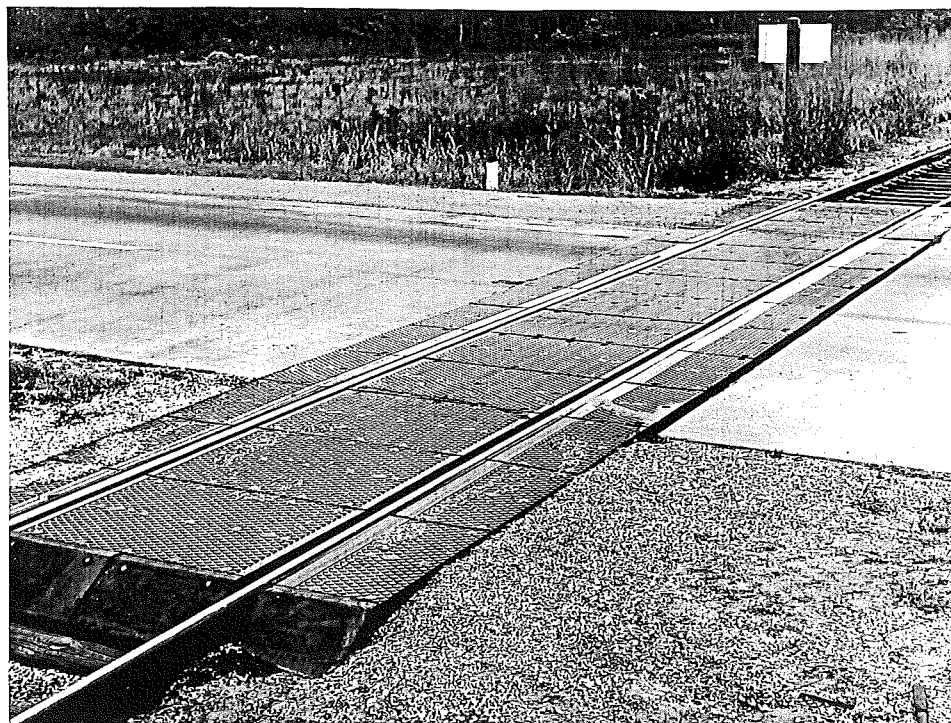
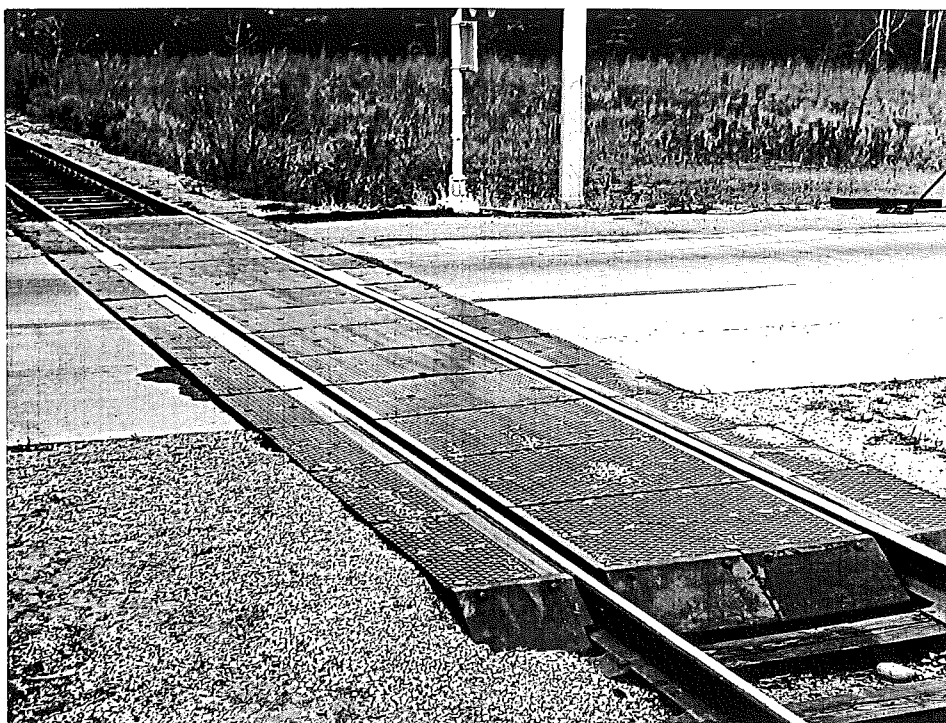
The condition of the crossing before replacement is shown in Fig. 1. As illustrated, the crossing surface on both roadways was higher than the adjacent pavement edge. It is thought that this elevation differential (approximately 1 in.) contributed considerably to the relatively early failure of the crossing by causing the pads and foundation to be subjected to high impact forces resulting from crossing vehicles. On both roadways, both the approach and leaving slabs were noted to dip toward the crossing, thus indicating that settlement of the subgrade had caused the variation in elevation. A tension crack in the leaving slab surface about 30 ft from the crossing was considered substantiating evidence that loss of subgrade support had occurred. Because the slabs were dipping toward the crossings, and an open space varying in width from 1 to 2-1/2 in. existed between the concrete headers and the pads, water could freely enter the subgrade thus making it very susceptible to settlement. The

Figure 1. Condition of crossing before replacement, showing elevation differential: northbound (top) and southbound (bottom).

1. Close cooperation between the Railroad Company and the Department is desirable to ensure that rails and roadway surfaces are constructed to correct elevations.

4. As soon as possible after construction the joint on each side of the crossing should be sealed to prevent water from entering the ballast and roadway subgrade. Periodic resealing might be necessary to maintain an effective seal.

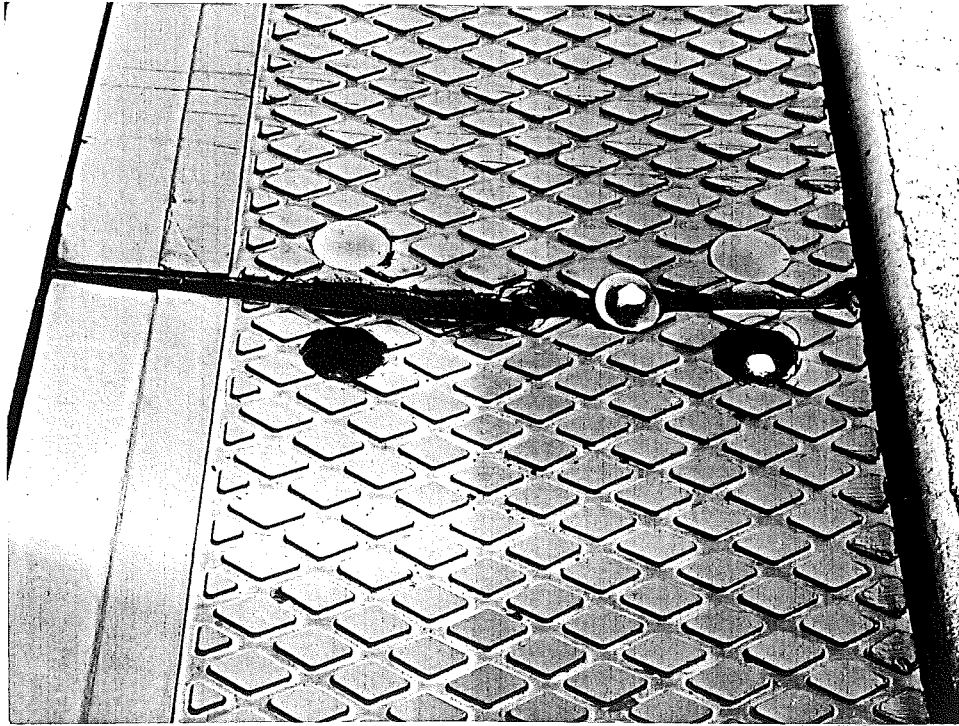
side pads on both sides of the track were loose, whereas the center pads were in good condition. An attempt to fasten the side pads by use of spikes during an earlier repair is illustrated in Fig. 2. The previously described open space between pads and concrete header is also noticeable in Fig. 2. Although the crossing has been subjected to an average daily traffic volume of about 4,500 vehicles, of which 22 percent was estimated as commercial, there was no apparent wear of the pad surface.

Figure 2. Close-up of side pad condition in old repair area, also showing open joint.

5. Since loose pads will result in wear on bolt holes, bolts, and shims, re-tightening of the bolts appears advisable after the crossing has been subjected to vehicle traffic for some time.

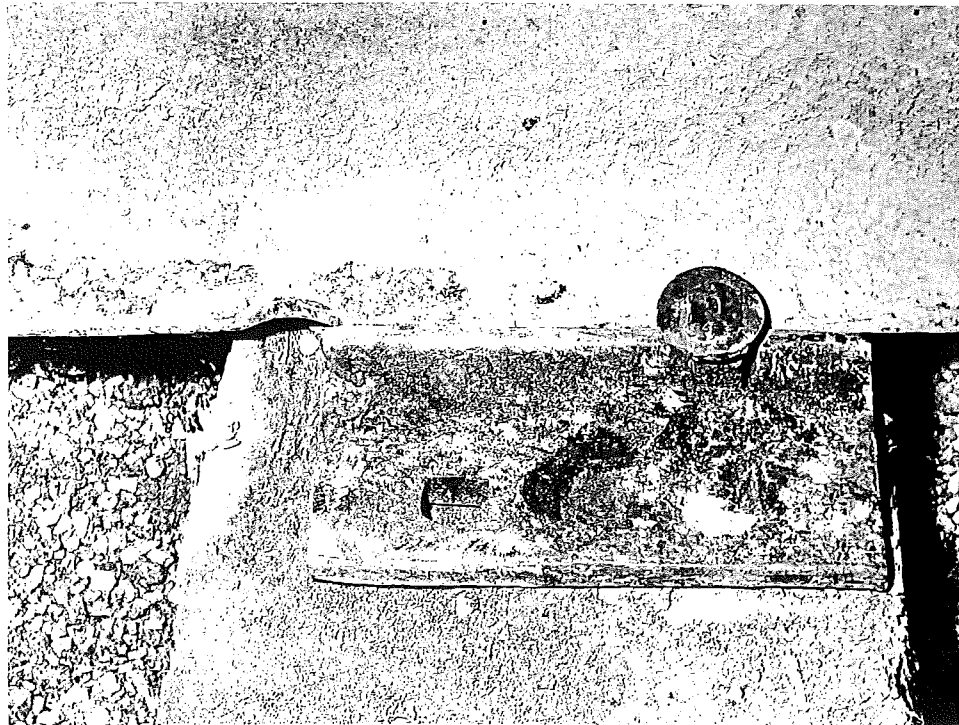
After the pads and shims were removed, the rails and ties were inspected. The south rail was still spiked to the ties, but the north rail was loose. It appeared that settlement of the rail ballast had occurred along the approach edge because the ties were not in contact with the rail. As a result, the north rail was actually suspended across the roadway surface and was subjected to vibrations each time a vehicle crossed. It is thought that as the ballast settled, these vibrations eventually caused the spikes to loosen or the spike heads to wear through the rail flange as illustrated in Fig. 3.

Figure 3. Wear of rail flange caused by vibrations in rail. Photo taken after rail was moved a few inches to the left and re-spiked.

2. Because ballast re-work is somewhat difficult after the pads are in place, the manufacturer recommends that the track be laid and subjected to rail traffic for a few days before installing the pads. Re-compaction of the ballast before placing the pads will minimize settlement.

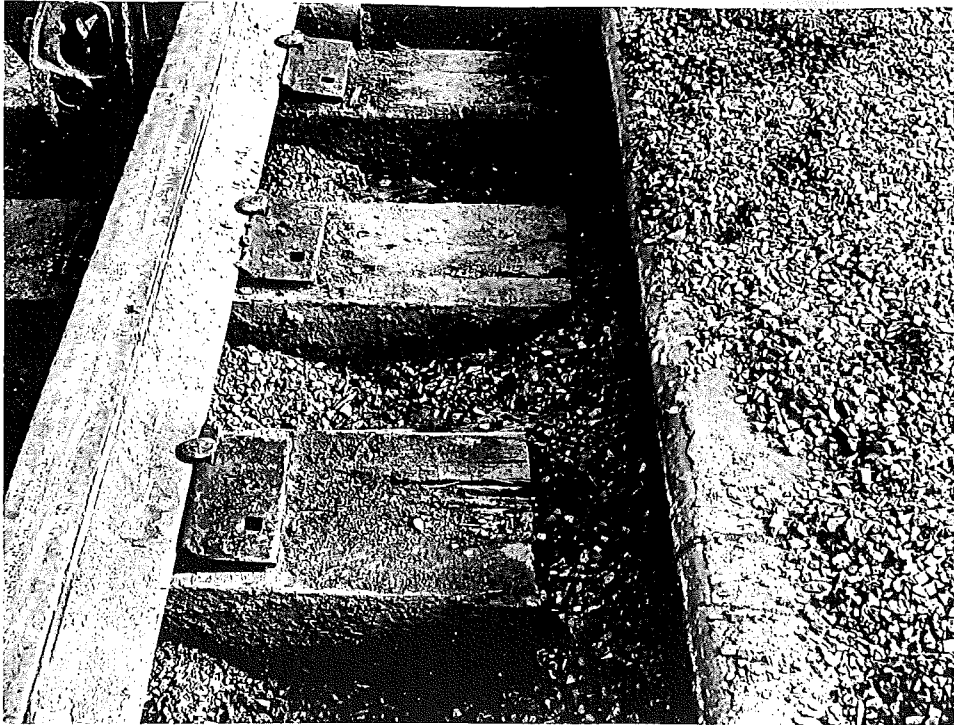
The ties were laid on 18-in. centers, but were not spaced with equal extensions beyond the rails. For this reason, and also because some ties were shorter than the required 8 ft 6 in., in many cases the outer row of lag bolts was too close to the tie ends or missed the ties completely. Tie length and edge distance of the outer row of bolt holes in the ties are summarized in Table 1. Variation in tie length and location of bolt holes are shown in Fig. 4. A vertical section of the crossing in Fig. 5 illustrates the condition of the shims extending beyond the ties. Because some of the side pads were fastened to the ties with only the inner row of lag bolts, these pads were rocking when vehicles crossed and their shape eventually distorted.

Tie No. *	Tie Length	Edge Distance of Lag Bolt From...		Remarks
		North End of Tie	South End of Tie	
1	8'-6"	2-1/4"	1-1/2"	----
2	8'-6"	2-1/4"	3/4"	Bolt hole sheared out on south tie end.
3	8'-6"	2-1/2" and 2-1/4"	3/4" and 1"	----
4	8'-6"	1-3/4"	1-1/4"	----
5	8'-6"	1-3/4" and 1-1/2"	1/2" and 1/2"	Both bolt holes sheared out on south tie end.
6	8'-7"	2-3/8"	1-1/4"	----
7	8'-4"	1/4" and 1/2"	3/4" and 3/4"	Both bolt holes sheared out on south and north tie ends.
8	8'-5"	1-3/4"	----	Bolt missed south tie end completely.
9	8'-6"	2-3/4" and 2-3/4"	1" and 1"	Both holes sheared out on south tie end.
10	8'-0"	3/4"	----	Bolt missed south tie end completely.
11	8'-5"	3/4" and 1"	1/2" and 3/4"	Both holes sheared out on south tie end.
12	8'-5"	2"	----	Bolt missed south tie end completely.

Figure 4. Condition of exposed ties. Note sheared-out bolt holes in top and center tie. Bolts missed the bottom tie completely.

3. Only ties and shims of correct dimensions should be used, and they should be of the best quality available.

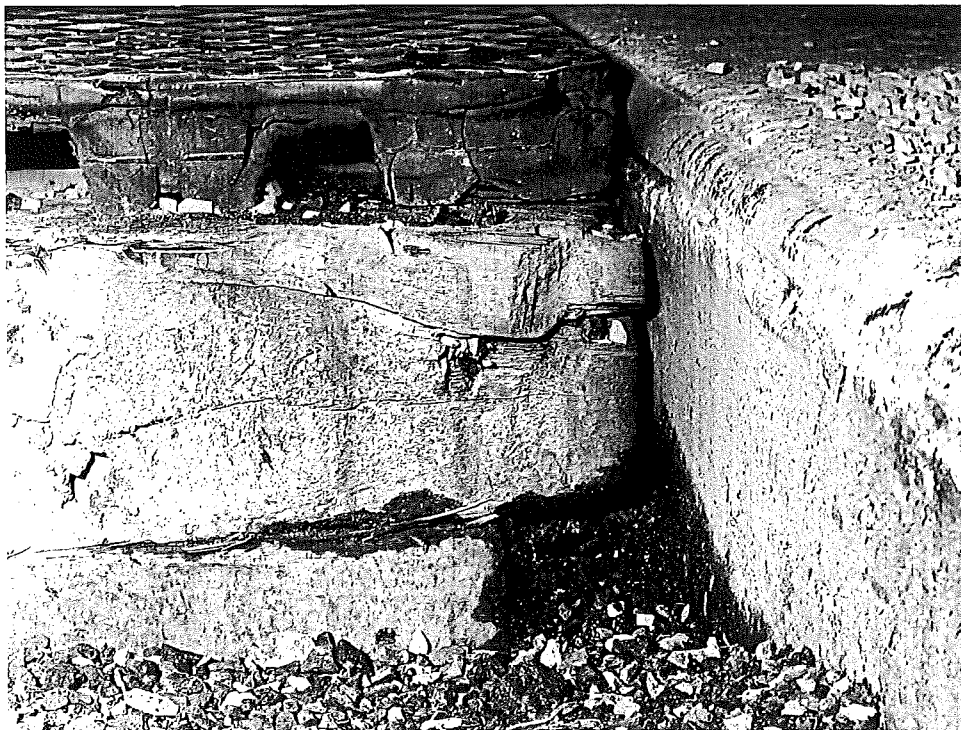
Figure 5. Vertical section of the crossing illustrating shim extension beyond tie end.
