PERFORMANCE OF HOT-POUR AND COLD-APPLIED  
JOINT SEAL MATERIALS

Projects 30-31, C2; 38-7, C5; 46-3, C8  
US-127, Relocation South of Jackson

Research Laboratory  
Testing and Research Division  
Report No. 254  
February 20, 1956

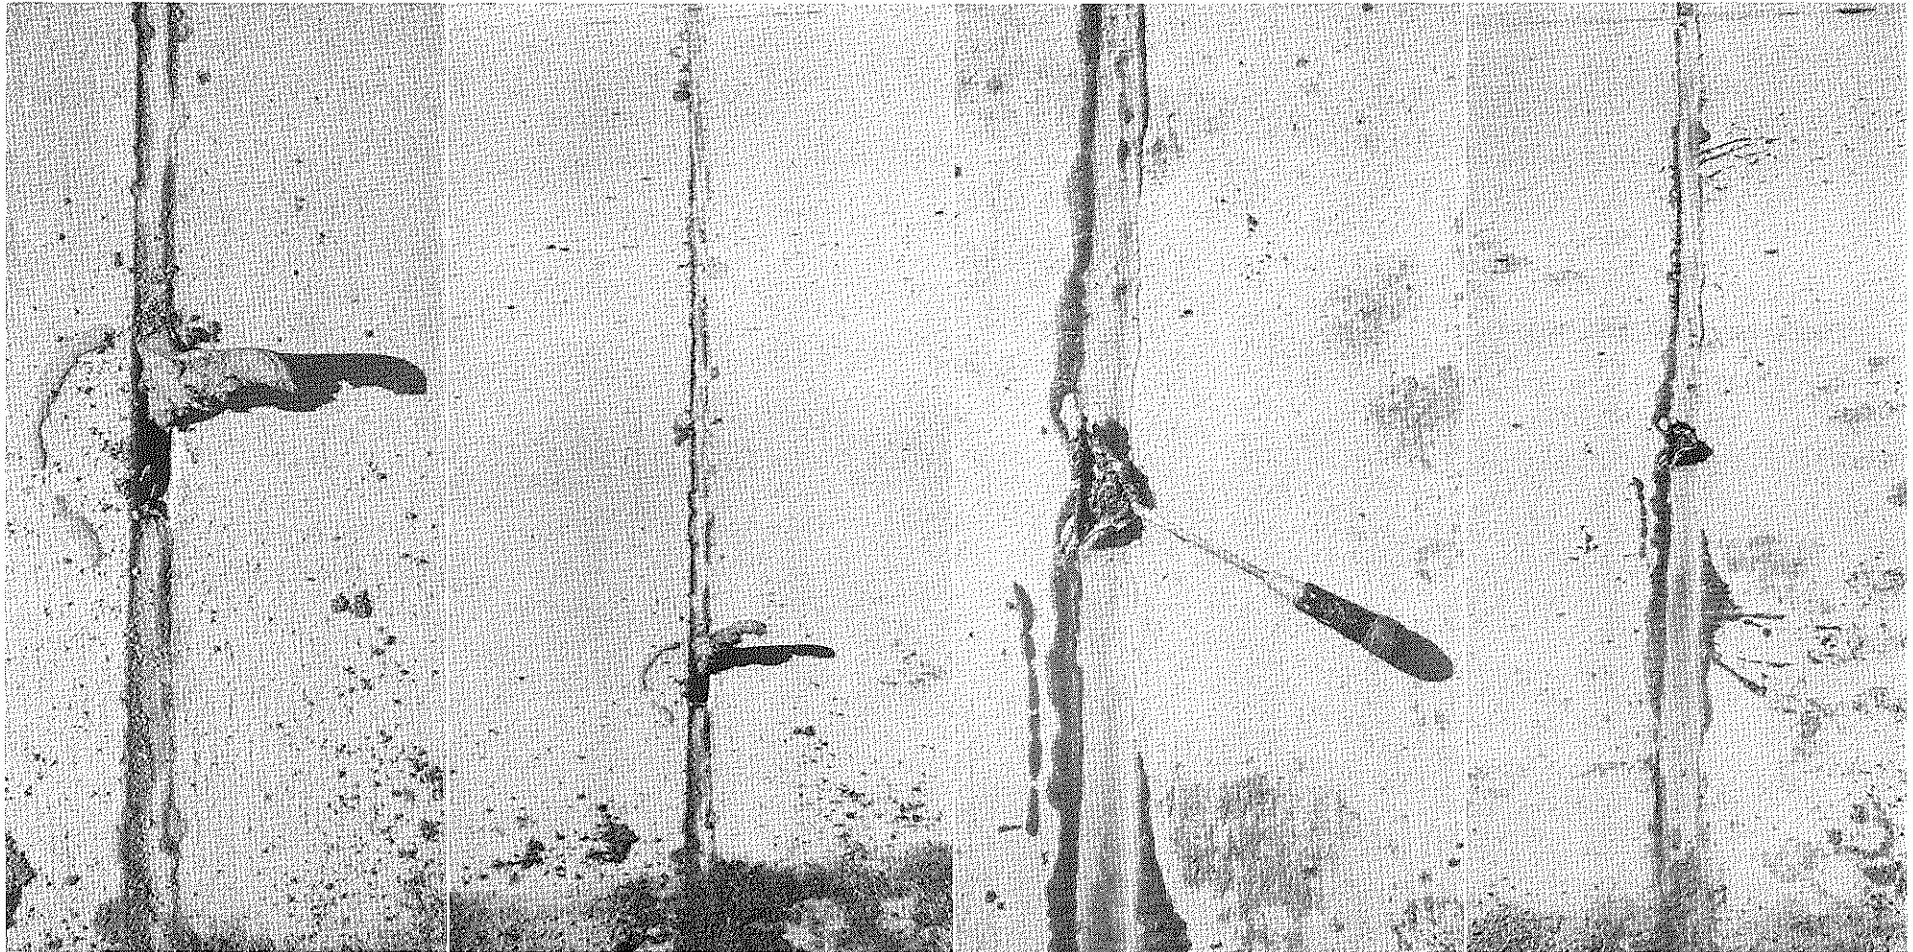
All of the hot-pour joint seal had lost adhesion to the joint faces even though some joints appeared well sealed at the surface, (Figure 1-C and 1-D). In mandrel-formed joints that had not been protected with jute rove before sealing there was a considerable amount of sand under the sealer (Figure 1) but in those protected with jute rove before sealing (Figure 2) and in the sawed joints (Figure 3), little or no sand was found.

The sand in the mandrel-formed joints where jute had not been used before sealing with hot-pour joint seal had apparently been there before the joints were sealed. Examination of Figure 1-C and 1-D will indicate that sufficient sealing material is in the joint to form a mechanical seal by compaction from traffic. This joint was opened close to maximum on the day the picture was taken since the temperature on that day was below freezing. Even at this near maximum opening there is no space through which sand could enter the joint. It is therefore probable that these joints had not been cleaned out before the sealer was poured.

A. STATION 78 + 20 CLOSE - UP.

B. STATION 78 + 20 OVERALL VIEW.

C. STATION 92 + 35 CLOSE - UP  
APPEARS SEALED AT SURFACE.

D. STATION 92 + 35 OVERALL VIEW.

FIGURE I. FORMED CONTRACTION JOINTS IN WHICH JUTE ROVE WAS NOT USED PRIOR TO SEALING WITH HOT-POUR RUBBER-ASPHALT JOINT SEAL. SEALER LACKED ADHESION AND A CONSIDERABLE AMOUNT OF SAND WAS FOUND UNDER JOINT SEAL.

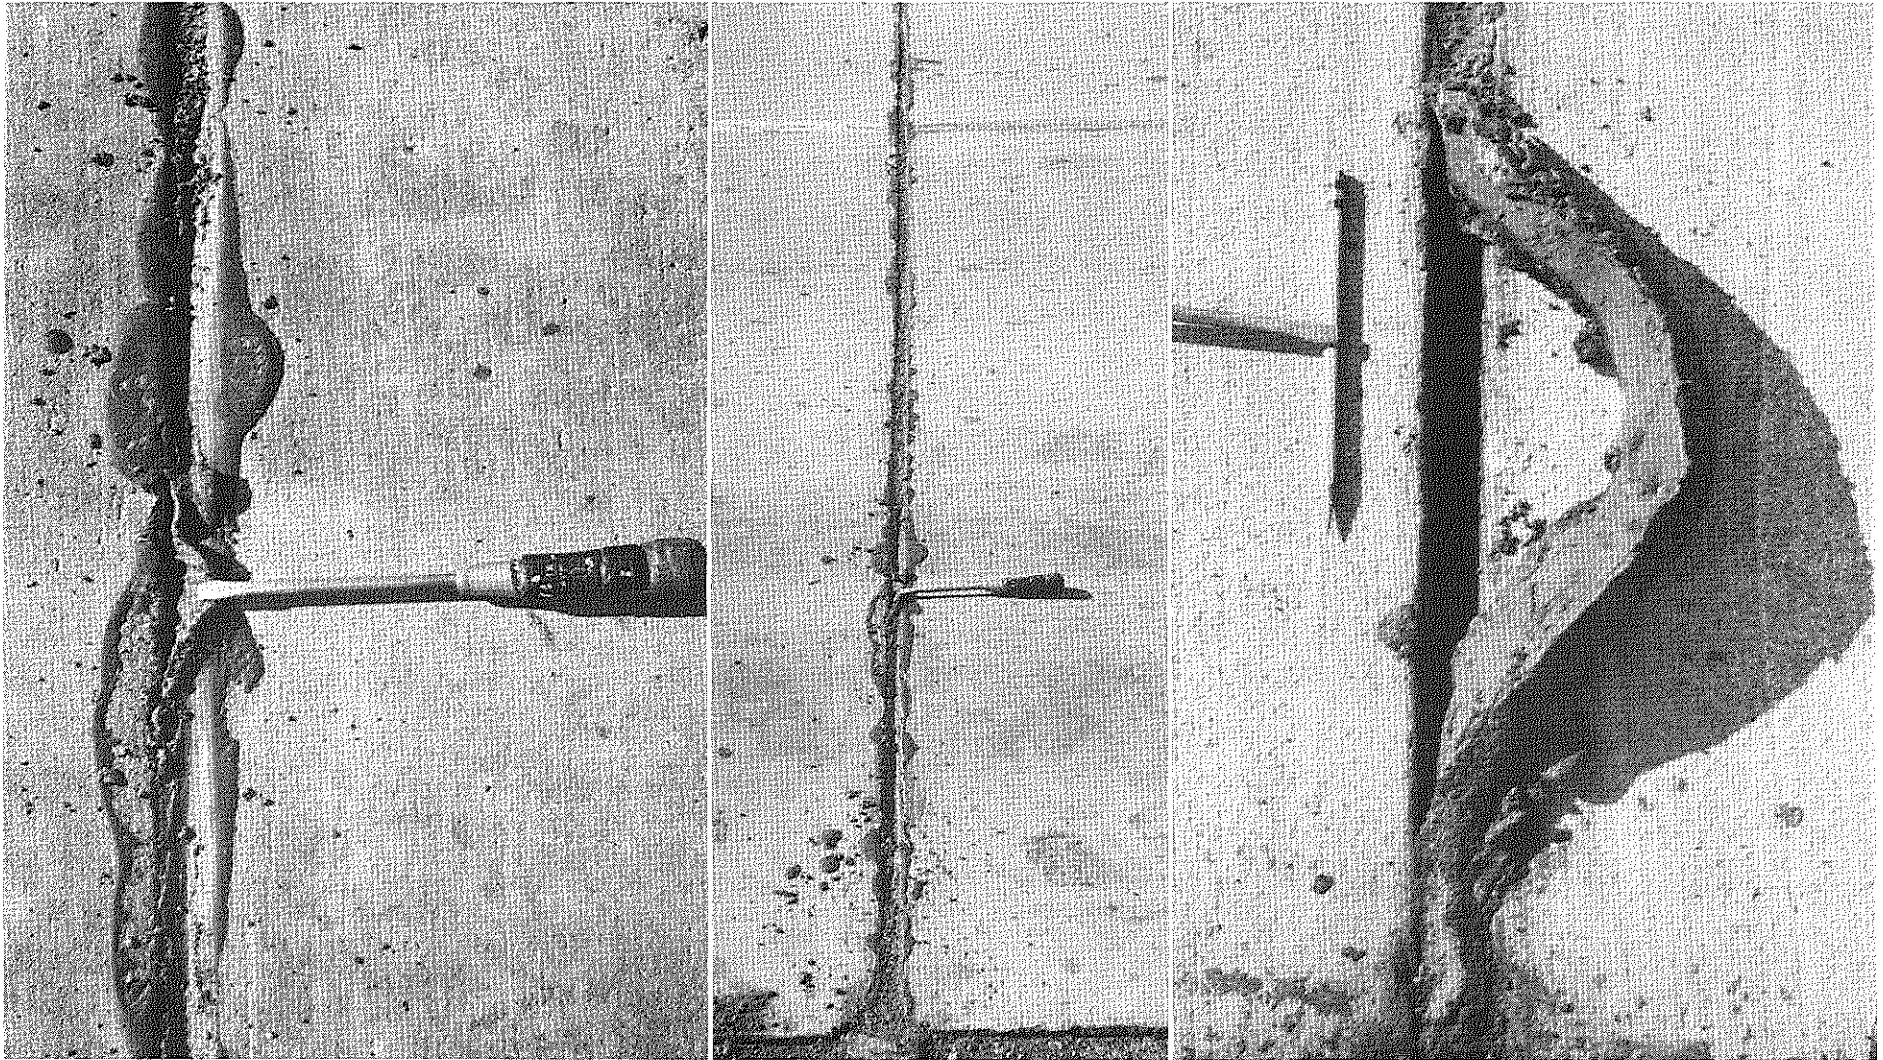
A. STATION 170 + 10 CLOSE - UP.

B. STATION 170 + 10 OVERALL VIEW.

C. STATION 328 + 10 EXTREME ADHESION LOSS.

FIGURE 2. FORMED CONTRACTION JOINTS PROTECTED WITH JUTE ROVE PRIOR TO SEALING WITH HOT-POUR RUBBER-TYPE JOINT SEAL. SEALER LACKS ADHESION BUT LITTLE OR NO SAND WAS FOUND UNDER JOINT SEAL.

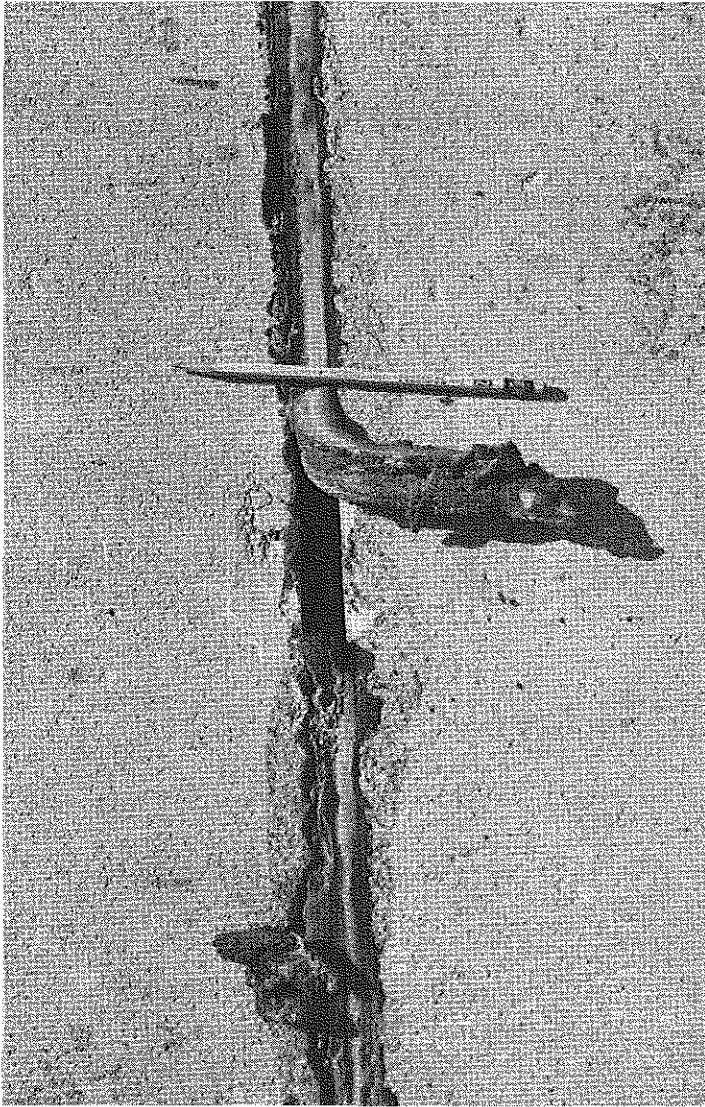
A. CLOSE - UP.

FIGURE 3. STATION 316 + 20 SAWED CONTRACTION JOINTS SEALED WITH HOT-POUR RUBBER-TYPE JOINT SEAL SEALER LACKED ADHESION BUT LITTLE OR NO SAND WAS FOUND UNDER JOINT SEAL.

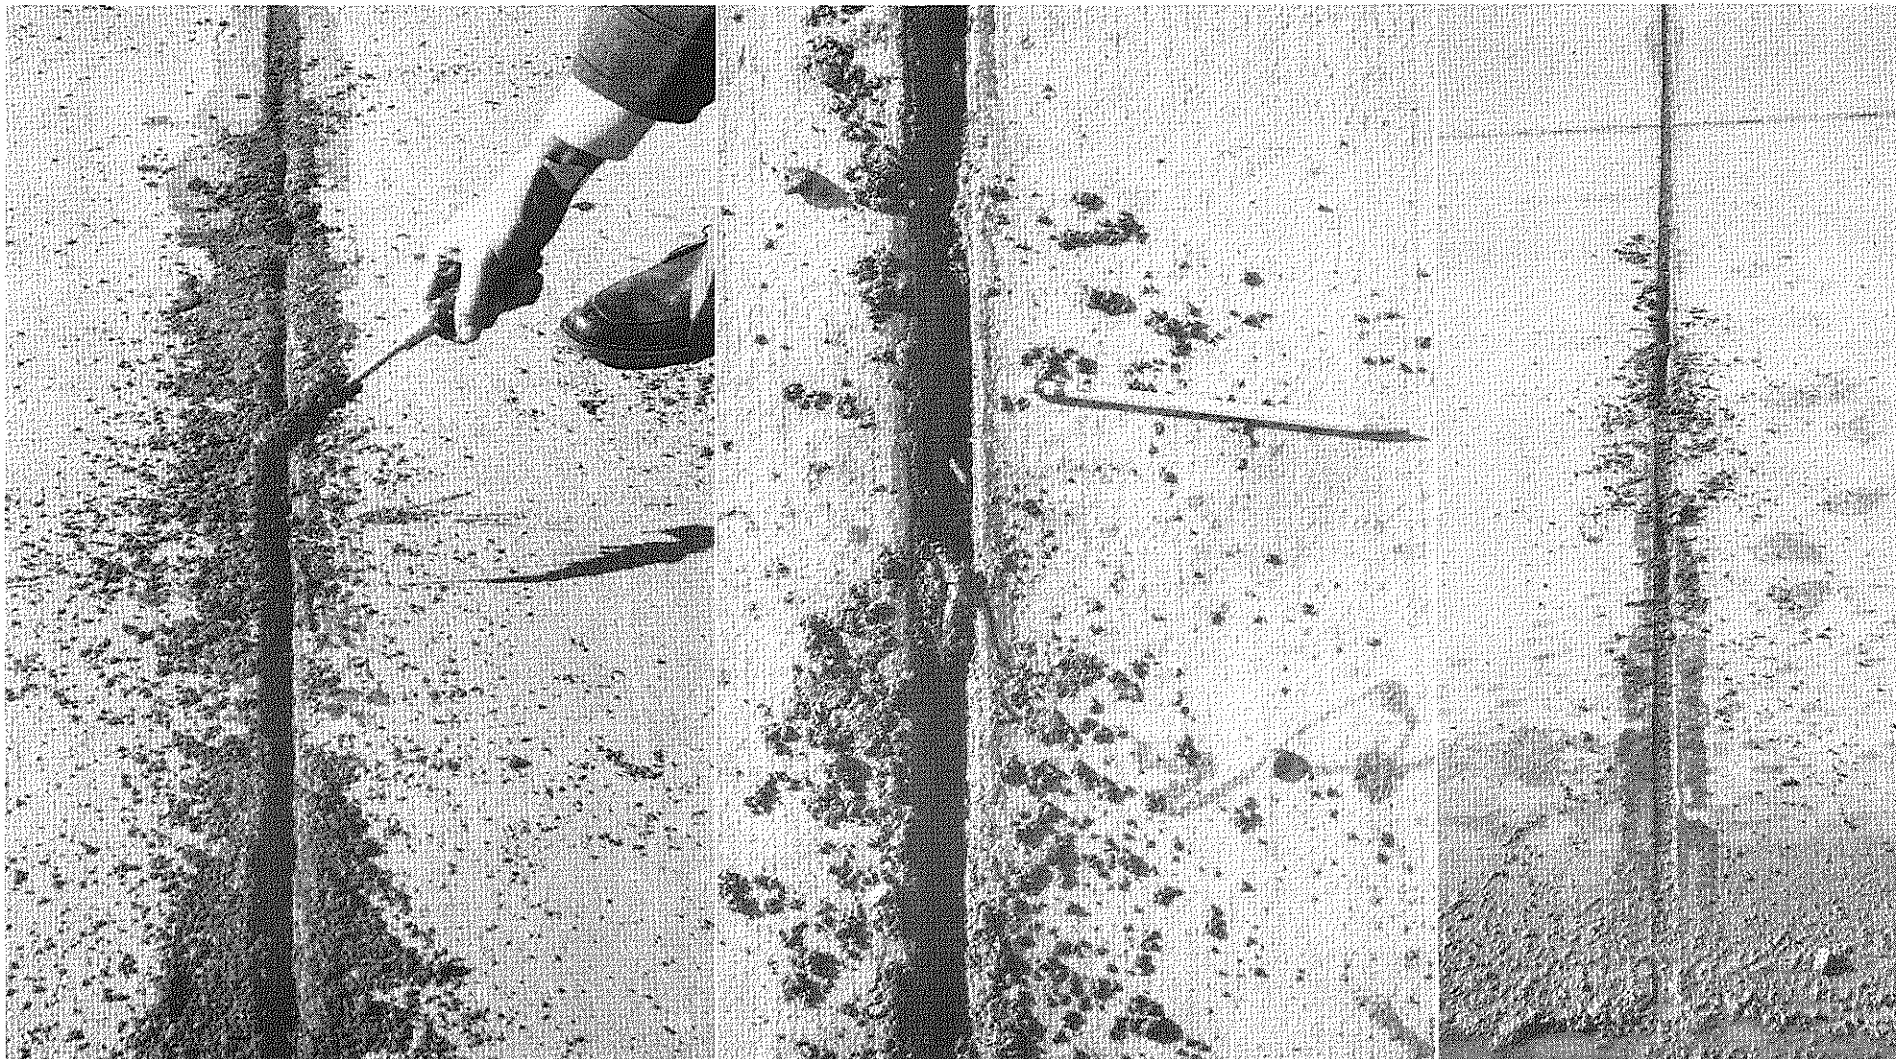
Joints in which cold-applied sealer had been used appeared to contain only a small amount of the sealer in the bottom of the joint groove while the remainder of the groove was filled to pavement level with sand. This condition existed in both mandrel-formed joints (Figure 4) and in styrofoam or paper formed joints (Figure 5).

The small quantity of cold-applied sealer found in the joints sealed with that material could be due to loss of sealer through the crack below the joint groove or to insufficient filling of the joint grooves at the time they were sealed.

A. STATION 83 + 15 NO JUTE ROVE  
USED PRIOR TO SEALING.

B. STATION 366 + 85 JUTE ROVE USED  
TO PROTECT JOINT PRIOR TO  
SEALING.

C. STATION 366 + 85 OVERALL VIEW.

FIGURE 4. FORMED CONTRACTION JOINTS SEALED WITH COLD-APPLIED JOINT SEAL.  
A SMALL AMOUNT OF SEALER WAS FOUND IN THE BOTTOM OF THESE JOINT  
GROOVES AND THE REMAINING SPACE WAS FILLED WITH SAND.

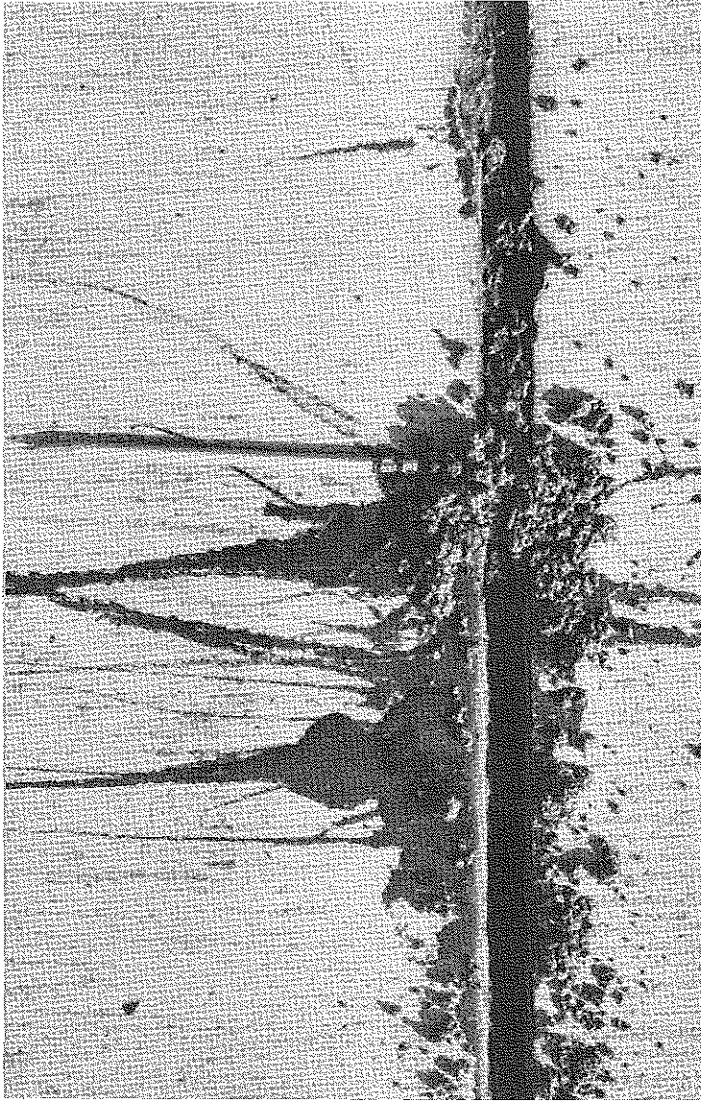
A. CLOSE - UP.

FIGURE 5. STATION 547 + 45 STYROFOAM CONTRACTION JOINT SEALED WITH COLD-APPLIED JOINT SEAL. A SMALL AMOUNT OF SEALER WAS FOUND IN THE BOTTOM OF THE JOINT GROOVE AND THE REMAINING SPACE WAS FILLED WITH SAND.
