MICHIGAN DEPARTMENT OF TRANSPORTATION
M•DOT

EVALUATION OF THE DELAMINATION
OF THE POLYURETHANE TOPCOAT

Research Laboratory Section
Materials and Technology Division
Research Project 92 TI-1630
Research Report R-1328

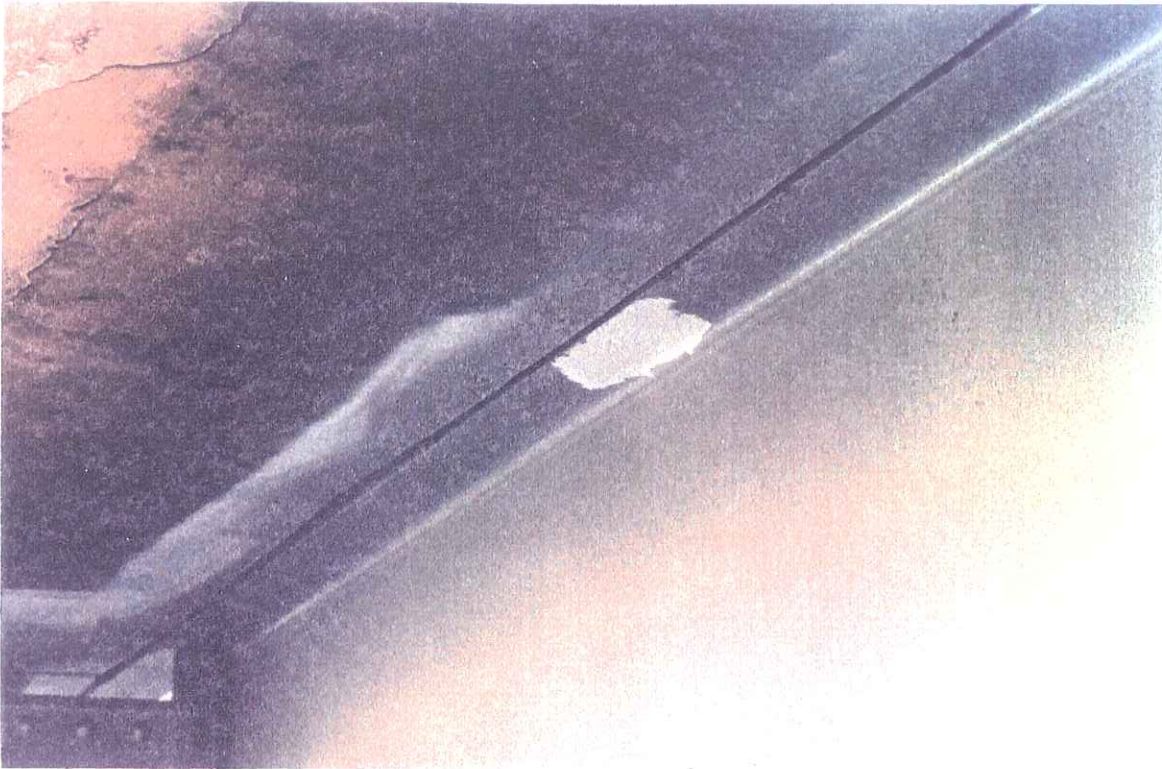
Peeling top coat on bottom of top flange

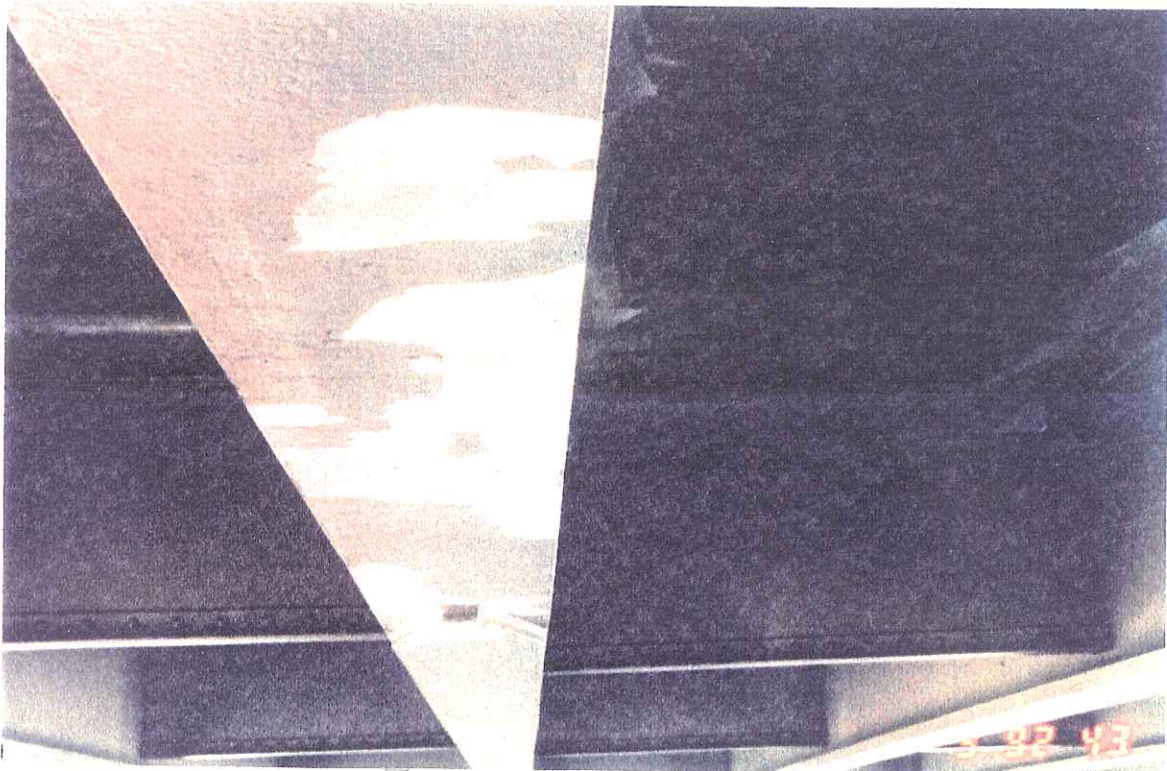
Peeling top coat on bottom of bottom flange

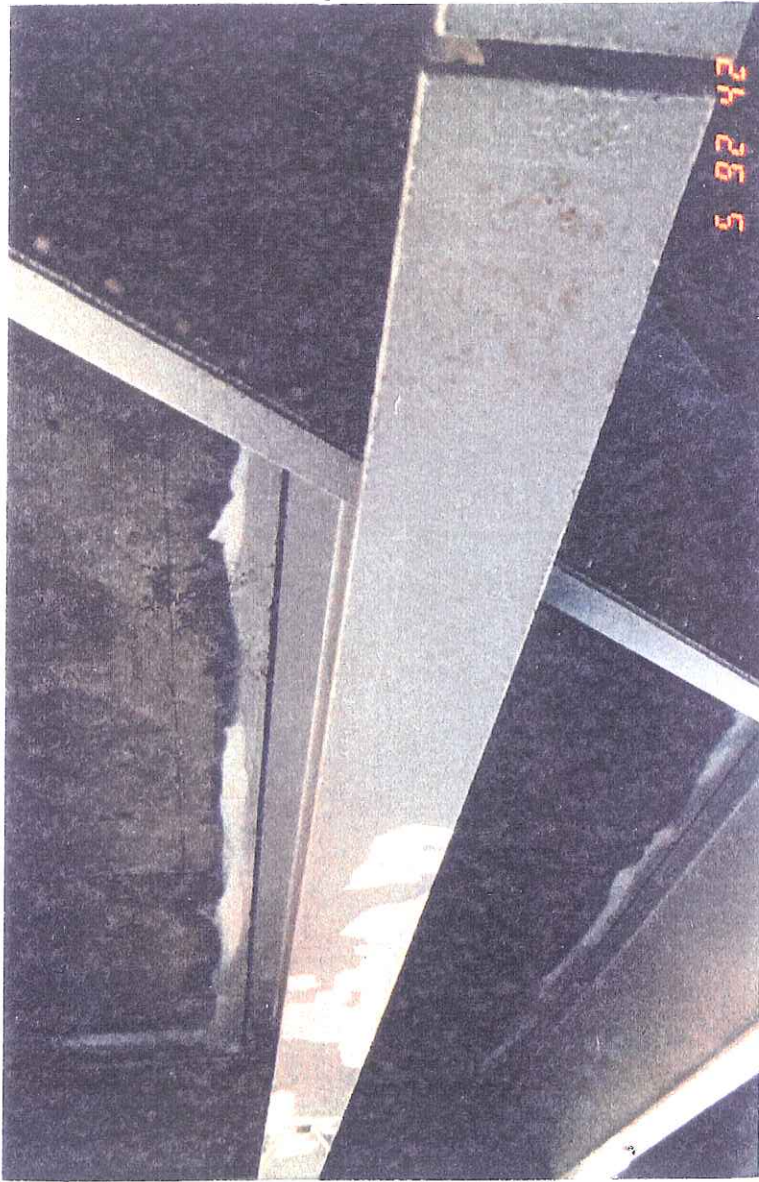
Peeling topcoat on bottom of bottom flange
