R-717

OFFICE MEMORANDUM

MICHIGAN
DEPARTMENT OF STATE HIGHWAYS

Subject: Corrosion-Resistant Guardrail. Research Projects 60 G-102, 62 G-113, and 62 G-122. Research Report No. R-717.

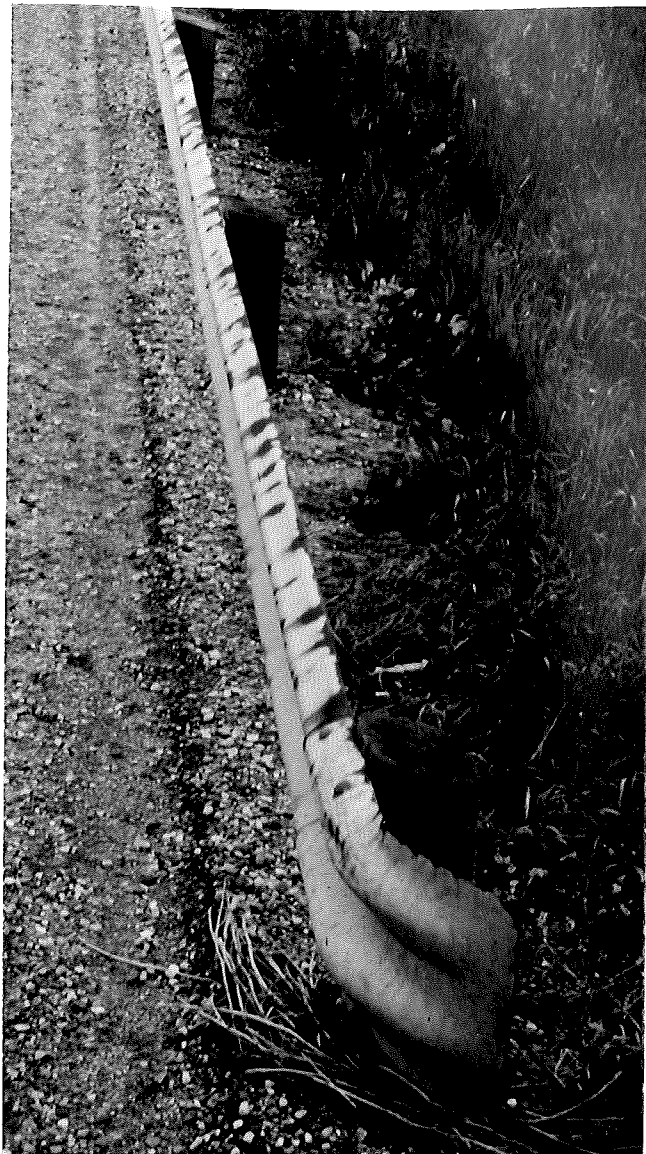
The two original galvanized installations have been maintenance free, regarding coatings, during their 12 years of service. They are now showing weathering loss of galvanizing on the top portions of the railings which will spread, necessitating coating replacement within several years (Fig. 1). On a few subsequent installations, notably I 96 in Farmington and US 127, north of Jackson, the weathering-away loss of galvanizing has been at a slightly faster rate, for unknown reasons.

Figure 1 (left). Typical 12-yr old galvanized guardrail, showing spotty weathering-away loss of zinc coating (red rusting) on the top portion, spreading from the cut ungalvanized edge. WB M 78 W of M 47 (June 1969).

3. Galvanized Guardrail -- The galvanized guardrails in service have lengthened the maintenance recoating cycle to 10 to 15 years compared to the former two-year cycle for the painted rails. Experience shows that the currently specified thickness of galvanizing will last about 15 years, although a minor portion will last fewer years because of localized deicing salt attack, "white rusting."

Because of their good performance including, (a) lower installed cost and lower maintenance cost than painted railings, and (b) proven good delineation, we recommend that galvanized guard rails continue to be used until better types are found. In the meantime the Department should study the possibility of increasing the coatings' life by:

1. Increasing the thickness of the galvanizing and,
2. Requiring a low cost spray-on coating, similar to auto under-body types, to be applied on railings after installation, to prevent the deicing salt attack sometimes noted on new railings.

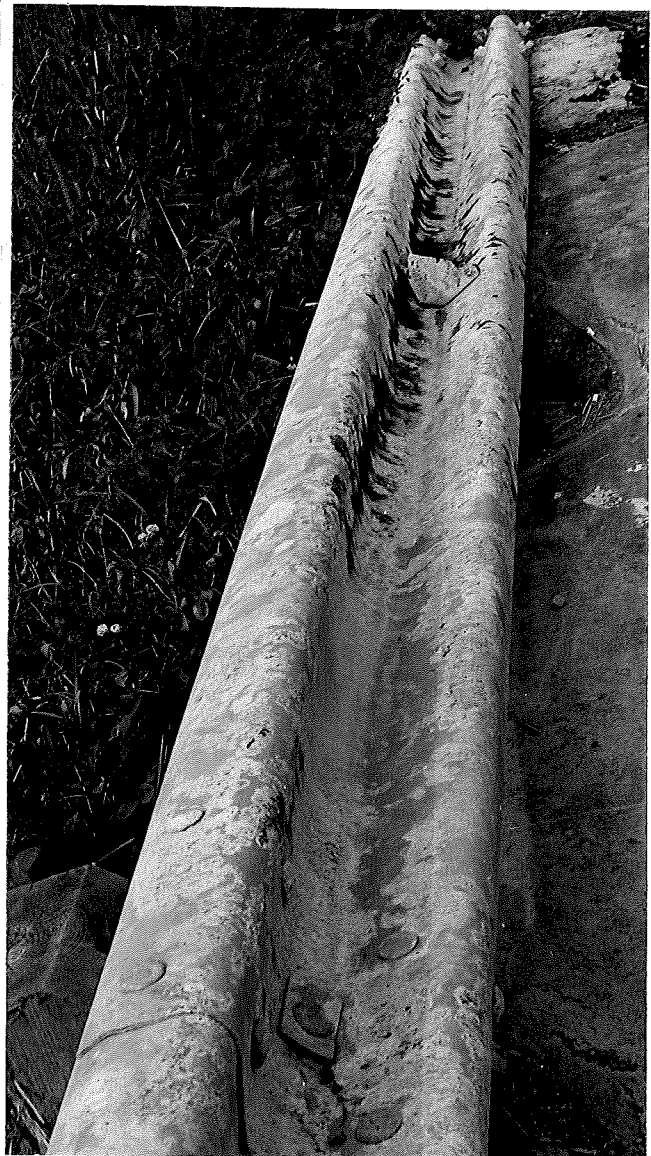
In Spring 1962, aggressive spotty deterioration of galvanizing on guardrails was noted on some new installations, notably the then-designated I 196 in Grand Rapids. This Winter-connected deterioration has occurred to varying extent on other installations. A bad case was noted on I 496 in Lansing in early 1969 (Fig. 2); but a short installation, also made in 1968, on US 27 in North Lansing on structure X01 of 33034 showed no attack. Observing this type of chancy deterioration we have noted that it is most apt to occur on new galvanizing before weathering can develop a protective oxide. It is also more apt to occur on certain areas of a highway system. This deterioration, most noticeable at the Spring thaw, is due to impingement of de-icing salts and/or encasement by snow or salt-laden snow, and appears to be governed to some extent by snow removal procedure. Other Northern-belt states are experiencing the same problem.

Figure 2 (right). Appearance of galvanized end-wing on I 496 in Lansing after one Winter's exposure. This was the worst railing on the project, showing much white and red rusting. Railings installed about November 1, 1968 were unable to develop protective film before Winter. The new buried type end-wing with its reflective washer is particularly susceptible since it resembles a damaged trough.

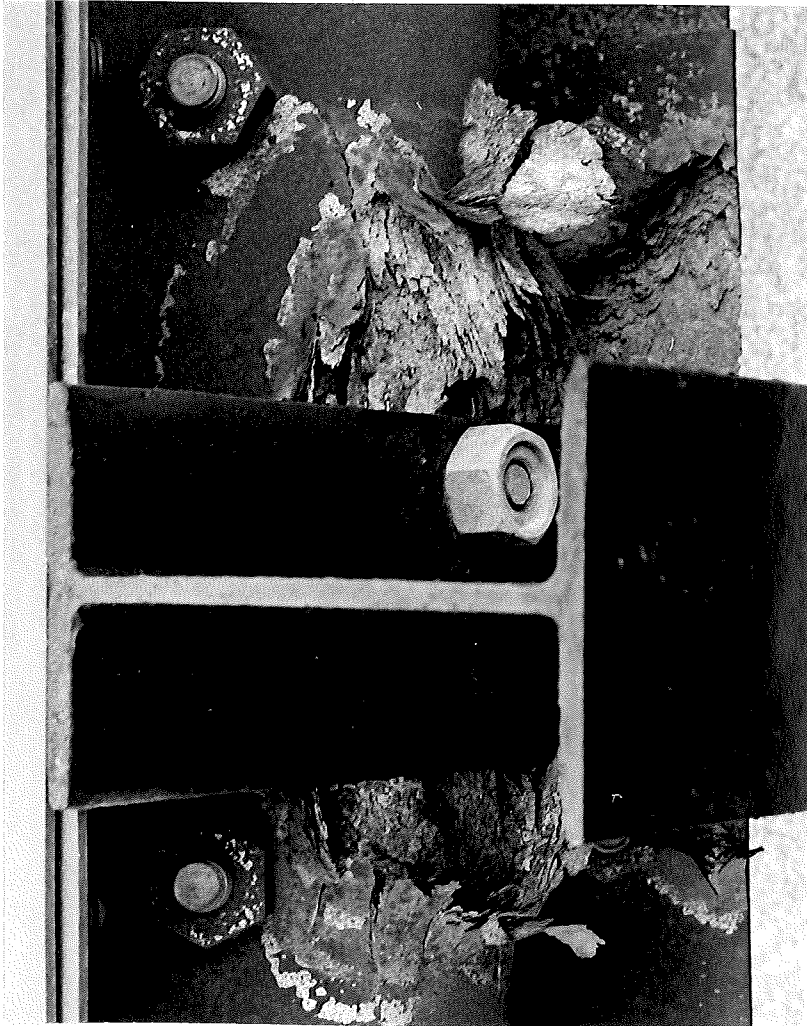
Aluminum Guardrail: The Department is evaluating the performance of aluminum guardrail on two projects. The first was installed in 1959 on US 27 in North Lansing on structure X01 of 33034. The fronts of the rails have performed very well, but the lap joints at the posts are showing a most aggressive deterioration which could have been minimized had galvanized or wood posts been used (Fig. 3). The second was installed on I 296 in Grand Rapids in 1962. It is a bigger installation, being about a mile long. As of this date, it shows almost none of the lap joint deterioration, though the same painted steel posts are used as in Lansing. The reason for this difference in behavior is not known. However, a disadvantage would be the high thermal coefficient of expansion which causes some strains in the aluminum railing (Fig. 4).

Figure 3 (above). Aluminum guardrail after 10-yr service shows bad corrosion where joined to painted steel post. Attack is judged to be a combination of mostly bi-metallic and some chloride corrosion. US 27 in North Lansing (July 1969).

1. Aluminum Guardrail -- Defer recommendations pending further observations on the variable performance of test railings.

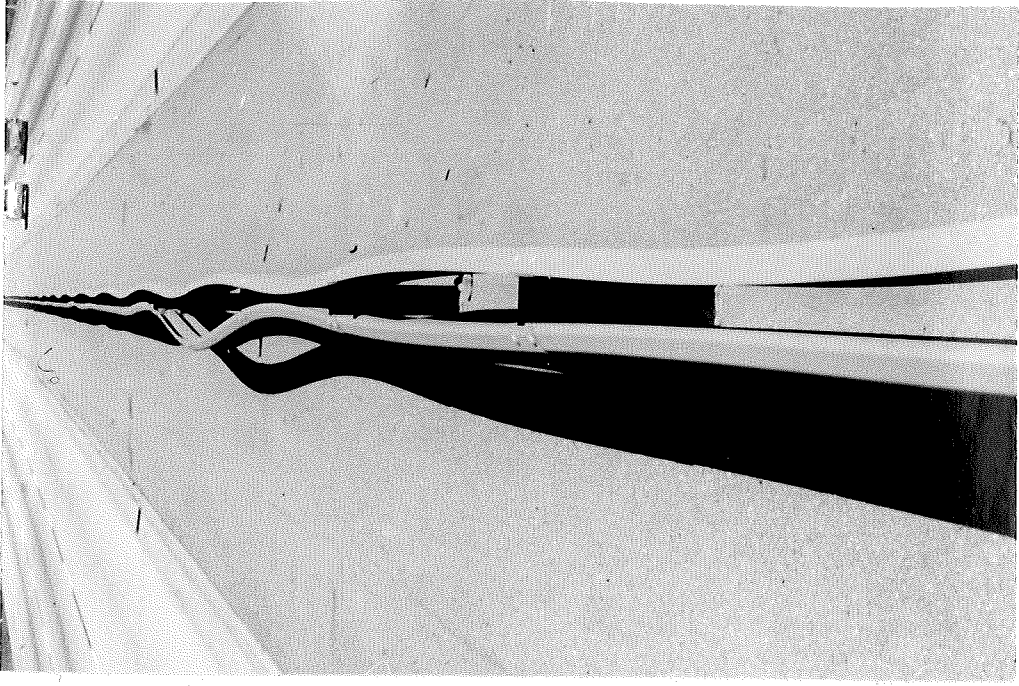
Figure 4 (right). Aluminum guardrail on I 296 in Grand Rapids shows expansion and bulging in the heat of Summer, breaking bolt on one post (left). However, no significant lap corrosion was evident, here, where joined to steel posts (August 1969).

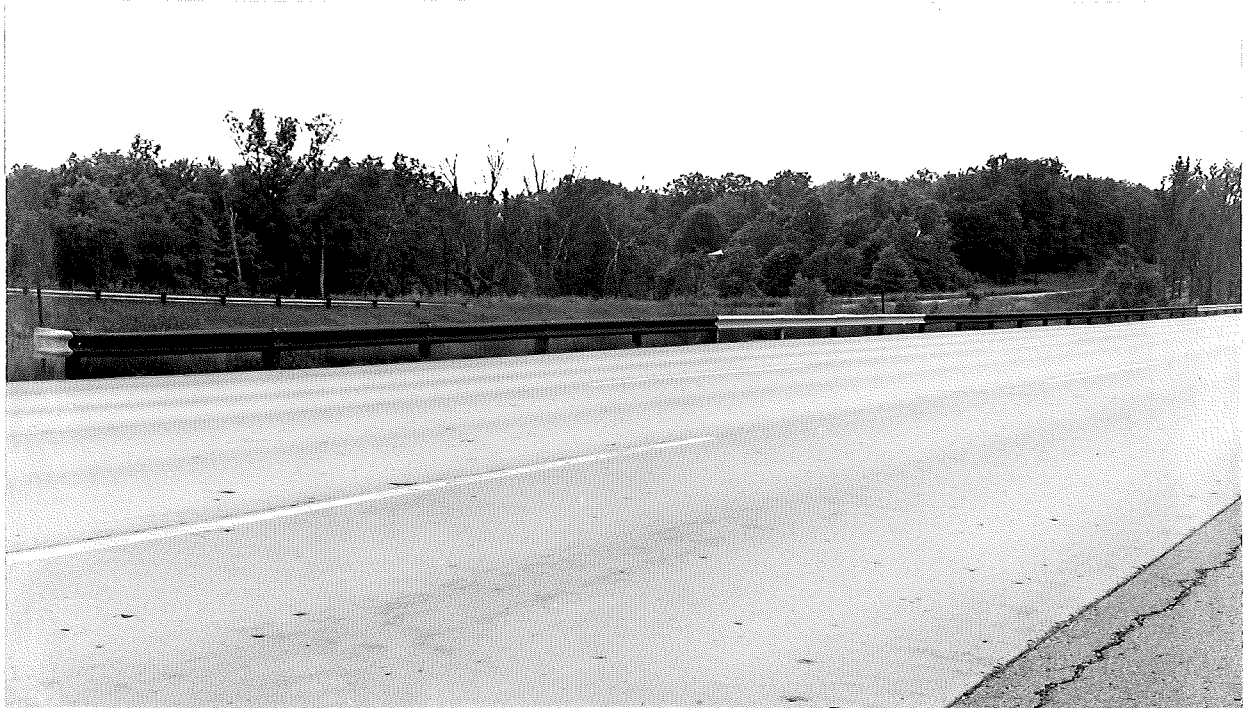
As of this date, the alloy steel guardrails have a good appearance due to development of a uniform coating of protective oxide, though at an earlier inspection two locations showed blotchiness due apparently to salt splashes. The lap joints showed no accelerated deterioration.

Regarding their daytime delineation, inspecting personnel rated them as being more neutral, i. e., providing less striking contrast than the galvanized railings. However, the daytime delineation was rated as adequate (Fig. 5).

Figure 5. Daytime appearance of galvanized and unpainted alloy steel guardrails on SB I 75 N of Pontiac after about 6 yrs of service. The rails at either end are galvanized as are the four in the middle (damaged replacements).

2. ASTM A 588 Alloy Rails -- The small footage under test has performed well enough to merit additional evaluation on larger footage in other projects, especially regarding its ability to delineate adequately under variable weather. The additional footage should include the reflective washers.
