**IDENTIFY CAUSES FOR UNDER
PERFORMING RUBBLIZED
CONCRETE PAVEMENT PROJECTS**

**FINAL REPORT
VOLUME II - APPENDICES**

**Michigan State University
Pavement Research Center of Excellence
Department of Civil and Environmental Engineering
East Lansing, Michigan 48824-1226**

**TESTING AND RESEARCH SECTION
CONSTRUCTION & TECHNOLOGY DIVISION
RESEARCH REPORT - RC 1416 (APPENDICES)**

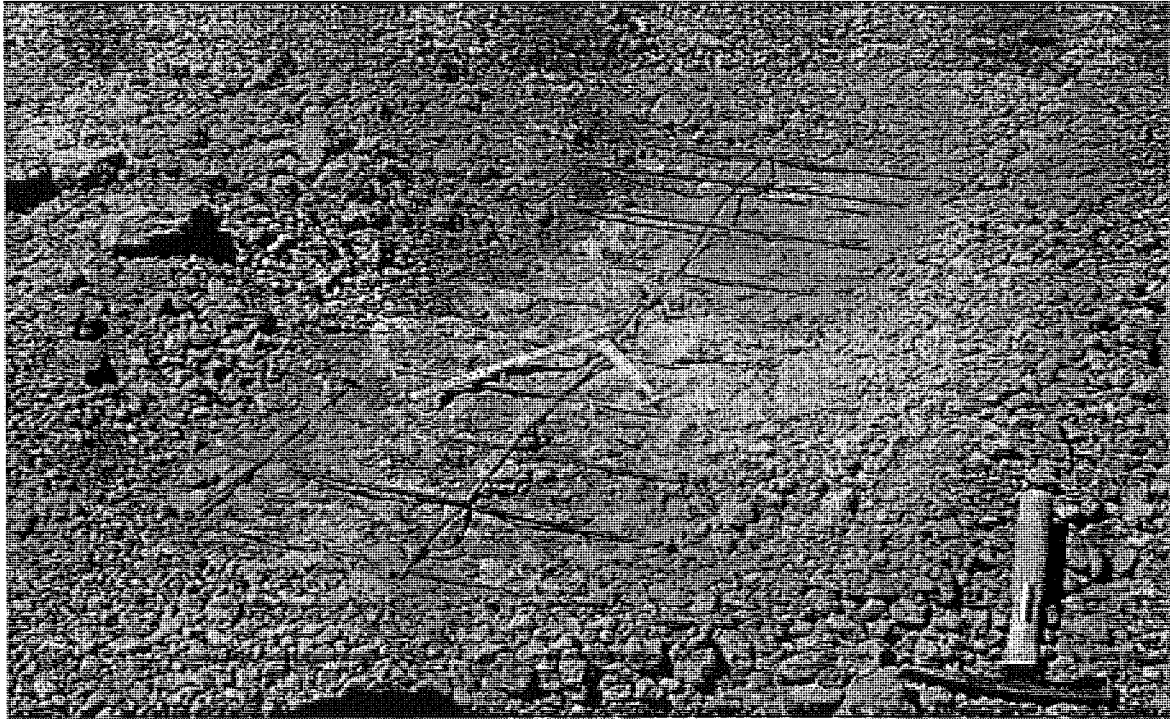
On the first visit, the rubblization process was observed and one trench was made in the rubblized concrete pavement across the southbound passing lane. The purpose of trenching was to investigate the uniformity and the effective depth of the rubblization process. During the second field trip, two trenches were made in the rubblized concrete pavement across the southbound traffic lane. One trench was dug at a transverse joint and the other at mid-slab. In general, it was observed that:

- Strips of fine and coarse rubblized materials were almost evenly spaced 175-mm (7-in) apart (almost the width of the sonic shoe).
- At a transverse joint, the trench contained large pieces (0- to 250-mm (0- to 10-in)), with an average size of approximately 100-mm (4-in) of rubblized material above the temperature steel.
- The trench at mid-slab consisted of small pieces (0- to 125-mm (0- to 5-in)), with an average size of approximately 50-mm (2-in) of rubblized material above the temperature steel.
- The rubblized concrete beneath the temperature steel appeared to be fractured concrete.
- The surface of the fractured concrete consists of peaks and valleys that extend in both the longitudinal and transverse directions.

Figure B.1 US-131 SBIL (Cedar Springs) trench in rubble concrete (station 37+558.5)
resonant breaker

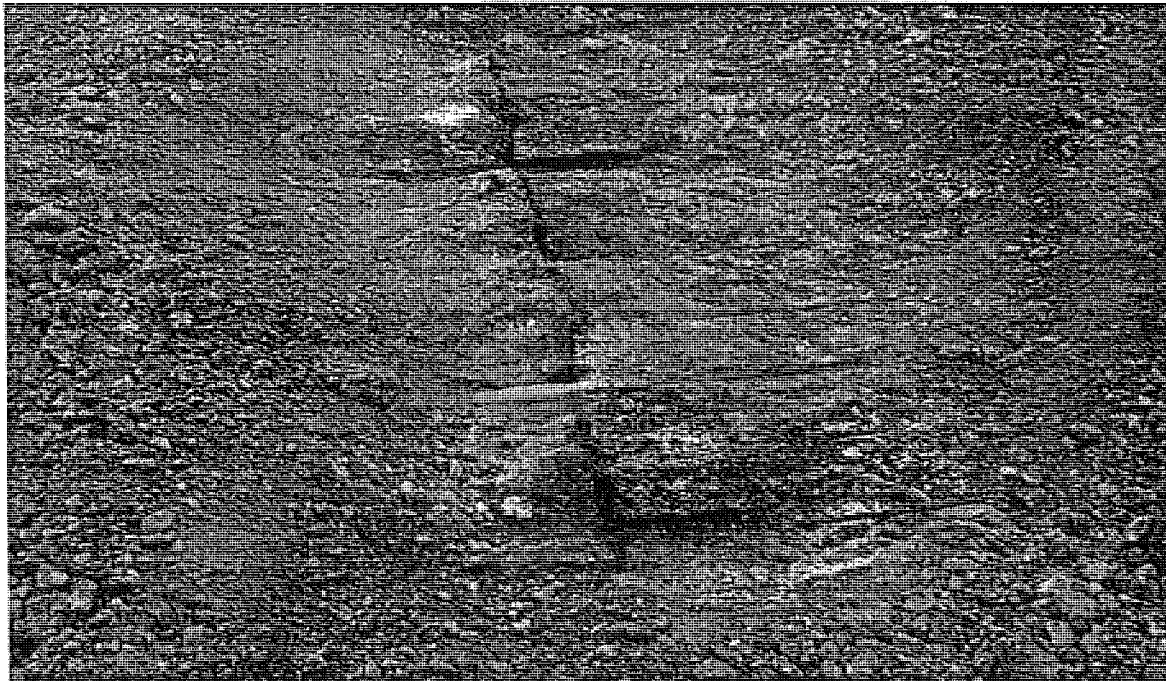
Figure B.2 US-131 SBOL (Cedar Springs) trench in rubble concrete at transverse joint
resonant breaker

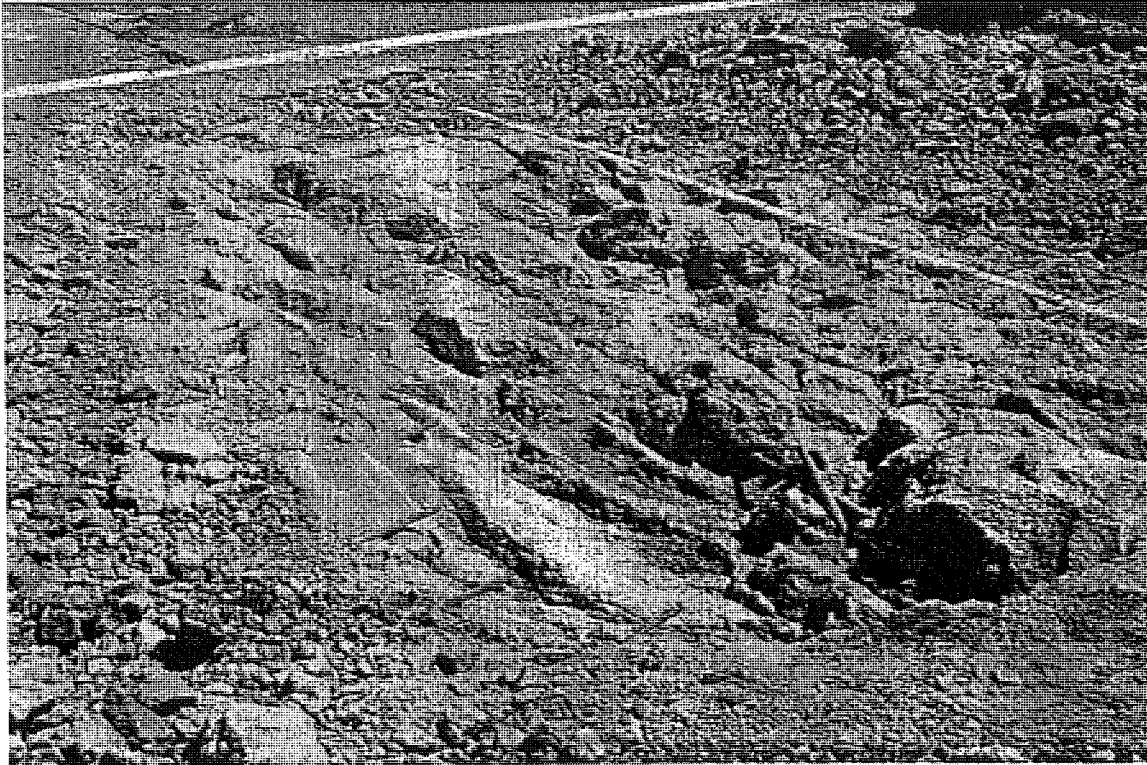
and 12+000. The first three trenches were at mid-slab locations and the fourth trench was at a transverse joint. In general, it was observed that:

- The rubblization process produced a well rubblized concrete above the temperature steel and a fractured concrete under the steel.
- The vertical cracks in the fractured concrete beneath the steel were spaced at 100 to 125-mm (4 to 5-in) in the longitudinal direction. The same spacing was measured between the drop hammers.
- In at least one location, the original aggregate base was exposed underneath the rubblized concrete near a transverse joint.
- Slag aggregate was used in the concrete.
- The large pieces of rubblized concrete that were removed for more detailed inspection showed internal fractures.
- Peaks and valleys in the fractured concrete existed longitudinally and across the lane.

Figure B.3 M-50 EB (Dundee) trench in rubble concrete at transverse joint
(station 12+000) badger breaker

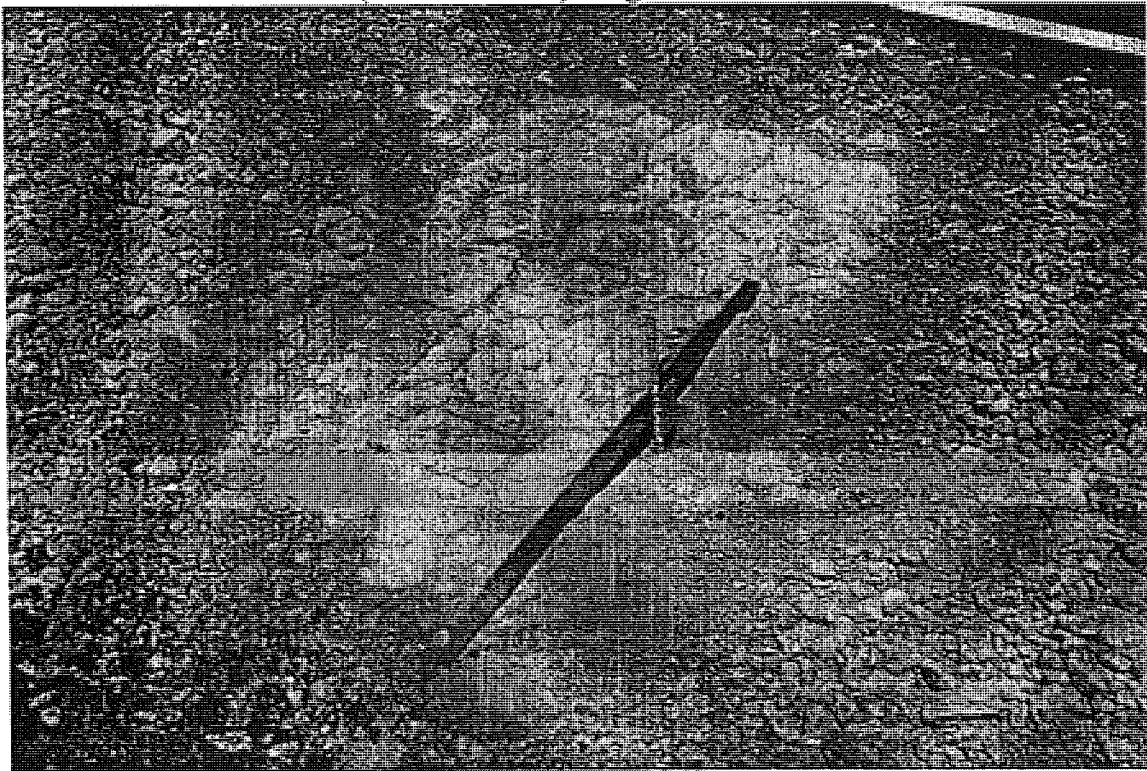
Figure B.4 M-50 EB (Dundee) trench in rubble concrete (station 10+441)
badger breaker

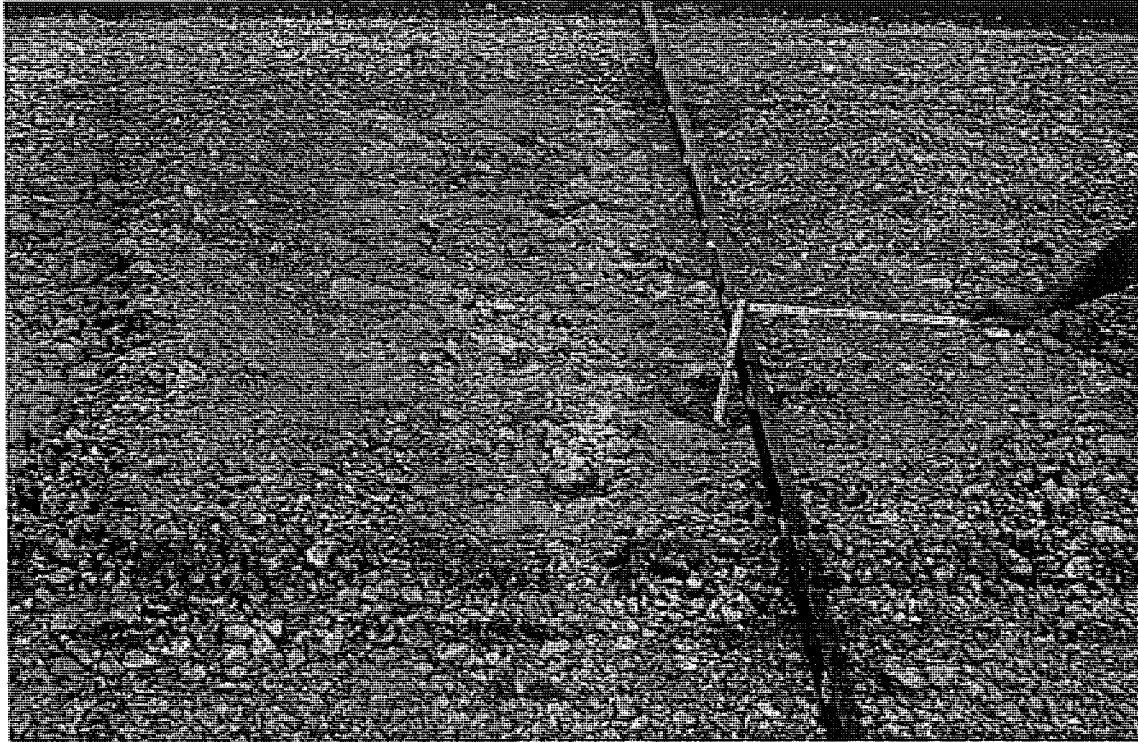
Figure B.5 US-31 SB (Honor) trench in rubble concrete (station 26+130)
badger breaker

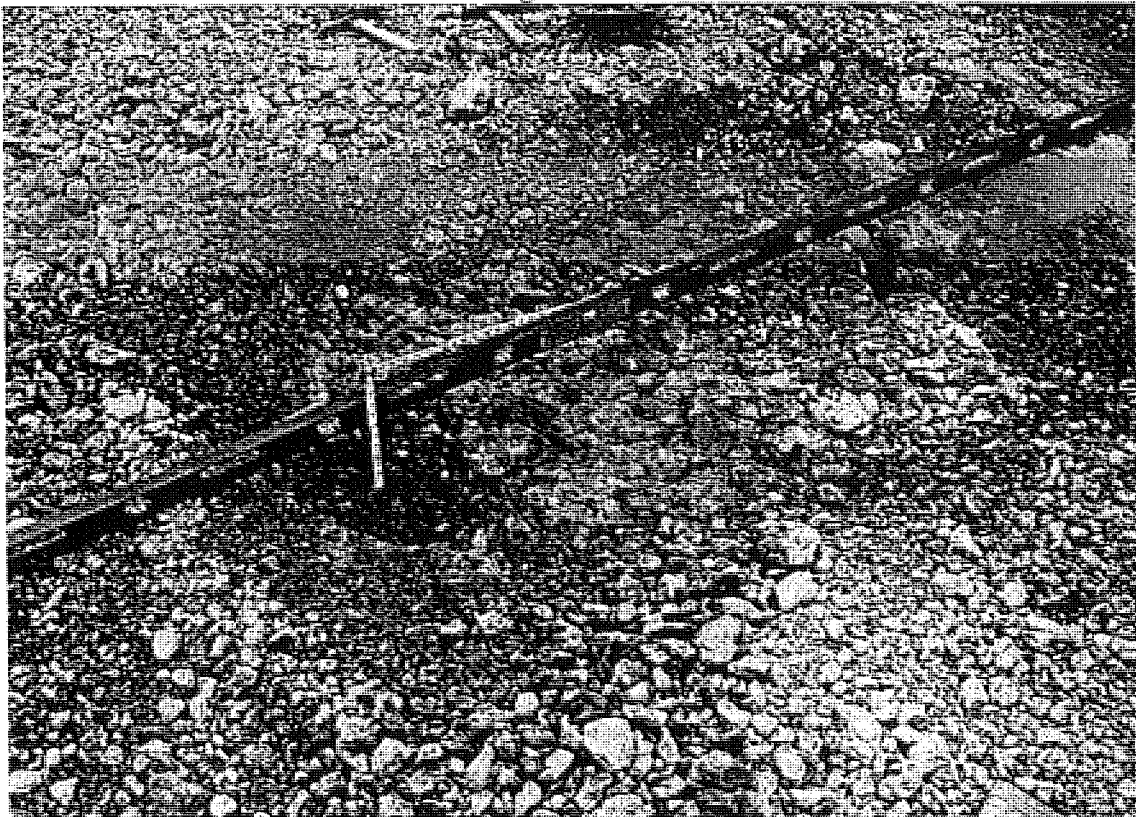
Figure B.6 US-31 SB (Honor) trench in rubble concrete (station 26+652)
badger breaker

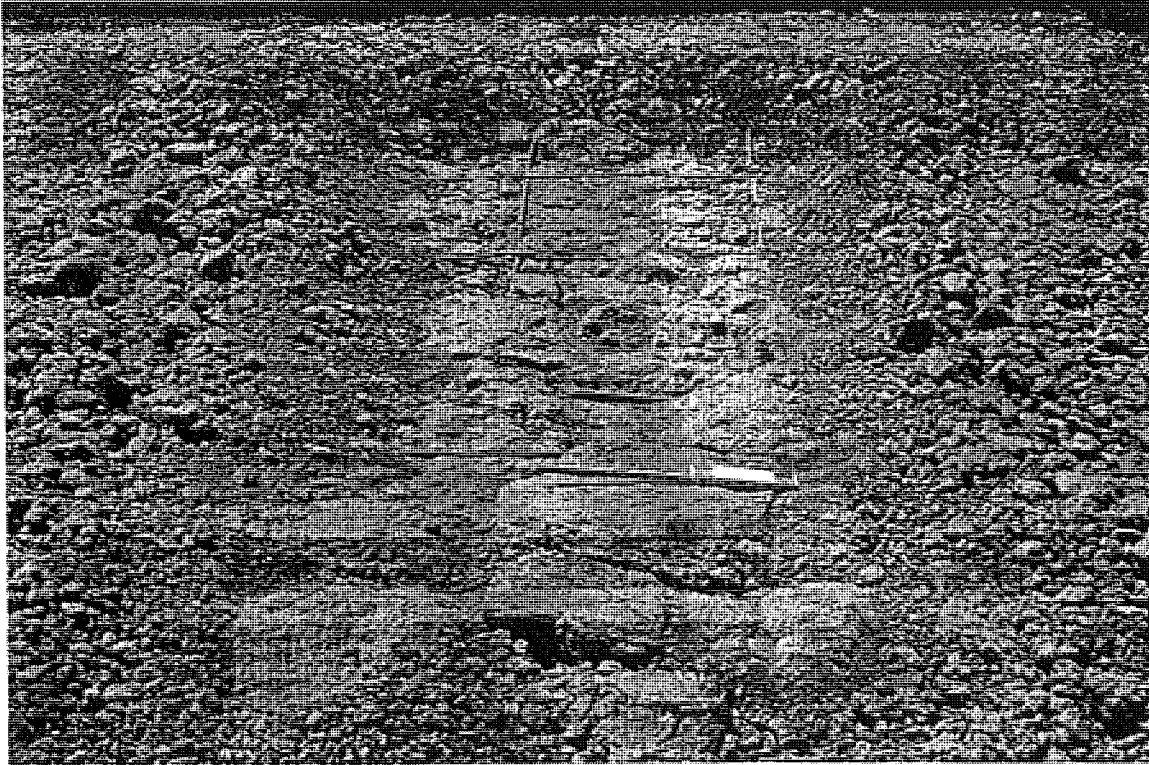
Four trenches were made in the northbound lane. Three trenches were made at mid-slab locations, away from transverse cracks and joints, and one trench at a transverse joint. The first trench at station 53+621 revealed poorly rubblized concrete (the depth of the rubblized concrete was very shallow). This could be related to the high speed (260- to 290-m/hr (850- to 950-ft/hr)) of the rubblizing equipment. After examining the material in the trench, the operator of the equipment reduced the speed to 245-m/hr (800-ft/hr). Another trench was then made at station 53+900 where better rubblized concrete was found. A drainability test was performed at this trench. After the 100-mm (4- in) of loose rubblized concrete material were removed, 75 liters (20 gallons) of water were placed on top of the fractured concrete in the trench. The water dissipated very slowly and it was ponding after twenty minutes. However, air bubbles were observed coming out of various cracks in the fractured concrete. The third trench was also made at mid-slab at station 54+210 where good and full depth rubblized material was noted.

Figure B.7 M-53 NB (Almont) trench in rubble concrete (station 54+210)
badger breaker

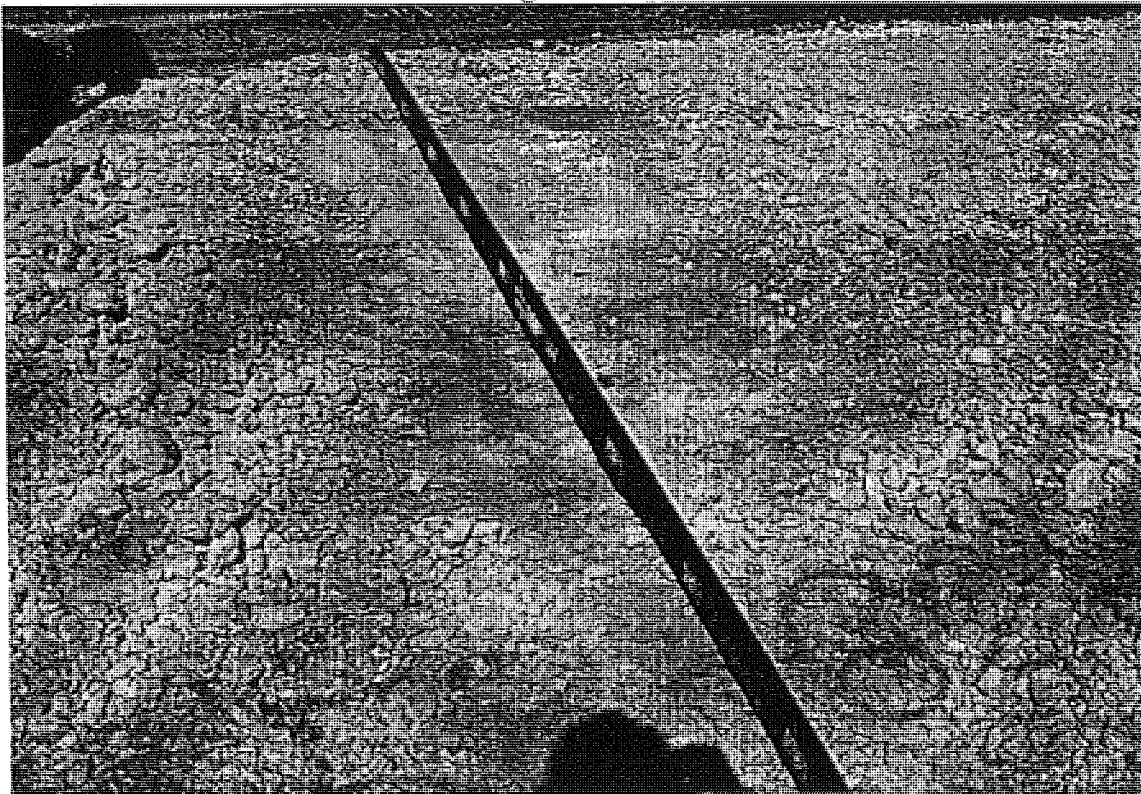
Figure B.8 M-53 NB (Almont) trench in rubble concrete (station 53+621)
badger breaker

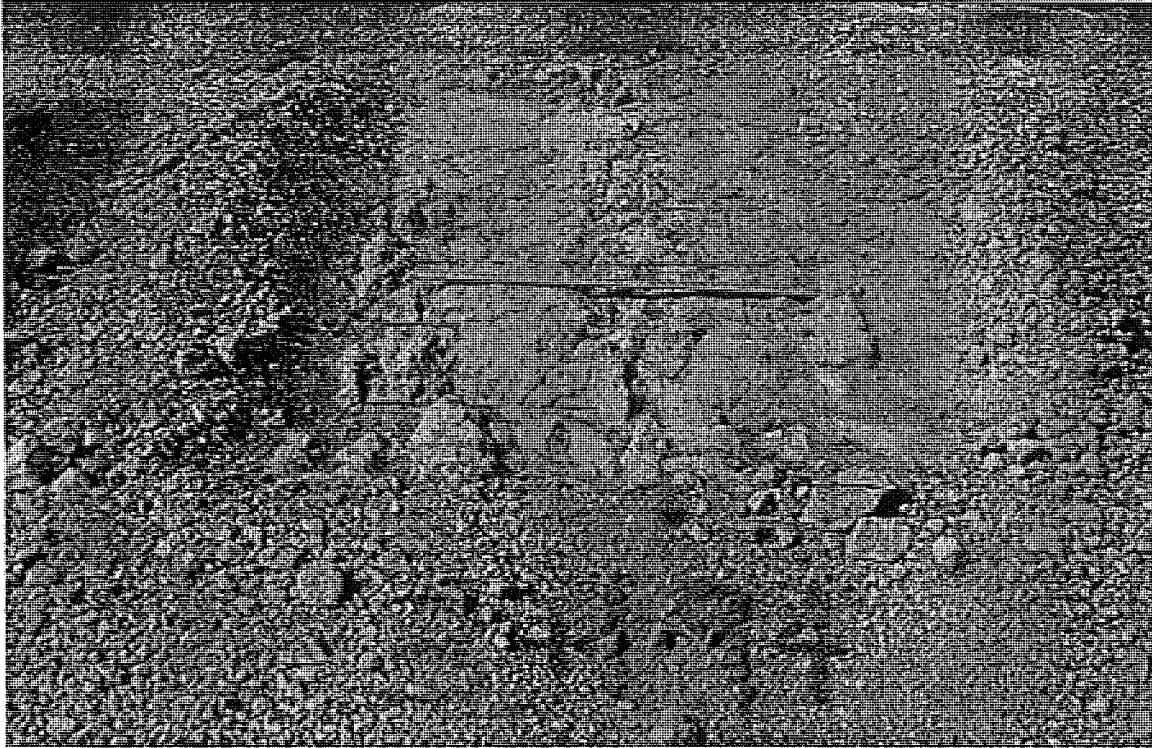
Three trenches were made in the northbound lane. Two trenches were at mid-slab locations at stations 3+180 and 3+194 away from transverse cracks and joints. It was observed that the area was poorly rubblized (large pieces of concrete) above the steel. No fractures were observed in the fractured concrete. It was also observed that about 100-mm (4-in) of the concrete was rubblized in the vicinity of the centerline and only 50-mm (2-in) were rubblized along the shoulder.

One drainability test was performed at each trench. In the first trench, 50 liters (15 gallons) of water was placed on the fractured concrete in an area of approximately 1.9-m² (20-ft²). In the second trench, 75 liters (20 gallons) of water was placed on top of the fractured concrete in an area of approximately 2.2-m² (24-ft²). In both tests, the water did not infiltrate into the fractured concrete and no air bubbles were observed coming out of it. Indeed, forty minutes into the test, the water was still ponding. One further observation was made is that the loose rubblized material appears to contain a high amount of dust. The water did not permeate through this material in the horizontal direction.

Figure B.9 M-18 NB (Beaverton) trench in rubble concrete (station 3+194)
badger breaker

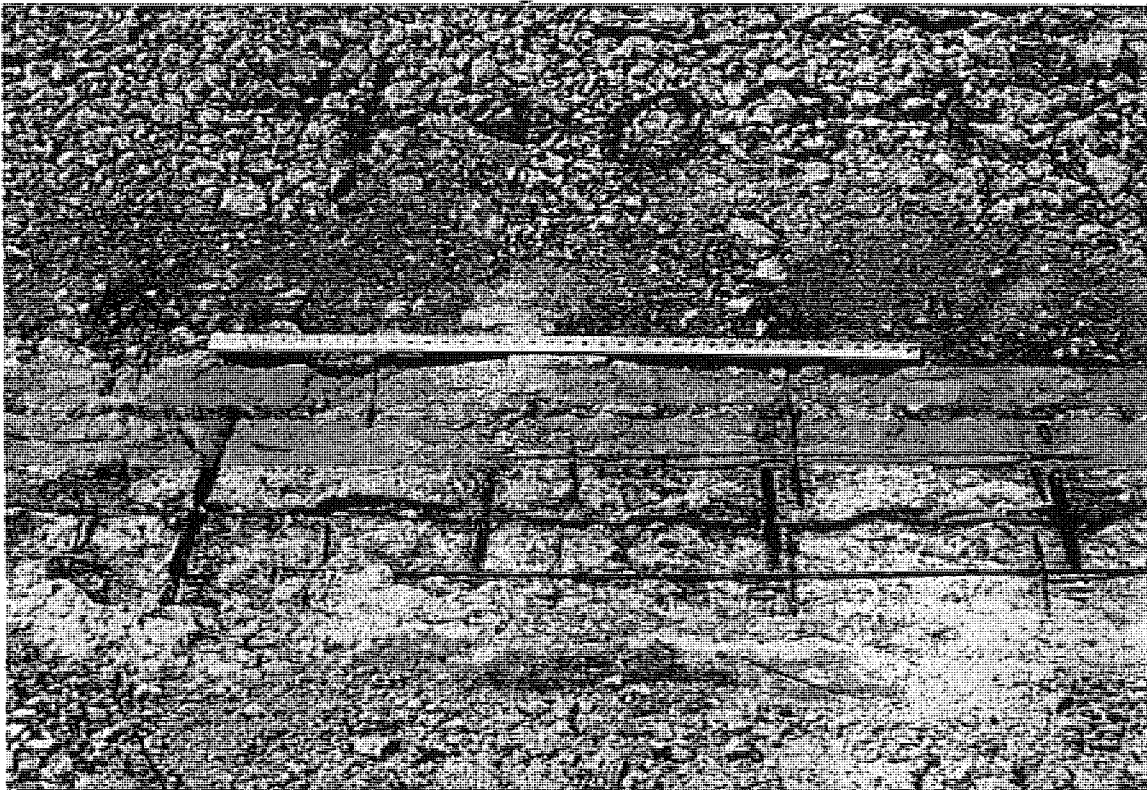
The third trench was at a transverse joint at station 4+034. The joint sealant material was weathered. The recovered dowel bars showed severe corrosion and necking under the joint.

One dowel bar was split into two pieces. The rubblization above the temperature steel was relatively good. In general, it was observed that:

Figure B.10 M-18 NB (Beaverton) trench in rubble concrete at transverse joint
(station 4+034) badger breaker

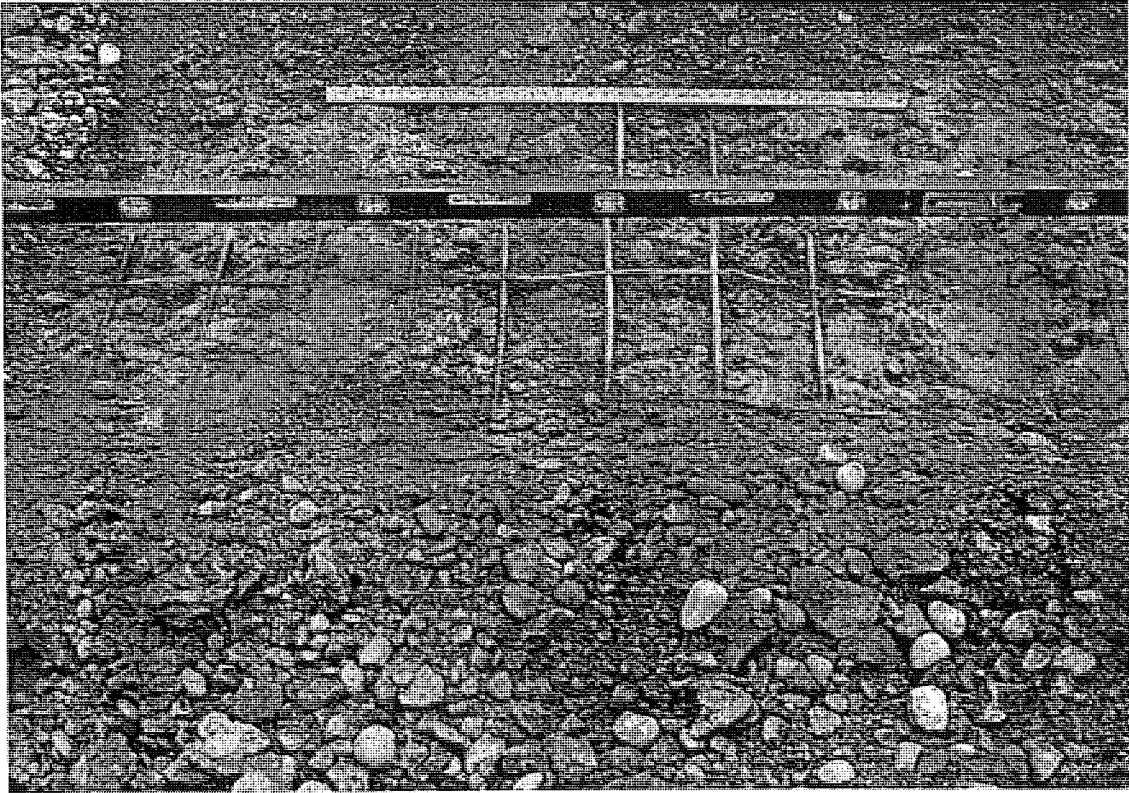
To check the depth and uniformity of the rubblized concrete, three trenches were made in the northbound passing lane at mid-slab locations. The first trench was made at station 9+858 where the temperature steel overlapped by 300-mm (12-in), which decreased the energy delivered to the fractured concrete beneath the temperature steel. Hence, the breakup of the concrete beneath the temperature steel was limited. However, the concrete above the temperature steel was rubblized throughout its thickness. The second trench was made at station 10+690, where it was evident that the road was constructed as a cut section. Upon trenching, the temperature steel was found de-bonded and exposed across the trench, except for one peak of intact, but well fractured, material, which extended to the surface of the concrete. The concrete was rubblized to a depth of 50-mm (2-in) beneath the temperature steel. A third trench was made at station 11+641 where very shallow rubblization was found. The temperature steel was mainly bonded and the concrete above the temperature steel was fractured in different areas.

Drainability tests were performed at the first and third trenches. Fifty liters (15 gallons) of water were placed on top of the fractured concrete surface in both trenches on areas of 2.0-m² (21-ft²). The rubblized concrete in the first trench was very moist from rain the previous day, while the rubblized concrete in the third trench was dry, due to drying from the sun and trenching at a later time of the day. The first trench resulted in about a 25-mm (1-in) draw down of the water, which occurred within the first six minutes. Air bubbles were observed coming out of the cracks in the fractured concrete. The third trench resulted in about 20-mm

Figure B.11 Old US-131 NBIL (Rockford) trench in rubblized concrete
(station 9+858) resonant breaker

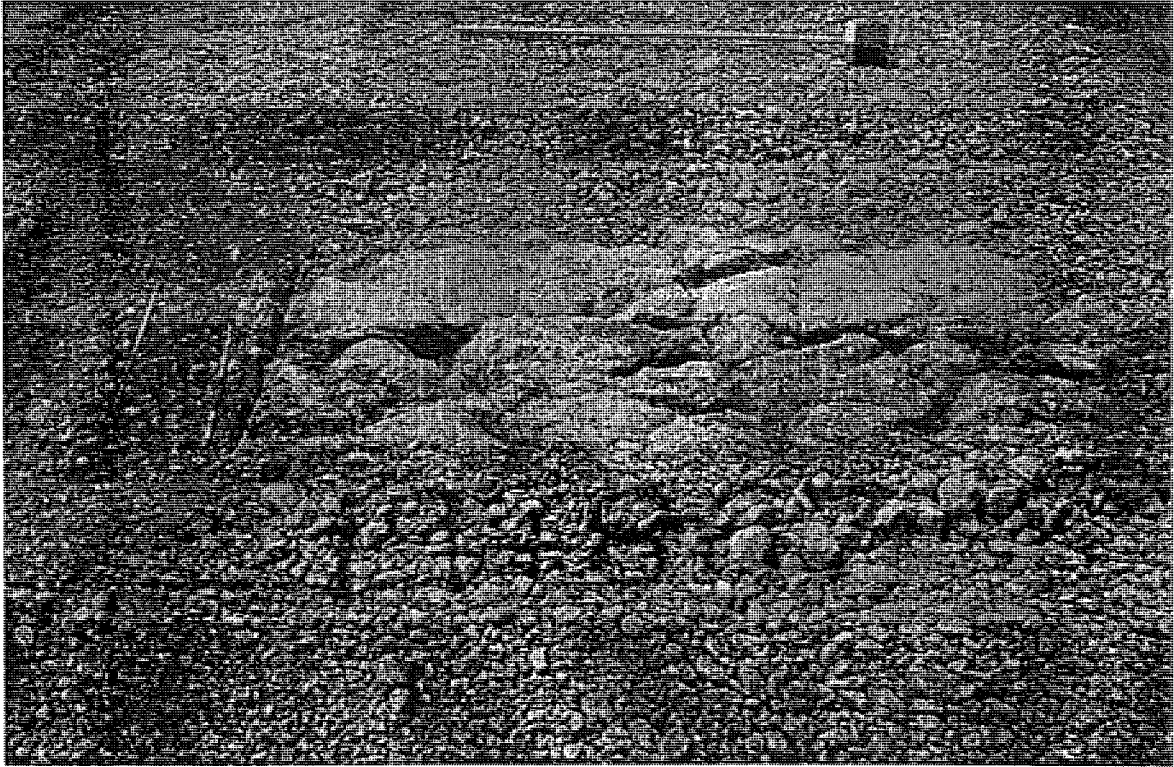
Three trenches were made on the project in mid-slab locations. A trench at station 19+867 yielded a good rubblization in the concrete widening and a poor rubblization in the original concrete. The concrete in the widening strip was rubblized down to the depth of the longitudinal #4 re-bar at 100-mm (4-in). The original concrete was only rubblized to 200- by 300-mm (8- by 12-in) pieces or larger, which had vertical fractures around the edges of the pieces extending only to a depth from 0- to 125-mm (0- to 5-in). However, these vertical fractures did not facilitate the movement of the rubblized concrete as a large mass. No temperature steel was exposed in the original concrete at this location.

Figure B.13 US-10 EB (Evert) trench in rubblized concrete (station 19+867)
badger breaker

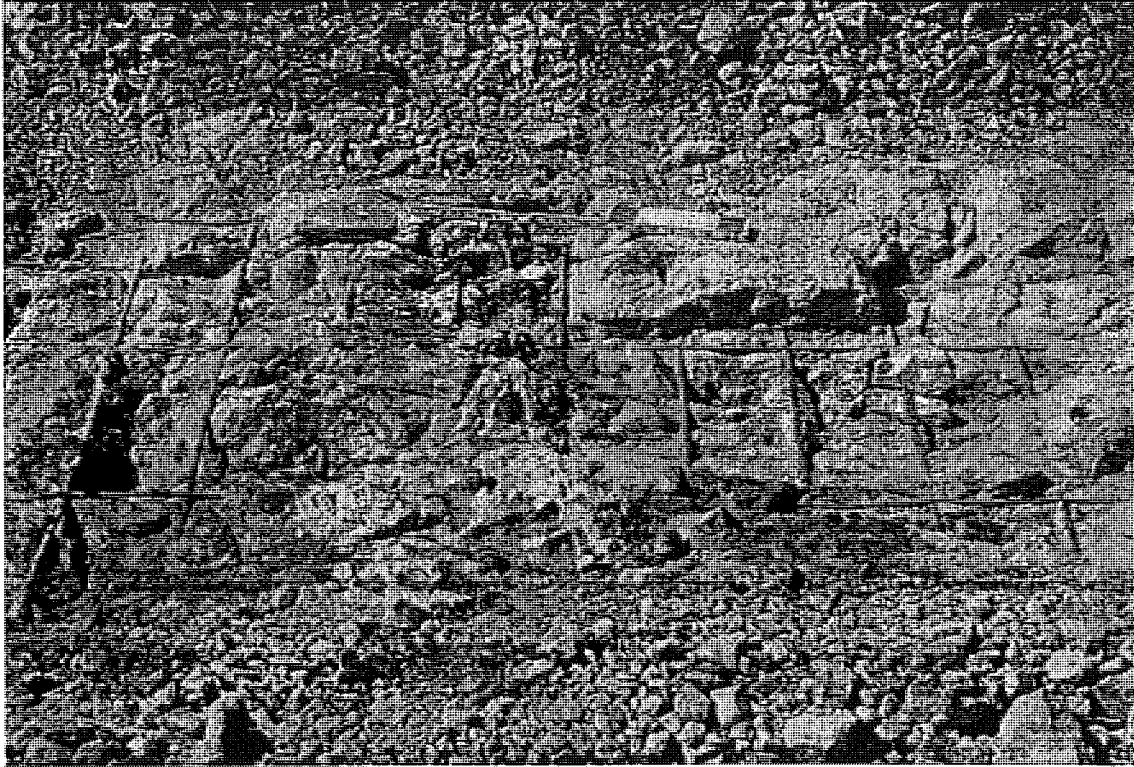
Two trenches were made in the southbound lane at mid-slab locations. The first trench was made at station 2+200, where the pavement is on a super-elevated curve and the velocity of the rubblizer was approximately 300-m/hr (975-ft/hr). The temperature steel was exposed in the trench across portions of the lane. A few areas with large fractured concrete were found in the outer part of the lane above the temperature steel.

A drainability test was made at station 2+200. However, due to the fact that the trench was on a super-elevated curve, the results at this location are not comparable to other projects. Fifty-liters (15-gallons) of water were placed on the fractured concrete surface. Water flowed very fast across the trench and down the super-elevation. All of the water was gone from the trench in 5 minutes. The majority of the water was lost to horizontal seepage through the top loose rubblized concrete, as evidenced by the trenching next to the trench on the lower side of the super-elevated curve.

Figure B.17 US-31 SB (Elk Rapids) trench in rubble concrete (station 2+200)
badger breaker

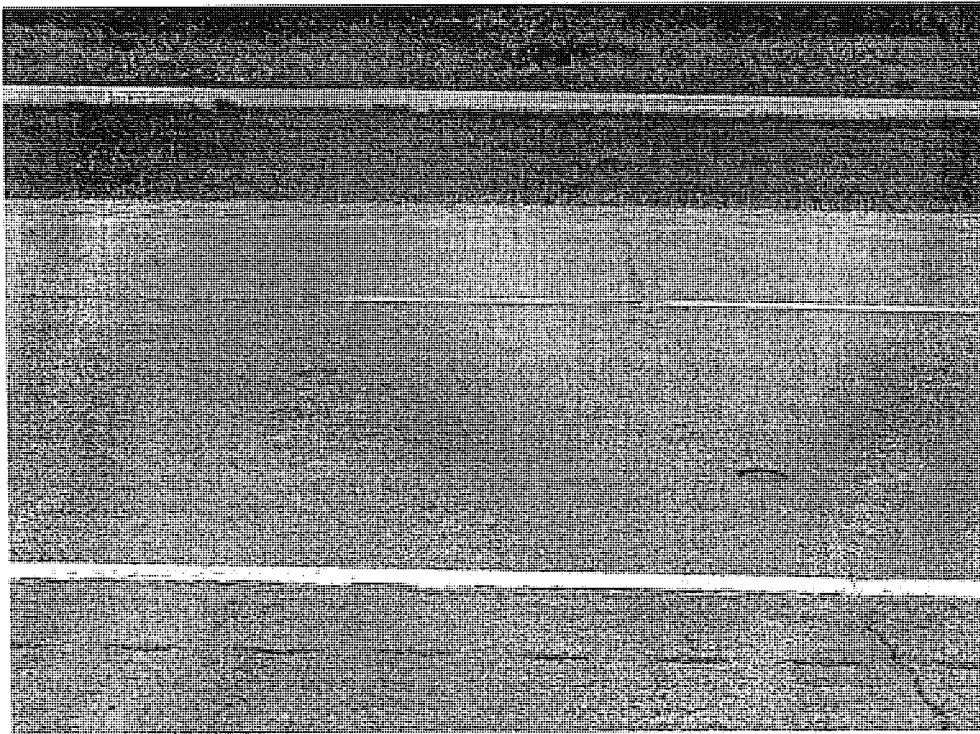
Figure C.11 Transverse crack across lanes on I-194 NB section 1 test site 2

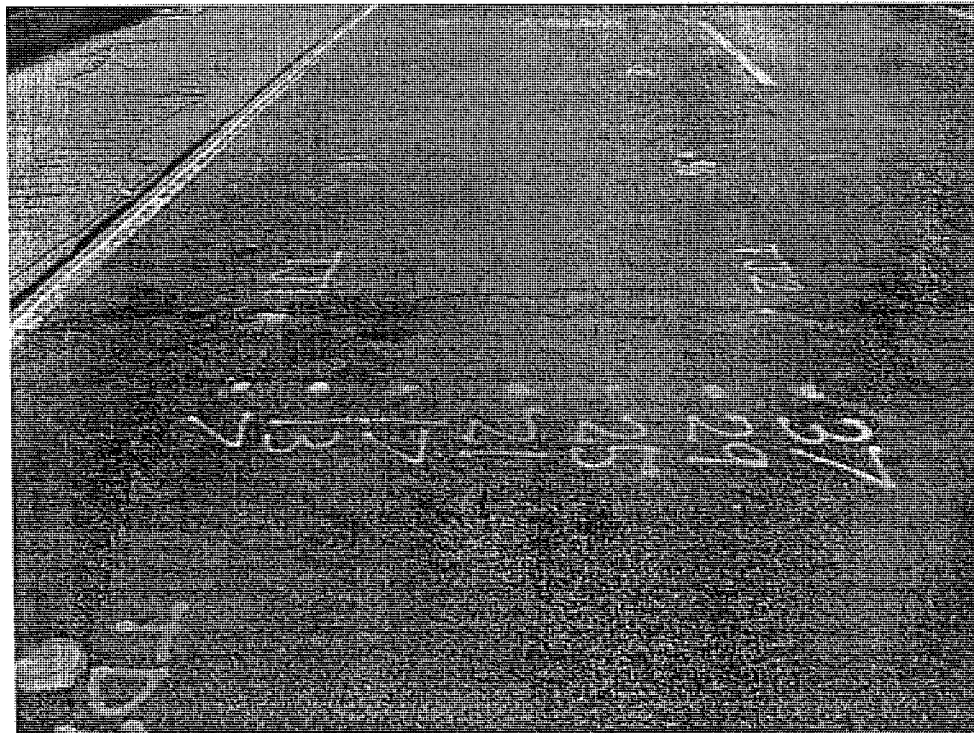
Figure C.18 Transverse joint reflective crack on US-27 SB section 2 test site 1

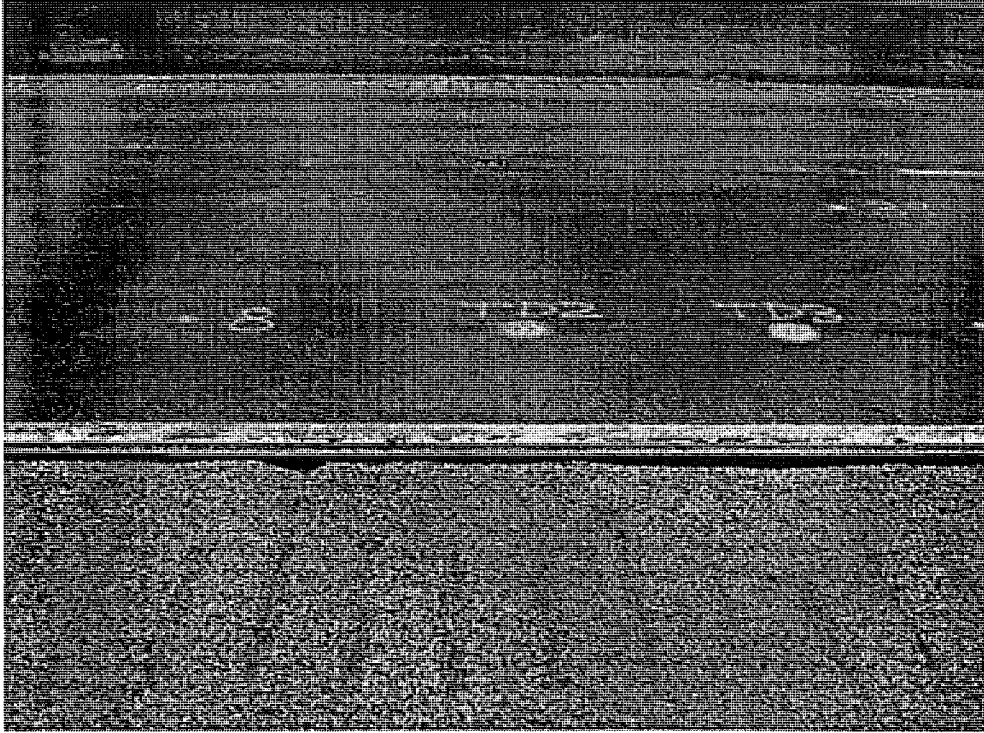
Figure C.19 Cores TD2 and TD3 over an alligator crack on US-27 SB section test site 1

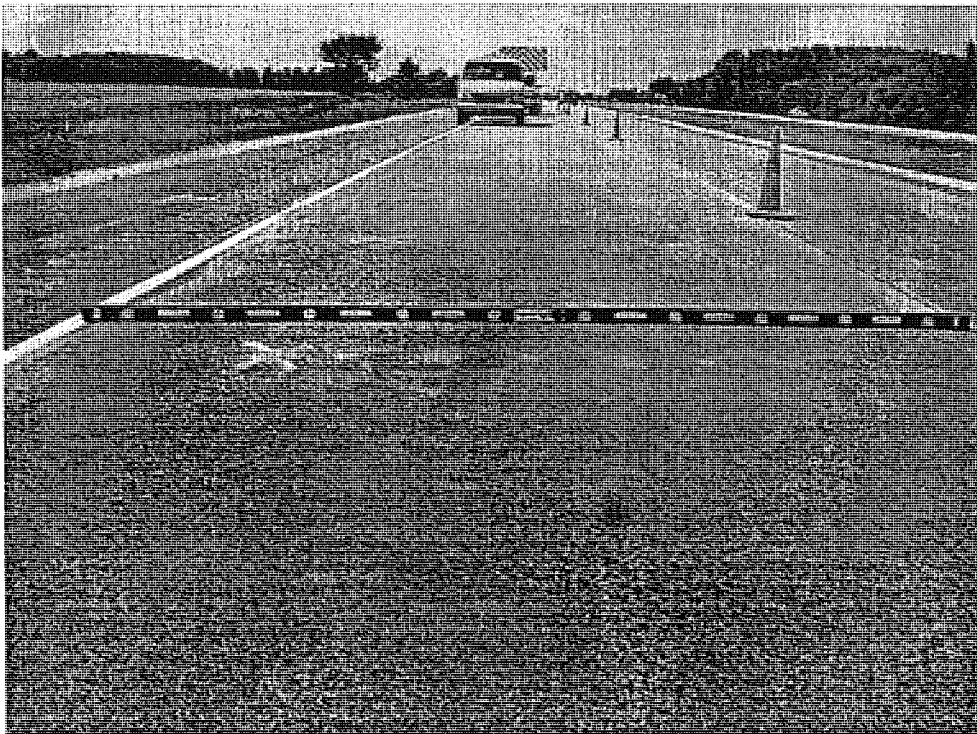
Figure C.20 No measurable rut on US-27 SB section 3 test site 1
