## OFFICE MEMORANDUM

MICHIGAN  
STATE HIGHWAY DEPARTMENT  
JOHN C. MACKIE, COMMISSIONER

Subject: Performance of Metallic and Non-Metallic Base Plates for Joints.  
Research Project 53 G-70. Report No. 343.

Reported by O. L. Lindy and L. T. Oehler

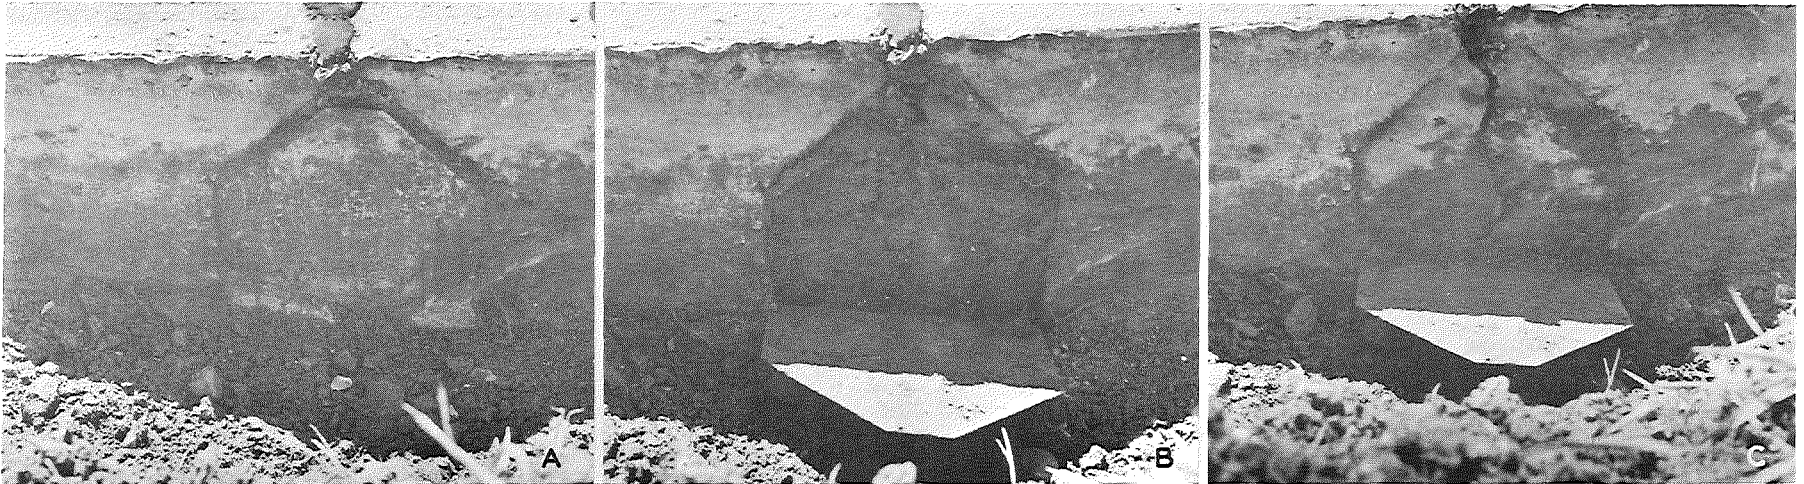
4. End plates of some metal base plates were pulled away from the concrete at joints, possibly when construction equipment scraped the pavement edge (Figs. 1 and 2). The non-metallic base plate adhered better to the concrete and appeared less susceptible to this type of damage.

Figure 1. This metal base plate at the inner slab edge, although well aligned with the joint groove (A), contained foreign material against the slab face (B), and within the joint crack (C). 1172+62; EB; 34044, C3

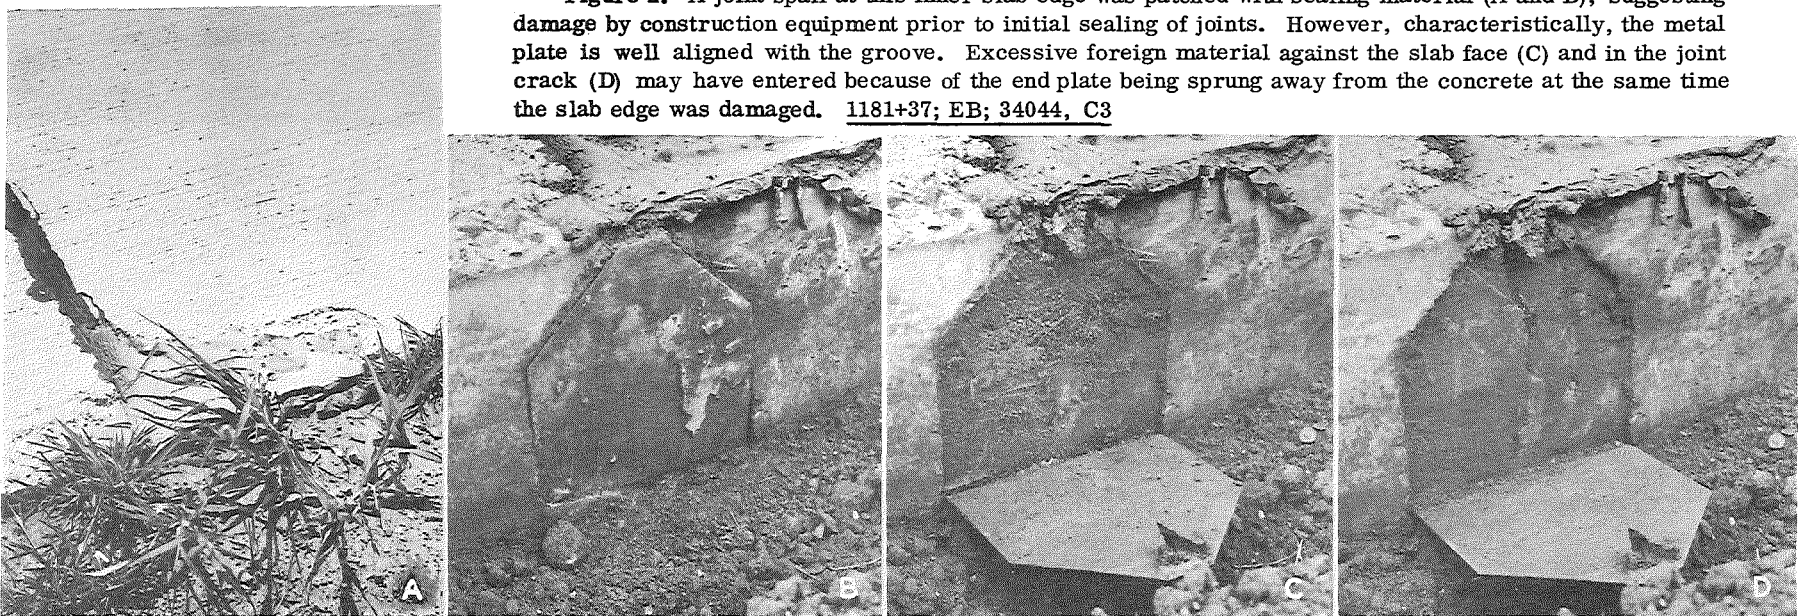
Figure 2. A joint spall at this inner slab edge was patched with sealing material (A and B), suggesting damage by construction equipment prior to initial sealing of joints. However, characteristically, the metal plate is well aligned with the groove. Excessive foreign material against the slab face (C) and in the joint crack (D) may have entered because of the end plate being sprung away from the concrete at the same time the slab edge was damaged. 1181+37; EB; 34044, C3

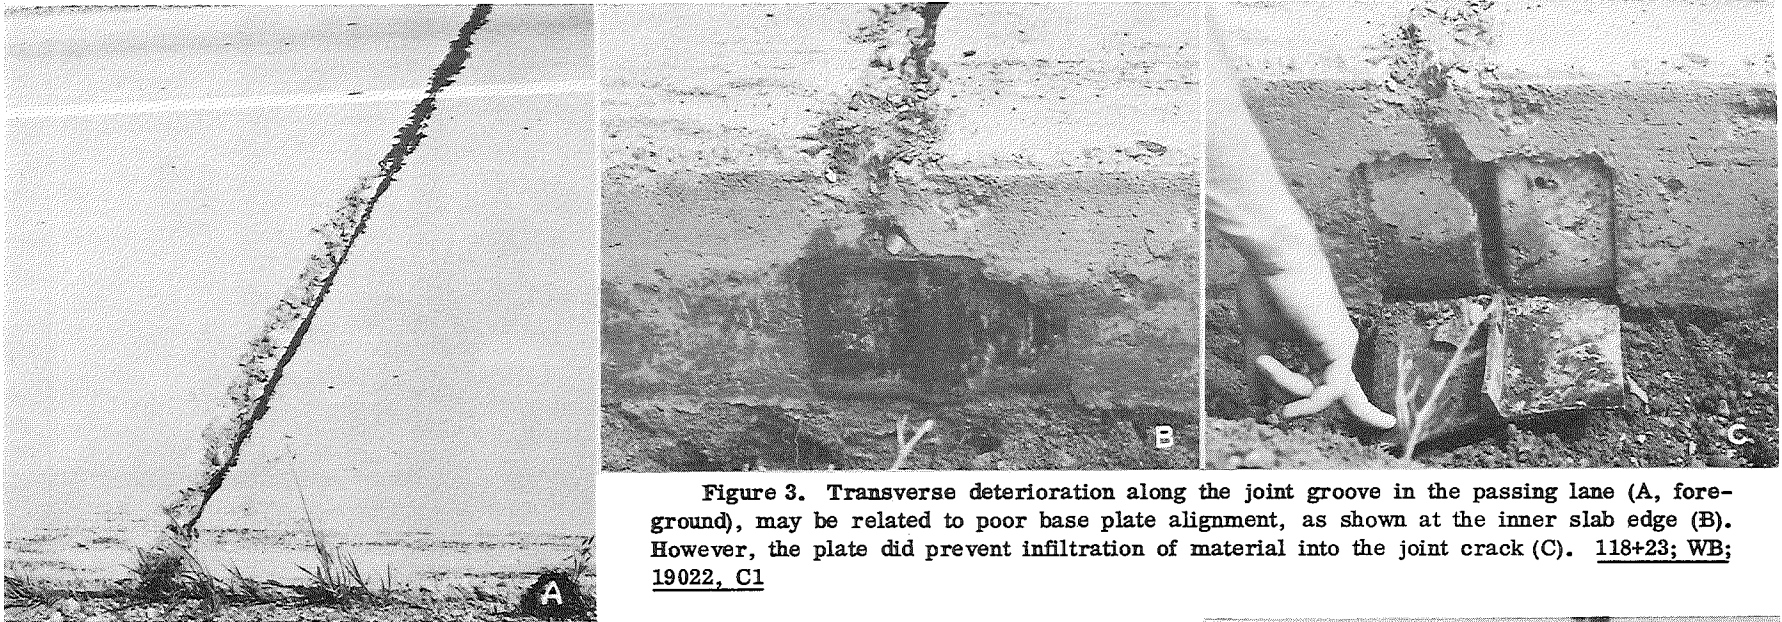
Figure 3. Transverse deterioration along the joint groove in the passing lane (A, foreground), may be related to poor base plate alignment, as shown at the inner slab edge (B). However, the plate did prevent infiltration of material into the joint crack (C). 118+23; WB; 19022, C1

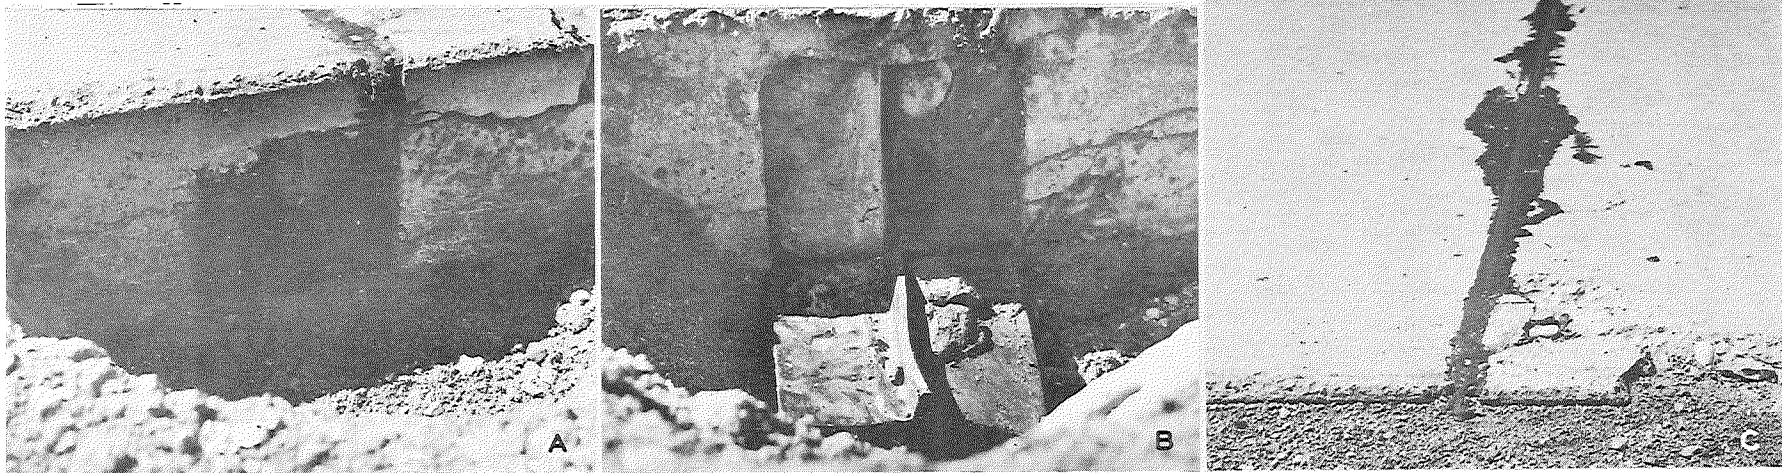
Figure 4. The most extreme misalignment of a non-metallic base plate and a joint groove encountered in this field inspection was found at this outer slab edge (A). The slab edge spalling (C) and longitudinal edge cracking (A) appear to be related to this misalignment. The foreign material behind the base plate (B) seems to have entered from the longitudinal crack. 202+91; WB; 19022, C1

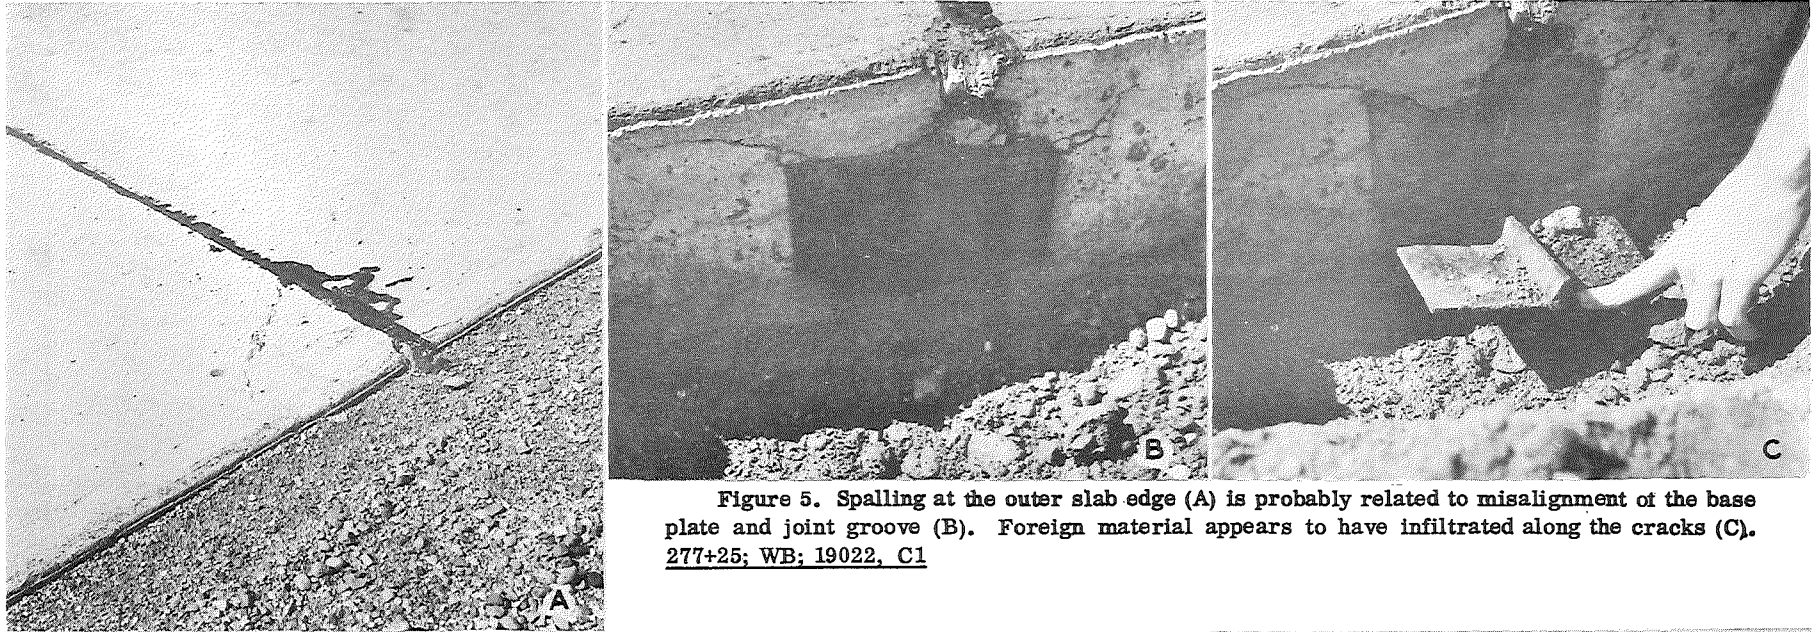
Figure 5. Spalling at the outer slab edge (A) is probably related to misalignment of the base plate and joint groove (B). Foreign material appears to have infiltrated along the cracks (C). 277+25; WB; 19022, C1

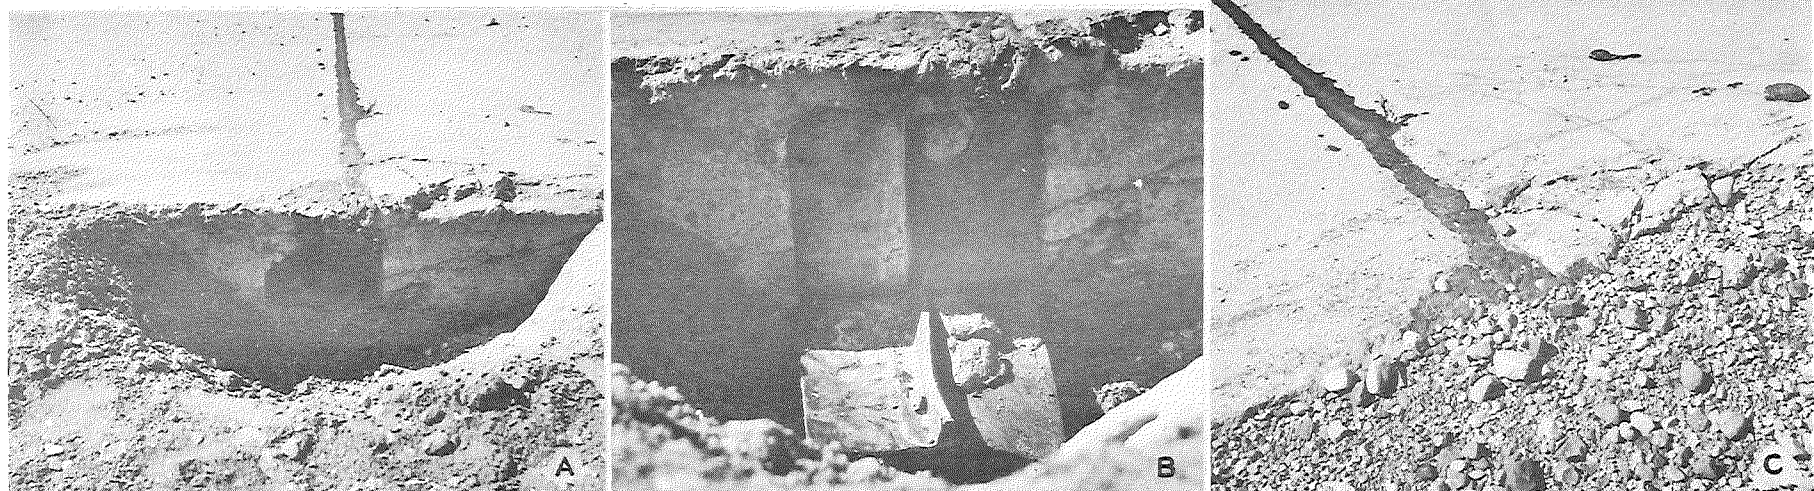
Figure 6. Severe spalling at this joint (C) may be associated with poor alignment of the base plate and joint groove (A). At this outer edge, a slight amount of foreign material has infiltrated (B), again along the slab cracks. 309+88; WB; 19022, C1

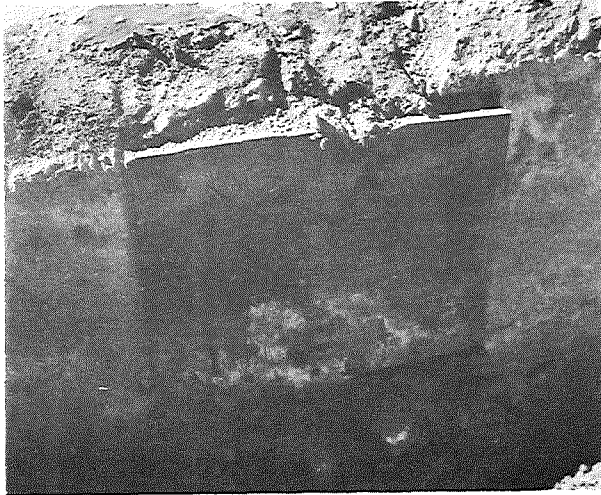
Figure 7. The condition of the outer slab edge at this joint (left) probably resulted from damage during pavement construction. The non-metallic base plate, which was pulled away from the concrete during construction operations, has allowed foreign material to infiltrate between the plate and the slab face (right). 312+76; WB; 19022, C1

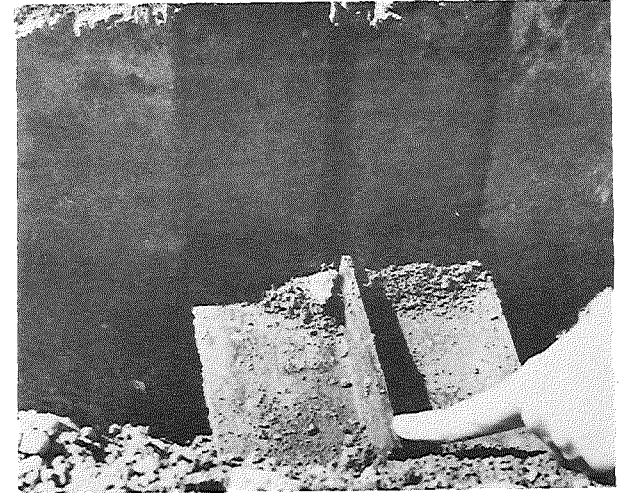
1. Metal base plates were generally better aligned with the top joint groove than were the non-metallic base plates, because the metal plates are aligned with the dowel assemblies by means of aligning wires or straps, before concrete is poured. Alignment of the non-metallic base plate is more subject to human error.
2. At some joints, the non-metallic base plates were not long enough or were not properly placed to provide sufficient material for end plates, and as a result these ends were brought up against the paving forms in curves rather than right angles. Thus, when concrete was poured, slab thickness at the joint corner was diminished by the curves, with an equivalent weakening of the slabs at these points (Fig. 8).

Figure 8. At both the outer and inner slab edges (A and B), the non-metallic plate at this joint was embedded in the pavement concrete and incorrectly aligned with the joint groove. Exposing the joint crack at the inner shoulder (C) disclosed foreign material between the plate and slab face. Spalling at the outer slab edge (A) is probably related to undercutting of the slab by curving the base plate rather than forming a right angle, thus reducing concrete thickness at this point. 323+15; WB; 19022, C1

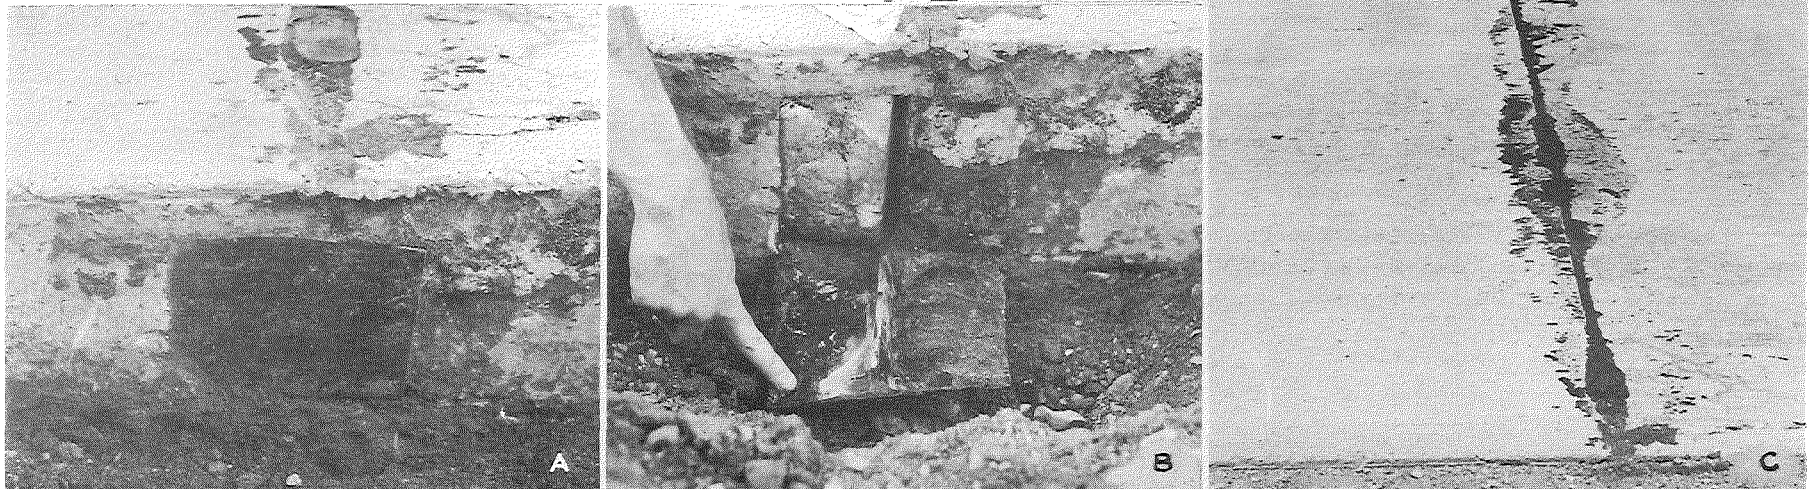
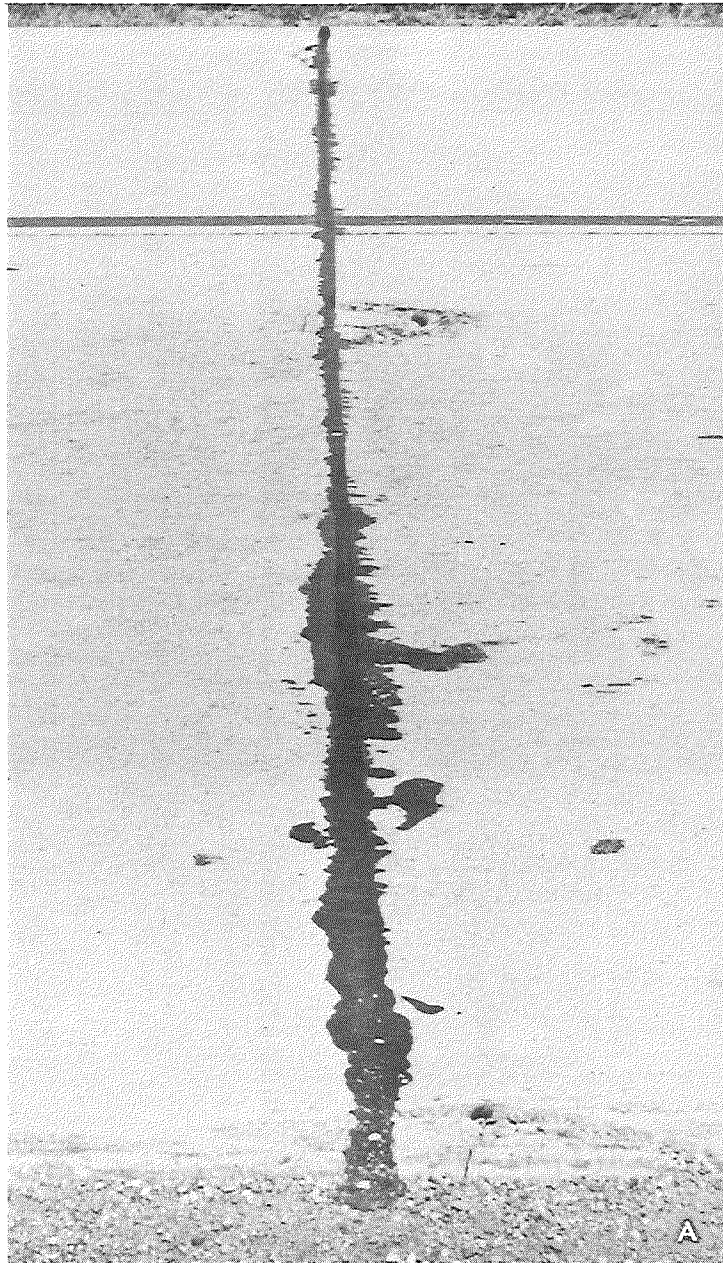
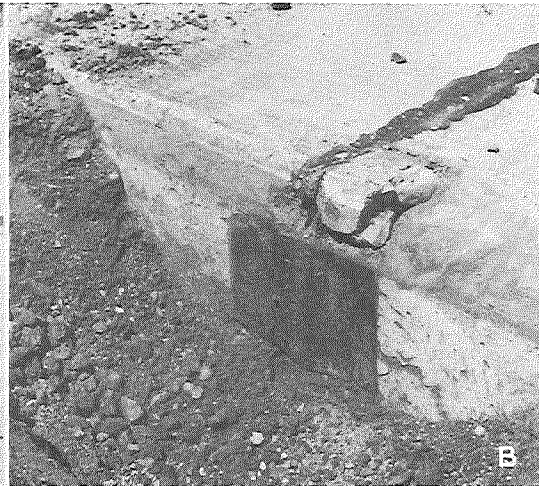
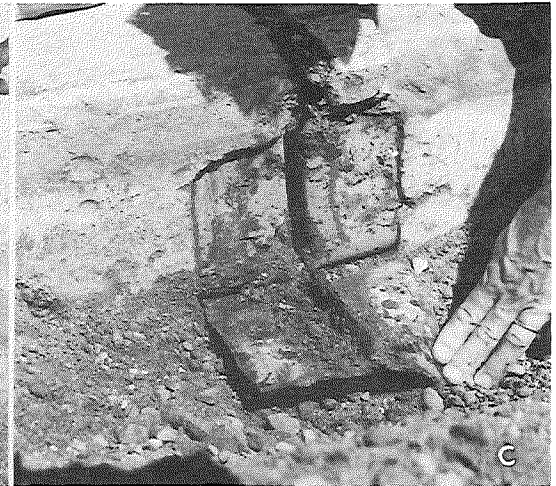
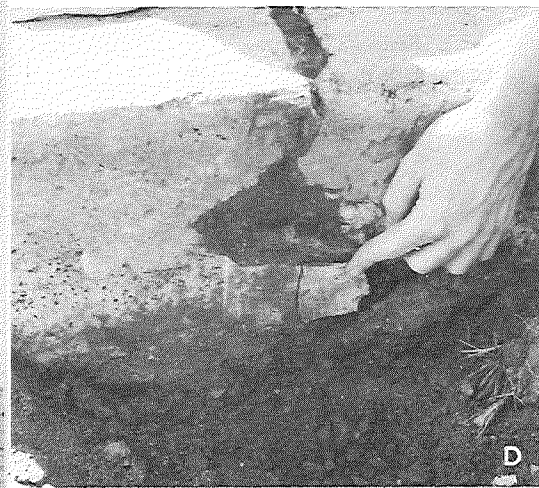
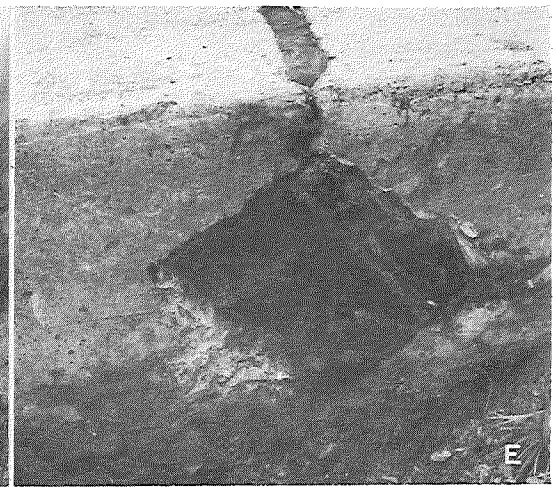
3. Certain base plates of both materials were tilted out of vertical alignment with the joint groove, either by improper placement on the subgrade, or disturbance during paving operations (Fig. 11e).

Figure 11. Spalls were observed near the inner edge, near the centerline, and at the outer edge of this joint (A, view from outer edge). Excavation at the outer edge showed fair alignment of the base plate and joint groove (B), with considerable infiltration of foreign material (C). However, excavation at the inner edge (D) showed base plate embedment in the slab concrete. The extreme tilt of the base plate (E) suggests that it may have been moved by paving equipment during pouring or placed on an unlevel base. In either case, the dowel bar assembly may also have been tilted, a possible explanation for the surface spalling. 1392+42; EB; 34044, C1
