**MAINTENANCE OF NEOPRENE SEALED  
CONCRETE PAVEMENTS**

**First Progress Report**

**Research Laboratory Section  
Testing and Research Division  
Research Project 75 G-217  
Research Report No. R-1065**

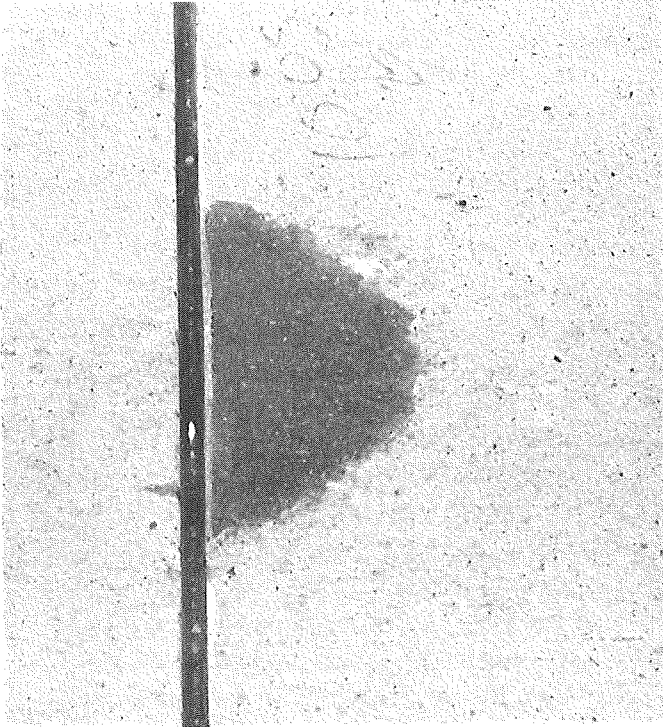
◀ Epoxy Mortar

A typical repair of each type is shown in Figure 2. Basically, the repair procedures worked satisfactorily, with some minor difficulties encountered. It was discovered that some spalls, especially at expansion joints, extended below the dowel bars. This greatly increased the amount of work required to remove the unsound concrete. It also made forming the groove more difficult because the plane-of-weakness crack needed to be preserved in the spall area. The problem was solved by inserting a highly compressible polyethylene foam in the crack. A coating of grease was applied to all exposed dowel bars to act as a bond breaker.

Figure 2. Typical spall repairs just after curing.

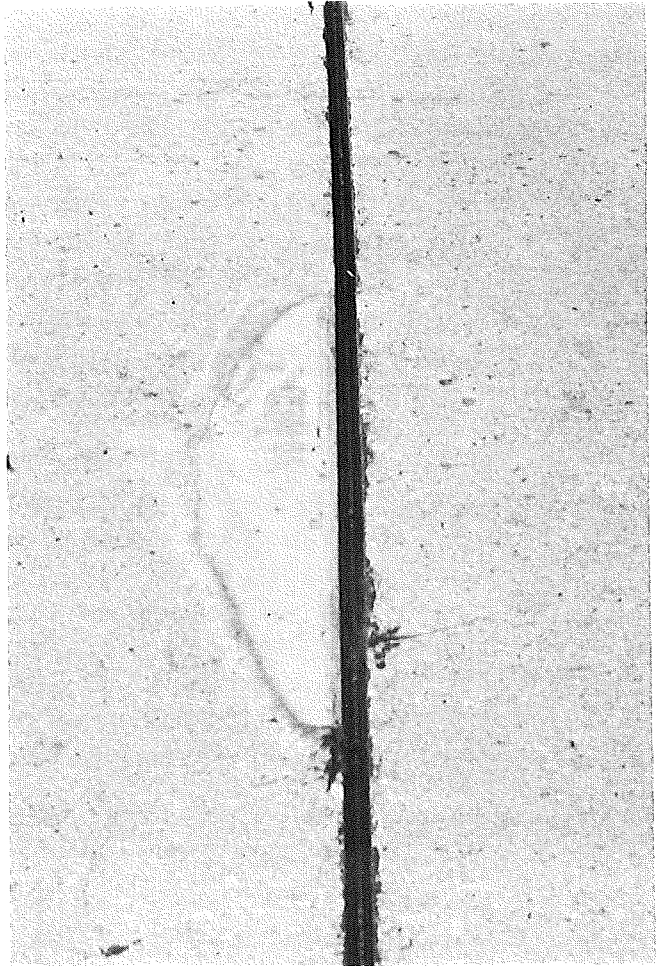
▶ Portland Cement Mortar

The performance of the spall repairs and resealed joints was observed in November, 1976 and again in February, 1977. On the first survey, four of the portland cement mortar patches were noticed to contain shrinkage cracks and some adhesion failure. These conditions were the same on the February survey. The seven epoxy mortar patches were found to be in good condition on both surveys. On the first survey, four Set 45 mortar repairs exhibited minor bond loss and spalls. One repair had cracked parallel to the joint groove. On the second survey, six more patches were found to contain minor spalls, some loss of bond, and one patch had failed completely. The minor spalls had occurred along the seal, but in no case is the function of the seal impaired.

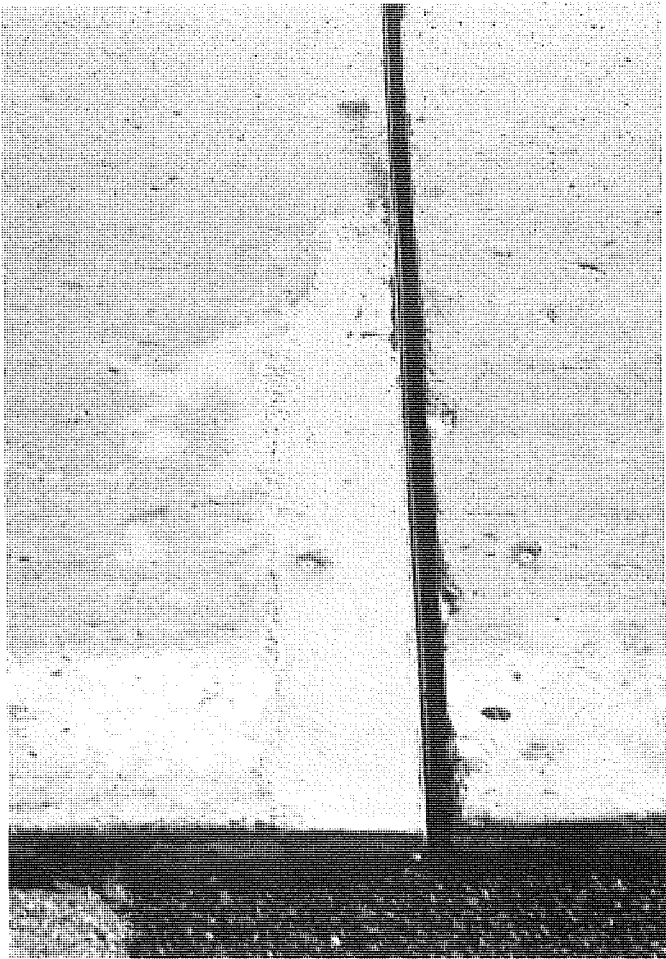
◀ "Set 45" Mortar

Of the three mortar materials used, the Set 45 mortar appears to possess the properties required for spall repair work. It is mixed and placed easily, cures sufficiently in two hours or less to carry traffic, tool and equipment clean-up can be done with water, and performance under traffic is good. The epoxy patches showed excellent performance but mixing, placing, and cleaning of equipment and tools are more difficult and must be done with more precision. The portland cement mortar patches show promise; however, curing time amounts to four hours or more which makes it less desirable for use in this application.

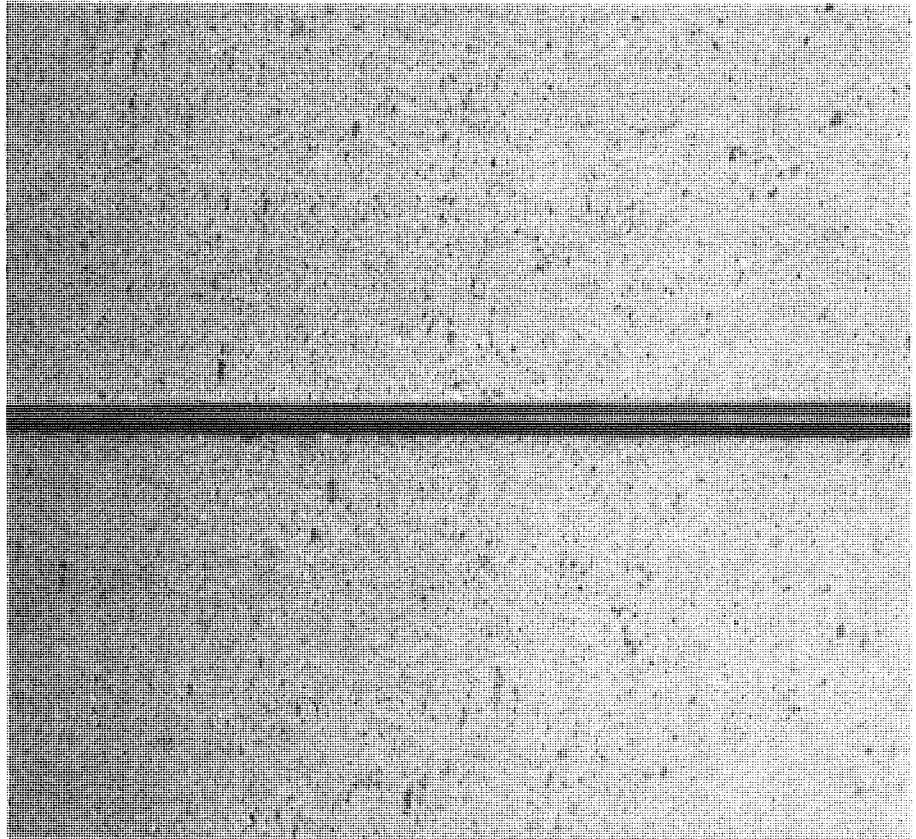
Description: A satisfactory joint contains a neoprene seal that exerts sufficient pressure on the groove walls to prevent foreign materials from entering the joint. The seal itself is generally without tears and only minor spalls have occurred along the groove edges.

Rating Number: 0

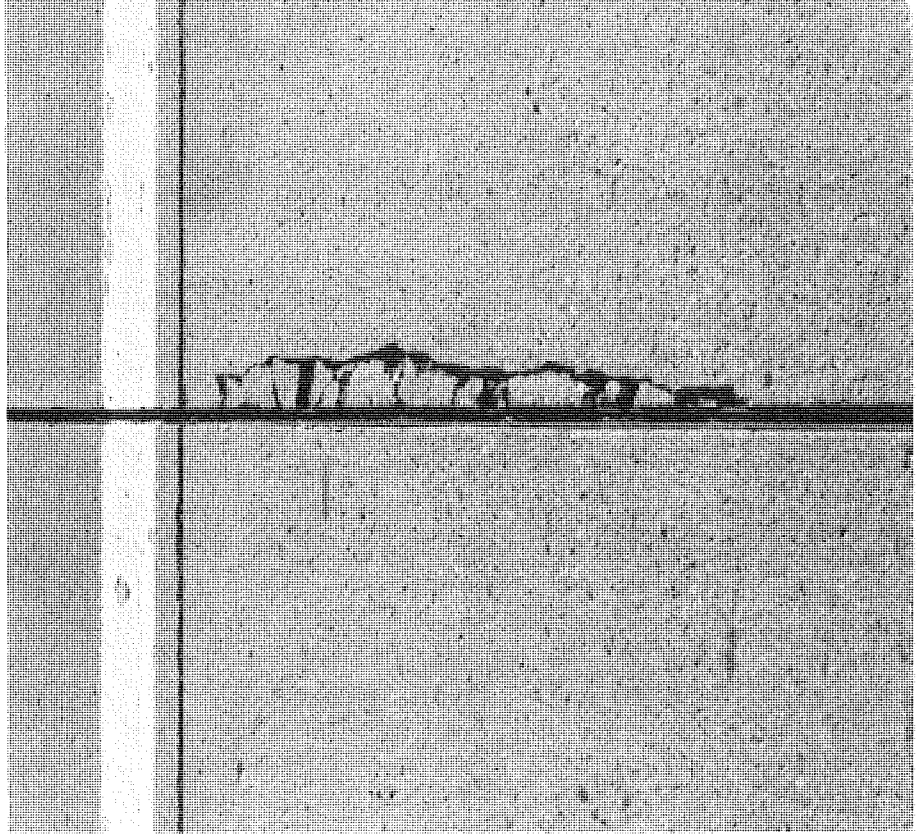
Name: Shattered Spall

Description: Shattered spall is the breaking or cracking of the concrete along the joint groove. Generally, most of the broken concrete pieces are still in place and the seal is still under compression. The spall can also be a solid piece.

Rating Number: 1

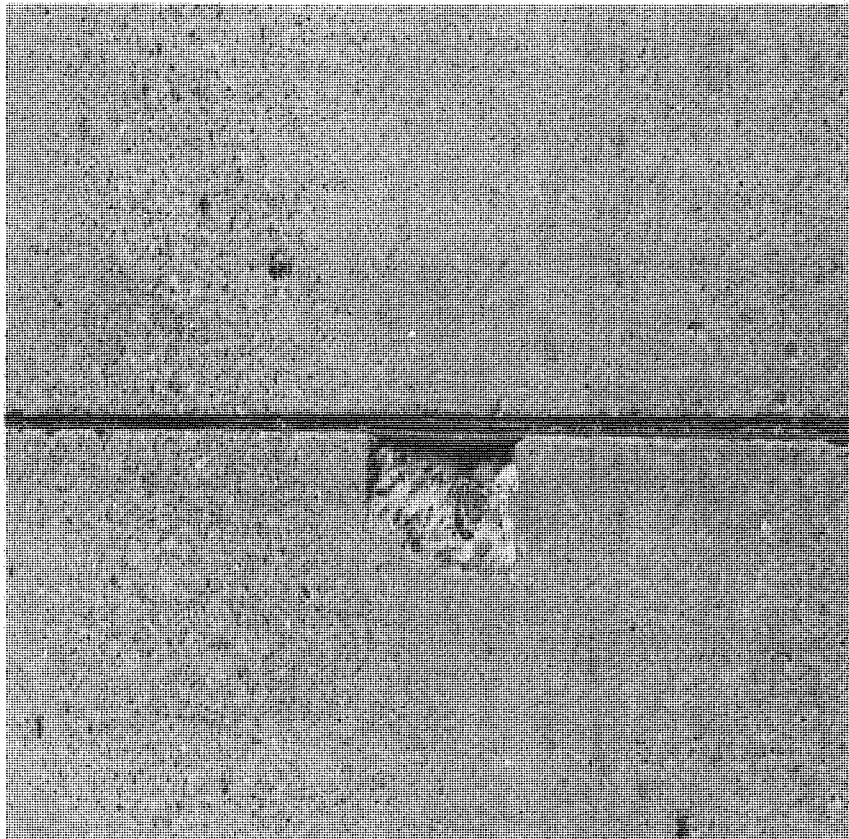
Name: Open Spall

Description: An open spall is the breaking or cracking of the concrete along the joint groove and the broken concrete is missing. Seal compression is lost in the spall area.

Rating Number: 2

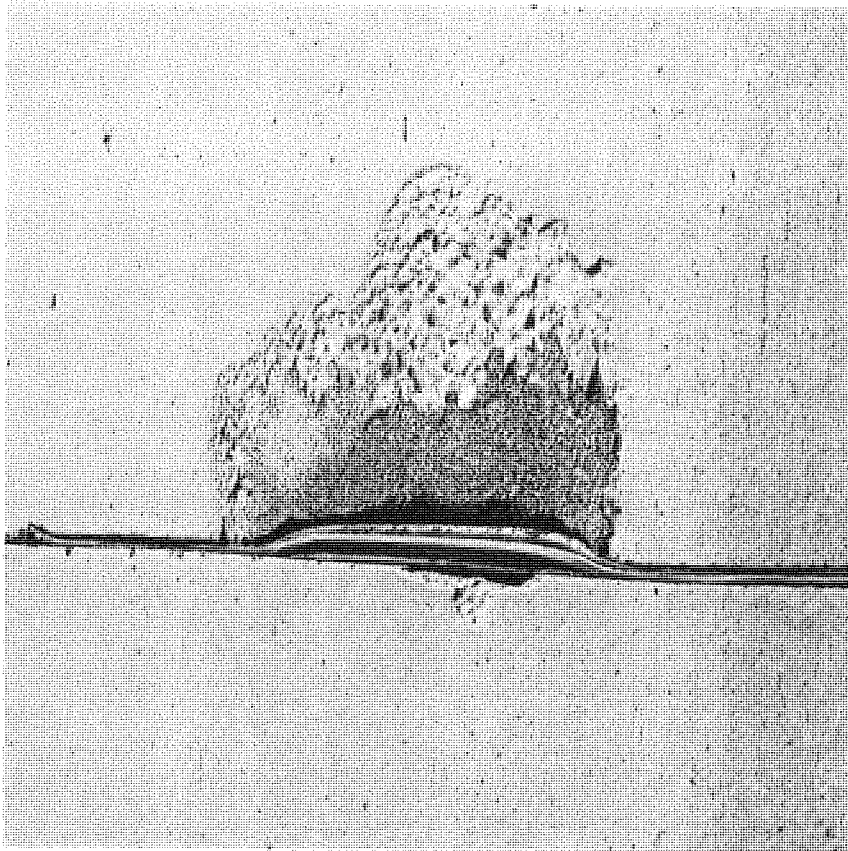
Name: Joint Spall

Description: A joint spall is the breaking or shearing of the concrete along the joint groove. The spall extends from the bottom of the groove and several inches away from the joint. The broken concrete is missing and bituminous repair may be required. Compression in the seal is lost and the seal may be torn in the spall area.

Rating Number: 3

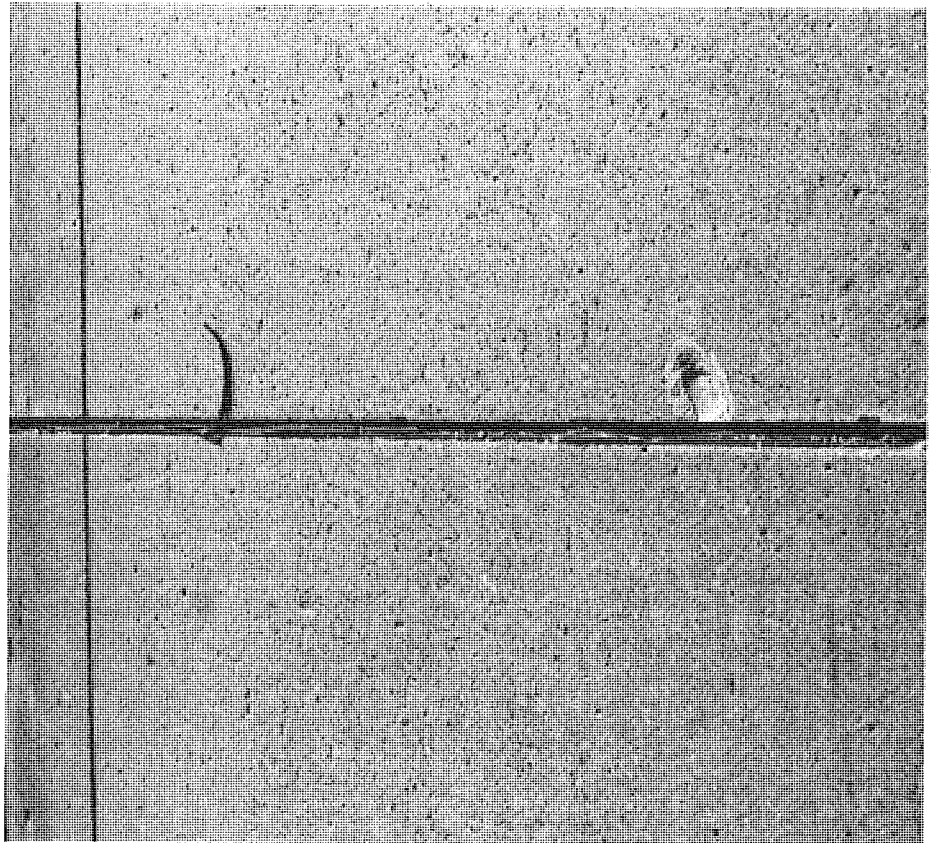
Name: Tight Seal

Description: A tight seal is an expansion joint seal that is compressed beyond its design limit. The groove opening may range in width from 1/4 to 1/2 inch, the seal normally is torn, but no spalling has occurred. The seal is still sealing the joint satisfactorily.

Rating Number: 4

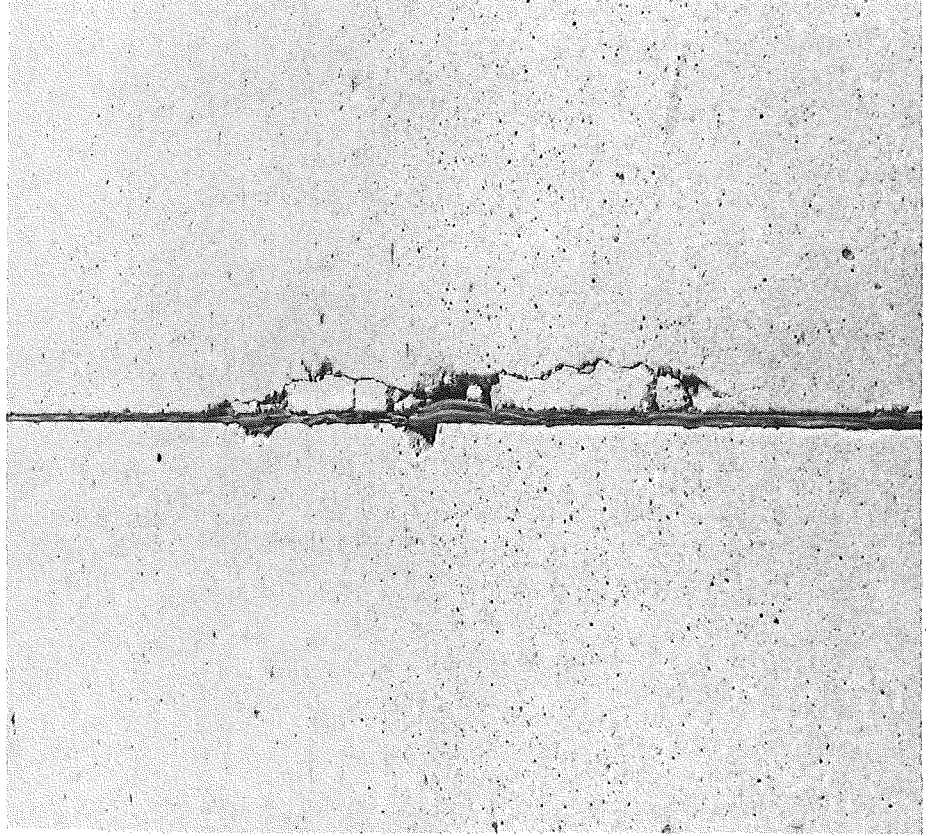
Name: Tight Seal with Spalled Groove

Description: A tight seal with spalled groove is an expansion seal compressed beyond its design limit and spalls along the groove have occurred. The seal normally is torn and the spalls may be either shattered, open, or of the joint spall type.

Rating Number: 5

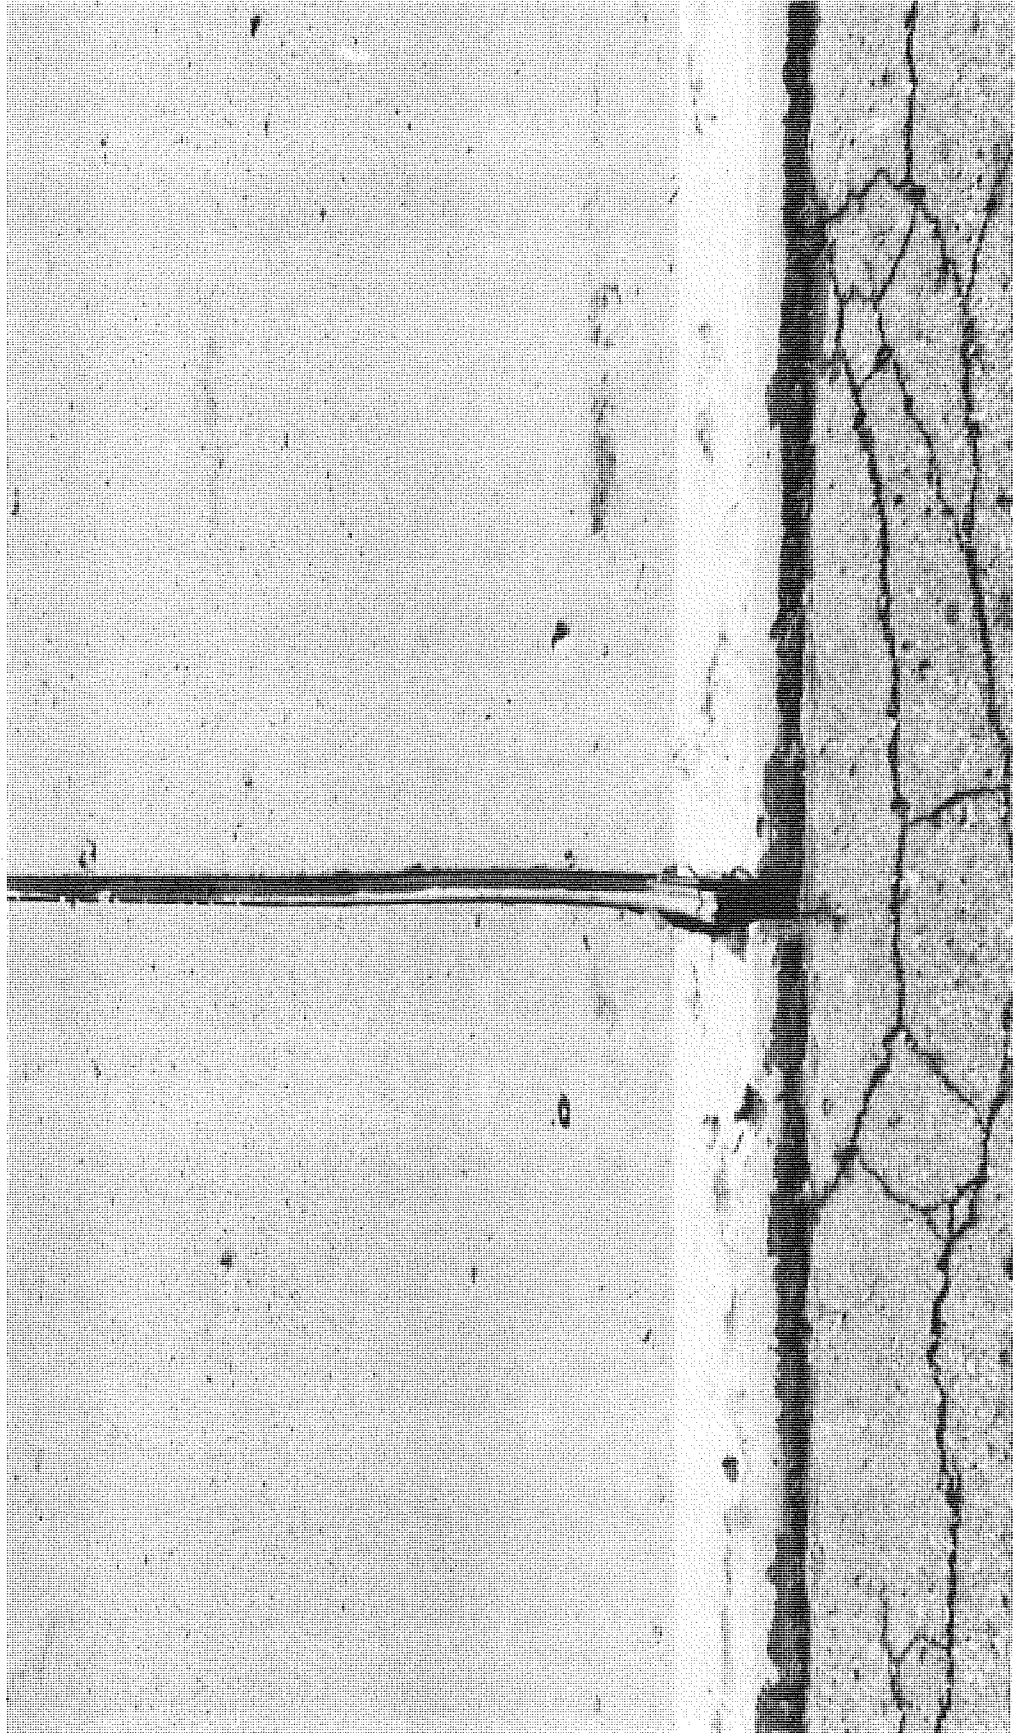
Name: Loose Seal

Description: A loose seal is one where the pressure on the groove walls is lost. Spalls of either of the three types may be present.

Rating Number: 6

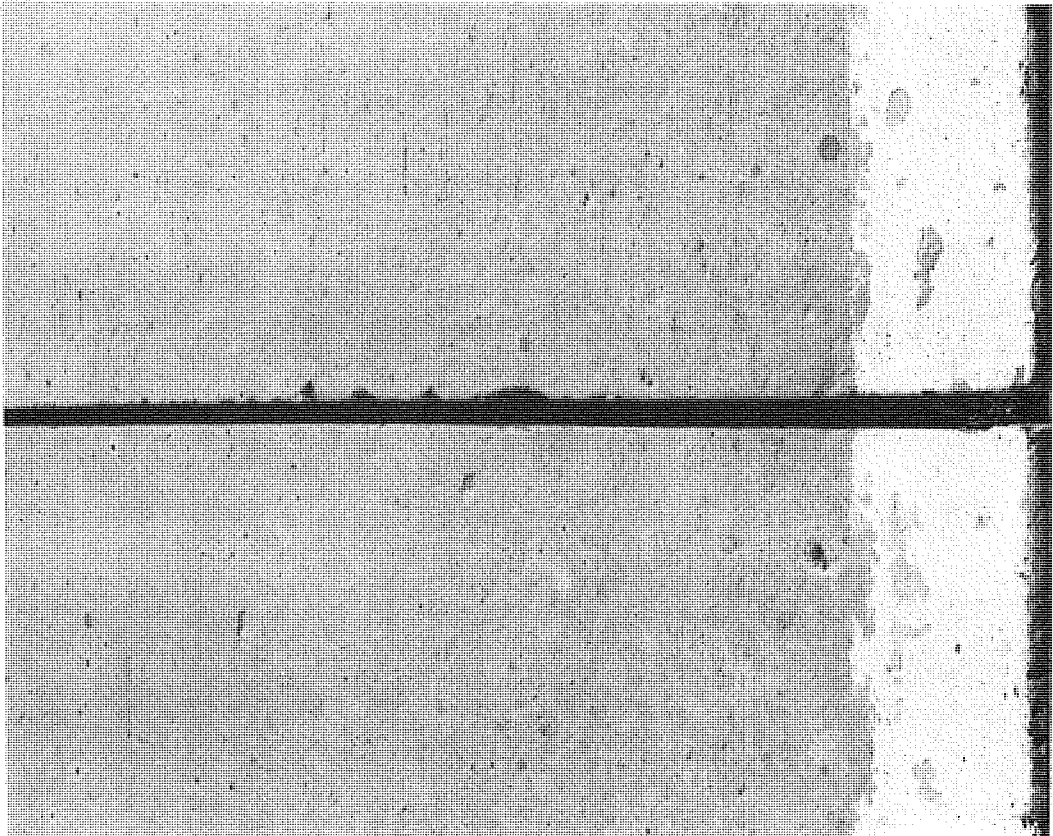
Name: Lost Seal

Description: A lost seal is where part of, or the entire length of seal is missing. Spalls may be present.

Rating Number: 7

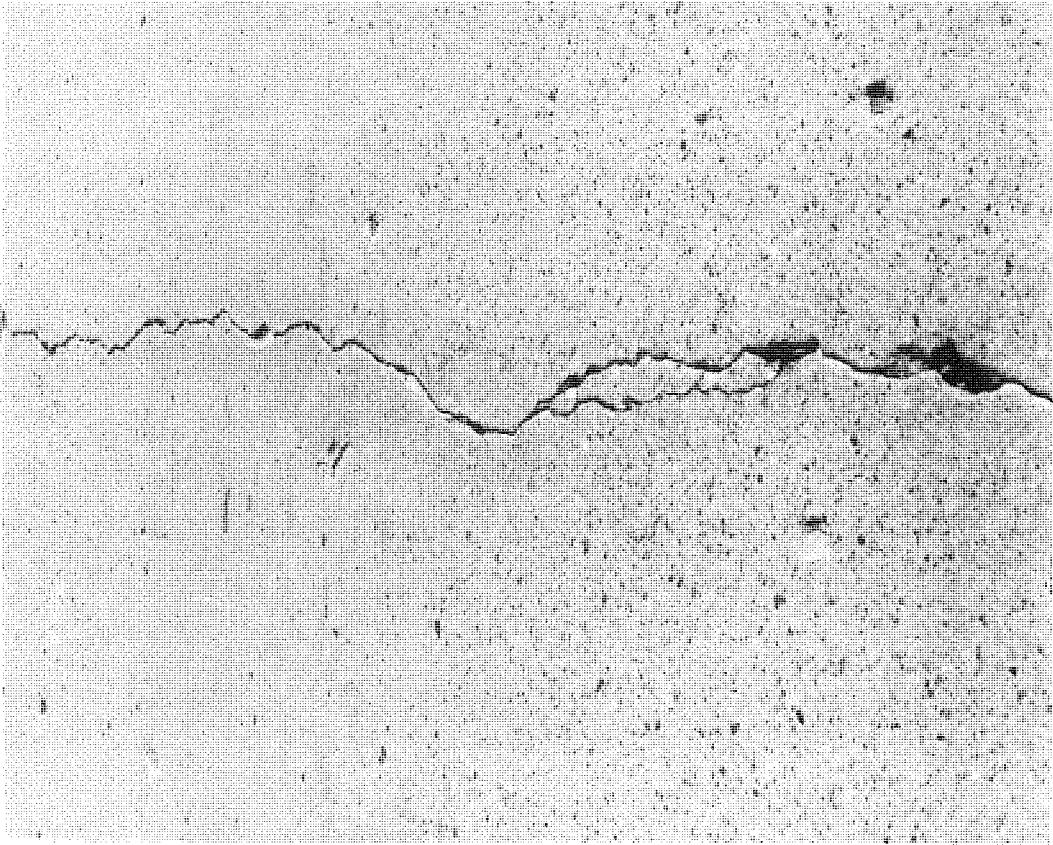
Name: Open Transverse Crack

Description: An open transverse crack is 1/8 inch or more in width at the surface.

Rating Number: 8
