A FIELD STUDY OF JOINT AND CRACK RESEALING  
METHODS AND MATERIALS

Highway Research Project 53 G-68

Research Laboratory  
Testing and Research Division  
Report No. 268  
November 1, 1956

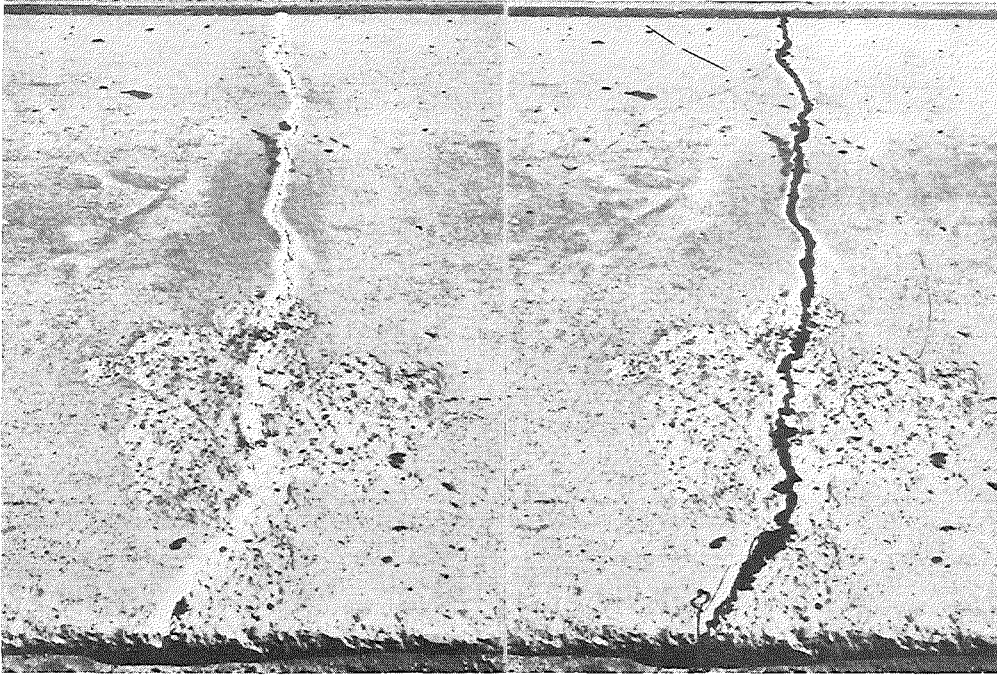
▲ FIGURE 12. CLOSED CRACK AFTER SANDBLASTING SHALLOW GROOVE ALONG CRACK.

As soon as a decision had been made to seal closed cracks, two such cracks were sandblasted until a shallow groove was formed along the crack. The groove was 3/16 to 1/4 in. deep and 1/2 to 3/4 in. wide at the top. The pavement surface was cleaned with sandblast about 1/2 in. each side of the groove, blown out with air, and the crack sealed. Sealing material was applied in one pour to a level sufficient to allow an overlap on the pavement surface of about 1/8 in. This allowed the top surface of the sealer to be slightly higher than the pavement surface. After traffic had crossed these two cracks for 24 hr. it appeared that the sealing material tended to become even more firmly wedged down into the groove and seemed to form a very tight seal. As a result, all closed cracks from station 581+65 to the west end of the project were treated in this manner. A crack of this type is shown ready for sealing in Figure 12 and after sealing, in Figure 13.

1. Sandblast until a shallow groove is formed along the crack. The groove should be 3/16 to 1/2 in. deep and 1/2 to 3/4 in. wide. The pavement surface should be sandblasted for about 1/2 in. each side of the groove.

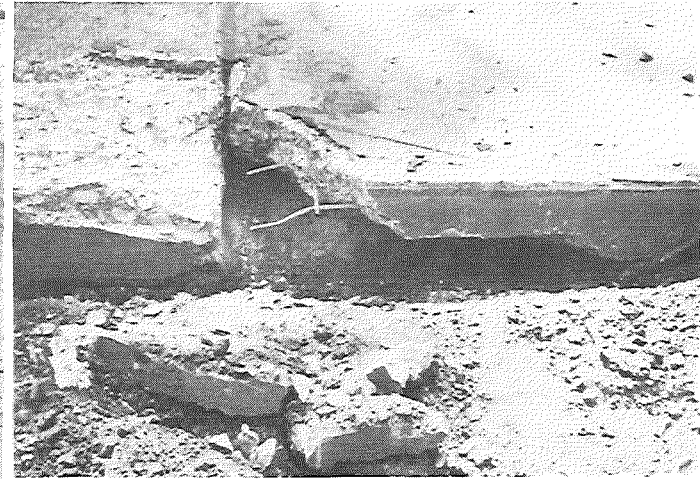
▲ FIGURE 14. CORNER BREAK WITH LOOSE AND UNSOUND MATERIAL REMOVED.

It was found that usually only one corner break was apparent at the pavement edge. Removal of a section of the shoulder always indicated, however, that the other corner was also broken. It appeared that compressive stress at the joint caused the upper corner of one slab and the lower corner of the other to shear off at an angle of about 30 deg. to the horizontal. This condition is apparent in Figure 14 and is typical of all corner breaks examined in detail.

Figures 14 through 17 show the various steps used in making these repairs. The loose and unsound concrete was removed with an air hammer and the joint filler and groove form set in place. A wide board was used as a form for the pavement edge. A very thin water slurry of cement containing 10 percent by weight of a well known anti-shrink admixture was brushed into the faces of the old concrete for a bond coat. A grout made of 60 volumes of gravel of 1-in. maximum size, 40 volumes of No. 8 sand, and 33-1/3 volumes of cement containing 10 percent by weight of the same admixture was then packed into the cavity by hand and consolidated by tamping in with the end of a small board, Figure 15. This grout mixture was unusually dry, containing just enough water to retain its shape when squeezed into a ball in the hand, and was consolidated on the surface patches simply by tramping on it with the feet. Figure 16 shows a patch at this stage and ready for the finish coat. A 1/2-in. surface coat, in which the gravel was replaced by No. 8 sand, was used to finish off the patch. The patch was covered overnight with curing paper and then alternately wetted and dried for several hours in order to rust the iron in the admixture. Figure 17 shows a typical finished patch.

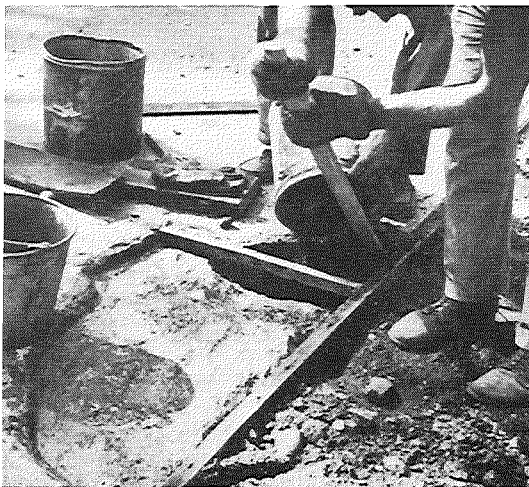
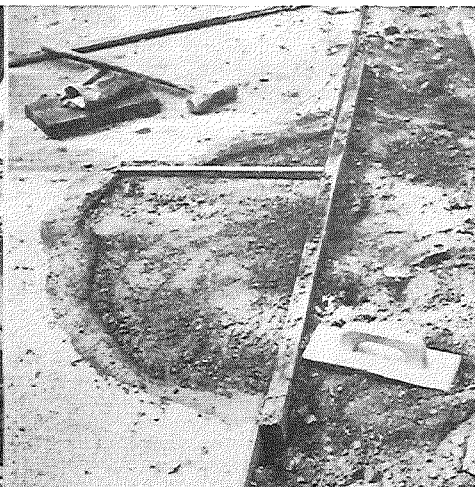
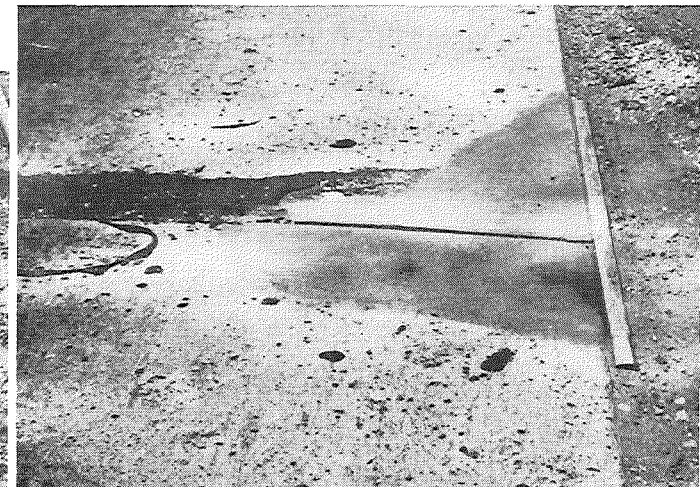
▼ FIGURE 15. ADDING GROUTING MIXTURE.

▼ FIGURE 16. READY FOR FINISH COAT.

▲ FIGURE 17. A TYPICAL REPAIRED CORNER BREAK.

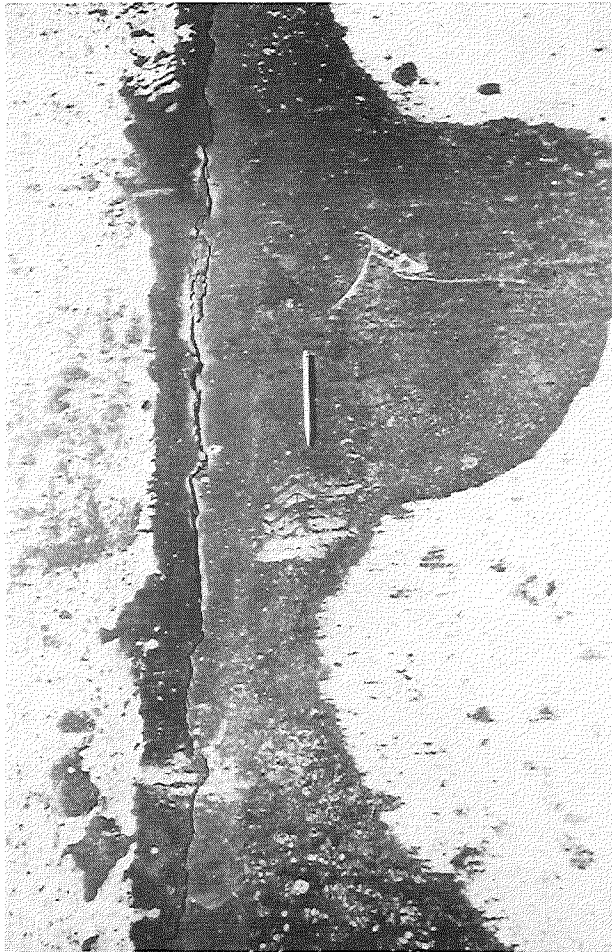
After 1-1/2 yr. of service the Brand A material had continued to deteriorate to the point where in all transverse joints it was badly cracked and separated from the joint faces. In addition, Brand B had also started to deteriorate. In about half of the transverse joints and all of the open cracks containing this sealer, failures occurred in both cohesion and adhesion, while in the remainder of the transverse joints the seal was still intact. A few of the transverse joints containing Brand C sealer showed adhesion failures in which adhesion to one joint face was lost but most of the joints containing Brand C were in very good condition.

▲ FIGURE 18. FAILURE MAINLY IN COHESION; TYPICAL OF BRAND A FAILURES AT 2 1/2 YEARS.

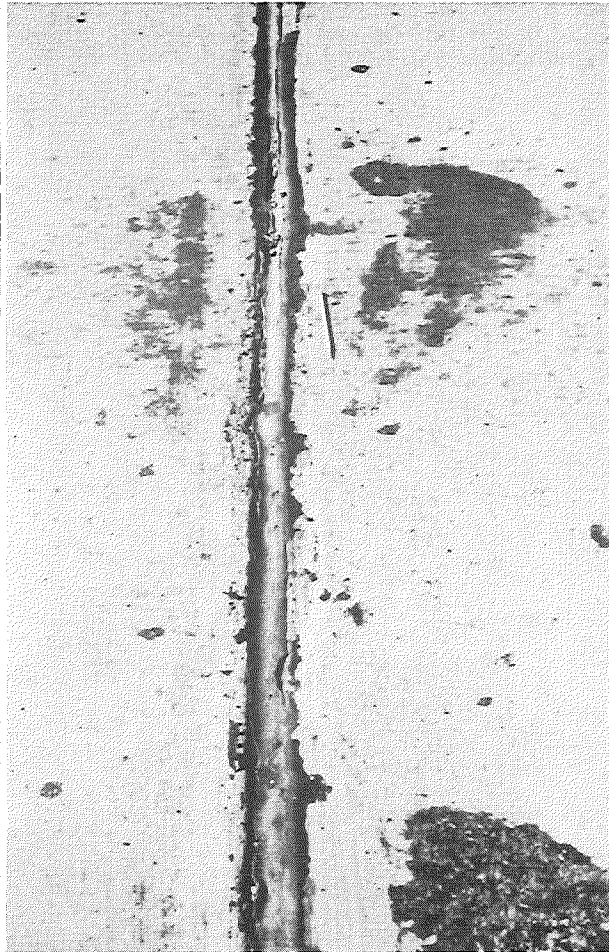
In the 2-1/2 yr. survey it was found that the only major changes since the previous survey had occurred with Brands A and B sealers in transverse joints. With the exception of a few adhesion failures, all of the Brand A failures had now become manifested as cohesion failures. The deterioration of Brand B sealer had continued to a point where all transverse joints containing this material had failed in adhesion. The remainder of the maintenance repairs appeared to be in exactly the same condition as they were at the time of the previous survey one year earlier. The Brand C sealer still showed adhesion failures in only a few transverse joints with most of them in good

▲ FIGURE 19. ADHESION FAILURE; TYPICAL OF JOINTS RESEALED WITH BRAND B AT 2 1/2 YEARS.

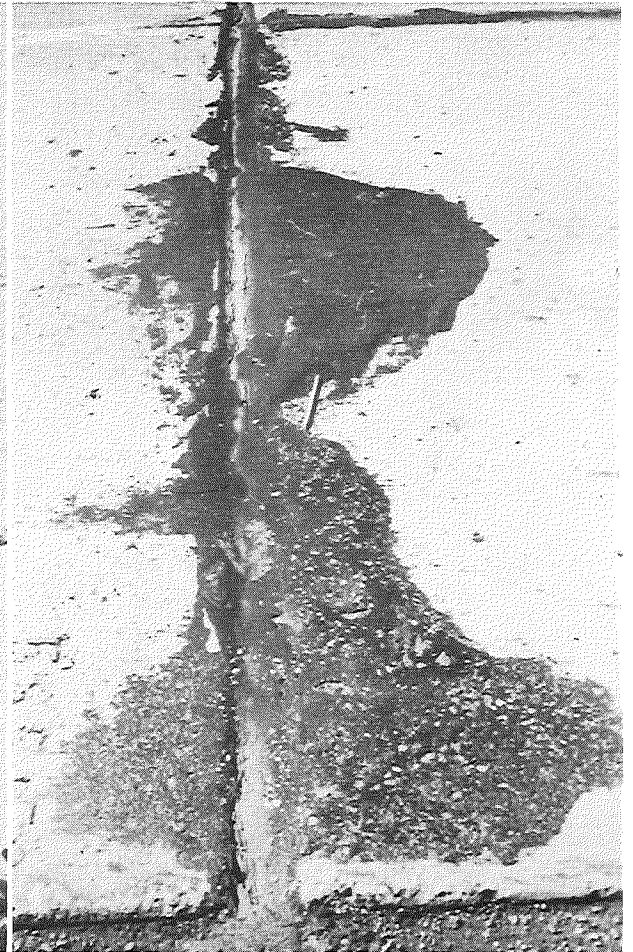
▲ FIGURE 20. SEAL STILL INTACT. TYPICAL OF JOINTS CONTAINING BRAND C AT 2 1/2 YEARS.

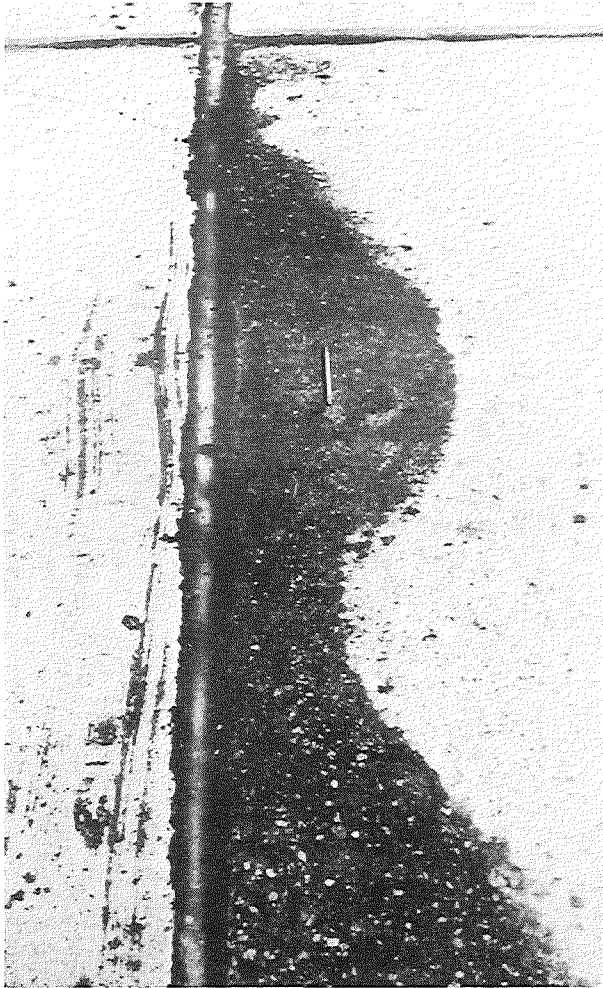
▲ FIGURE 21. BRAND D; IN GOOD  
CONDITION AT 2 1/2 YEARS.

condition. Transverse joints and open cracks containing Brands D, E and F were still well sealed with no apparent failures of any kind, while the longitudinal joint and the closed cracks were still maintaining an excellent seal regardless of the brand of sealer used. Typical condition of joints sealed with the six different brands of material are shown in the photographs of Figures 18 through 23, taken during the third survey in March, 1956.

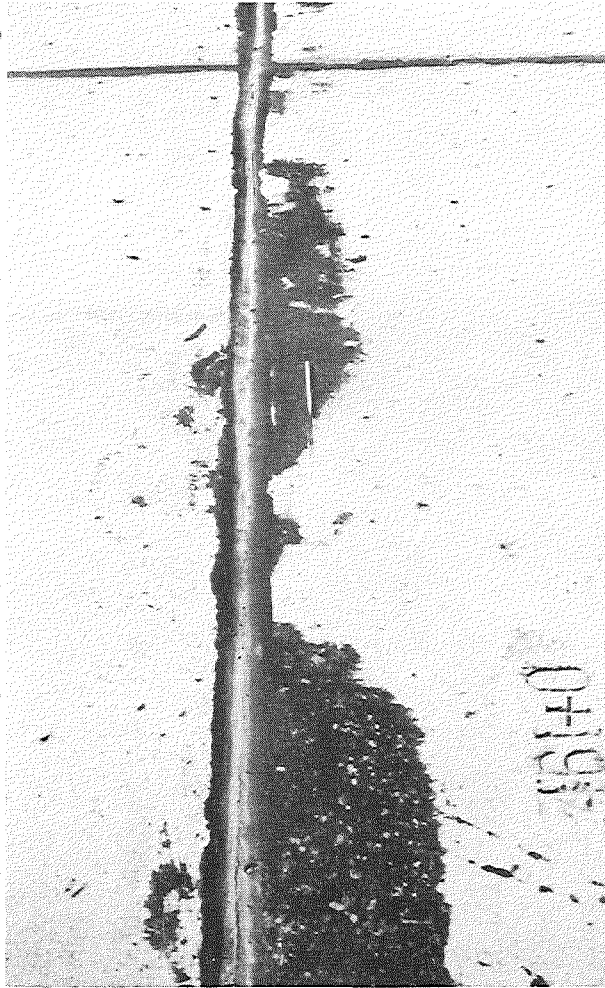
▲ FIGURE 22. BRAND E ; IN GOOD  
CONDITION AT 2 1/2 YEARS.

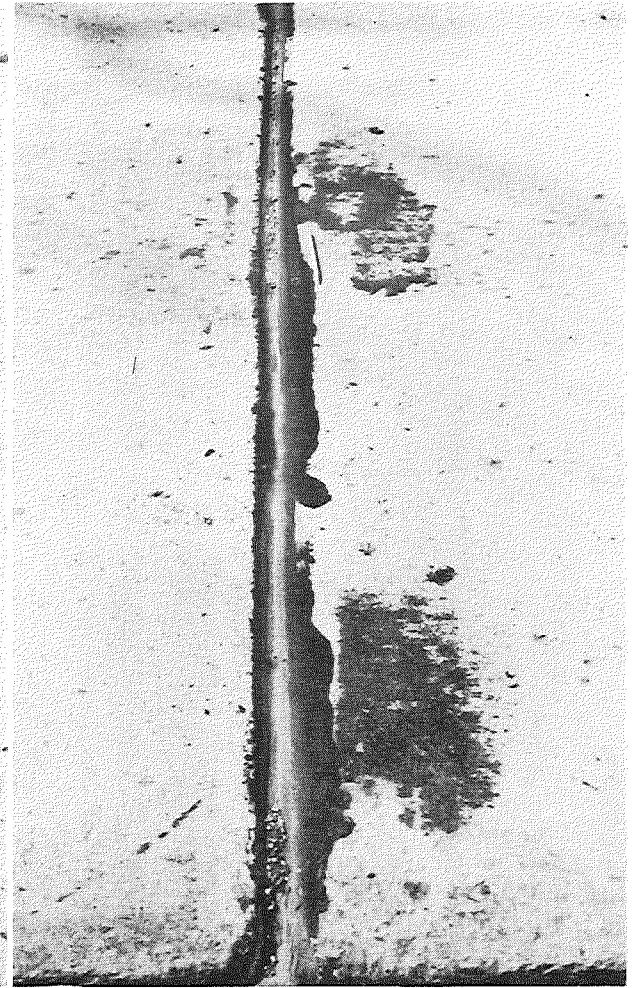
▲ FIGURE 23. BRAND F; IN GOOD  
CONDITION AT 2 1/2 YEARS.

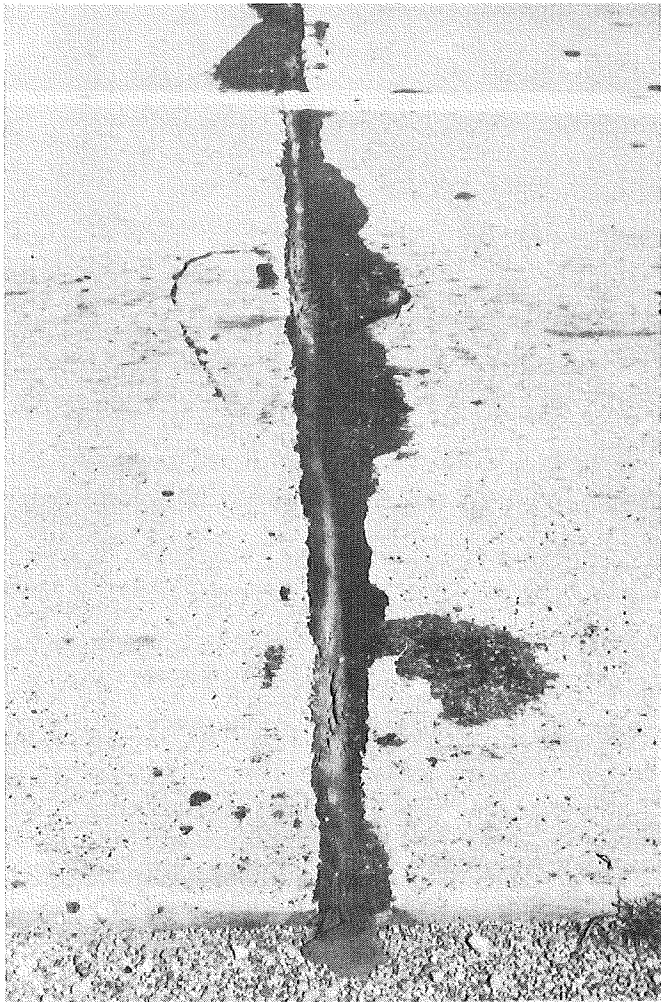
There was little change in the condition of the project when the fourth survey was made in October 1956, except what appeared to be a progression of failure in the Brand C material, Figure 24. On closer examination, however, it was found that the visible cracking and wrinkling of the sealer extended only slightly below the surface, with the seal still intact.

FIGURE 24. TYPICAL OF SURFACE CRACKING AND WRINKLING OF BRAND C AT 3 YEARS. SEAL STILL INTACT.

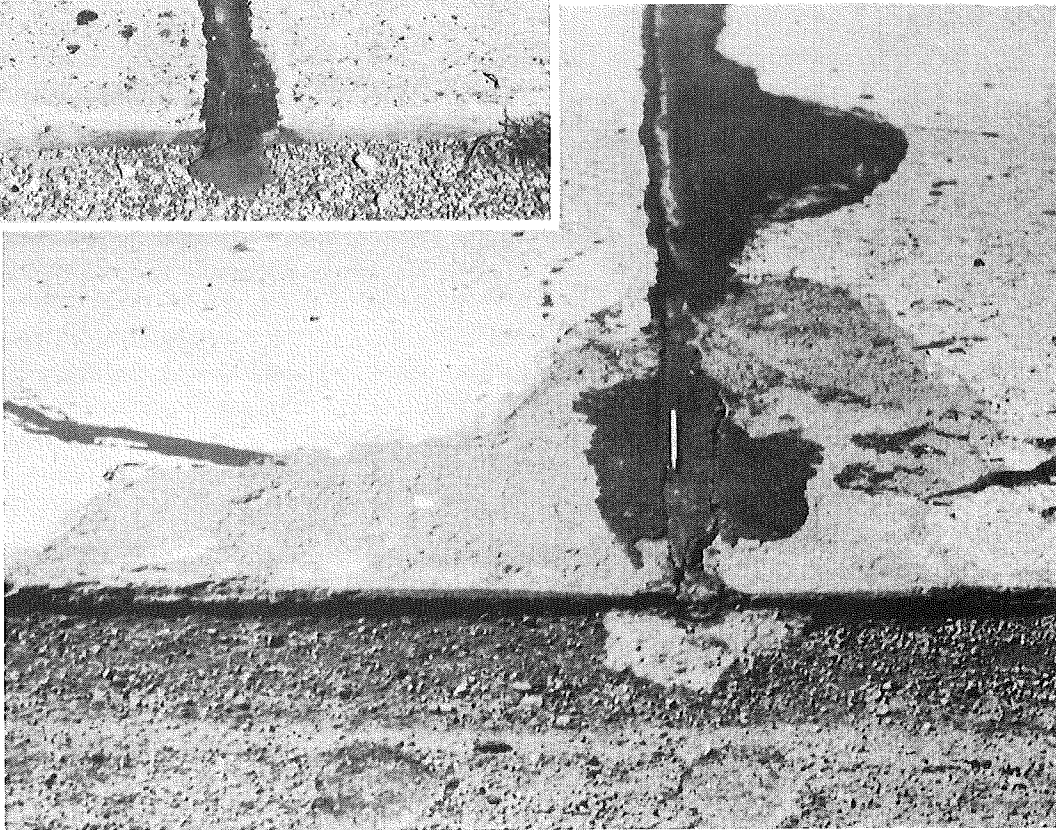
The concrete patches still remained bonded to the old concrete after 2-1/2 yr. and appeared to be sound, although some surface scaling was apparent (Figure 25).

FIGURE 25. REPAIRED CORNER BREAK AFTER 2 1/2 YEARS.
