**EXPERIMENTAL INSTALLATION OF
CHROME-ALLOY STEEL DOWELS**

J. E. Simonsen

Research Laboratory Section
Testing and Research Division
Research Project 63 F-75
Research Report No. R-979

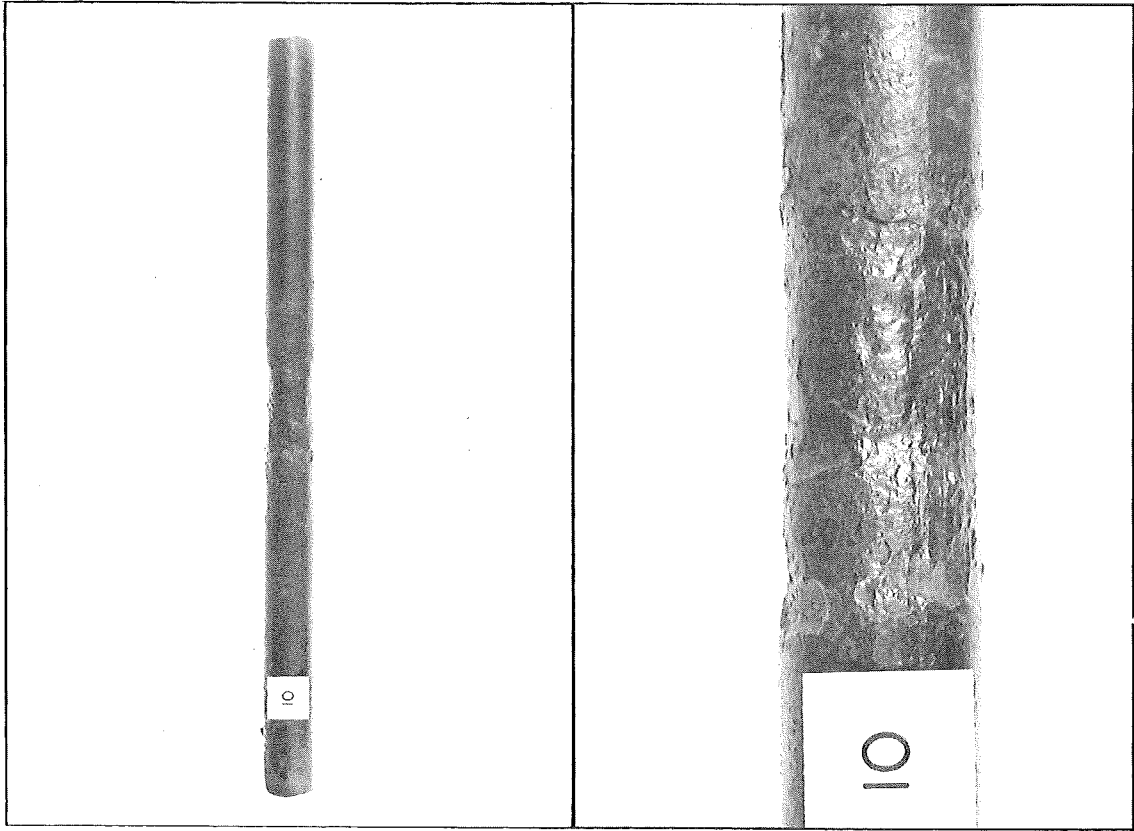
Dowel Bar Corrosion - Approximately two years after the pavements were constructed the condition of the dowels was examined by removing the seal and filler material above the dowels in expansion joints at two structures. Some rust and minor pitting were noted on both the chrome-alloy and standard dowels. In 1970 the outside dowel adjacent to the traffic lane shoulder was removed from a contraction joint on each project. Examination of the standard dowel revealed that the bar had corroded for a length of 1 to 2 in. in the joint crack area, and corrosion had penetrated to a depth of 3/32 in. at some spots in the corroded area (Fig. 2). The chrome-alloy dowel, shown in Figure 3, had a 2 to 2-1/2 in. length of corrosion in the joint crack area, and a maximum corrosion penetration of 1/8 in.

Figure 3. Corrosion condition of a six-year old chrome-alloy dowel removed from a contraction joint in the experimental pavement.

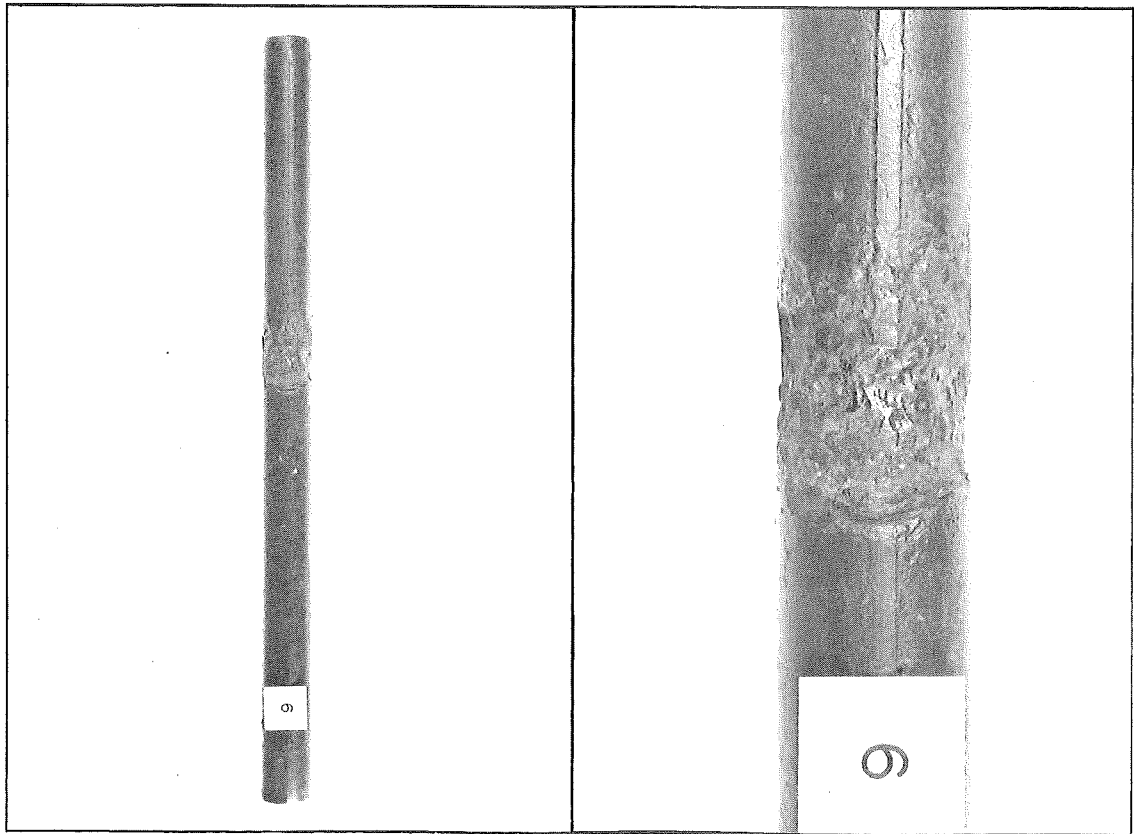
Figure 2. Corrosion condition of a six-year old standard dowel removed from a contraction joint in the control pavement.

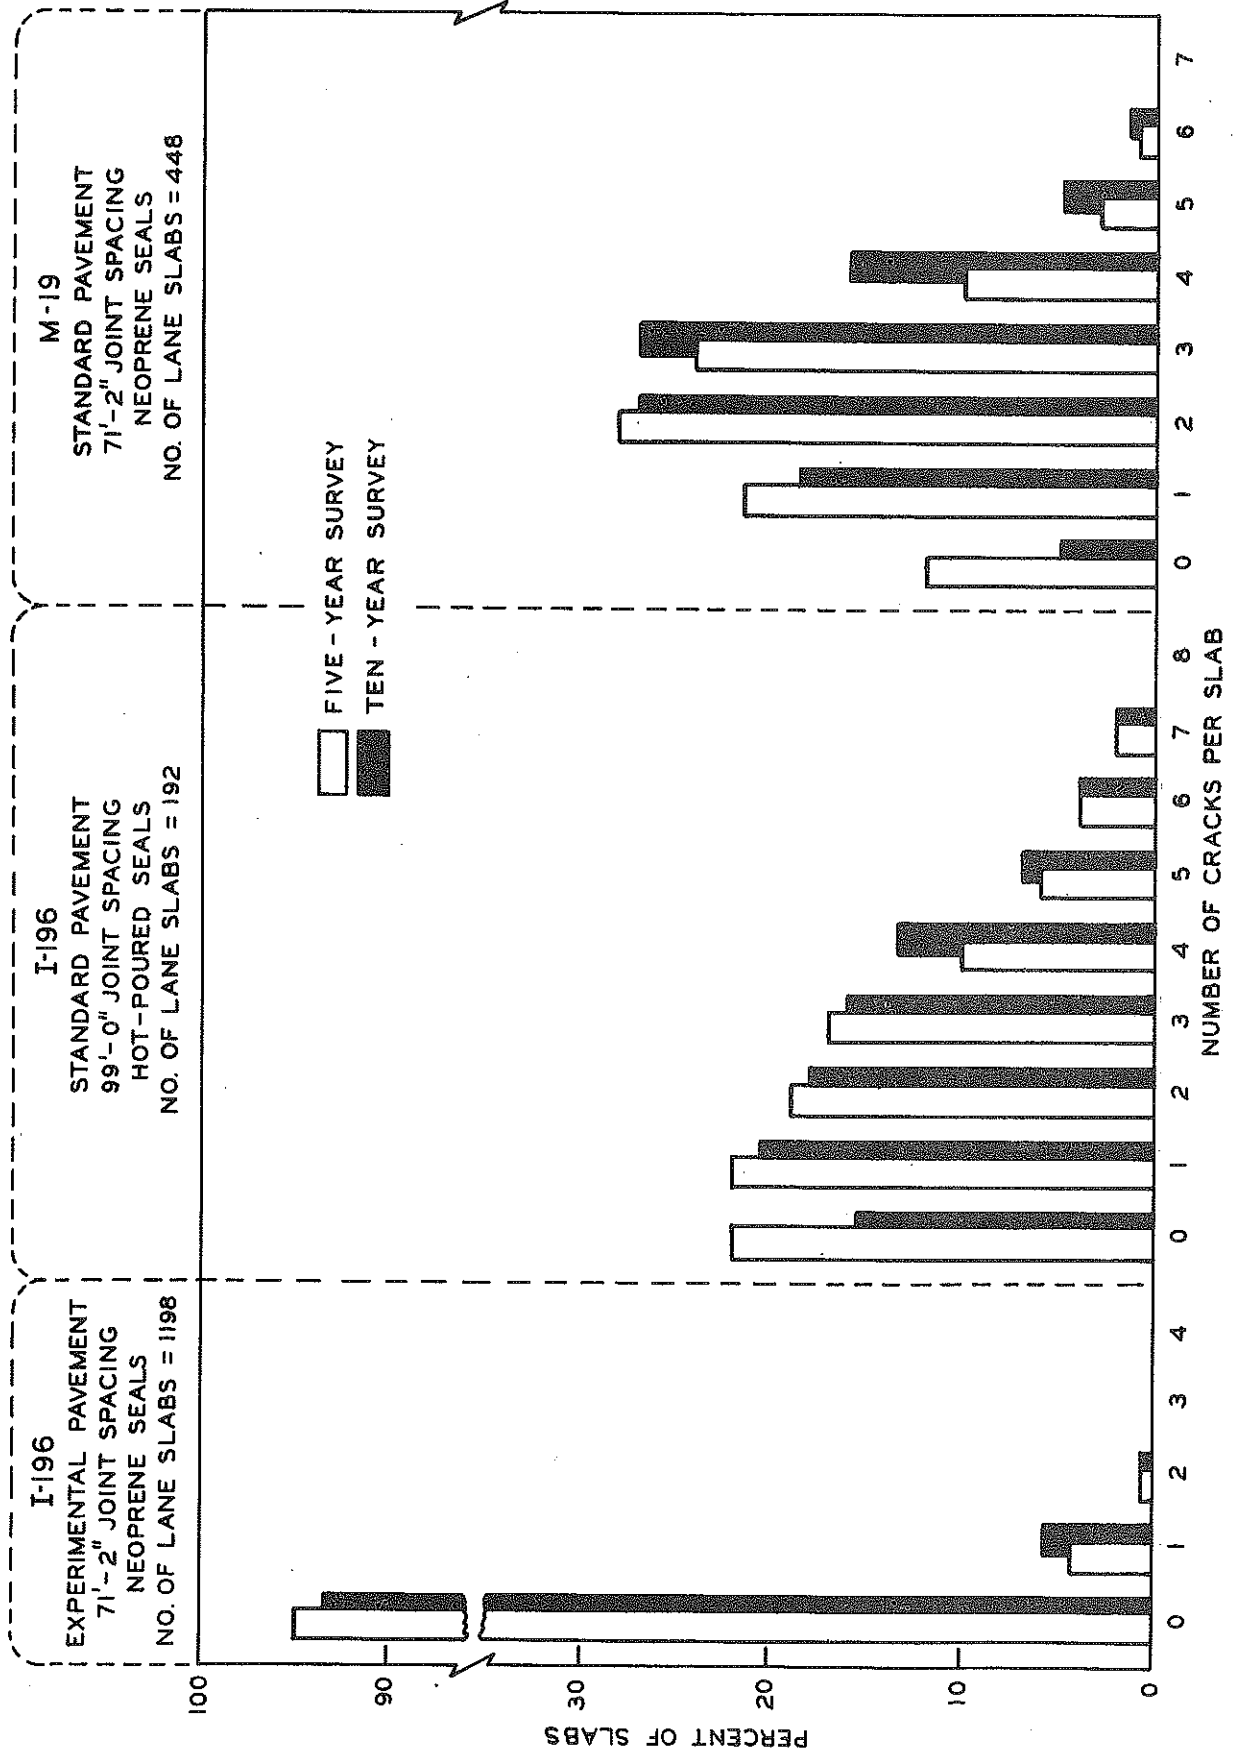
Transverse Slab Cracks - Dowel bar restraint along with loads, sub-grade support, concrete quality, and slab length affect the formation of transverse cracks. Isolation of the affect that each of these factors has on transverse slab cracking is not possible and, therefore, the results of five and 10 year crack surveys shown in Figure 4 must be interpreted with this in mind. Since the control section has 99-ft slab lengths, the results of crack surveys on M 19, which has the same slab lengths and seal type as the experimental pavement and is of the same age, have been included in Figure 4. The M 19 pavement (Project F 50092A, C1) is 1.4 miles long and is located between I 94 and New Haven in Macomb County.

It is of interest to note that after 10 years of service over 90 percent of the slabs joined with chrome-alloy dowels remain without cracks, whereas only 15 and 5 percent are uncracked on the control pavement and on the M 19 project, respectively. Also, the highest number of cracks in any slab was two on the experimental pavement, seven on the control project and six on the M 19 project. On the chrome-alloy project there is 0.07 cracks per slab after 10 years of service. On the standard project with 99-ft slabs there are 2.4 cracks per slab and on the standard pavement with 71-ft slabs, on M 19 there are 2.5 cracks per slab. The 10 year condition survey lists no joint repairs for the experimental pavement but shows 12 lane repairs on the control section, and two lane repairs on the M 19 project. The ADT counts indicate that M 19 carries only about one-half of the traffic compared to the I 196 projects.

Figure 4. Histograms of transverse cracks per slab for experimental and standard pavements after five and ten years of service.

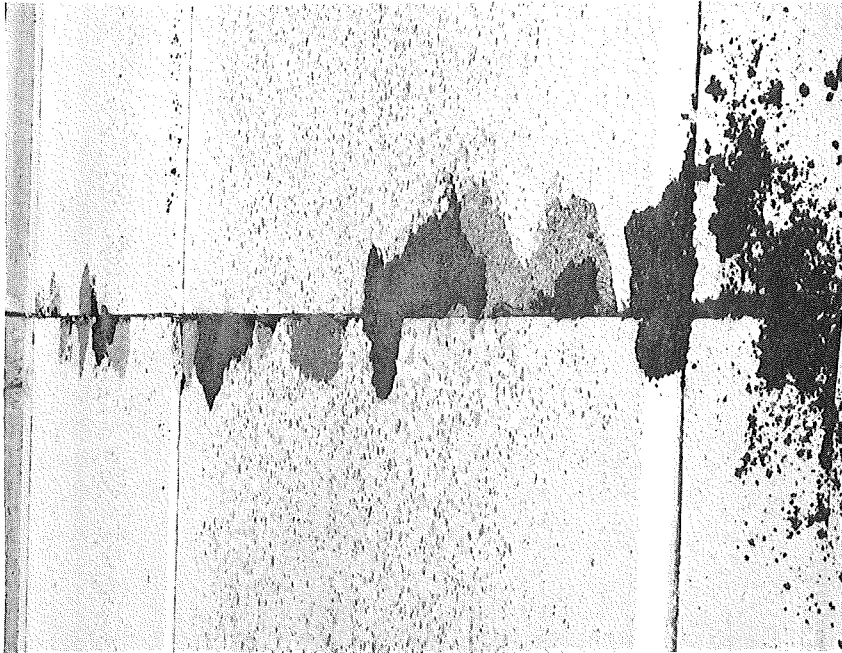
The design requirement for expansion joints at structures, at P.T.s, at ramp gores, etc., necessitated the installation of 77 expansion joints on the eastbound roadway and 72 on the westbound roadway. These expansion joints have undoubtedly contributed to the excellent performance of the pavement by relieving the compression in the slab. However, the compressive forces have now closed some of the expansion joints to the point where the neoprene seal is solid and severe spalling is occurring (Fig. 5). On a recent survey a total of 12 joints, six on each roadway were found to have spalled to the extent shown.

3. Severe spalling at some expansion joints is a sign of large compressive forces building up in the pavement which could cause joint failures to occur soon. The loss of more than 10 percent of the contraction joint neoprene seals results in infiltration of incompressible materials into the open plane-of-weakness cracks, further aggravating the problem of excessive slab compression.

Figure 5. Condition of expansion joint where compressive forces have caused spalling to occur.

2. The spalled expansion joints be replaced to provide new expansion space.

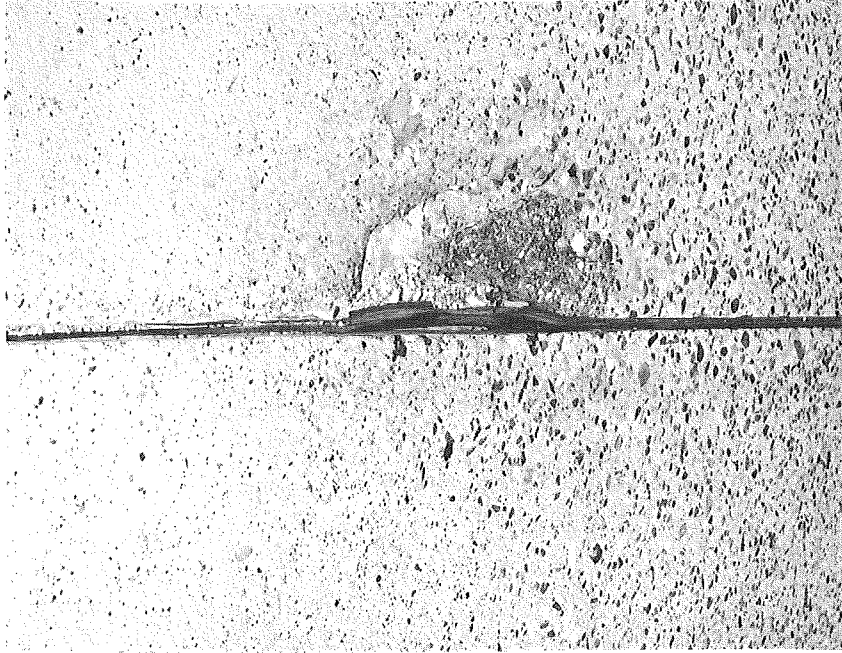
Another joint problem is the loss of seals in contraction joints. Currently, there are 67 joints with missing neoprene seals. Most of these seals are lost from joints near expansion joints. For example, 31 seals are missing in joints adjacent to expansion joints, and 17 are missing from the second joint following an expansion joint. The reason for losing the contraction joint seals near expansion joints is that the slabs compressive forces are smallest at these locations and, consequently, when the slab contracts, larger joint openings will occur, as compared to locations where the compressive forces are larger. Spalling along the joint groove can also result in the loss of seals. As shown in Figure 6, a spall may result in the seal losing its compression and eventually traffic will tear the seal apart and out of the groove. Regardless of which way the seals are lost, the result is that the open plane-of-weakness crack fills with incompressible materials. As a result the compressive forces increase more rapidly to the point where joint failures may occur.

Figure 6. Neoprene seal being torn apart by traffic in a spalled area.

1. The experimental section be used in a study to determine procedures for resealing joints with missing seals and where spalling has resulted in loss of compression in the seals.
