# OFFICE MEMORANDUM

MICHIGAN  
DEPARTMENT OF STATE HIGHWAYS

March 30, 1967

Subject: Driving Performance of Aluminum Delineator Posts. Research Project  
65 NM-145. Research Report No. 629.

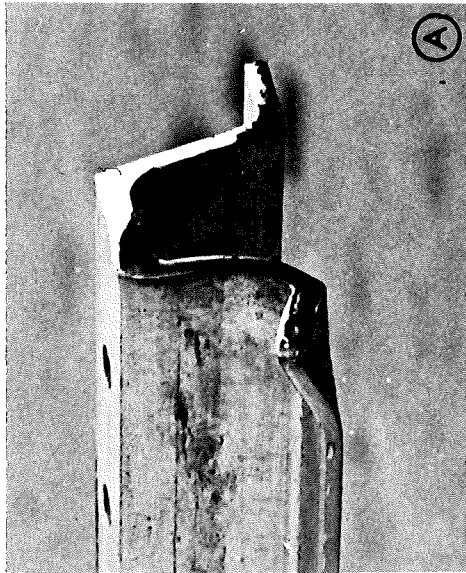
Driven in unfrozen sand

Figure 1. Conditions observed after driving under conditions indicated, included a) distorted end with bent flange, slight crushing of edges, and darkening where hammer contacted end; b) slight crushing when driven with steel cap; and c) bent flanges and typical crushing.

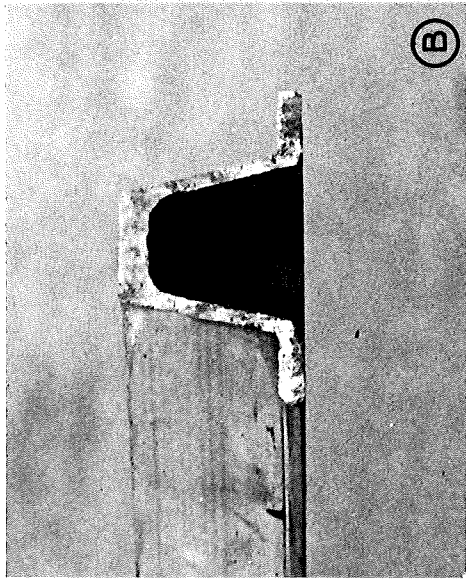
According to Maintenance personnel, Sites 3 and 4 represent the most extreme soil condition encountered when installing delineator posts. Five posts were driven at each site, except at Site 2 where only four were installed. All posts were driven with an air hammer without much difficulty, but distortion of the driving end of the post resulted in all cases (Fig. 1A), attributed mostly to unequal distribution of driving force on the post end. To minimize damage to the driving end of the post, the Reynolds representative furnished a steel driving cap. Although the cap was too large to fit in the air hammer guide, one post was driven at Site 1 with a sledge hammer to observe the benefit of using a cap. Only very slight crushing of the edges occurred (Fig. 1B).

Driven in unfrozen sand

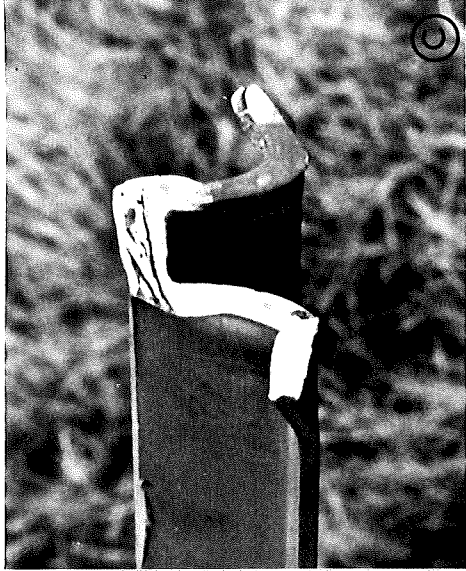
Severest installation damage occurred at Sites 3 and 4. Figure 1C illustrates typical distortion of posts driven under the conditions previously described for these sites. Examination of the bottom end of each post after removal revealed blunted end points and in some cases bent flanges (Fig. 2). End points driven in sand or unfrozen clay for all practical purposes suffered no damage.

Driven in frozen sand over clay or in frozen clay

In view of the uncertainties concerning overall performance of aluminum delineator posts, and because it appears that installation damage occurs even in relatively soft soil (using our present hammers), we recommend that use of this type of post be held in abeyance until further performance data are available.

We suggest that the shipment at Saginaw be accepted for use in an experimental installation. If such an installation is to be made, a new type of driving attachment would need to be developed, and periodic inspection of an equal number of posts of both types would be required. It would also be beneficial to install a considerable number of these posts during the next winter to evaluate any new driving attachment under the most severe conditions. Posts installed during the summer could be inspected for vandalism and snow removal damage.

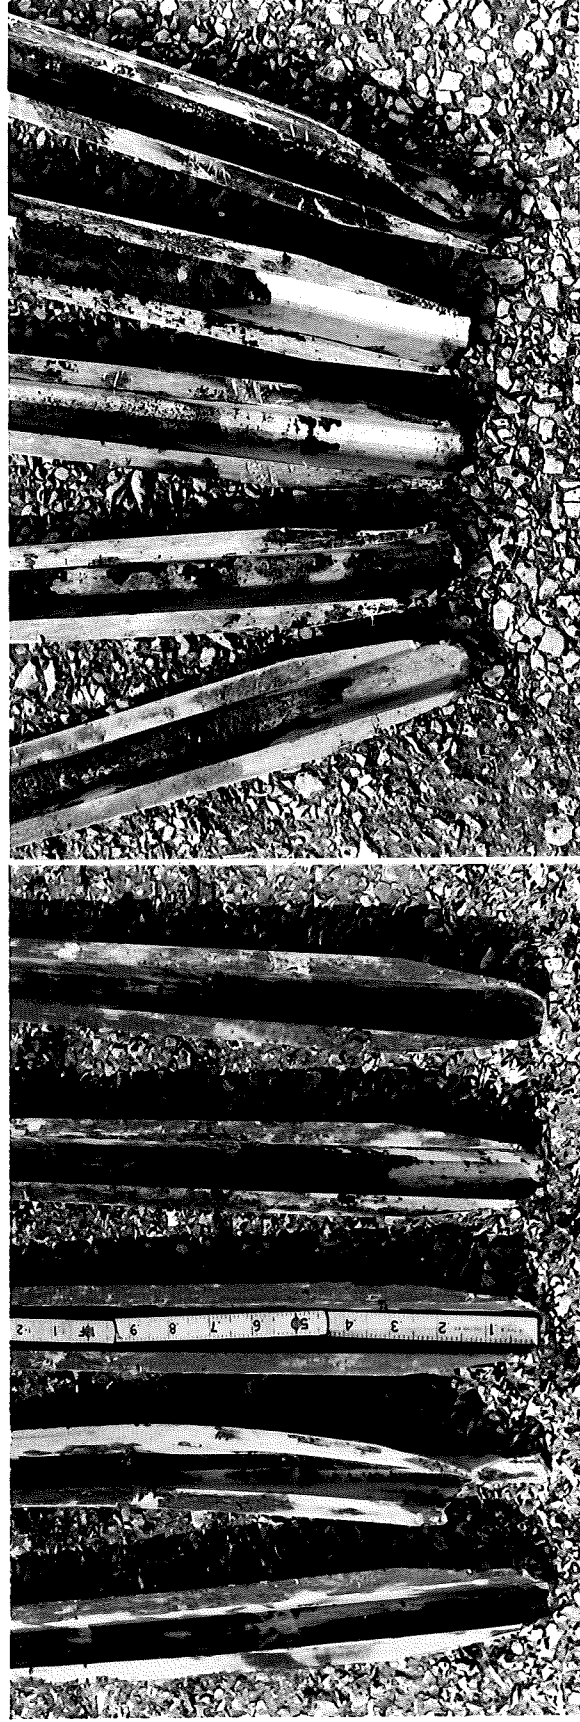
Figure 2. Condition of driving points of posts.

Site 3

Site 4
