MICHIGAN
DEPARTMENT OF STATE HIGHWAYS

Subject: 1971 Performance Tests of "Fast-Dry" White Pavement Marking Paints. Research Project 47 G-36 (24a). Research Report No. R-798.

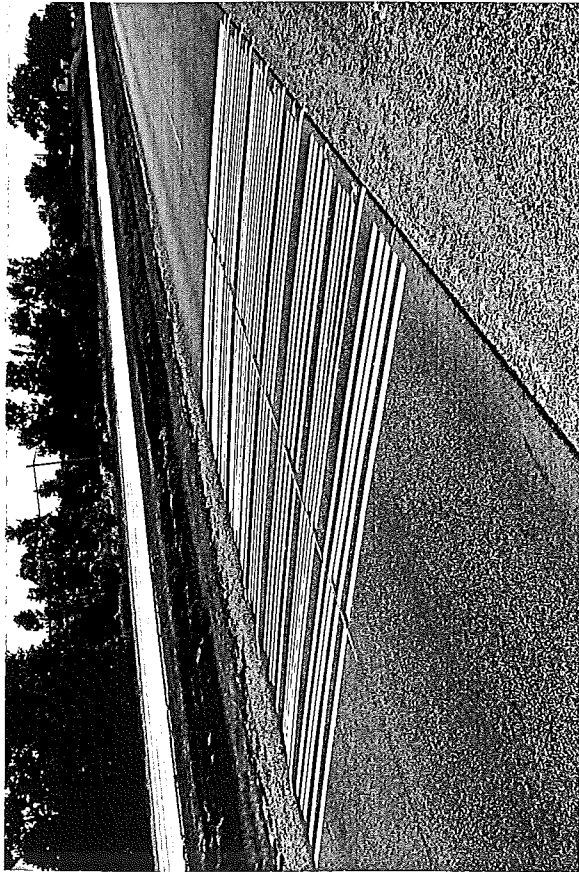
Figure 1. General initial appearance of test performance stripes on bituminous pavement of WB M 78, near Lake Lansing Rd.

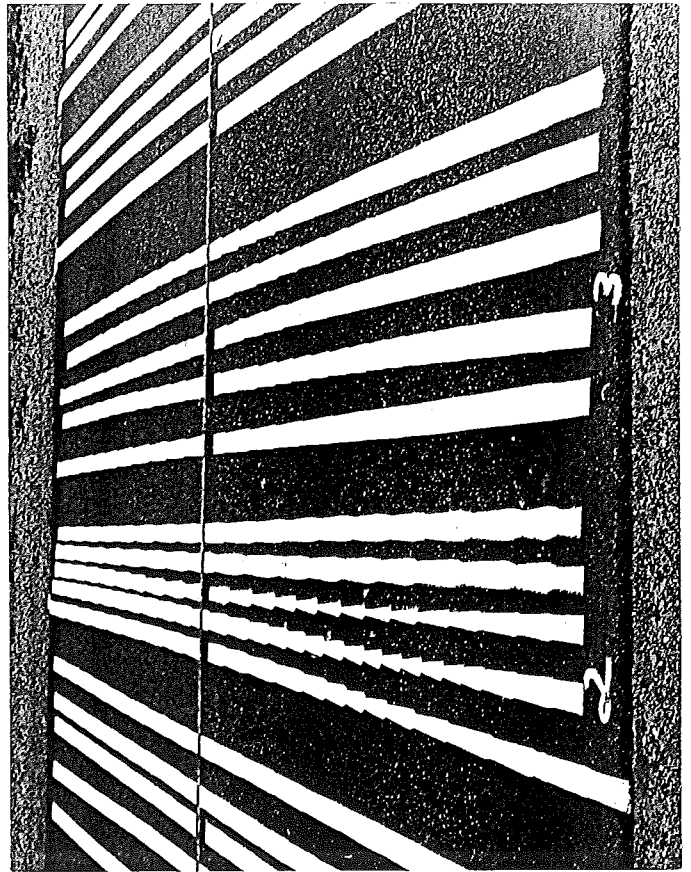
³ Paint was difficult to apply in test equipment, yielding varying width stripes, though application was satisfactory in roadway striping equipment.

Figure 3. Detailed initial appearance shows stripe-width surges laid-down by spray equipment; very distinct on set No. 2, less distinct on No. 3. Bordering sets Nos. 1 and 4 appear OK, on the bituminous area.

The applicator consisted of a Grayco, portable, airless, hot-spray equipment utilizing a 30 to 1 pressure ratio. The spray gun tip was marked No. 163-323. The heater, a recirculating type, was rated 2100 watts on 110 ac, with a thermometer range of 0-250 F. The equipment was a fortuitous pick-up from the Department's excess property. Subsequently, a holding tank for glass beads and a bead spray-gun were added to the equipment, shown in Figure 2. As used, the equipment did not contain the precise controls for film thickness and bead ratio as the applicator for test regular-dry paints, but the consensus was that it did the job, especially considering its initial use. (Measurements taken on bituminous striping with a gage indicated a 15 to 17 mil wet thickness for all). Some improvements will be incorporated in the equipment to eliminate the stripe-width surges that were produced on several paints in this year's tests (Fig. 3).

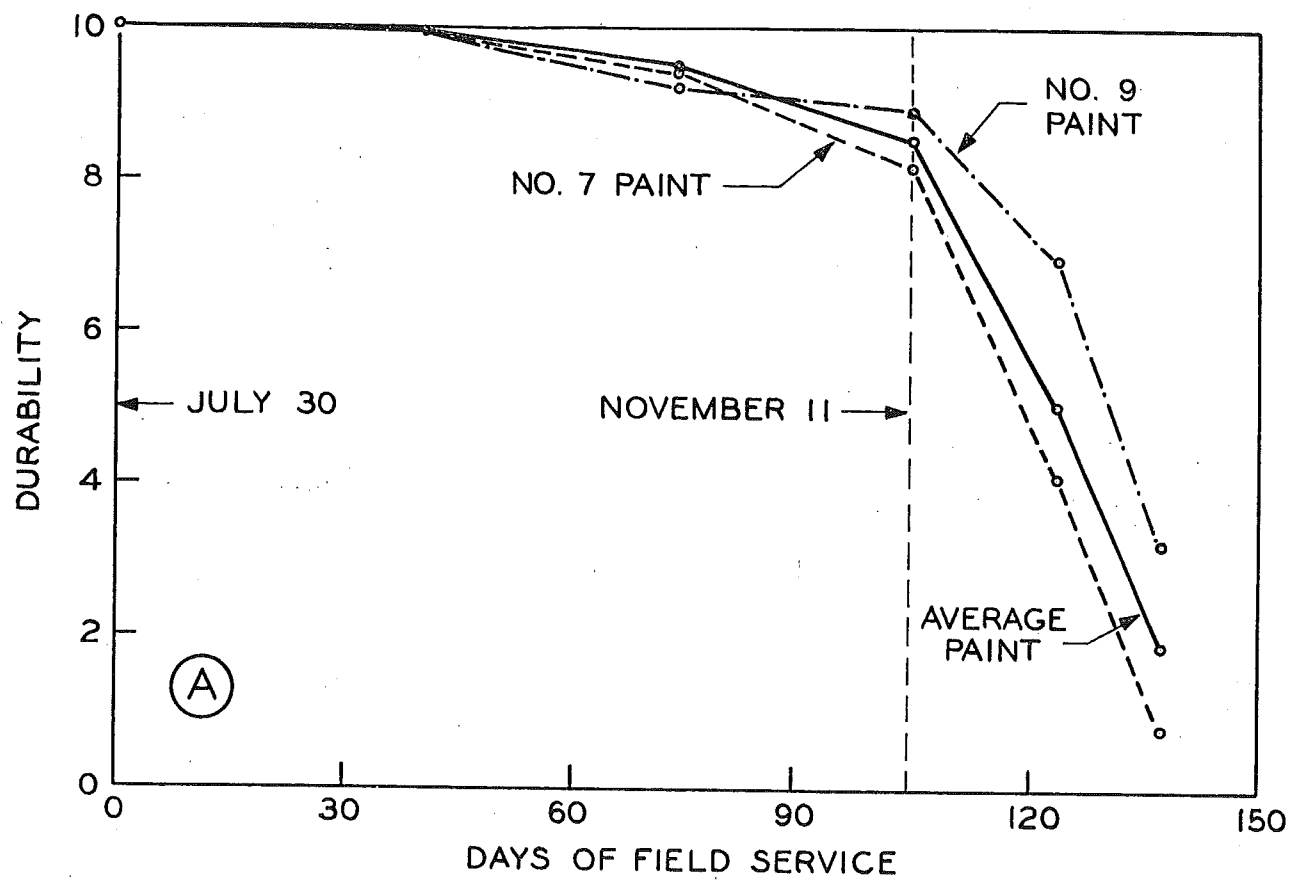
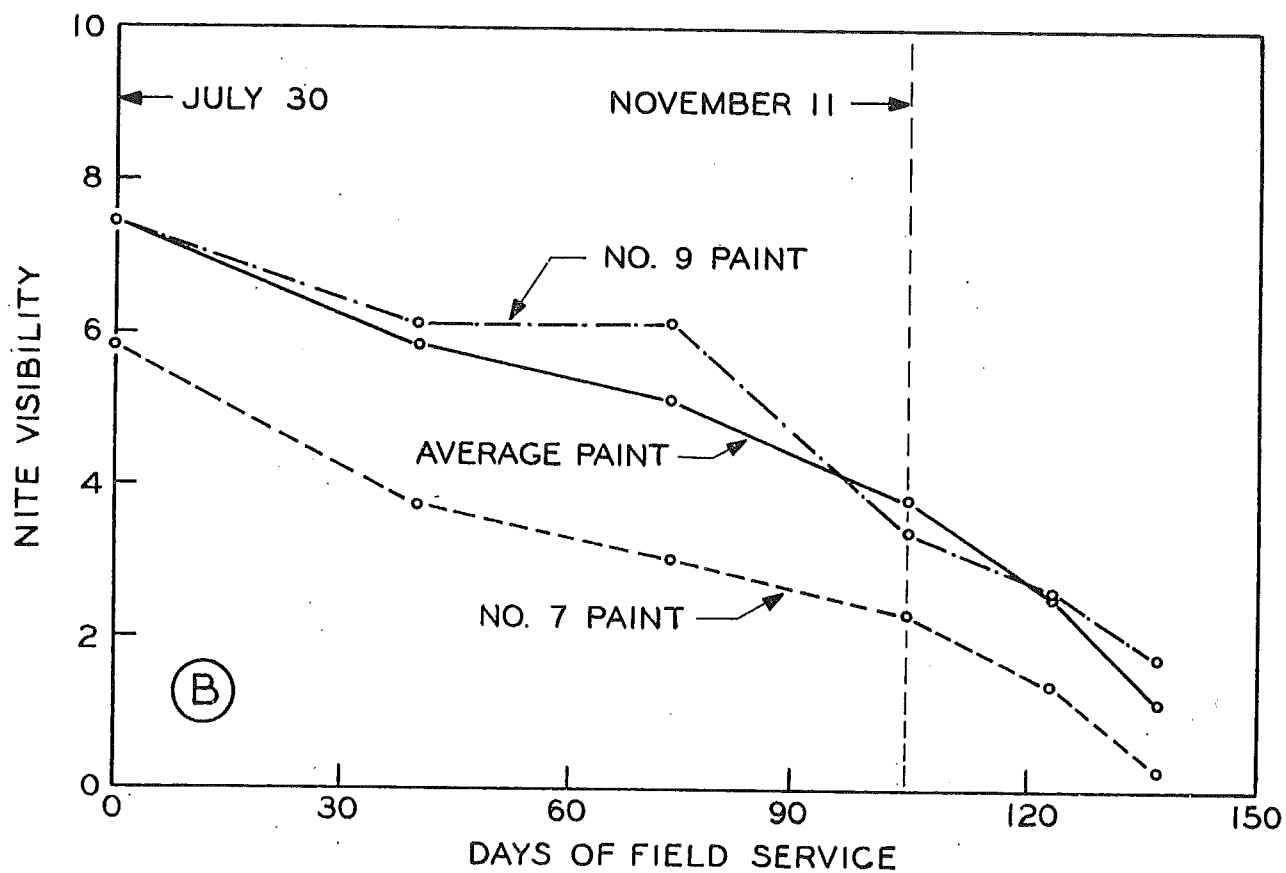
In an effort to discern differences in performance of the test paints, the rating intervals were shortened during the November-December period when studded tires begin appearing on vehicles. How these tires and the accompanying winter weather deteriorate the paint stripes can be discerned in graphs of Figures 4a plotting durability against exposure time for an average of all the paints, and for one of the better performers and one of the poorer performers. Actually, the fast deterioration of the paint stripes after the November 11 rating can be ascribed mostly to studded tires, though winter weather is tougher on paint stripes than summer weather as can be seen in comparable graphs of paint stripe performance in reports before 1968. The accompanying night visibility values for the same paints are graphed in Figure 4b.

Figure 4. Field service for some test paints vs. durability and night visibility.

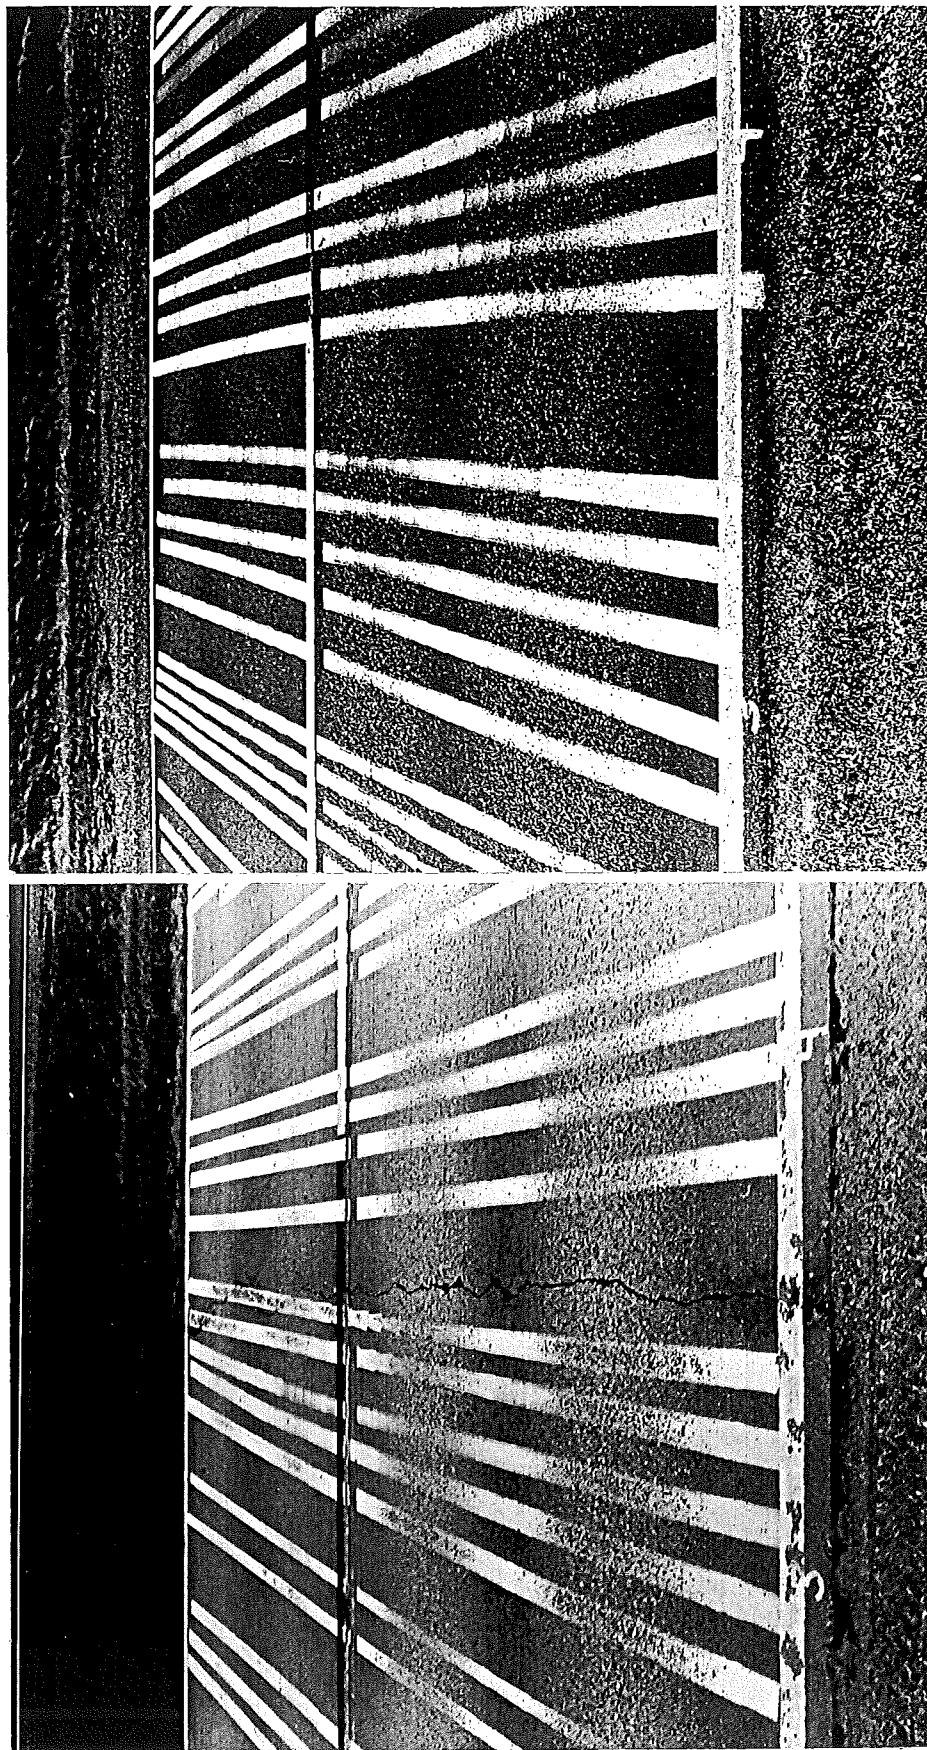
At the conclusion of the tests, the condition of the paint stripes was noticeably poorer on the concrete roadway than on the bituminous roadway across the road, as shown in Figure 5.

Figure 5. Condition of stripes after 139 days of service on M 78, a) concrete (left), and b) bituminous (right). The tire-track areas on the concrete show more deterioration than on bituminous for the same test paints.
