CRACKING OF CONCRETE PATCHES ON
PROJECT 49,7,C1, US 2, NORTH OF ST. IGNACE

E. A. Finney

Highway Research Project 44 G-27 (2)

Research Laboratory
Testing and Research Division
Report No. 105
December 15, 1947

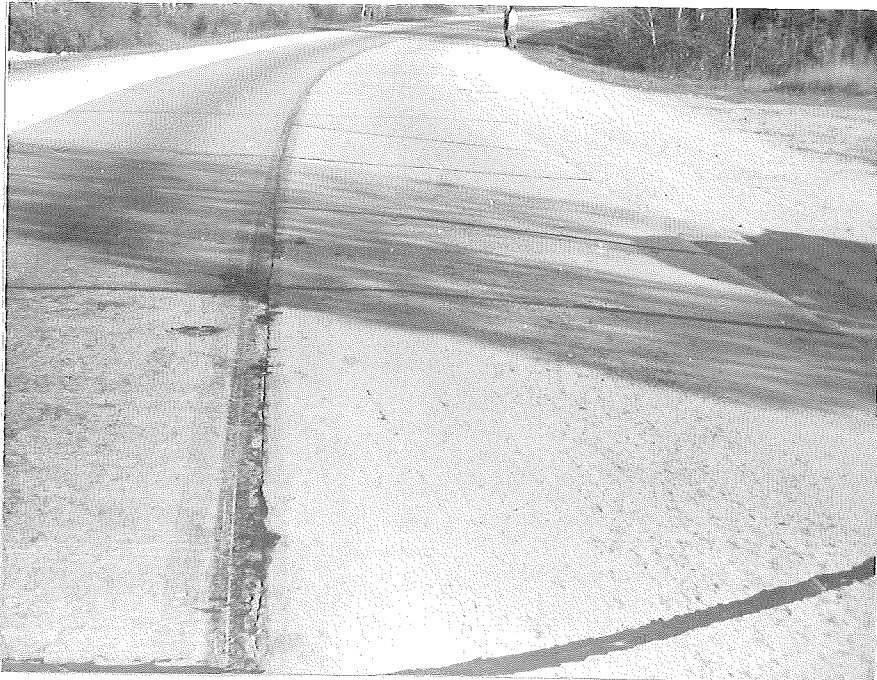
Figure 1. Cracking of patch in right lane at station 204+00 looking north. Note that cracks follow crack pattern in old concrete of adjacent left lane.

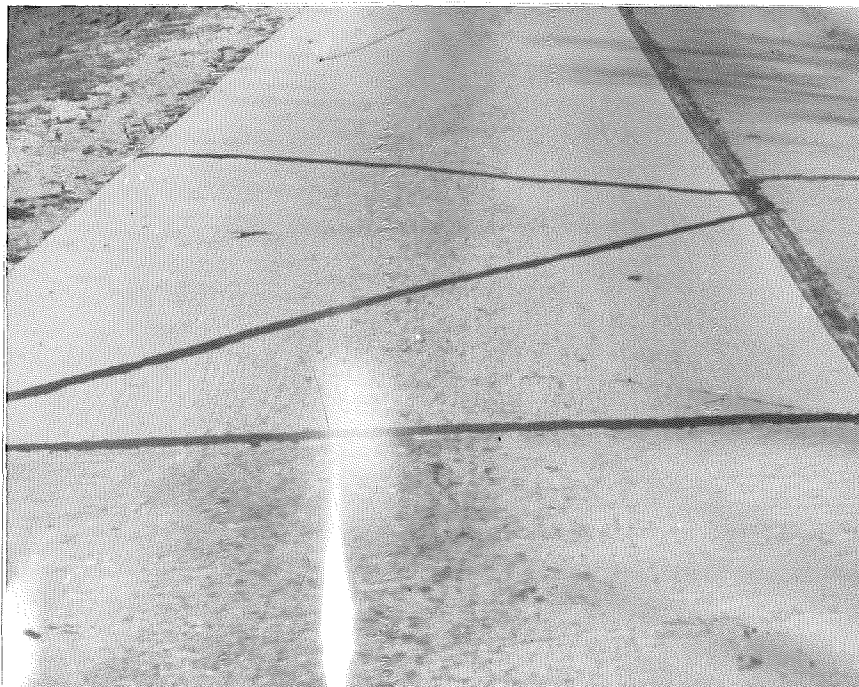
Figure 2. Diagonal and transverse cracking of new patch in left lane at Station 352+60 looking north.

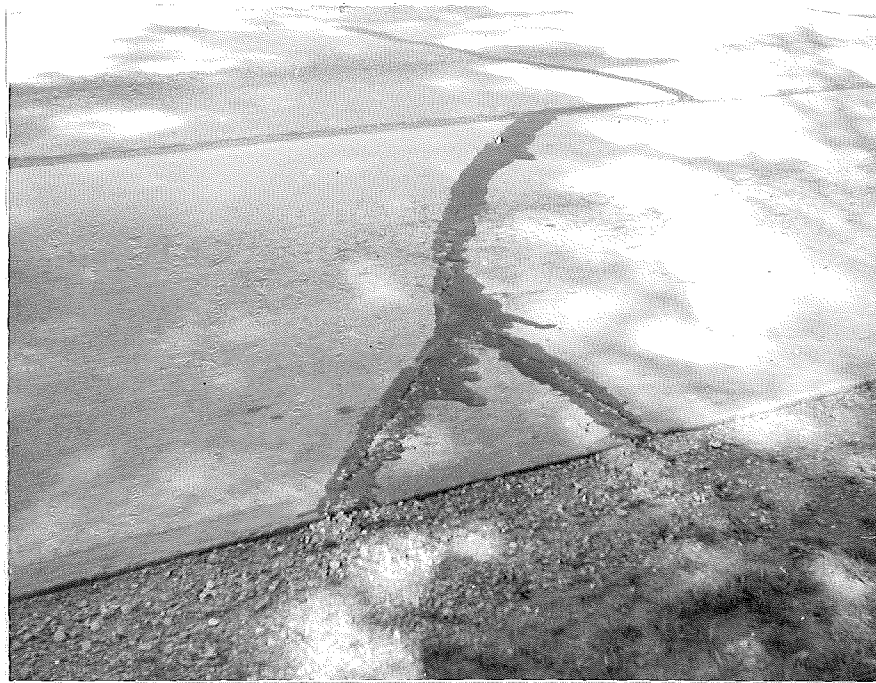
Figure 3. Cracking of new patch at Station 419+00 showing subsequent breaking out and faulting of section at slab edge.

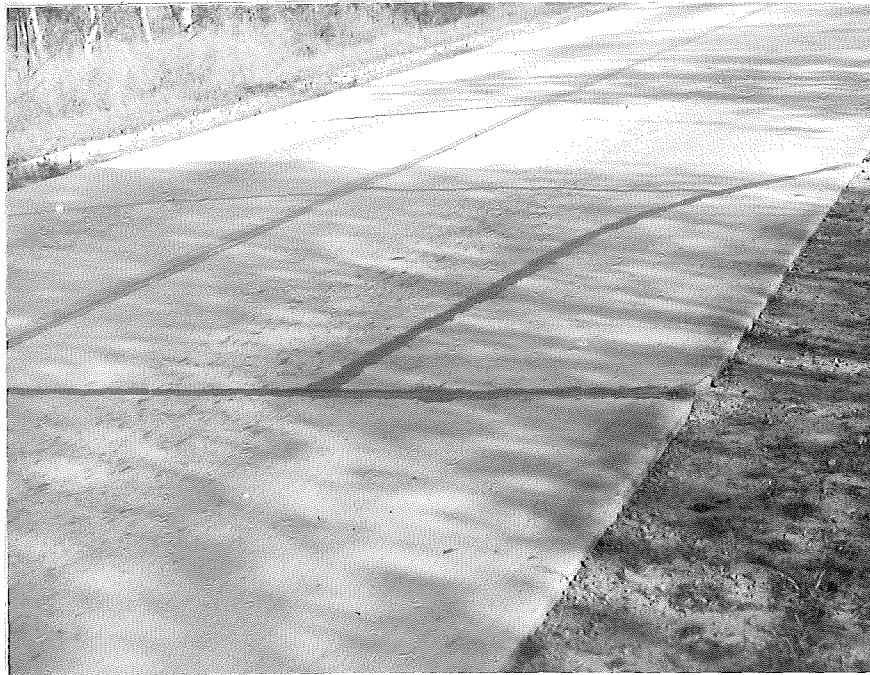
Figure 4. Corner break and transverse crack in patch right lane at Station 212+00 looking north.

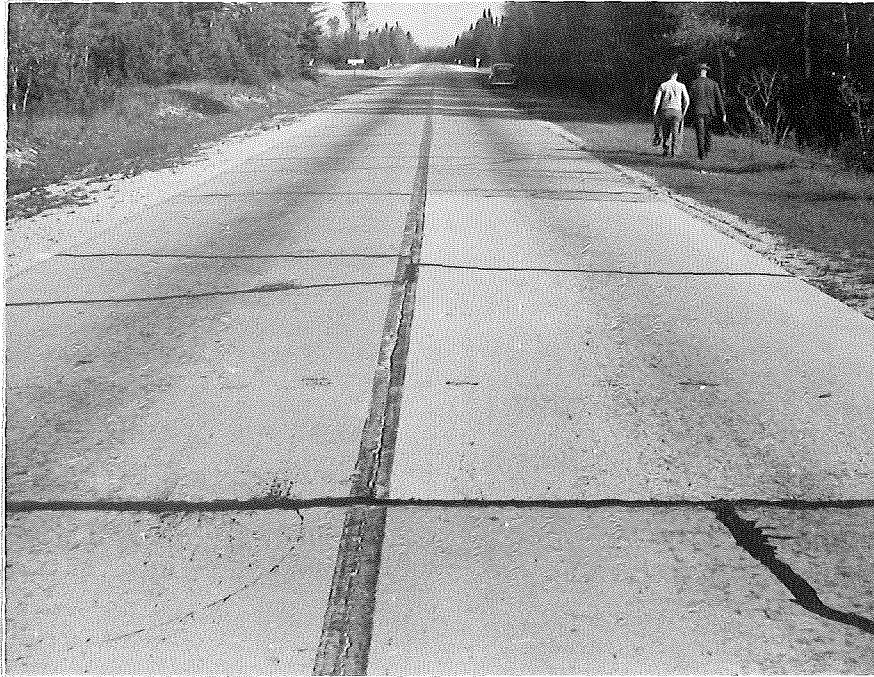
Figure 5. Cracking of new patch (on light area in right lane) in relation to cracking in old pavement. Station 416+80 looking north; end of project in distance.

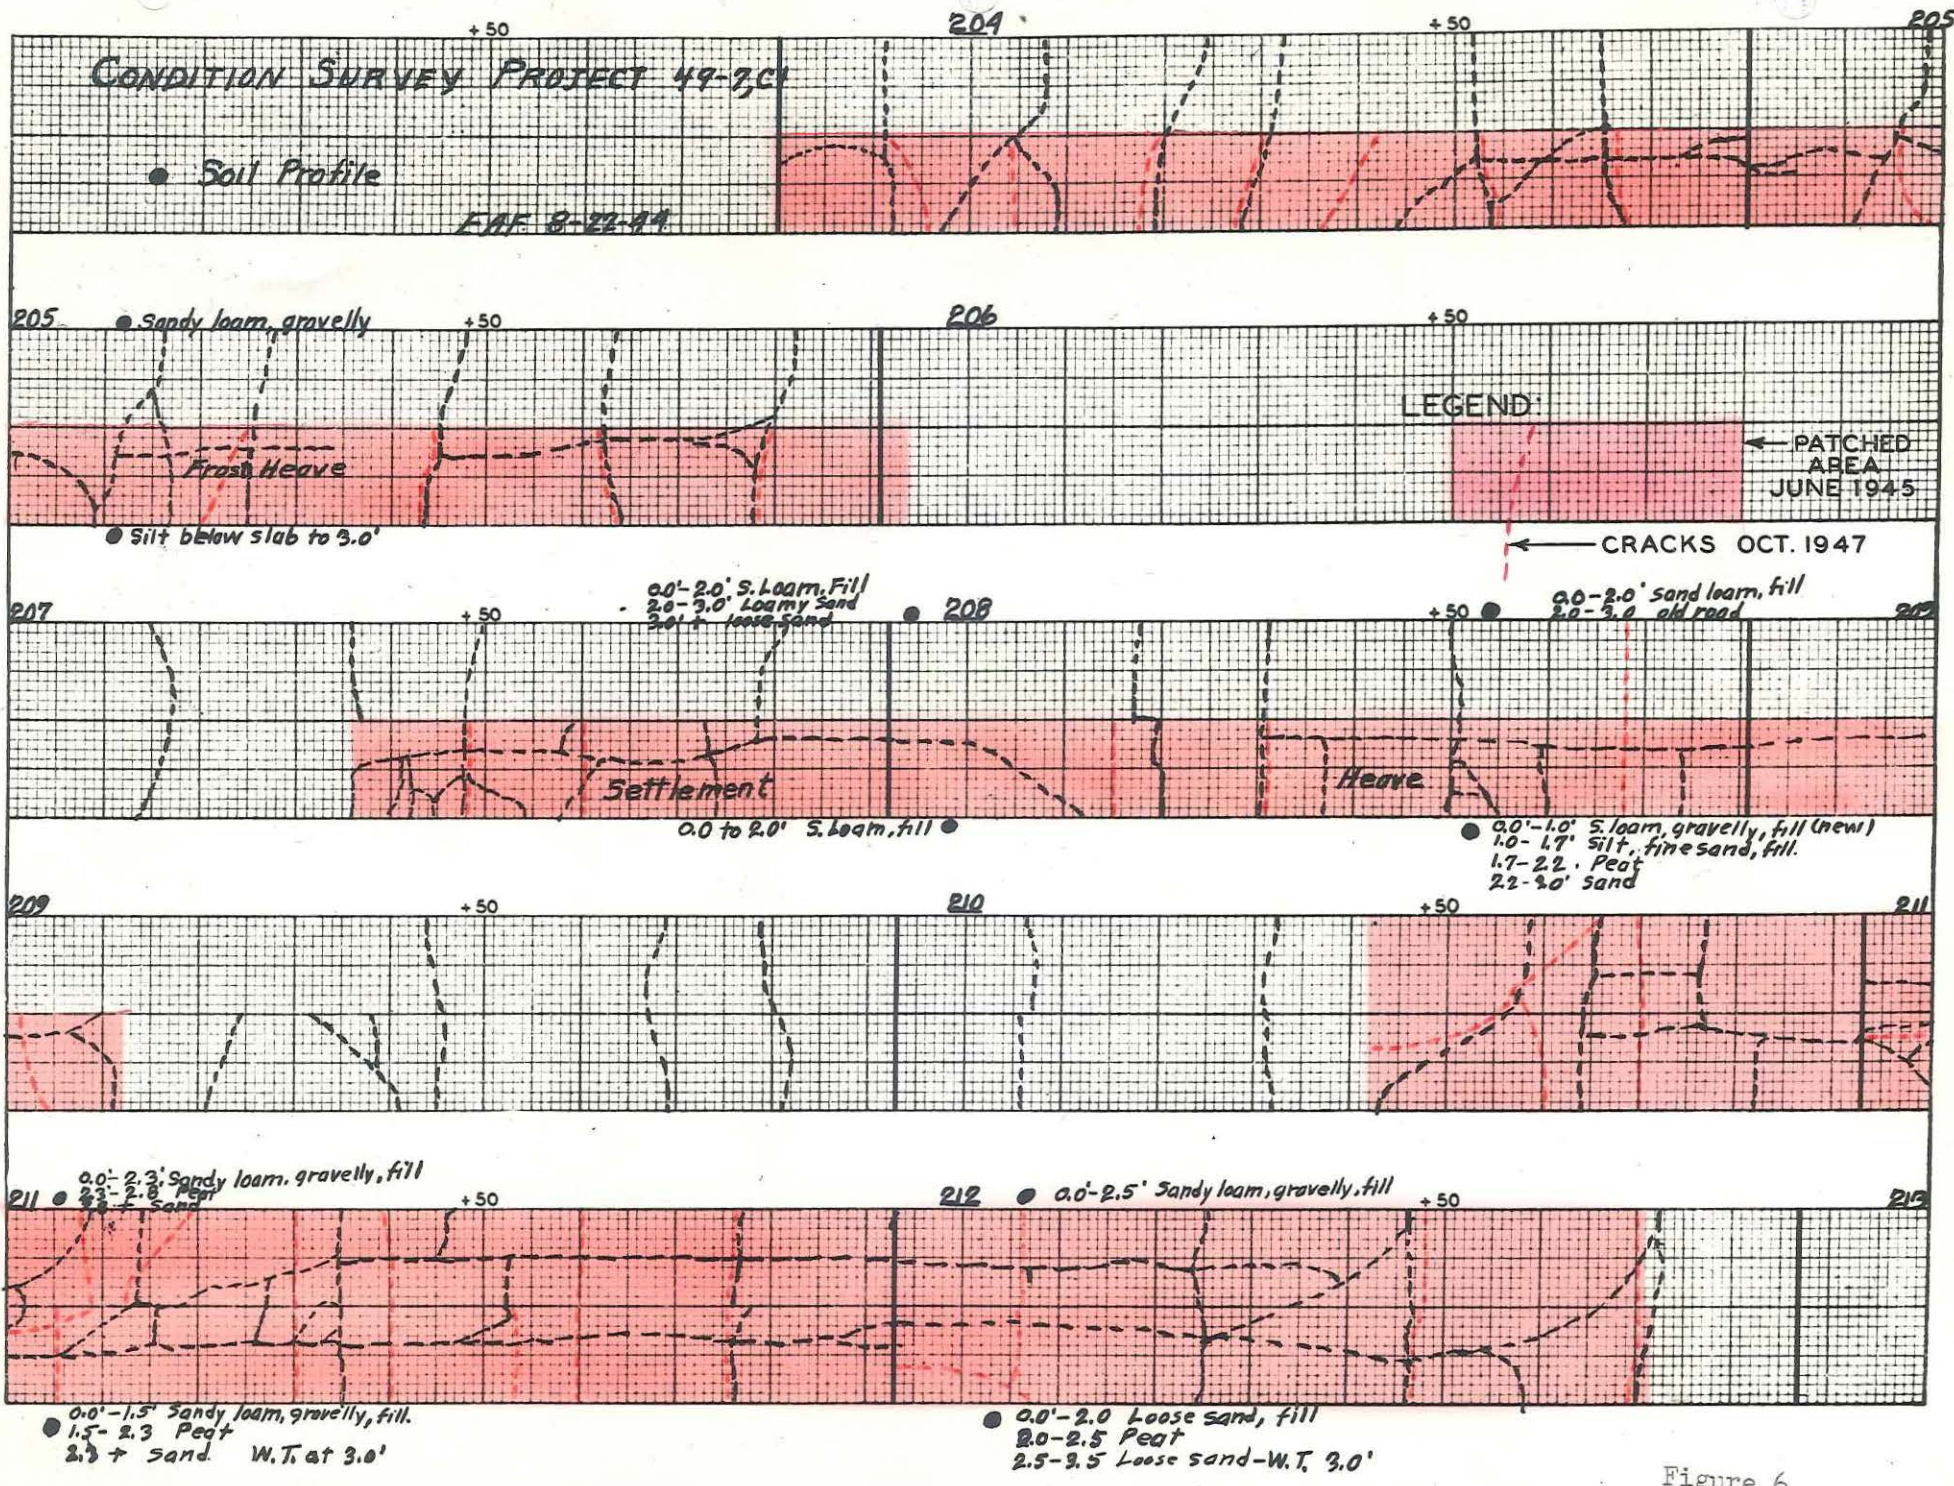
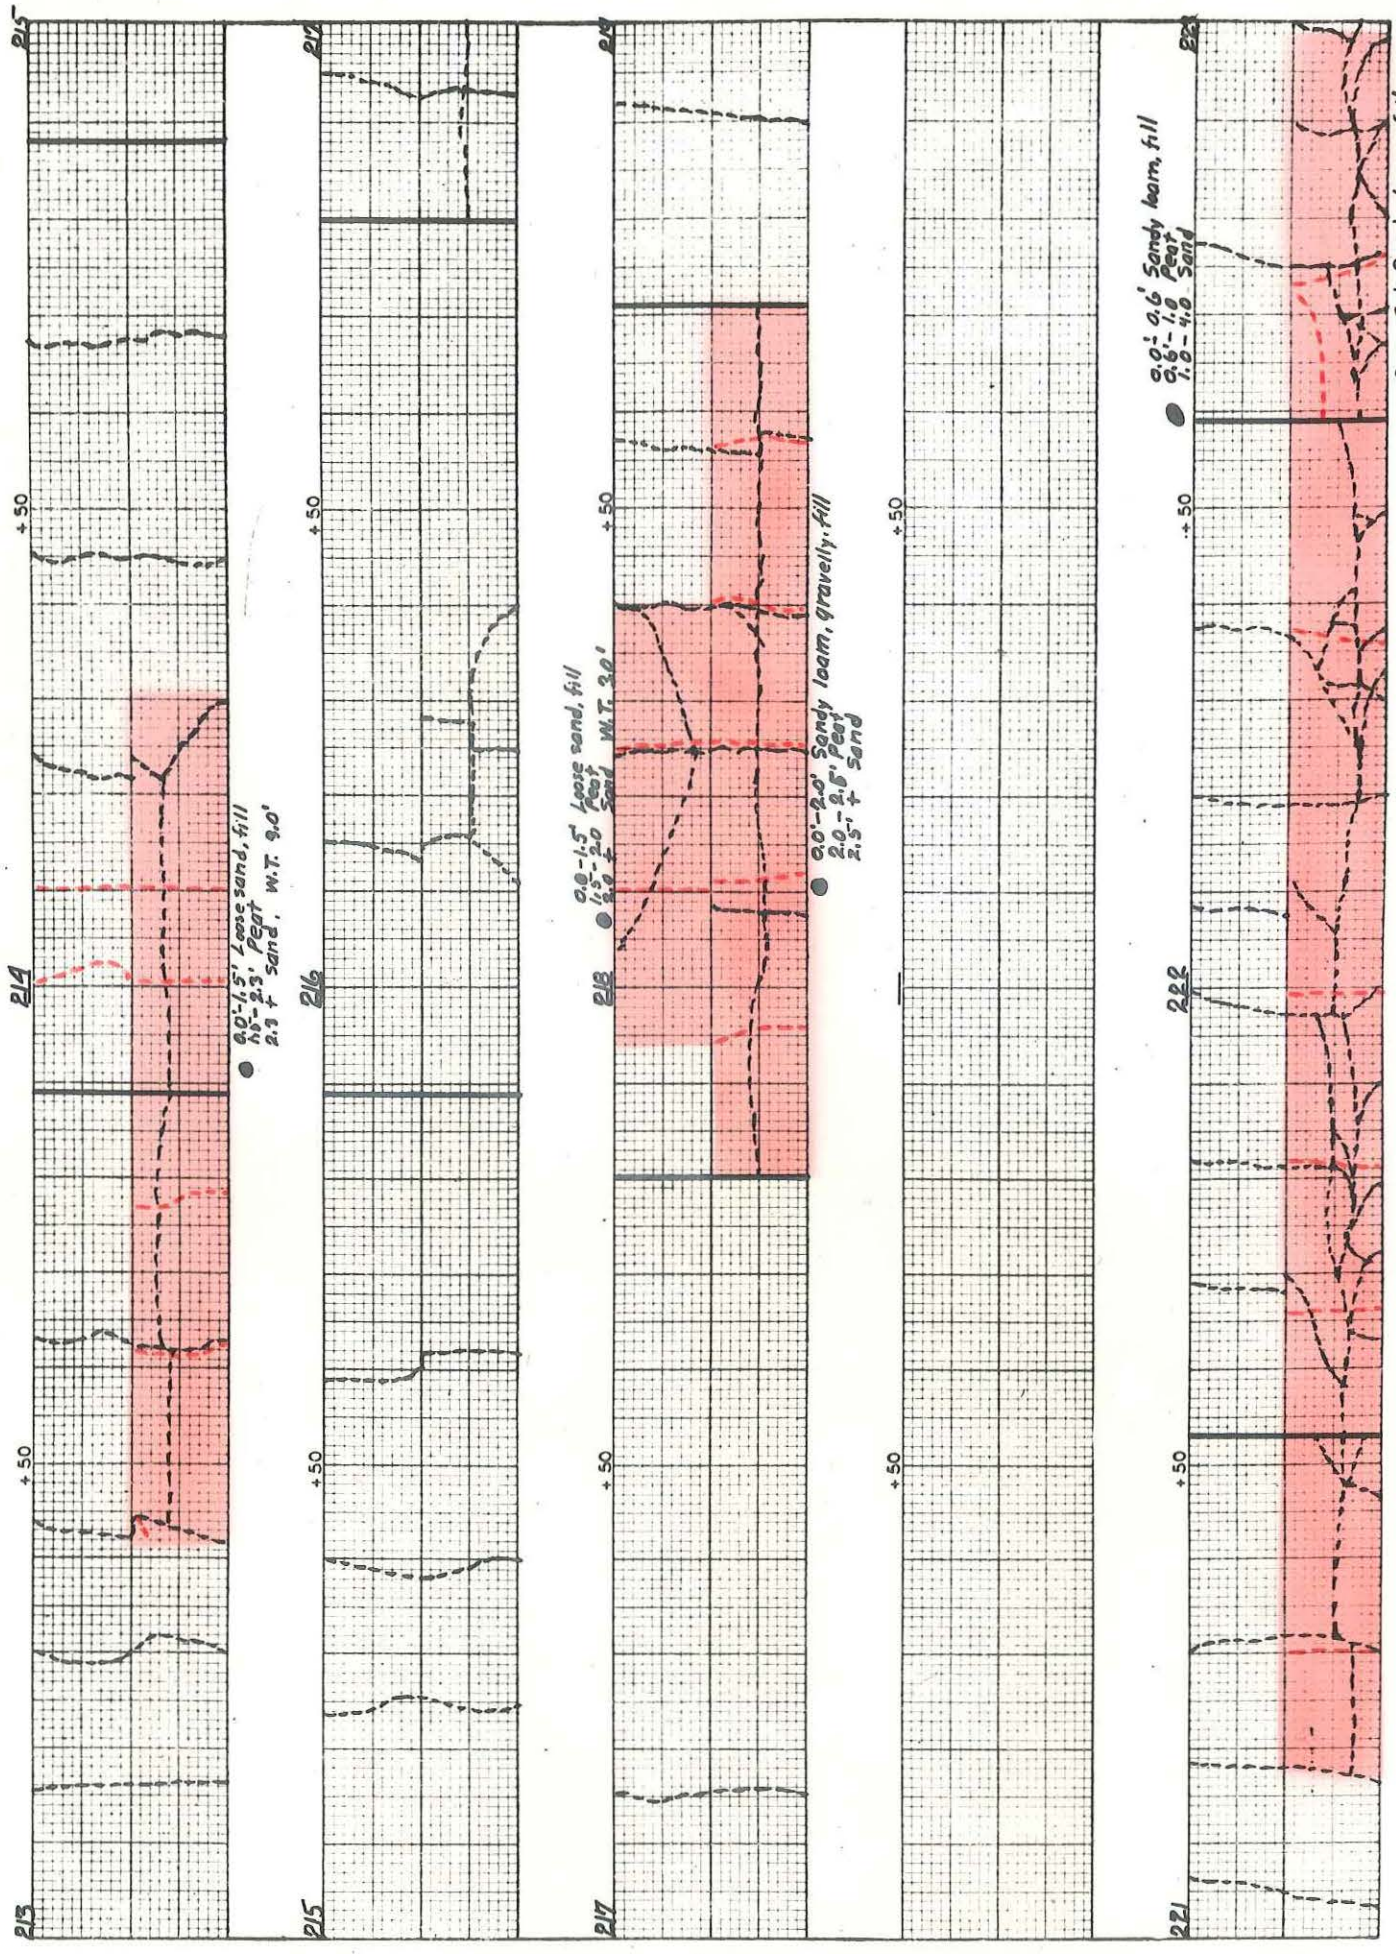
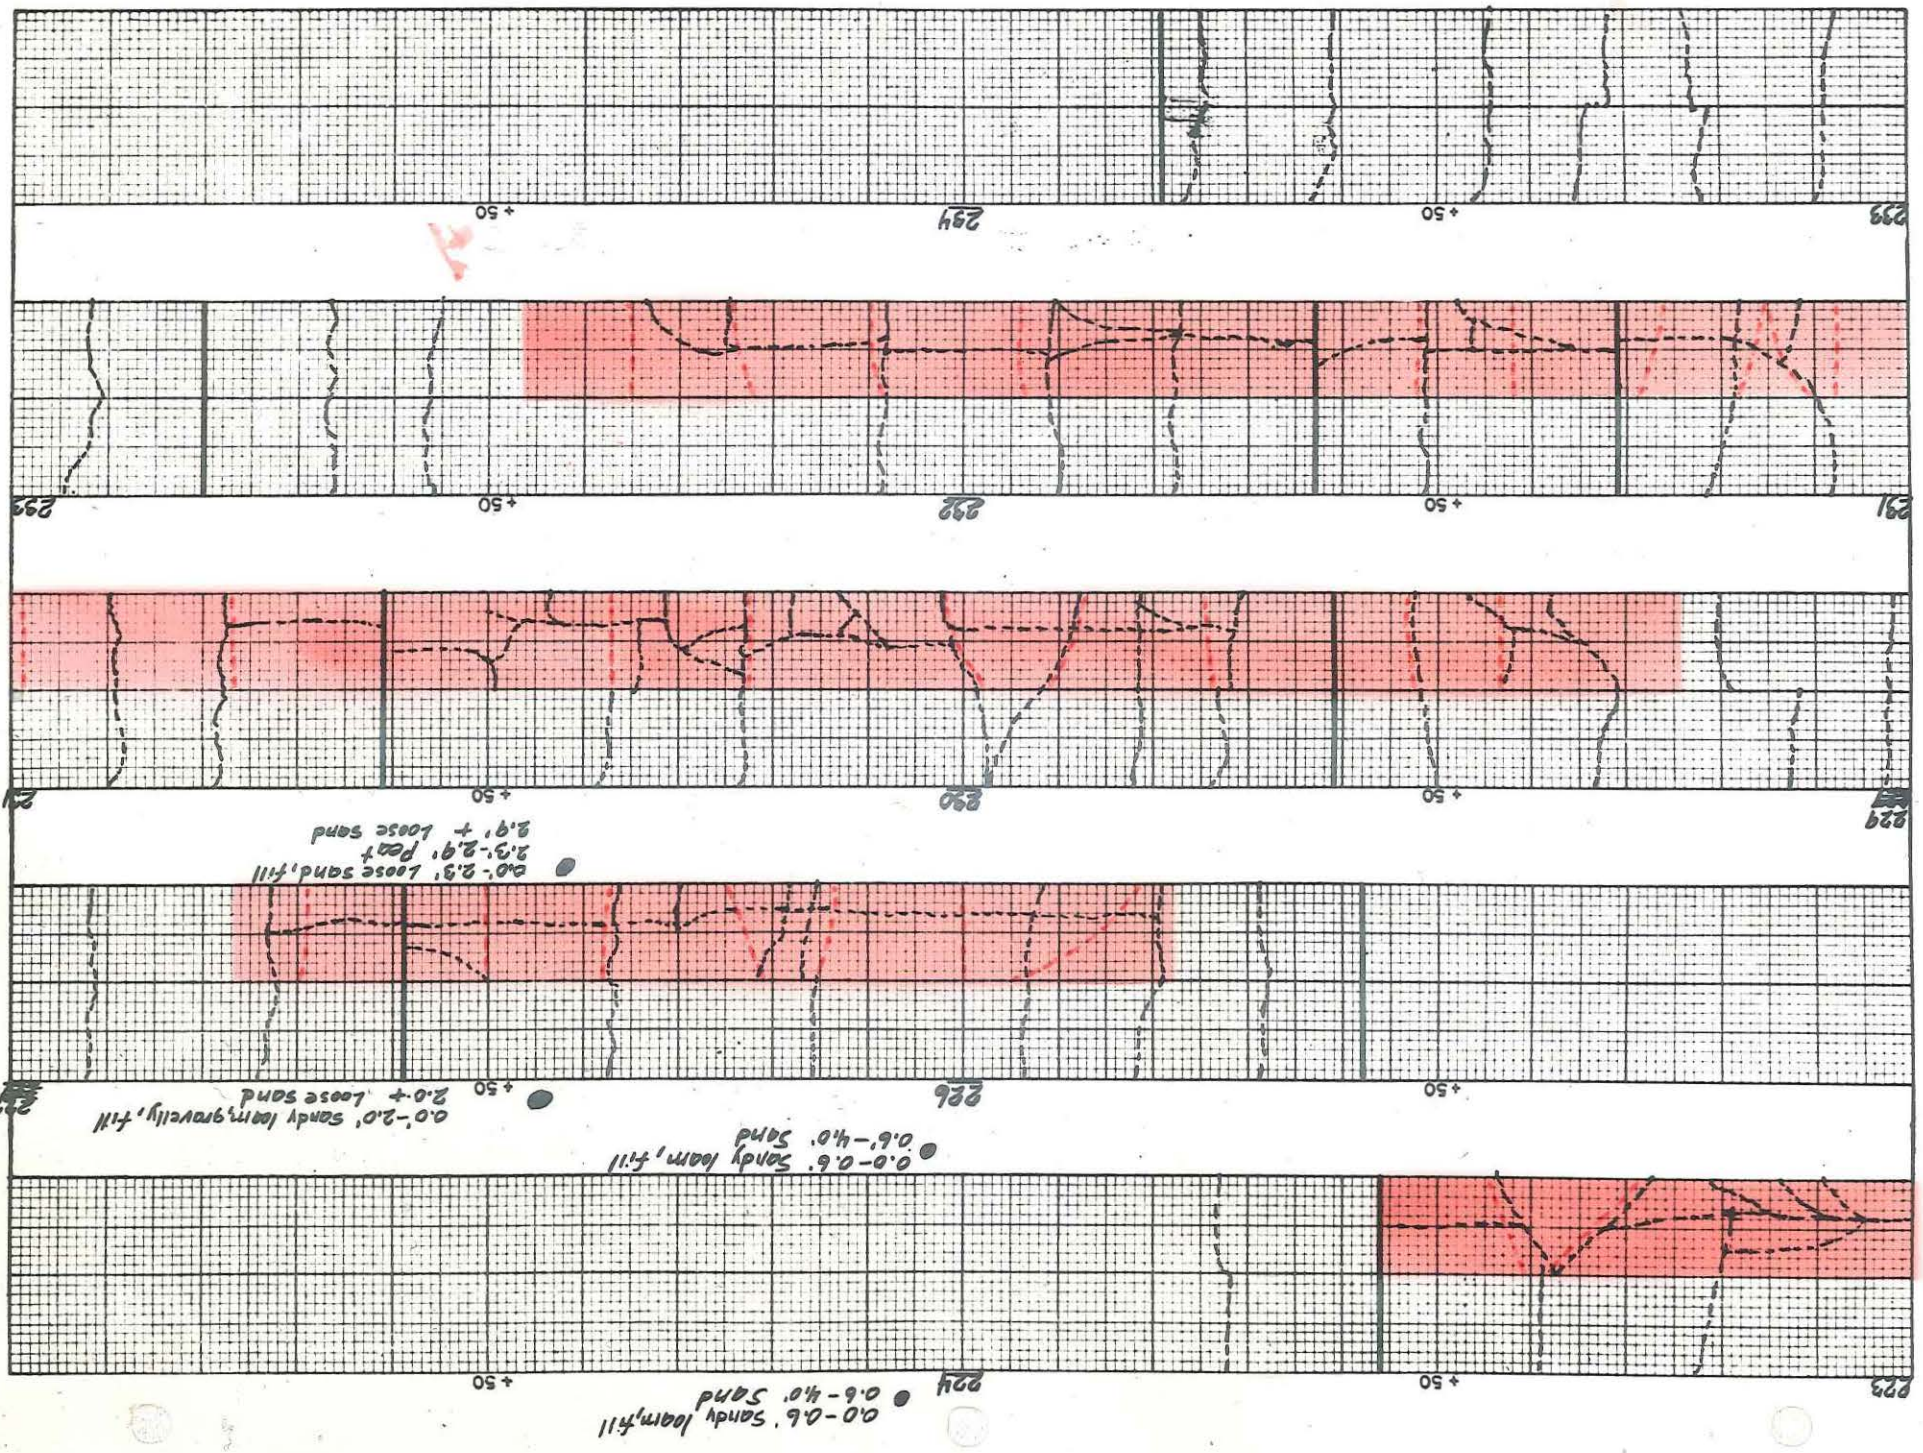
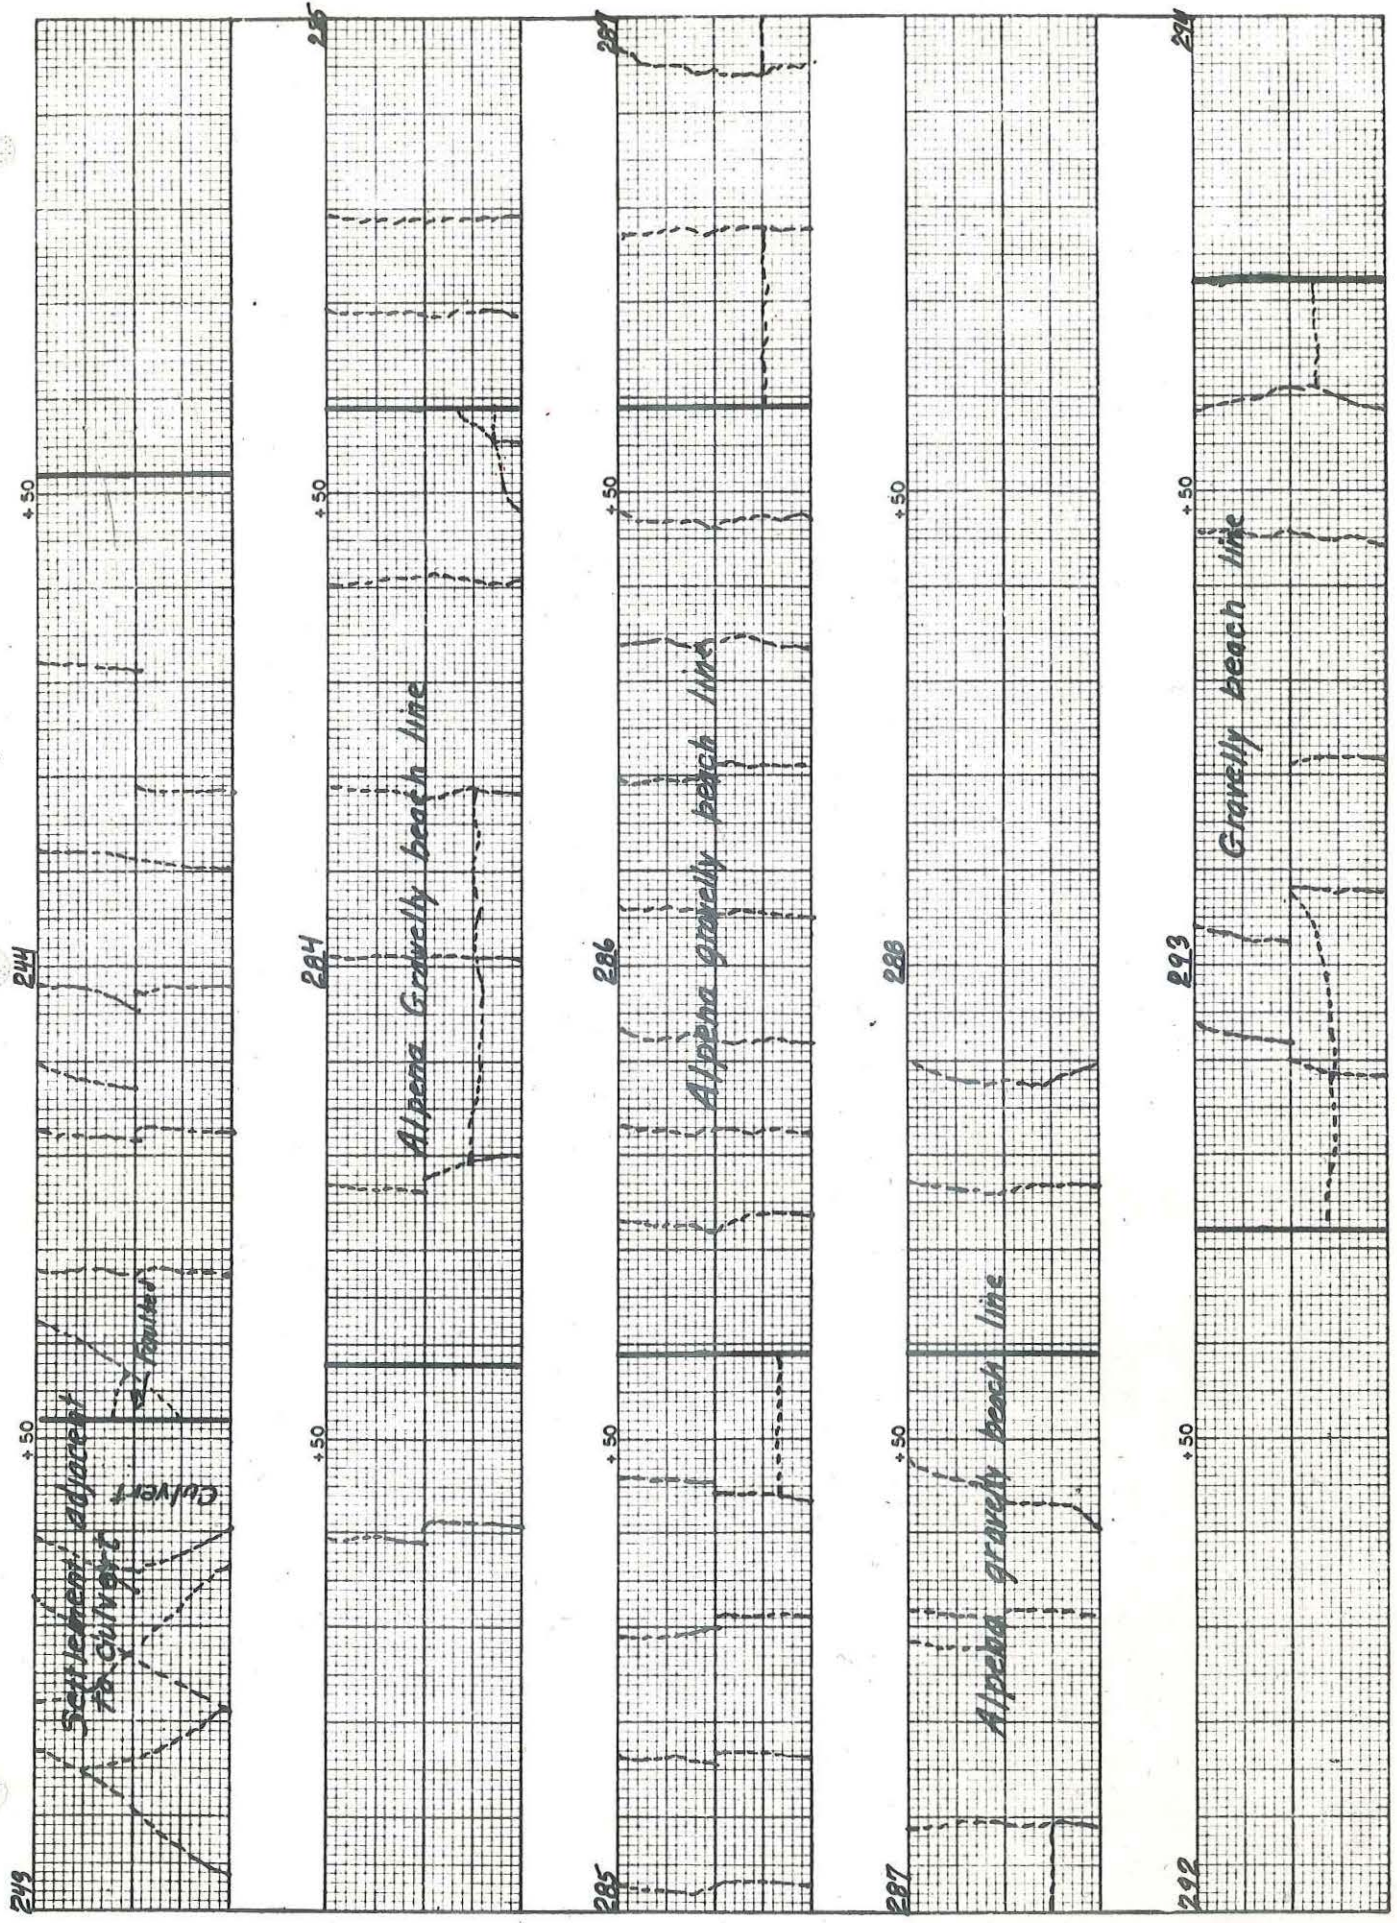
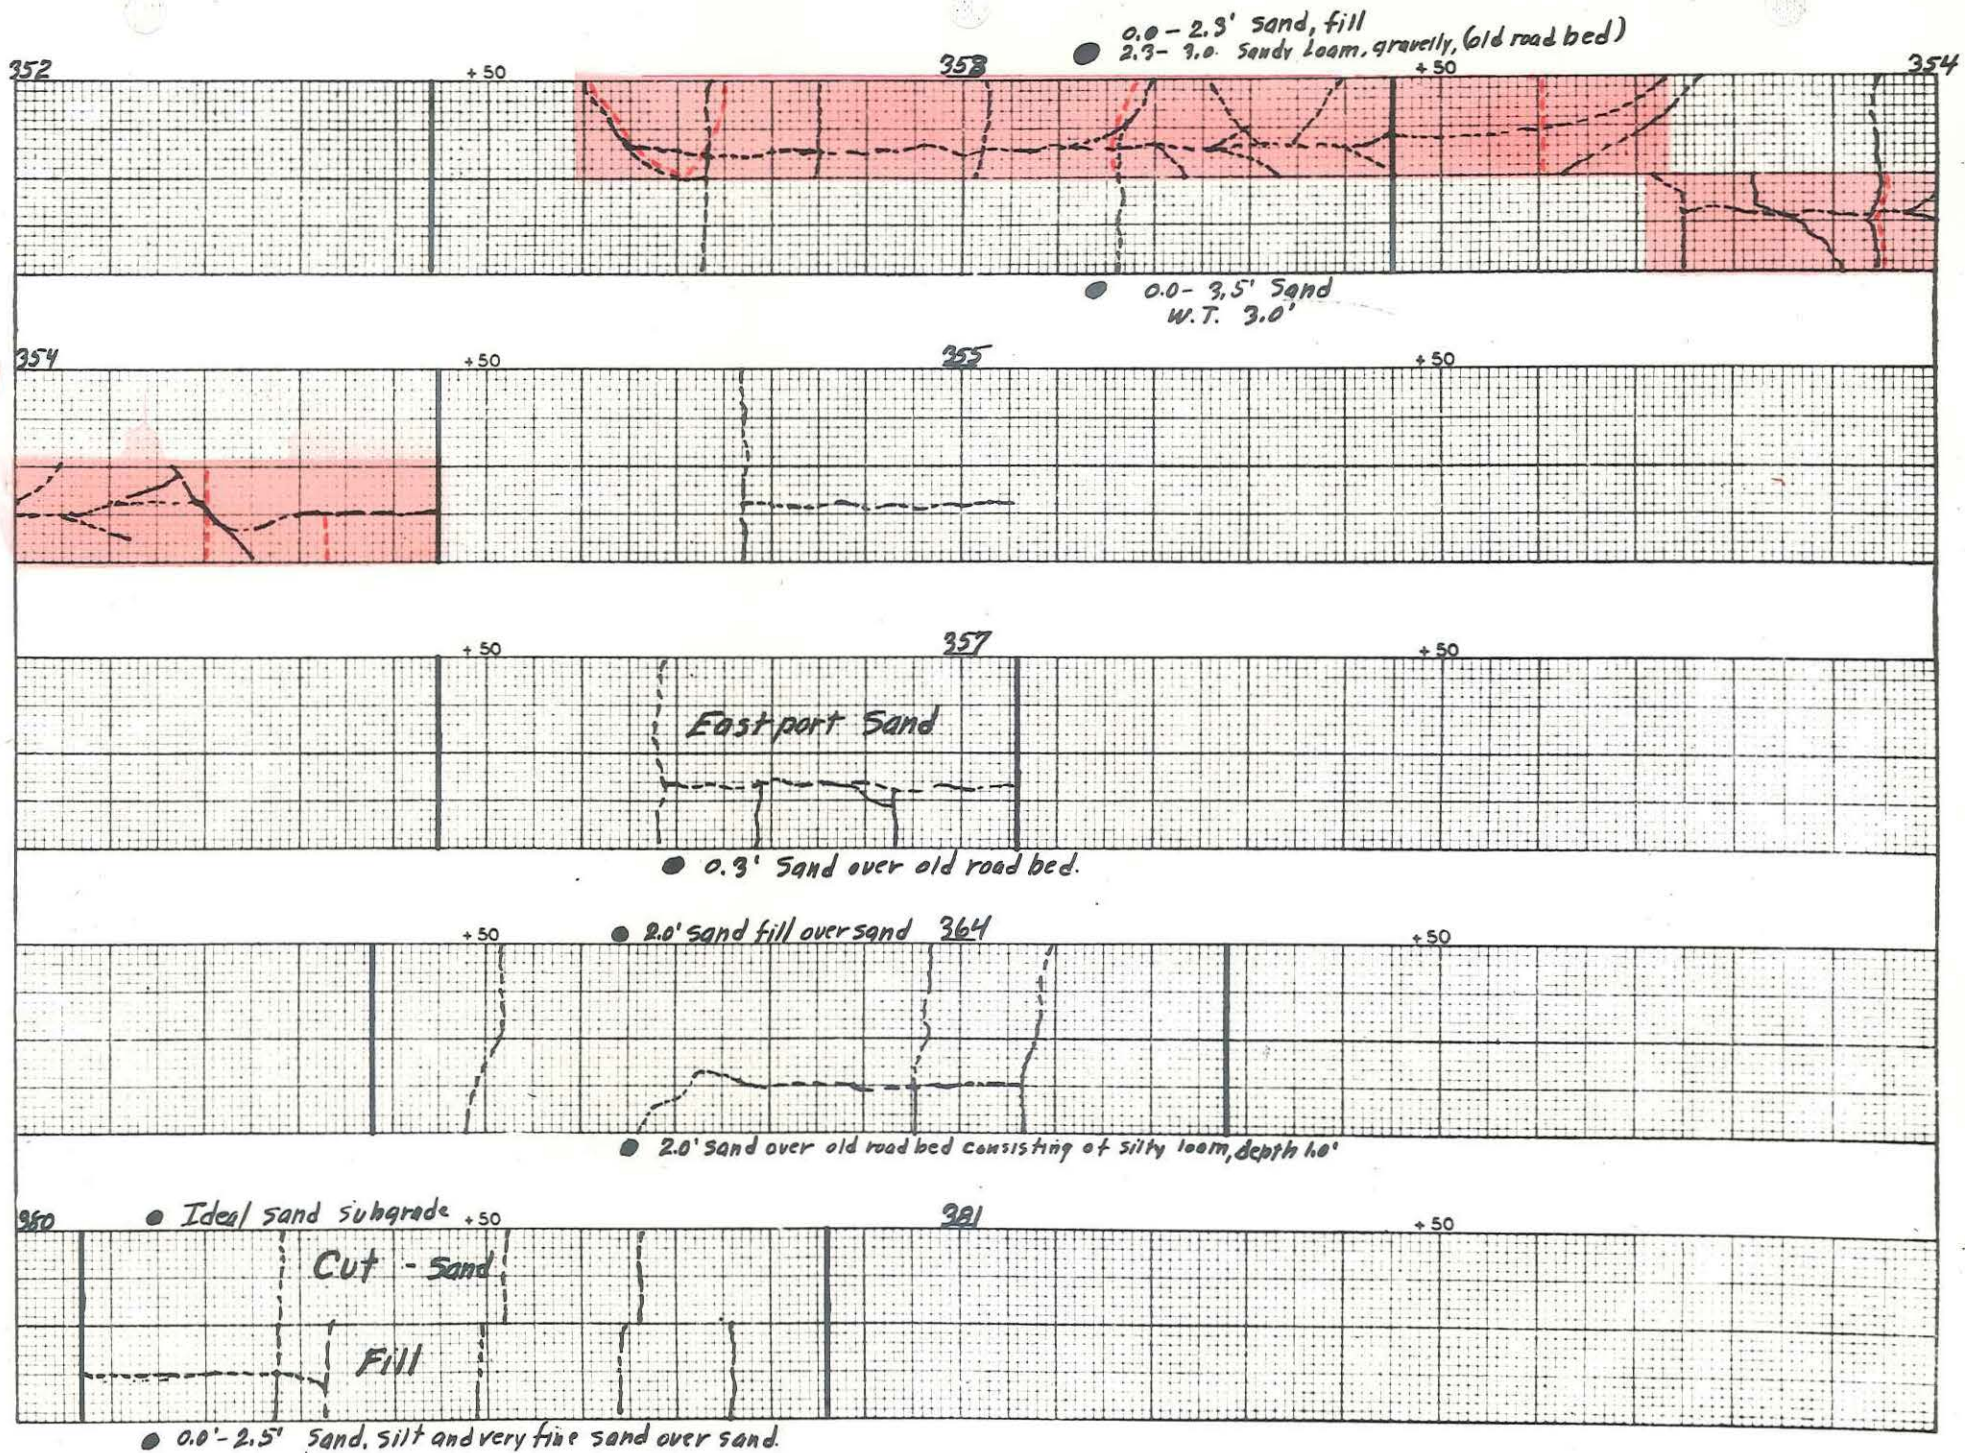
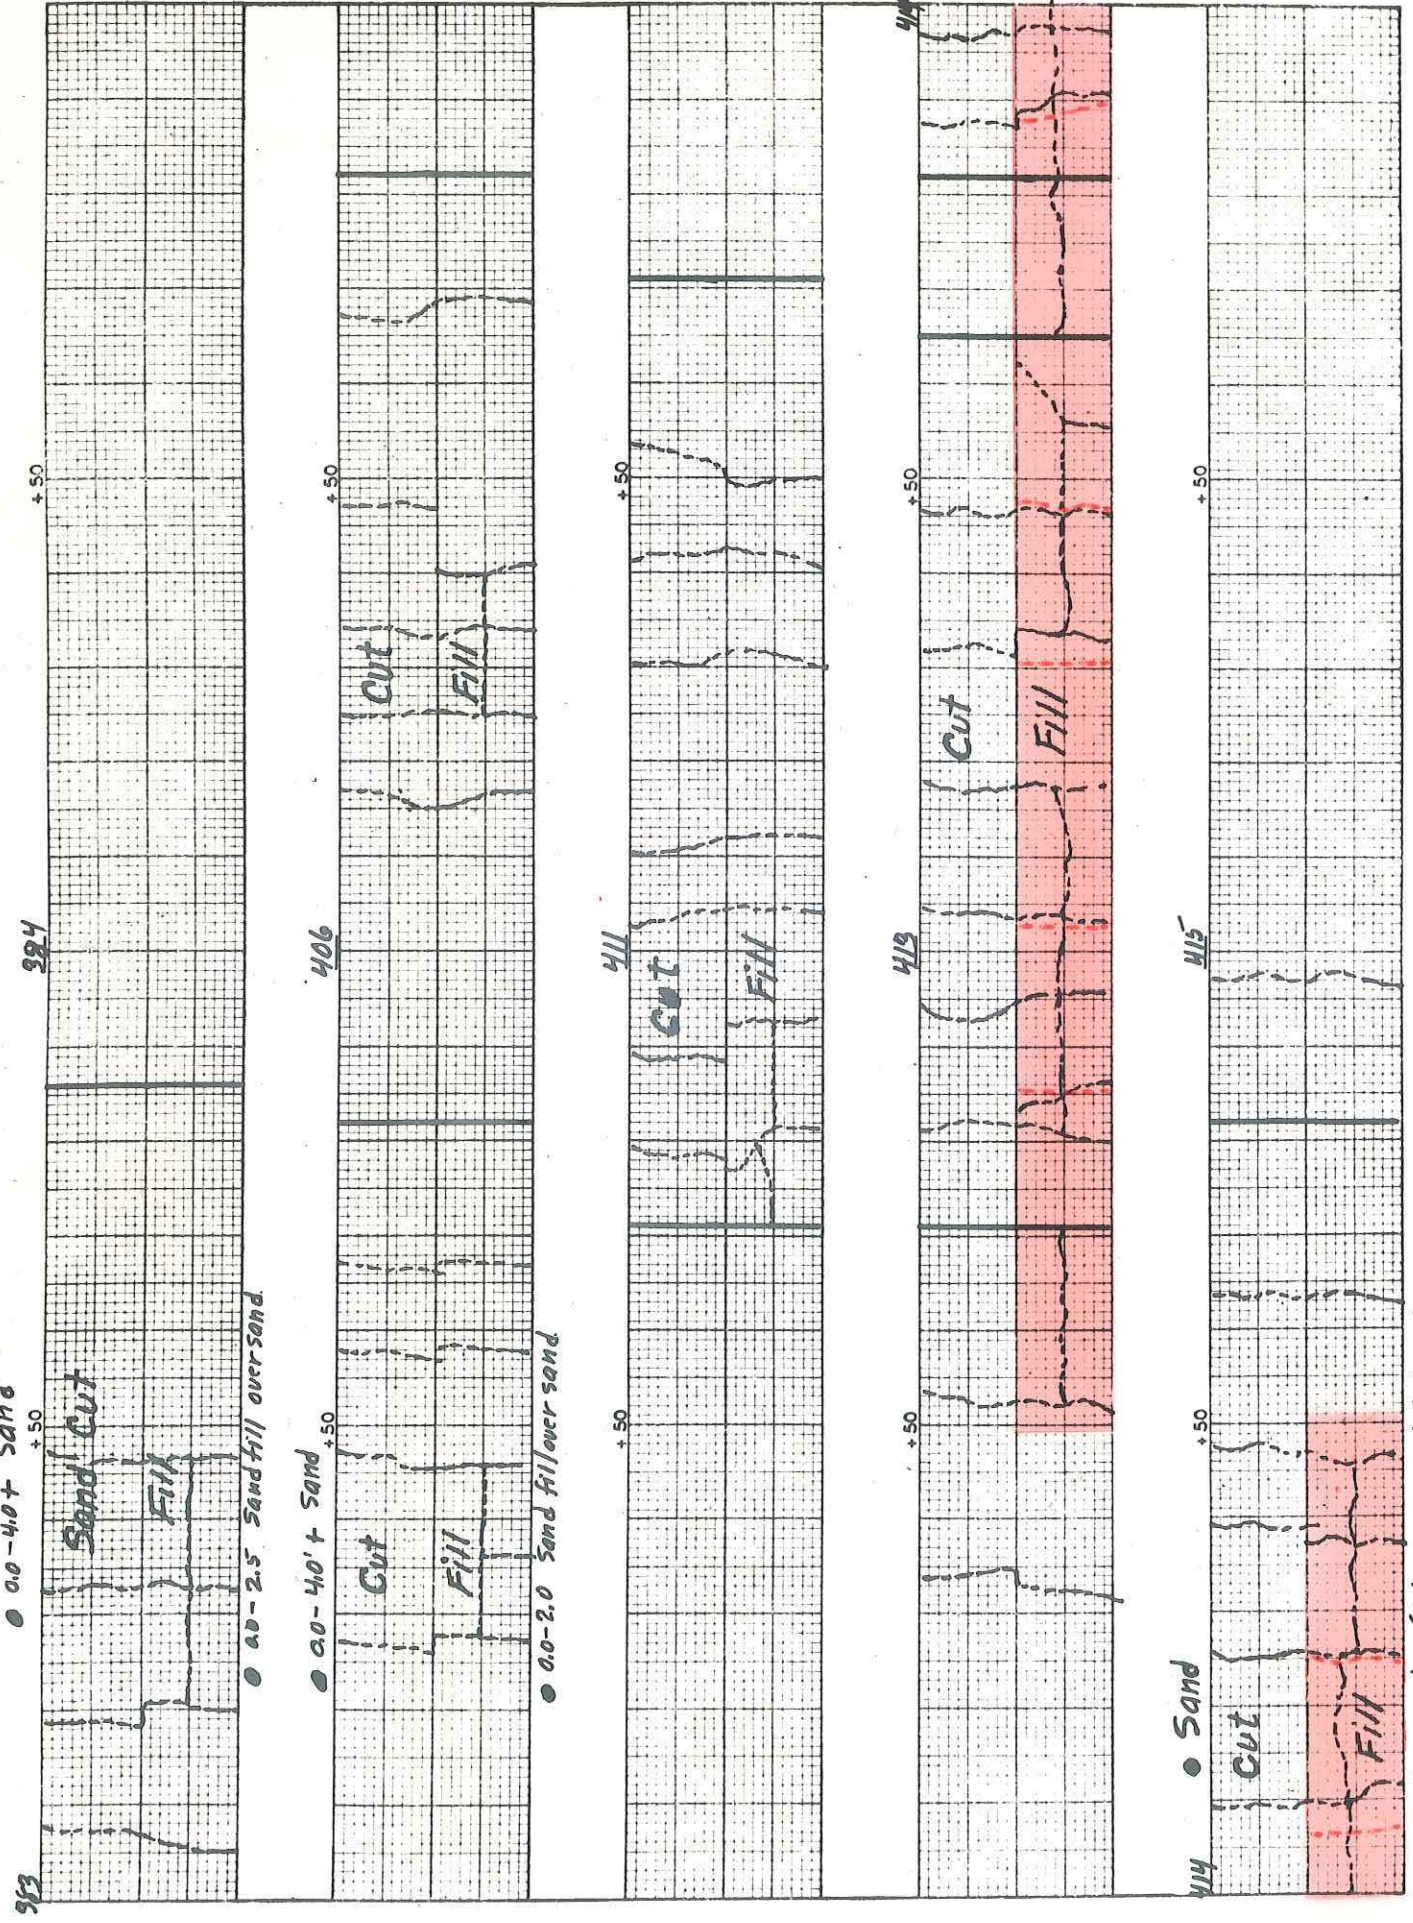
Figure 6

Attention is called to Figures 1 to 5 which illustrated typical cracking of the patches. The crack patterns are clearly defined by the bituminous material used in sealing the cracks. Also following Figure 5 there is included a complete set of condition survey graphs showing the state of cracking at the time of original survey in 1944. The areas patched in 1945 have been superimposed in red color on these graphs. The cracks in the patched areas are illustrated by dashed red lines.
