***FIELD INSPECTION  
OF  
TRAFFIC SIGNAL STRAIN POLES***

**FIELD INSPECTION OF TRAFFIC SIGNAL STRAIN POLES**

Testing and Research Section  
Construction and Technology Division  
Research Project 94 TI-1706  
Research Report No. R-1370

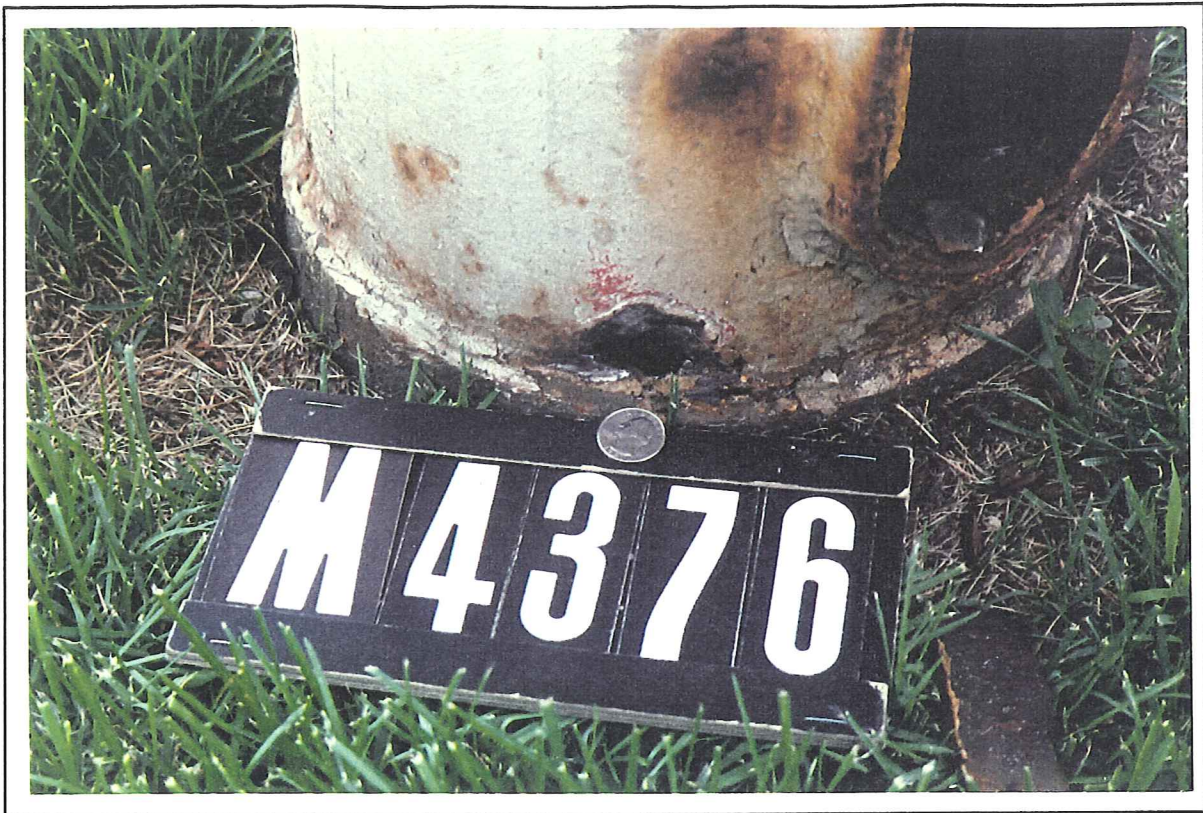
The Structural Research Unit inspected a total of 243 poles in District 8 on M-43 and M-50 and in the Metro District on US-12. Approximately 48 percent of the poles inspected were painted steel, 32 percent galvanized steel, and 20 percent wood. The sample population showed that the poles, for the most part, are performing well. Of the 243 poles inspected, only two were found to be defective. One of these was a heavily corroded painted steel pole with a buried foundation (Figure 10). The other was a wood post with 90 percent section loss at ground level (Figure 11). A representative form the Maintenance Division was contacted about the steel pole, and he said the pole was scheduled for replacement. The SRU contacted the Lansing Board of Water and Light that maintains the wood pole, and the pole has been replaced.

Figure 10 - Heavily Corroded Painted Steel Strain Pole

1. **Corrosion.** Painted steel poles, which comprise the largest percentage of poles in the survey, are more corrosion susceptible than galvanized steel poles. Inspectors should closely examine the base of these poles for section loss and corrosion buildup. Although galvanized steel strain poles are more corrosion resistant, with time they also are subject to corrosion. The estimated life of the protective zinc coating in a potentially salt-laden environment, i.e., in the immediate proximity of a highway, is 30 years. Therefore, the bases of galvanized poles should be examined.

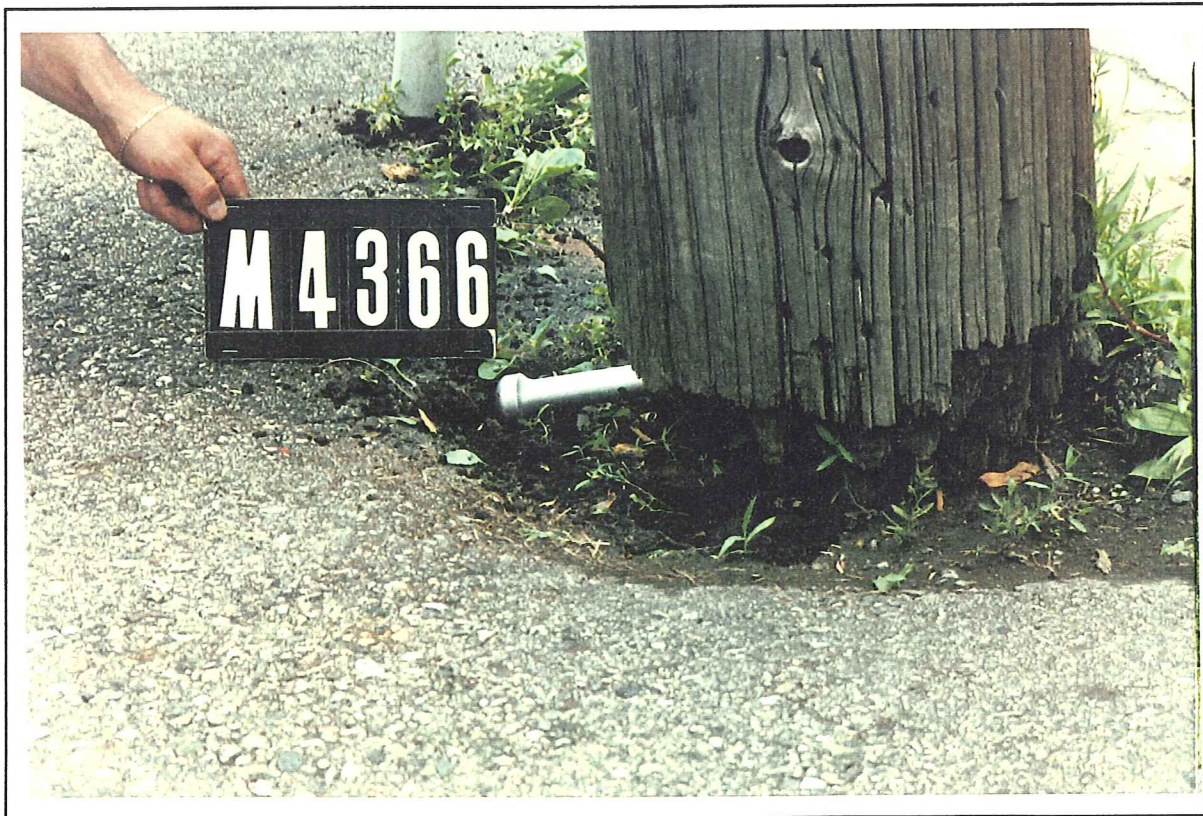
Figure 11 - Wood Strain Pole with Severe Section Loss

4. **Decorative Bases.** Decorative based that prevent access to the anchor bolts should not be used.
5. **Decay.** Wood Poles are subject to decay, especially at the base of the pole. Inspectors should closely examine the base of these poles for section loss and signs of deterioration. Signs of deterioration are staining or discoloration of the wood, surface depressions, and obvious section loss. A simple test that can be performed is probing the surface with a moderately pointed tool, such as a knife, awl, or screw driver. A decayed wood will be evident by excessive softness or a lack of resistance to probe penetration<sup>1</sup>.

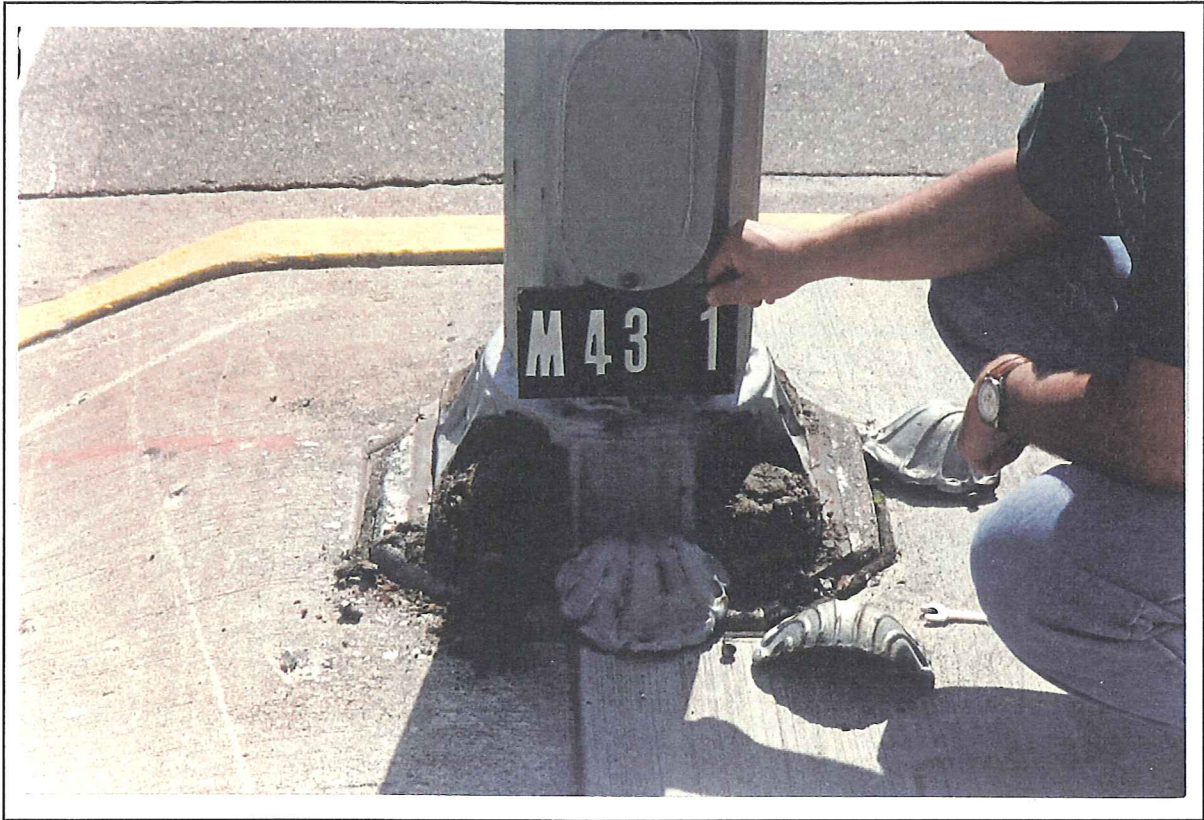
For the sample population of poles we inspected, grout was not used between the base of the pole and the foundation, so problems similar to IDOT did not occur. One potential problem area on many of the steel poles is the anchor bolt/nut covers. These covers trap debris and moisture, accelerating the corrosion of the nuts and bolts as shown in Figure 12. Sometimes the anchor bolts had to be cut to allow the installation of the covers.

Figure 12 - Corrosion of Anchor Bolts and Nuts Accelerated by the Use of Nut/Bolt Covers

3. **Anchor Bolt Nut Covers.** Anchor bolt nut covers should be removed because they trap debris which promotes corrosion of the anchor bolt and nut.

New poles that are installed should be galvanized steel or wood instead of painted steel poles. Strain poles must not be installed with anchor bolt/nut covers because the covers accelerate corrosion in the anchor bolts and nuts, and bolts have been cut to allow the installation of the covers.
