OFFICE MEMORANDUM

SUBJECT: Investigation of Popout Problems on M 14
Research Project 80 TI-649, Research Report No. R-1143

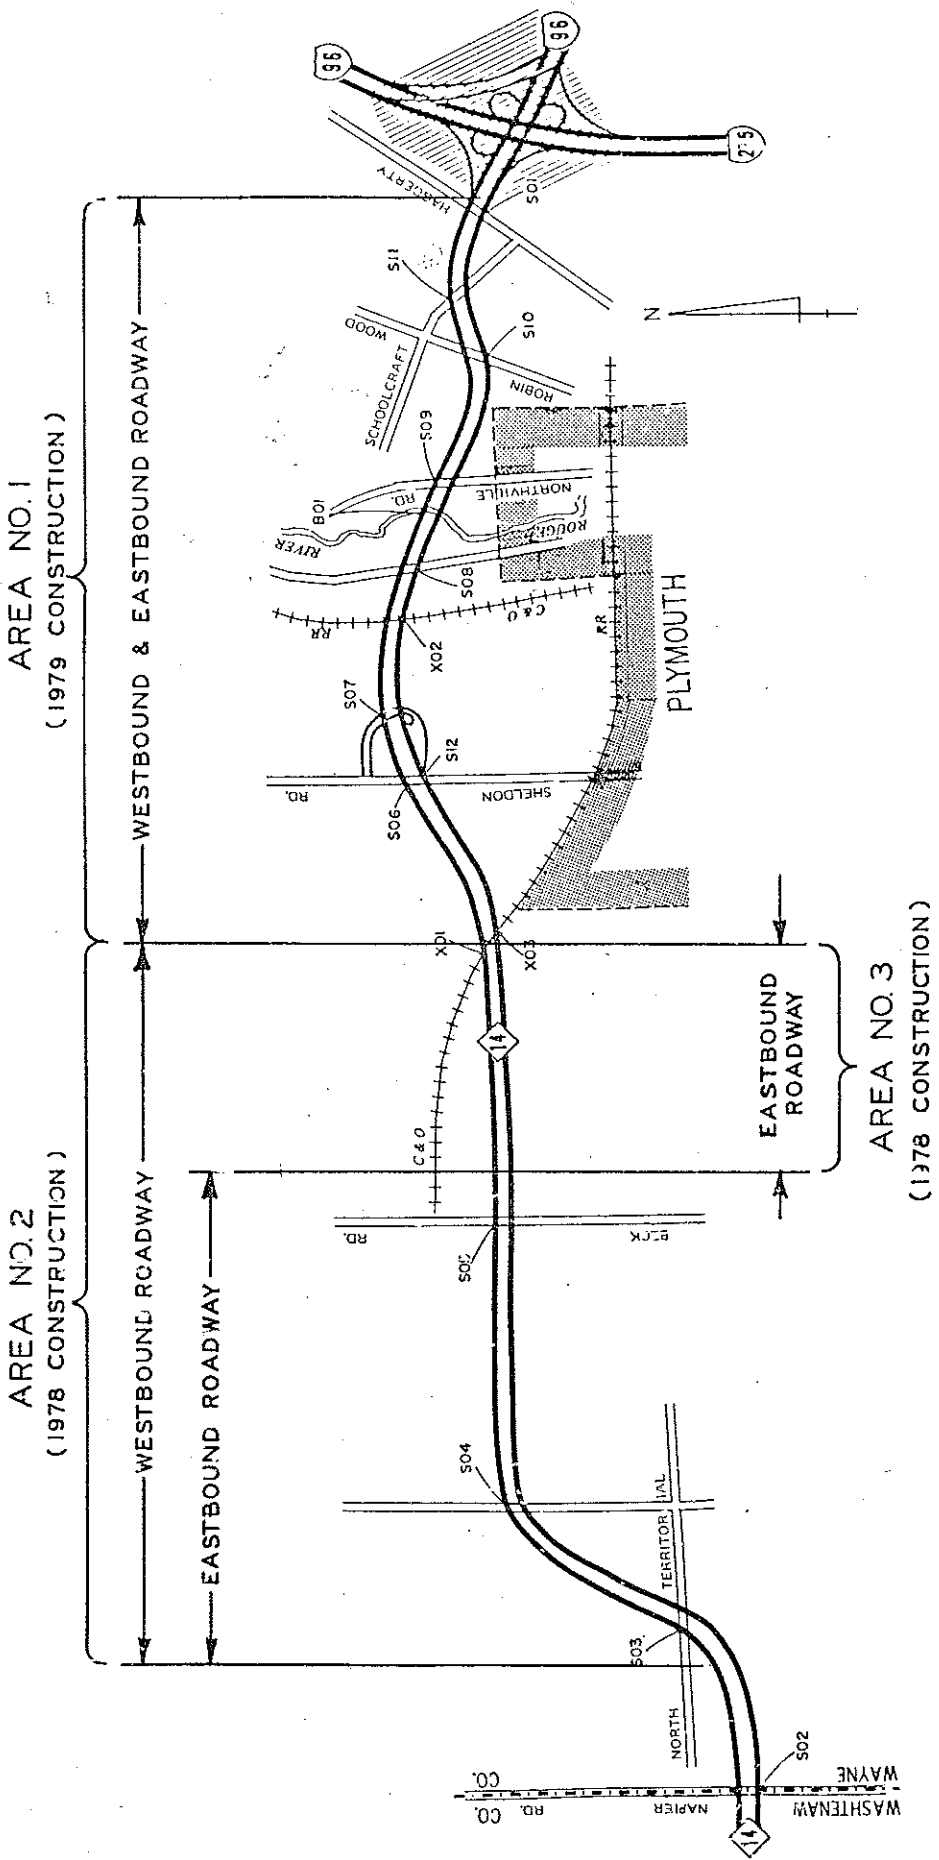
On the basis of the inspection results, it is evident that the most contamination is on the eastbound roadway between Beck Rd and the C&O RR overpass (Area 3, Fig. 1). The remaining pavement west of the railroad overpass (Area 2, Fig. 1) is only moderately contaminated and the portion of pavement east of the railroad (Area 1, Fig. 1) is only slightly contaminated.

Figure 1. Areas with different degrees of contamination.
